Infrared Thermographic Survey

Defects on External Wall

Block 1, Casa De Oro, in D.D. 124 Hung Shui Kiu,
N.T.

Date of Issue: 2022-12-30

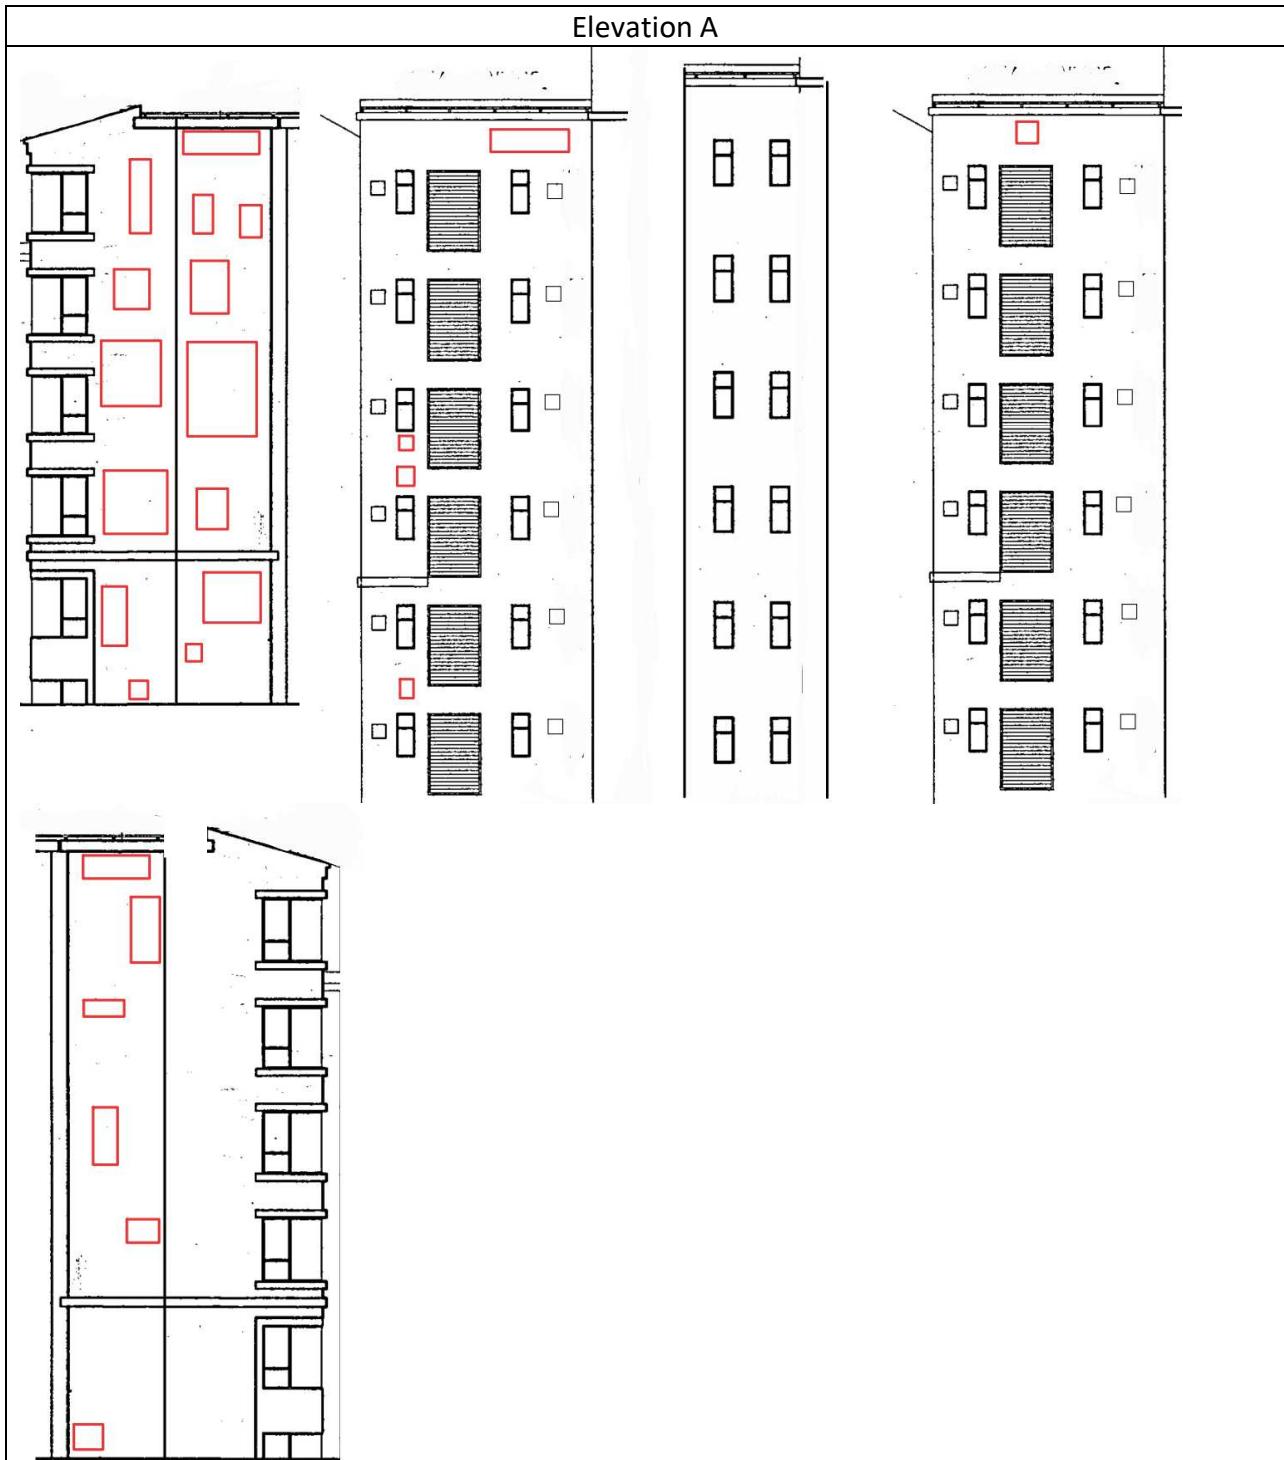
Elevation B

- Level 0 – Source of Noise
- Level I – Suspected Debonding
- Steep View of Angle (> 40°)
- Screening Objects
