## **TECHNICAL MEMORANDUM**

<b>Date:</b> 06/12/2023	<b>Study No:</b> 601CT0000029807
<b>To:</b> Larry Blackburn, P.E. ASM Rahman, Ph.D., P.E.	<b>Tech Memo No:</b> 601CT0000029807-TM1
<b>From:</b> Research Team	<b>Revision No:</b>
<b>Subject:</b> Evaluation of the Pavement Condition in Beltway 8 in Houston

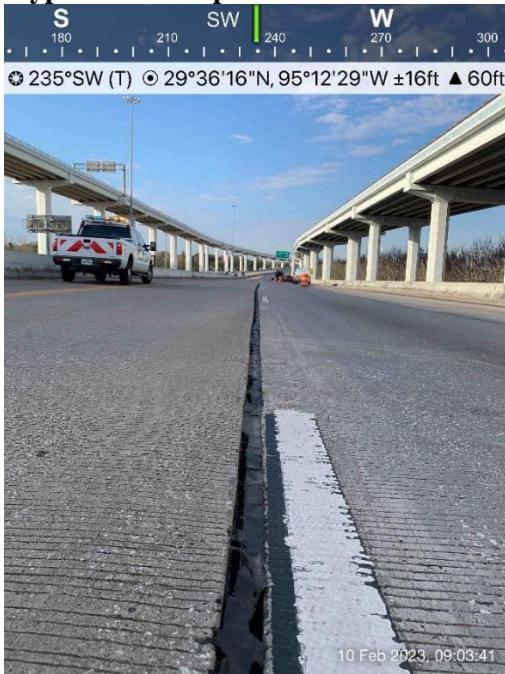
**3.a. Typical Lane Separation**

The condition of the subject section was evaluated onsite and lane separation, faulting, and settlement were the major distresses observed. These distresses lead to uneven roadway surfaces, which have the potential to result in serious accidents at highway speeds. Also, the depressed slab which is below the design grade collects water that could cause hydroplaning or ice formation during freezing temperatures. **Figure 3** presents some of the sections with lane separation, faulting, settlement and tilting of retaining wall observed in the site.

As a short-term strategy, a temporary repair may include filling the separated joints with flowable grout, which should minimize the infiltration of water through the joints. Long-term strategy should include addressing MSE wall issues, along with full-depth repairs and, if needed, hot mix asphalt overlays. In the case of the MSE wall, a geotechnical survey will be necessary to determine the most appropriate course of action.

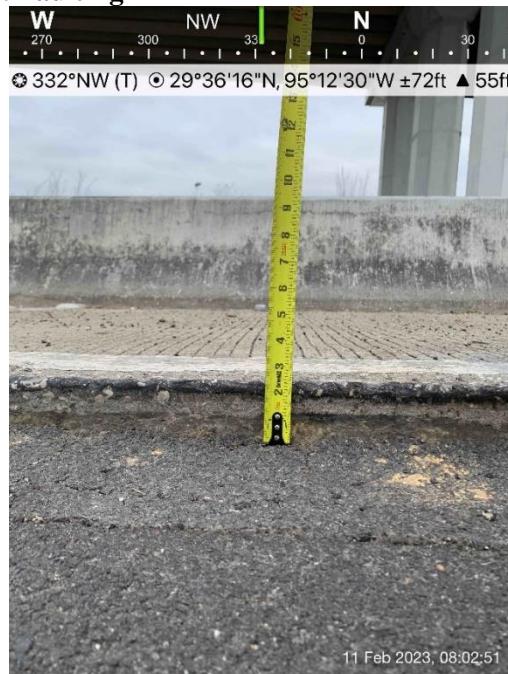
**3.d. Faulting**
