## TECHNICAL MEMORANDUM 3 & 4

<b>Date:</b> 07/31/2024	<b>Study No:</b> 0-7147 "Project Level Performance Database for Rigid Pavements in Texas, Phase III"
<b>To:</b> 0-7147 Project Team	<b>Tech Memo No:</b> 0-7147 Technical Memorandum 3 & 4
<b>From:</b> 0-7147 Research Team	<b>Revision No.: 1</b>
<b>Subject:</b>  Task 3. Performance Evaluation of Special Pavement Sections, Task 4. Performance Evaluation of Experimental Sections

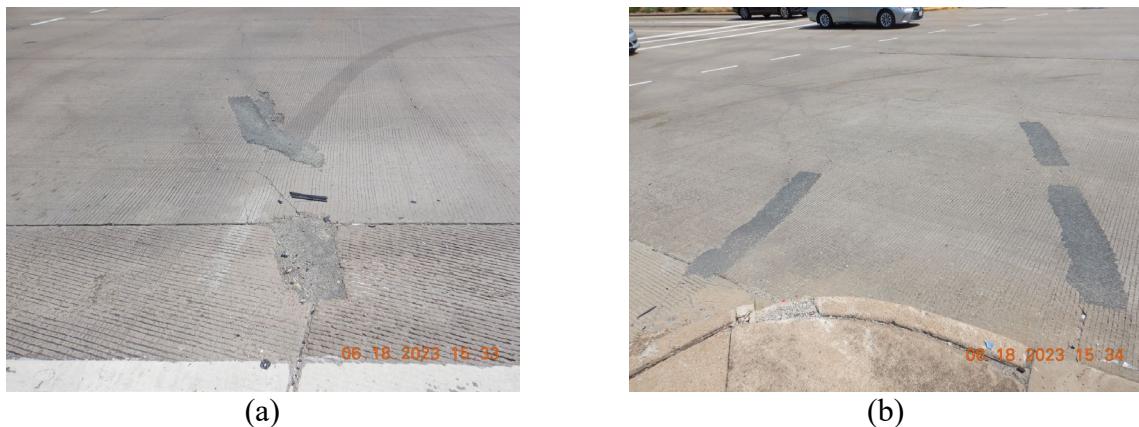
The traffic at this intersection is quite high, which necessitated the use of FT-CRCP at this intersection. After more than 20 years, this section has mixed performance. The portion of FT-CRCP under US 59 (now IH 69) is excellent, with transverse cracks so tight. The reason is that this area is in the shade all the time, with minimum concrete temperature variations. On the other hand, the sections outside of the US 59 bridge experienced severe spalling ([Figure 2](#)). In this project, siliceous river gravel (SRG) was utilized as the coarse aggregate, which explains why severe spalling occurred. However, it should be noted that this spalling issue and resulting poor performance in terms of ride quality does not have anything to do with FT-CRCP system.

*Figure 2 Observed Spalling (SH6)*

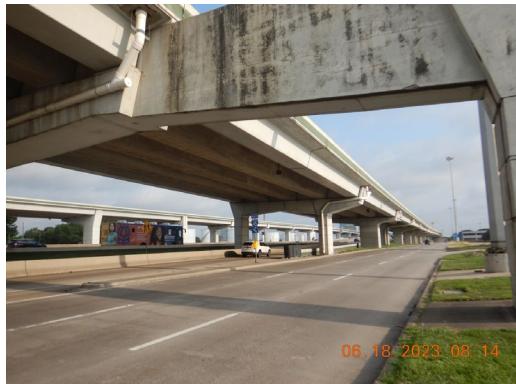
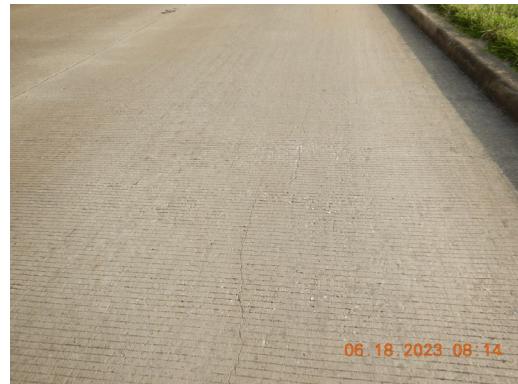
The IH 45 Frontage Road section, previously reported to have tight longitudinal cracks, was revisited approximately 10 years later. The subsequent evaluation found that these cracks remained still tight (**Figure 3**), indicating that this crack could be superficial in nature to relieve warping and curling stresses. Other than the longitudinal cracks, there were no distresses, and after more than 30 years in service, the section is still in excellent condition.

(b) Longitudinal Crack

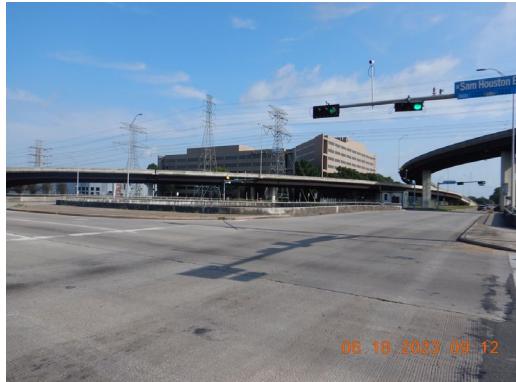
This section is on the embankment area, and numerous cracks were observed, some of which have large crack widths. Also, most of the cracks with large widths are not of typical transverse crack shape, which implies that these cracks were not to relieve environmental stresses (temperature and moisture variations); rather, they are due to volume changes in the embankment materials. As previously reported, these soil movements led to significant cracking, necessitating full-depth repairs to restore the pavement's integrity ([Figure 4](#)).

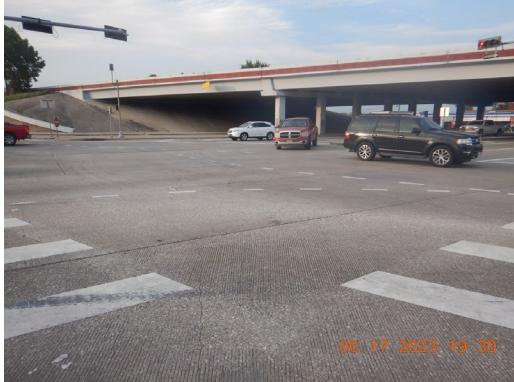
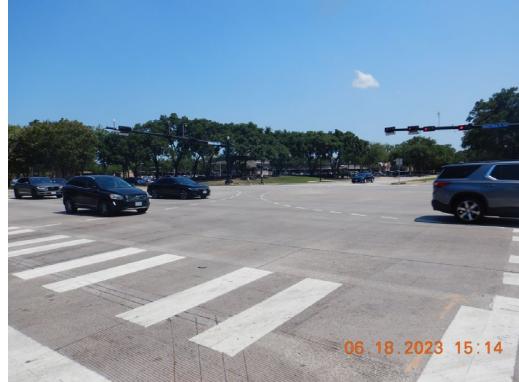
*Figure 5 Overview of other FT-CRCP in Houston*

Other FT-CRCP sections were generally found to be in excellent condition ([Figure 5](#)), showing minimal signs of distress. This overall good condition underscores the effectiveness of FT-CRCP in handling the demands of high-traffic environments, provided that initial construction and ongoing maintenance are managed effectively.

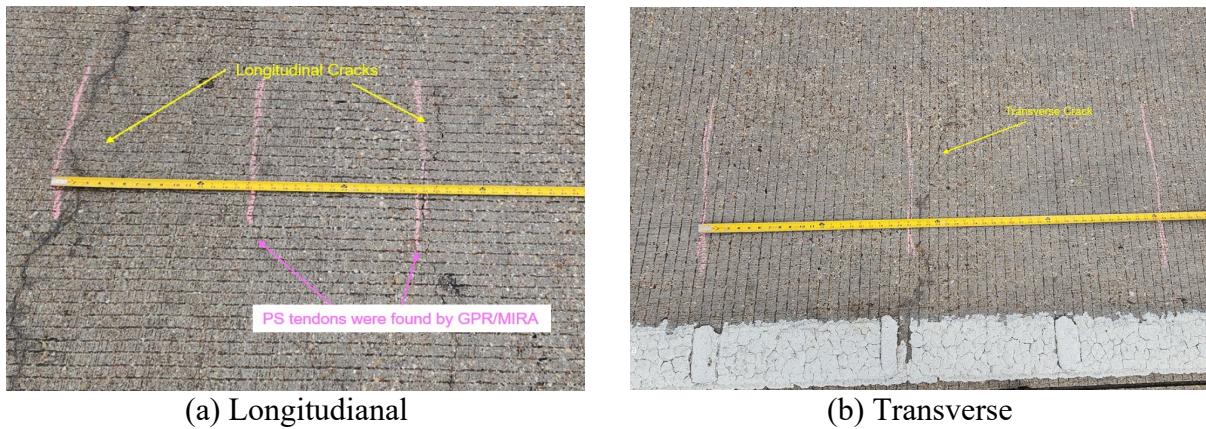
An evaluation conducted in June 2024 with TxDOT Maintenance Division revealed that the PTCP section remains in excellent condition, despite some observations of transverse and longitudinal cracks (as shown in [Figure 7](#)). Most of these cracks developed above the longitudinal and transverse pre-stressed tendons. It is quite similar to other cast-in-place concrete structures and pavement, where cracks usually develop along reinforcement from either differential settlement or Poisson's ratio effect.

**Figure 7 Observed Cracks & location of Steel**

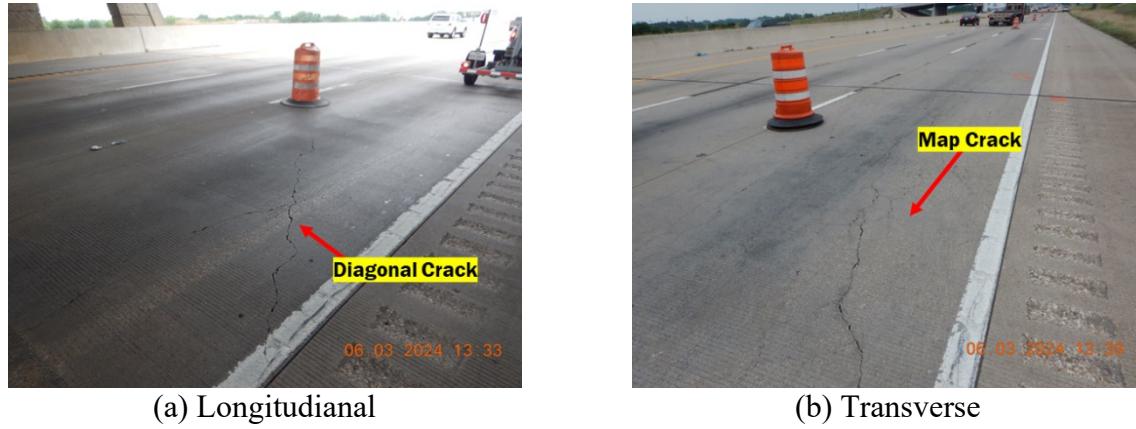
Even though the condition of the PTCP throughout the project is quite satisfactory, there is an area in the northern part the project in northbound, where a half-moon shape crack developed, along with evidence of undersealing. (see [Figure 11](#)). It was observed that there is a drainage issue in this area.

**Figure 11 Observed Distresses in PTCP section**

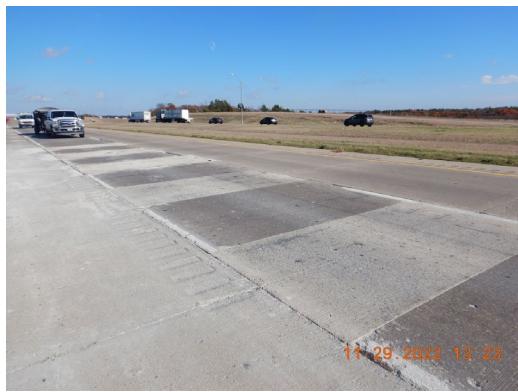
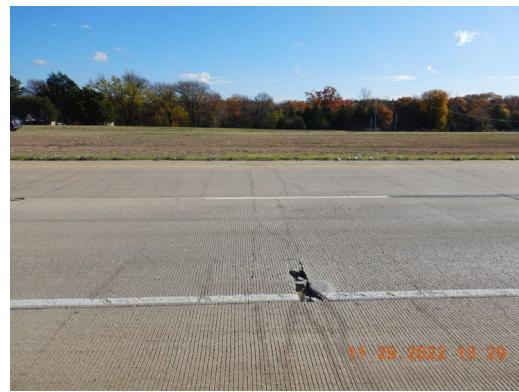
As for the condition of this pavement, numerous PCC patches were observed in the outside lane, attributed to construction issues as reported in 0-6590, even though a single distress was observed in the inside lane. As shown in [Figure 13](#), PCC patches were in the outside lane only, with one location where a distress was in progress.

(a) PCC patches in outside lane

(b) Distress in progress

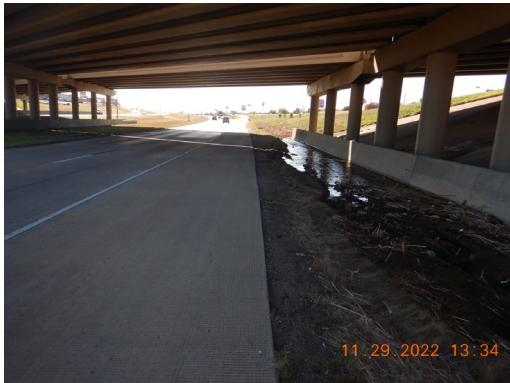
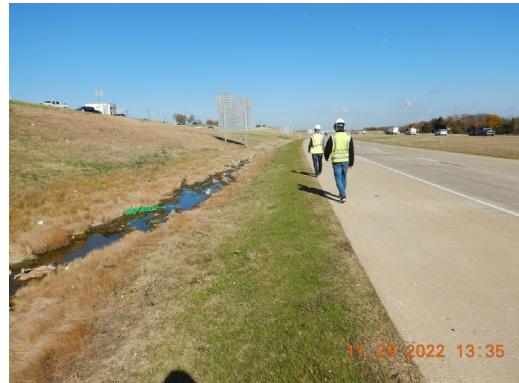
Additionally, drainage issues seem to be a pressing concern, as waterlogged areas were observed near the bridge as shown in [Figure 14](#), which could eventually compromise the base support of the pavement.

(a) waterlogging beneath the bridge

(b) drainage in the side of the road pavement

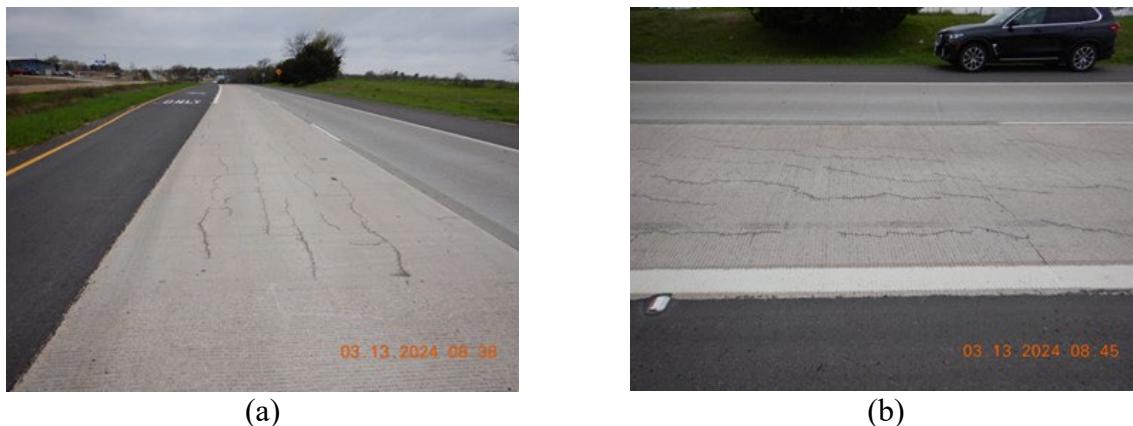
Both the outside and inside lanes experienced bonding issues, traced back to the use of high slump concrete delivered during construction. Two prominent issues were observed: debonding and longitudinal cracks. Debonding was more common in the outside lane, whereas the inside lane had more longitudinal cracks along with debonding issues.

A field visit in March 2024 revealed the extent of longitudinal cracks, as shown in Figure 16. Settlement cracks were also observed in the inside lane, along with debonding near the longitudinal cracks, which was partly linked to the use of high slump concrete.

**Figure 16 Longitudinal cracks observed in the inside lane**

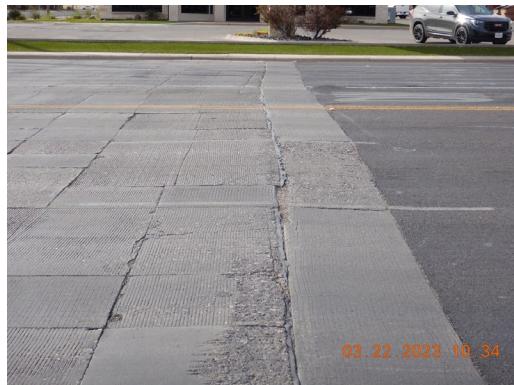
The whitetopping section in Midland in the Odessa District was constructed in 2002, and during the evaluation, it was observed that slab slippage was a major issue. [Figure 18](#) illustrates the extent of the observed distress, which may be due to the debonding between the concrete and asphalt layers, consistent with previous reports. During the field evaluations in the Midland section, lane widening was undersay, allowing for an observation of the side of the whitetopping as shown in [Figure 17](#). It was observed that not all the saw-cut joints propagate through the slab; rather, saw-cut joints were popped every 6-ft rather than every 3-ft, which is the slab size. This indicates that the natural joint spacing for this whitetopping section could be 6-ft.

**Figure 18 Sliding in WT section in Odessa**

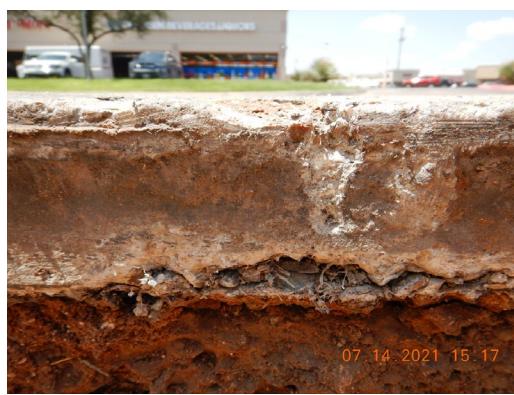
**Figure 19 Edge Cross Section View of WT in Midland at Sawcut Location**

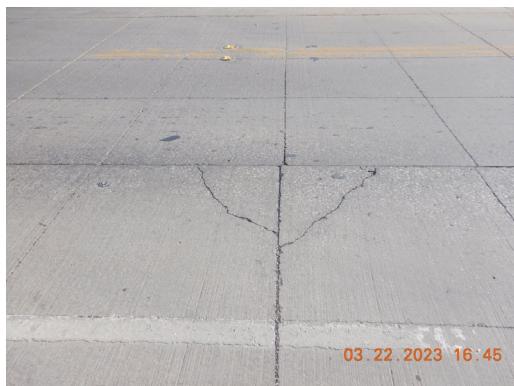
In the Abilene section, numerous diamond cracks were observed as shown in [Figure 20](#). The cause of these cracks is likely due to the joints being located in the wheel path. This distress is similar to what was observed in the Whitetopping project in Minnesota. The extent of the cracking worsened over time, and it is believed that these diamond cracks will compromise the long-term performance of whitetopping.

**Figure 20 Diamond Crack in WT Section in Abilene**

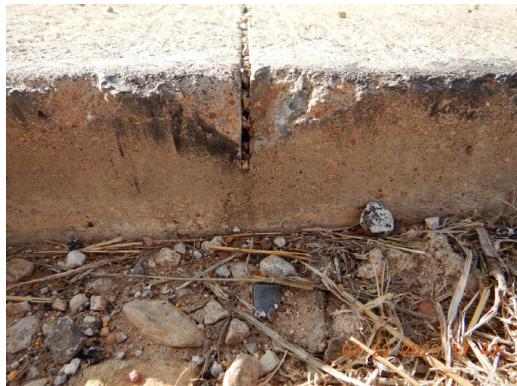
In the Cross Plains section in the Brownwood District, as shown in [Figure 21](#), it was observed that cracks did not propagate at all saw-cut joints, as observed in the Midland section. Some suggest that the lack of crack propagation is due to insufficient saw-cut depth. However, in the Cross Plains section, the saw-cut depth is one-third of the slab thickness, which should be sufficient. Despite this, some joints did not crack. This indicates that the 4-ft joint spacing applied in this whitetopping project is also somewhat smaller than needed. Based on the information from the Midland and Cross Plains sections, it can be concluded that slab sizes of 3-ft and 4-ft are smaller than needed for whitetopping design, and the current TxDOT design of 6-ft by 6-ft appears to be adequate.

***Figure 21 Edge Cross Section View of Whitetopping Project in Cross Plains***

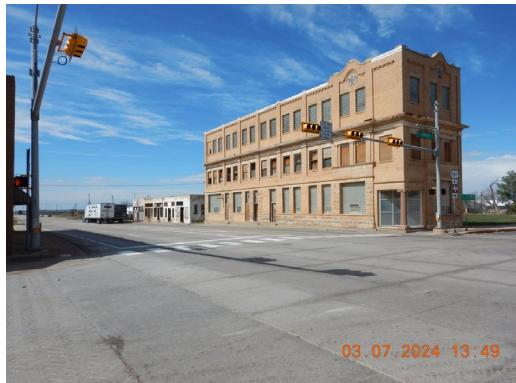
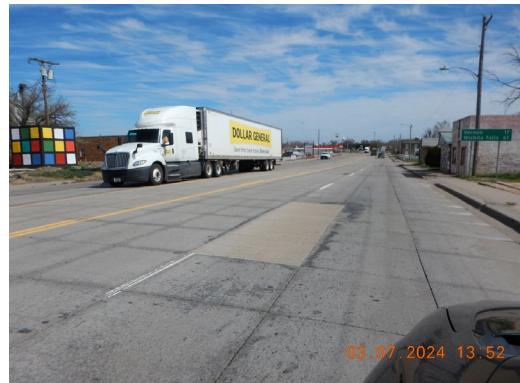
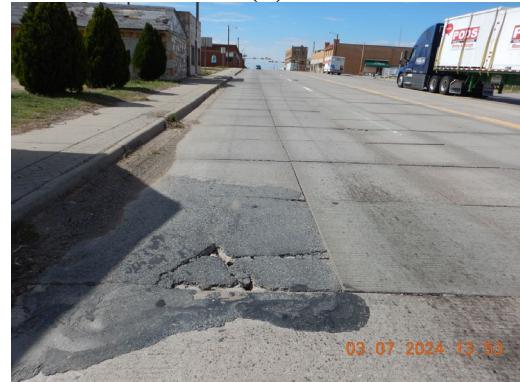
The whitetopping section constructed at the intersection in Chillicothe in the Childress District was evaluated and found to be in quite good condition. This section, constructed with a slab size of 5-ft by 5-ft, showed only one diagonal crack and FDR each, and one distress was observed at the transition to CRCP. However, the overall condition was notably good, with no sliding observed. The overview and observed distresses are shown in [Figure 22](#).

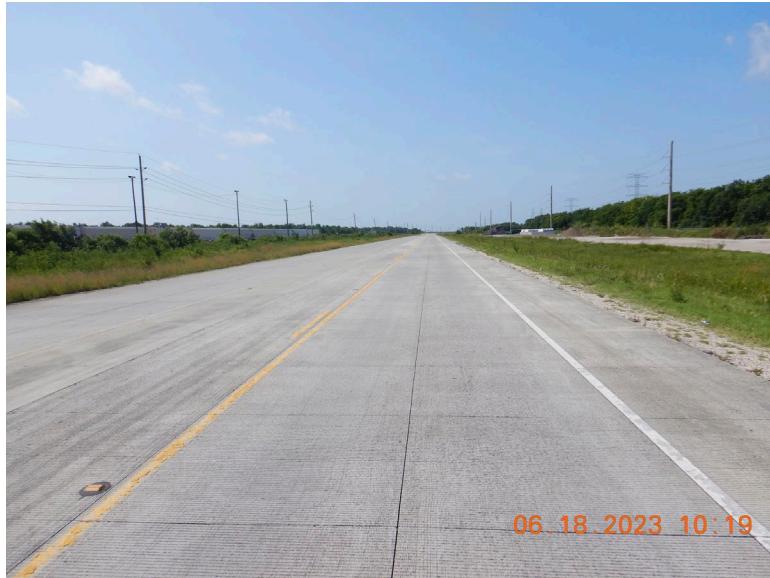
**Figure 24 Whitetopping in FM1405**

Lastly, an interesting whitetopping project was evaluated at FM1405 in Beach City, in the Beaumont District, with GPS coordinates 29.727999, -94.916286. This section is the only whitetopping project constructed on a regular roadway rather than at an intersection. The pavement is 6-in thick, slab size is 6-ft by 6-ft, and the entire section is approximately 3.3 miles long. The overall performance observed during the field evaluation was quite good as shown in [Figure 24](#). As shown in [Figure 25](#), however, in the northern part of the section near the railway, some distresses, including various types of cracks, were observed. These distresses were limited to the area near the railway, and no significant distress was observed elsewhere. The potential cause of the distress is attributed to the construction on an embankment, where volume changes in the subgrade likely led to the observed issues.

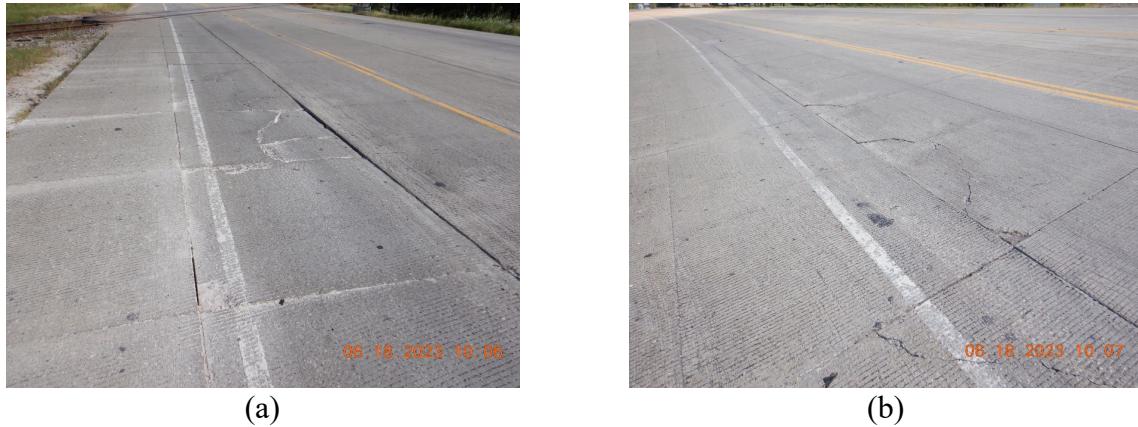
**Figure 25 Observed Distresses in FM1405**

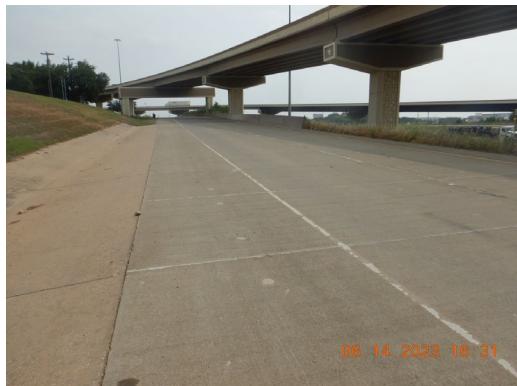
*Figure 26 PCP section in Georgetown*

The first section, shown in [Figure 26](#), is located on the northbound of IH 35 frontage road between Airport Road and SH 195 in Georgetown, with GPS coordinates [30.687526, -97.656608]. This section utilized the CTR method developed by UT Austin [8]. The CTR method involves applying post-tensioning to precast slabs, which is different from the most widely used method of PCP, where no post-tensioning is applied. The thickness of the pre-cast panels was 8-in. During the section evaluation, joint faulting and longitudinal cracks were observed, which were also mentioned in previous reports. Additionally, small cracks were observed at the slab edges, as shown in [Figure 27](#). However, due to the relatively low traffic volume in this section, these small cracks do not cause significant problems. The value of this section is quite limited since the traffic volume is so low, and no conclusions could be made whether this technology could be a viable option for highways with heavy truck traffic, which is unfortunate. In the future, it is advised that special sections are placed at roadways with heavy truck traffic, with the idea that failure could occur and repairs would be needed. The bottom line is that we learn more from failures and successes.

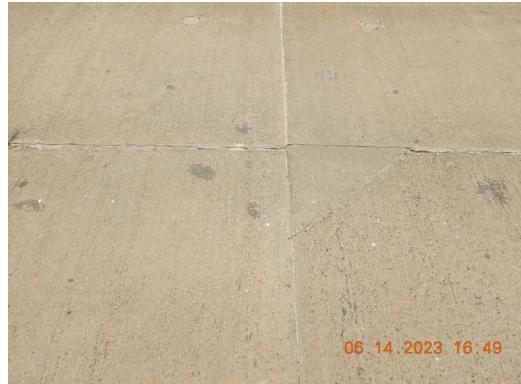
**Figure 27 Edge Crack in PCP Section in Georgetown**

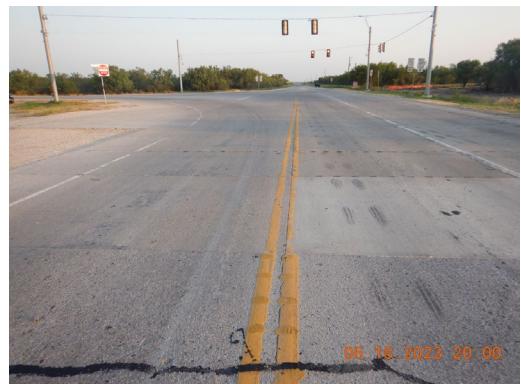
**Figure 28 PCP section in Fowlerton**

The second section, shown in [Figure 28](#), is located between SH97 and SH72 in Fowlerton in the San Antonio District, with GPS coordinates [28.496680, -98.801147]. This section, built in April, 2016 with 12-in slab thickness and 8-ft joint spacing, used the dowel bar installation method, a common approach for PCP [9]. No noticeable distress was found in this section. However, some minor slipping was observed at the ends of a few slabs and FDR was conducted, which does not significantly affect the overall structural performance. The traffic in this intersection is not high, even though most of the traffic appears to be trucks, and continued monitoring of this section is recommended.

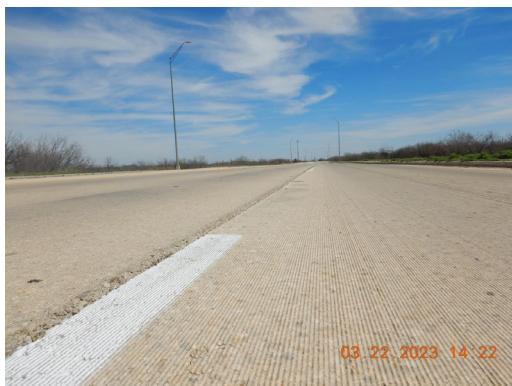
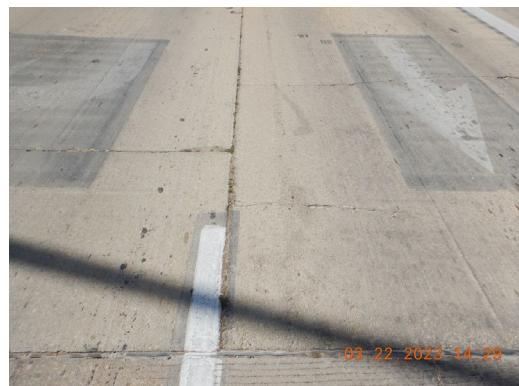
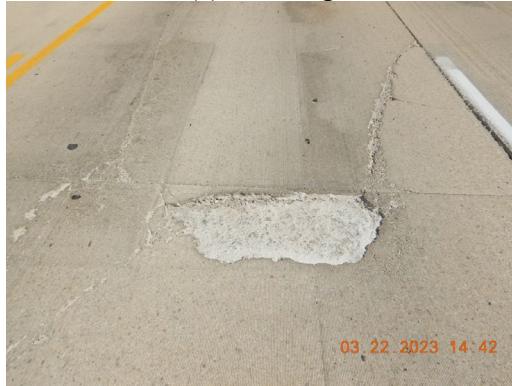
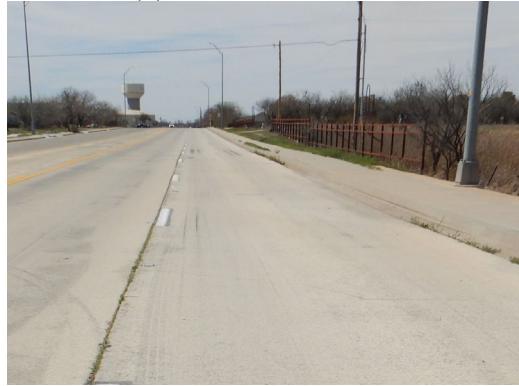
(a) Faulting

(b) Transverse Crack

(c) Spalling

(d) Undulation

**Figure 29 Observed Distresses in RCCP section in San Angelo**

- 1) The use of RCCP on major highway lanes is not recommended until new material design/construction methods that ensure good load transfer at transverse joints and no faulting are developed and proven to work.
- 2) Construction and material specifications that promote the compaction of RCC materials in RCCP should be developed.
- 3) RCCP may be a good candidate for rest areas or ports where riding quality is not critical.

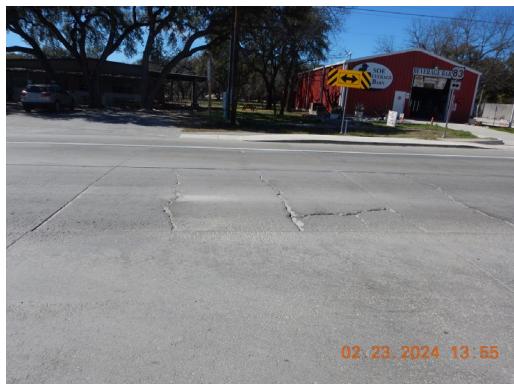
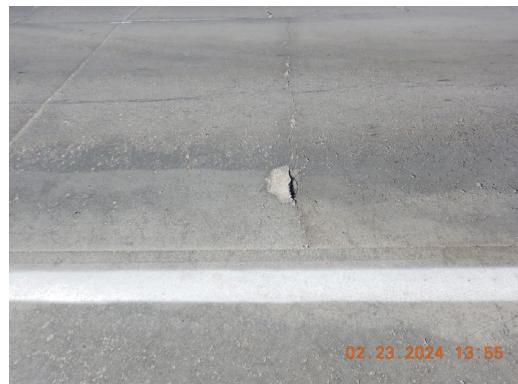
Another RCCP section evaluated was the pavement at US 83 and RM 337 in Leakey in the San Antonio District. The visual condition survey indicated that longitudinal & transverse cracks were present in several locations as shown in [Figure 30](#). Also, surface defects and small spalling were observed. Moreover, the primary issues were noise and reduced ride quality due to faulting at joints. The noise and deterioration of ride quality were significant enough to cause some complaints from nearby residents. One of the advantages of RCCP is stated that the smaller crack width due to the lower drying shrinkage of the PCC mix allows for excellent aggregate interlock at the joints. However, that advantage was not evident in this project. The traffic level in this project is really low, and the performance issues here – cracking and faulting – show that RCCP is not ready for implementation for mainlanes on major highways.

(a) Faulting & Cracks

(b) Transverse Crack & Surface Defects

***Figure 30 Observed Distresses in RCCP Section in Leakey***

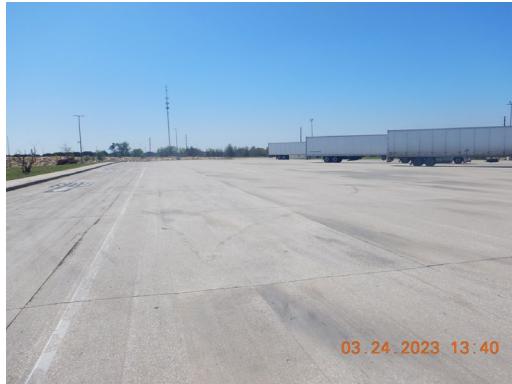
**Figure 31 RCCP section in Ranger Rest Area**

Lastly, an evaluation was conducted on a section of RCCP constructed at the rest area on IH 20 in Ranger. As shown in [Figure 31\(a\)](#), the overall performance of the section appeared to be good, but some distresses were found. [Figures 31\(b\) and \(c\)](#) show longitudinal and transverse cracks, and it was noted that one longitudinal crack already had been repaired. Interestingly, most of the cracks occurred near saw-cut joints. No in-depth evaluation was conducted to identify the cause(s) of these cracks; however, it is hypothesized that these cracks were due to poor jointing practices – low-sawcut and/or deficient saw-cut depth. However, since this is a rest area not related to driving quality, these issues are unlikely to affect its usability.

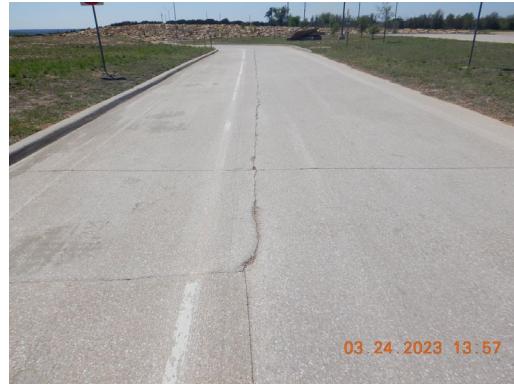
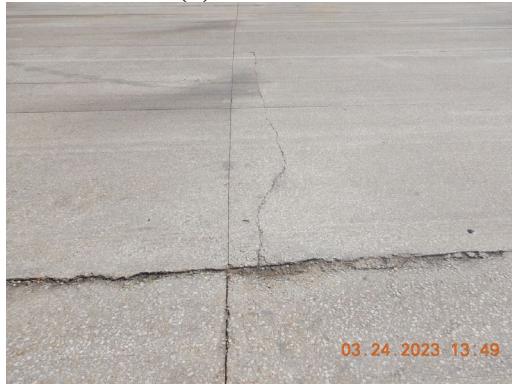
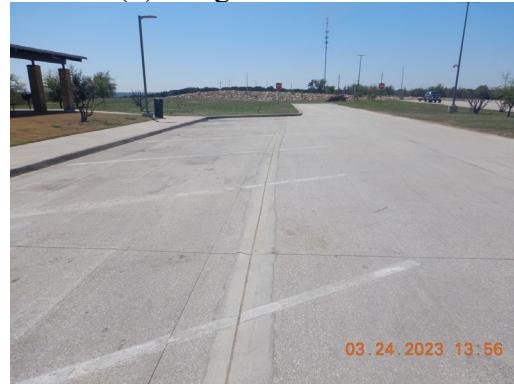
(b) Longitudinal Crack

(c) Transverse Crack

(d) Longitudinal Crack Repair

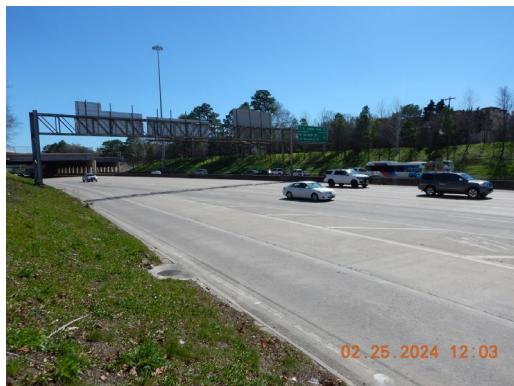
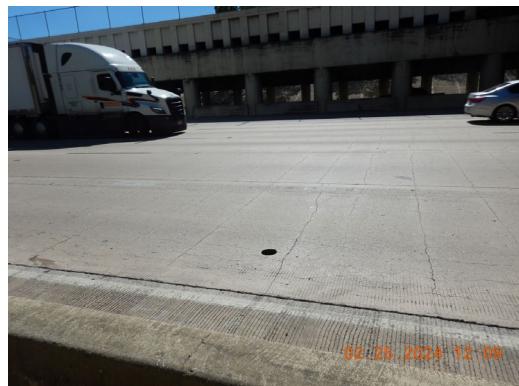
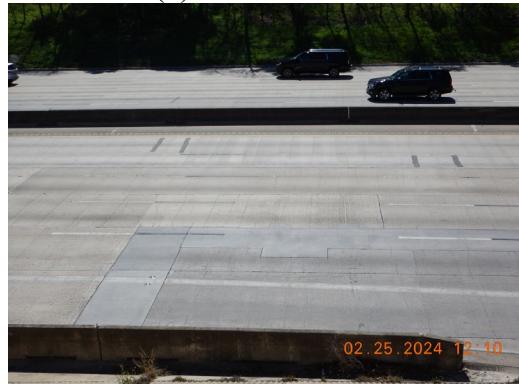
The current condition of this section is excellent, with some repairs made to address spalling and large FDR noted ([Figure 32](#)). Despite being in operation for almost 30 years and experiencing heavy truck traffic as well as submerged in the water several times, the evaluation of this section indicates that the use of 100% recycled materials resulted in satisfactory performance. Based on the early-age performance of this section, TxDOT made changes to Item 421 in 2004 Construction Specifications, which allowed the use of RCA for coarse aggregates for Class P concrete. The long-term good performance of this project suggests that the changes made in Item 421 were a good decision.

(c) FDR #1

(d) FDR & Spalling Repair

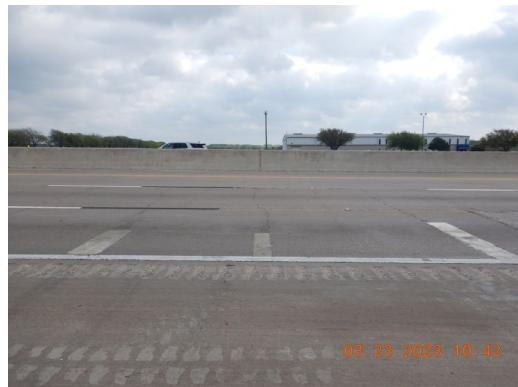
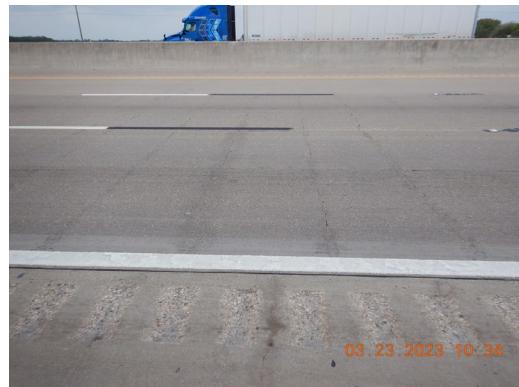
Numerous distresses were observed in the southbound direction, with significant repairs already carried out, as shown in [Figure 33](#). In contrast, the condition of the northbound section is almost perfect, with no repairs. Traditionally, TxDOT always placed longitudinal steel at mid-depth, regardless of slab thickness. When the slab is not large, the mid-depth placement of steel worked quite well, since the distance between slab surface and longitudinal steel is not excessive, ensuring the ability of steel in restraining concrete volume changes near the concrete surface, resulting in small transverse crack spacing and tight crack widths. However, as slab thickness becomes large, placing longitudinal steel at mid-depth resulted in large crack spacing due to the diminished ability of longitudinal steel in restraining concrete volume changes near the slab surface, which also resulted in larger crack widths and a higher potential for horizontal cracking at the depth of longitudinal steel. At the time this section was built, no consideration was paid to this aspect, primarily due to the absence of knowledge of the interactions between steel and concrete. Horizontal cracking was observed in the one-mat section in 1999, and it was the first horizontal crack ever observed in CRCP. TxDOT Research Project 0-7026 validated the hypothesis of horizontal cracking mechanism, which includes the placement of longitudinal steel farther away from the slab surface promotes warping and curling behavior while minimizing axial slab behavior, thus increasing horizontal cracking potential for thick CRCP with steel placed at mid-depth. The vast difference in the performance of identical pavement structures except for steel designs, built by the same contractor at the same time-frame using the same materials, with both pavement structures subjected to identical environmental conditions and comparable truck traffic (as a matter of fact, northbound truck traffic is much heavier than in the southbound), clearly indicates the significant effects of steel designs on CRCP behavior and long-term performance. In this project, distresses caused by initial horizontal cracking occurred in 2008 and 2009, about 9 or 10 years after the construction. The same type of distresses is observed on IH 35 just north of Temple, and forensic evaluations will be conducted in FY 25. These distresses are serious ones, which should be properly addressed. The findings of the forensic evaluations will be included in the final report, if the findings are available in time for the report preparation.

*Figure 33 Different pavement conditions between one and two mat sections*

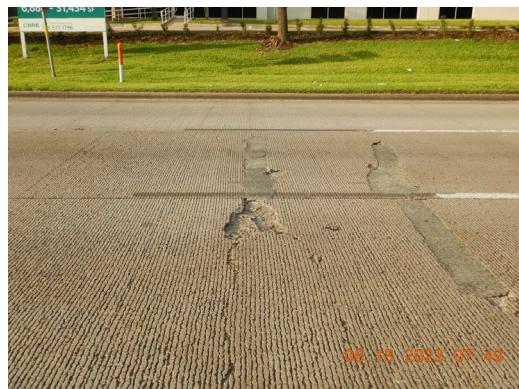
**Figure 36 Developing Spalling over time**

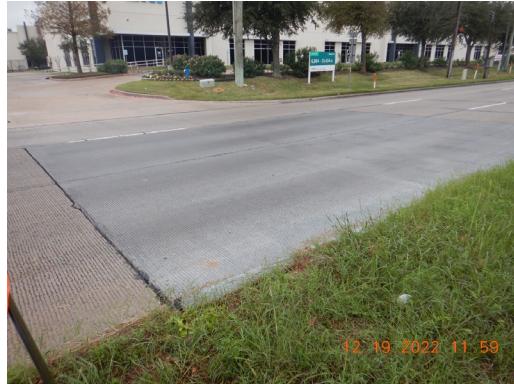
In addition, as shown in [Figure 37](#), a large full-depth repair was made three years ago. However, it was discovered that the width of one transverse repair joint was quite large, and tie bars at a repair joint were pulled out, as displayed in [Figure 38\(b\)](#). It is believed that the high coefficient of thermal expansion of the existing slab with SRG, along with lower steel amount and large crack spacing in the existing CRCP, caused the tie bars to be pulled out from the repaired section. This implies that there was debonding between tie bars and newly placed concrete in the repaired section. However, it is not known whether the debonding occurred while the repair concrete was still gaining strength. Regardless of what happened here, it shows the tie bar length was not adequate. To obtain more detailed information on the behavior of repair joints in this area, the research team discussed potentially installing gages to investigate the slab behavior here.

*Figure 37 FDR in BW 8 Section*

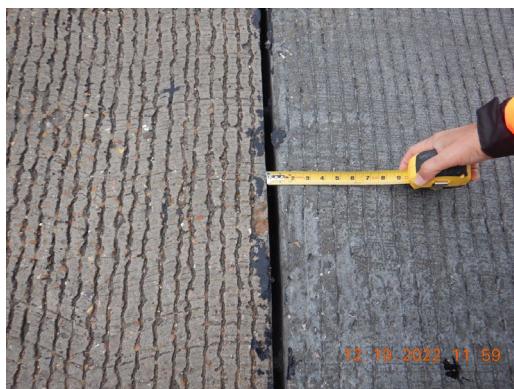
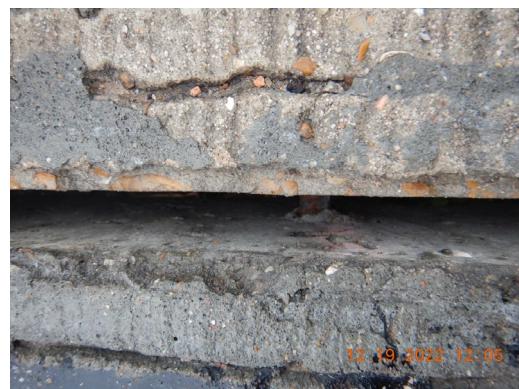
However, that would be out of the scope of this research project, even though the data will provide valuable information that could help TxDOT in improving reinforcement details in new construction and repairs of CRCP. Additionally, during the evaluation period, the weather was cold, which contributed to the widening of the joint due to shrink of concrete. Furthermore, the section was evaluated once more during the summer, and it was found that the joints had closed due to the warmer weather (see [Figure 39](#)), indicating that the slabs here moved more than expected. This large slab movement is indirect evidence that the bonding between tie bars and repair concrete was broken.

(a) Repair joint condition in winter

(b) Popped up tie bar

*Figure 38 Repair Joint in BW 8 Section*

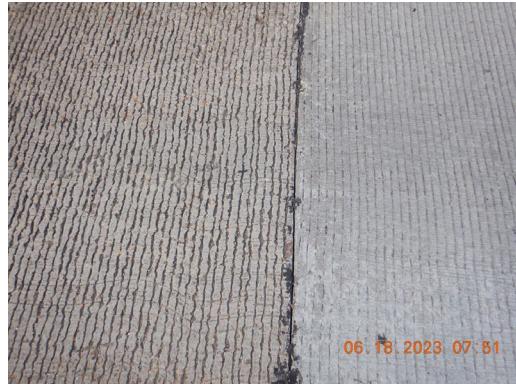
**Figure 39 Closed repair joint in summer in BW 8 Section**

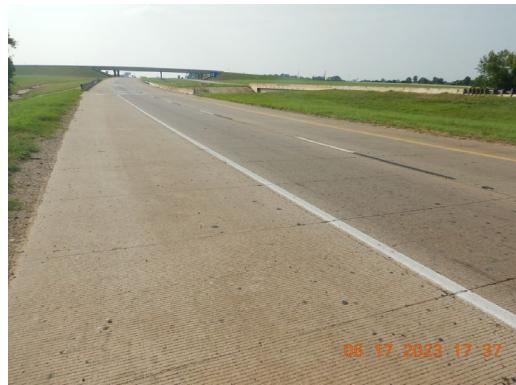
**Figure 41 Overview of US290SPS-1E**

The first half (500-ft) of the US290SPS-1E section introduced early-entry saw cuts with an almost consistent spacing (6-ft) at the initial construction stage, while the rest of the section did not. This early-entry saw cuts, or called active crack control, were implemented as TxDOT's efforts to utilize locally available SRG aggregates in Houston for CRCP. The initial thought was that, this active crack control would induce so many transverse cracks, resulting in smaller crack spacing, smaller slab movements, and thus lowering the potential for severe spalling. The depth of the early-entry saw was 1-in. [Figure 41](#) shows an overview of the section, with transverse active crack control in this test section. This section shows the presence of spalling at the saw cut joints or transverse cracks as shown in [Figure 42](#). However, the spalling here is not a typical type; rather, it appears due to the early-entry saw-cuts having caused damage along interfaces between SRG surface and surrounding mortar. SRG used in Houston area has quite hard, and saw-cutting while concrete is gaining strength at early ages could disrupt the bonding between SRG surface and mortar, resulting in distress resembling spalling as shown in Figure 42. The uncut section also began to show clear signs of early-age spalls at almost every transverse crack as shown in [Figure 43](#), even though there were more chipping than spalling. The findings in this section are that active crack control appears to help mitigate severe spalling observed in CRCP with SRG in Houston.

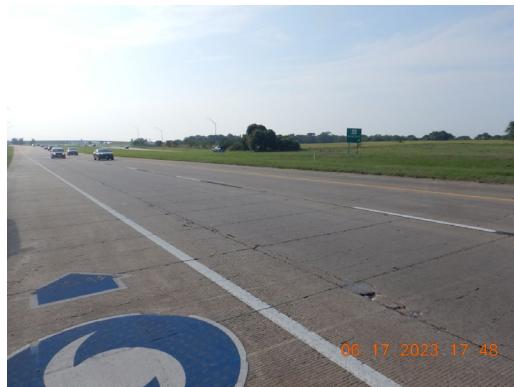
**Figure 42 Spalling in US290SPS-1E**

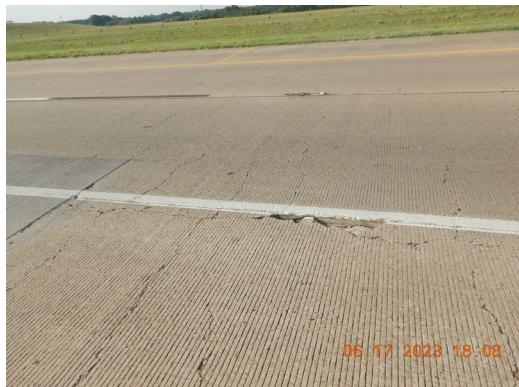
This section was constructed at different times of the day (night and morning) to examine the effect of construction time/temperature variables. However, both sections, with SRG used, showed very similar crack spacing distributions. As reported in previous studies, over 80-90% of the cracks in both sections had crack spacing less than 4 feet. Additionally, as shown in [Figure 44](#), there were many longitudinal cracks almost parallel to the longitudinal saw cut joint, resulting in large FDR as shown in [Figure 45](#). This is most likely because the longitudinal saw cut was introduced too late or at an inappropriate depth. Several longitudinal cracks were also found in the main lanes. However, despite the very narrow transverse crack spacing and significant heavy truck traffic, the US290-2E section did not exhibit any punchout distress after almost 30 years of service, which indicates negligible effects of concrete set temperature on CRCP performance.

*Figure 44 Longitudinal crack in US290-2E Section*

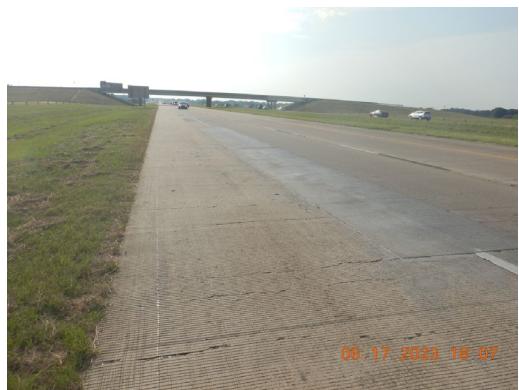
*Figure 45 Large FDR in US290-2E Section*

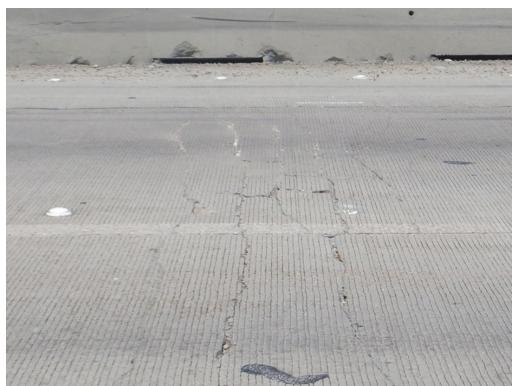
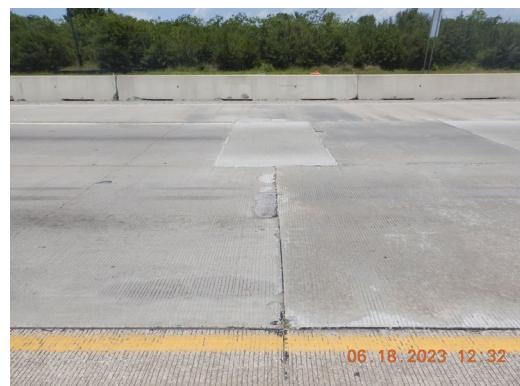
**Figure 47 Observed distresses in 0-4826 Section**

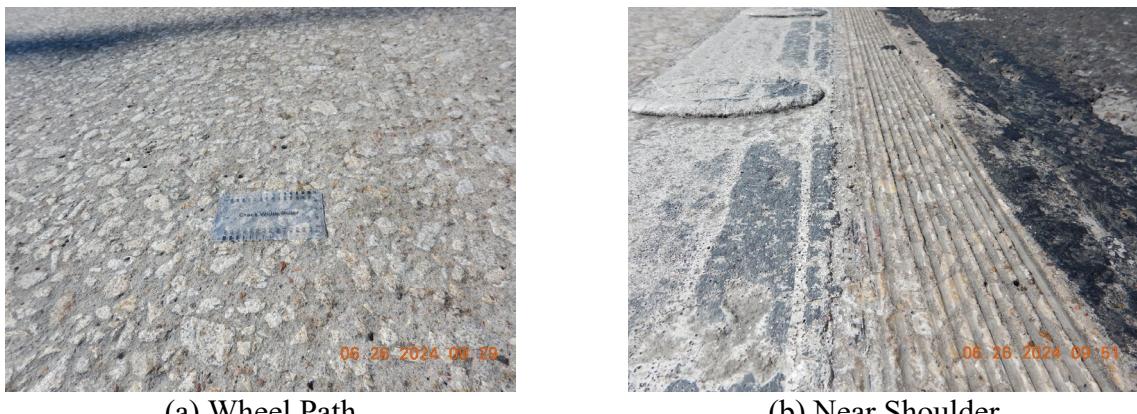
**Figure 49 Surface Texture of Diamond Grinding Section on IH35 W**

However, Figure 49, which illustrates the surface condition in June, 2024, shows the marked difference in the surface condition between along wheel paths and at shoulder – the macro texture generated by DG disappeared under the wheel loading. It is not known whether the loss of macro texture would result in lower skid numbers, since micro textures still remain under wheel paths. Evaluation of the effectiveness of DG on preserving skid resistance is quite complicated and is beyond the scope of this research study, and no further evaluations were performed.

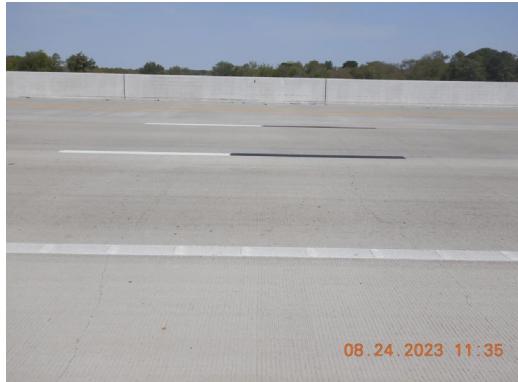
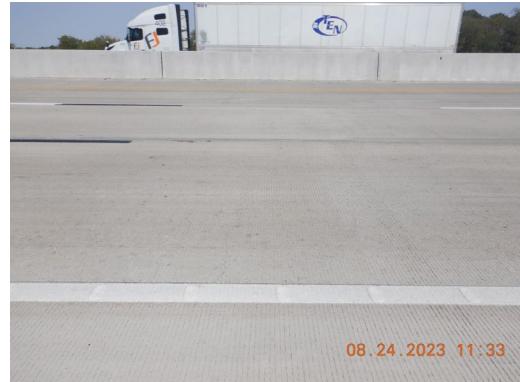
*Figure 50 0-7026 Section on IH35 in Hillsboro*

A total of four sections were constructed between 2020 and 2022. During field evaluations, notable distresses were not observed. However, there was a significant difference in crack spacing and crack width. Particularly in the upper depth section, the crack spacings and widths were quite small. [Figure 50](#) illustrates a close view of the mid-depth and upper depth sections on IH35 in Hillsboro in the Waco District. Even though it is not clearly shown in [Figure 50](#) due to the resolution and contrast of the pictures, placing longitudinal reinforcement at above the mid-depth effectively restrains the movement of concrete, resulting in smaller crack spacing and crack width. Conversely, the general section, where the reinforcement was placed at mid-depth, shows large crack spacing and crack width, indicating less restraints on concrete volume changes by longitudinal steel and potentially higher probability of horizontal cracking.
