## Computational Fabrication (Spring 2024)

### Assignment 2: Testing 3D Printer Capabilities

Submitted by: Krunal Rathod | krunal.rathod@usi.ch

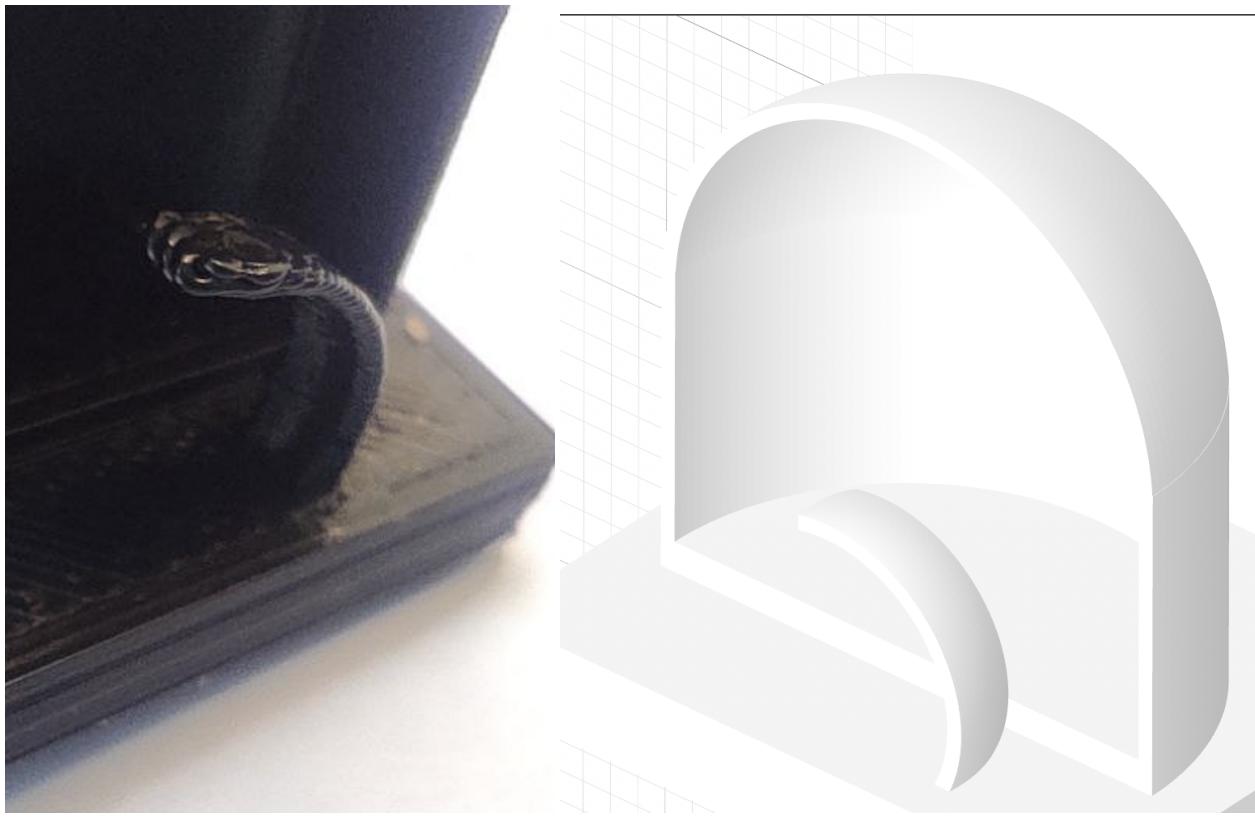
Figure 6: Overhang

While the 3D printer encountered difficulties with certain features, such as smooth walls and complex geometries, etc., it demonstrated capability in printing overhanging parts above 90 degrees successfully. This accomplishment highlights the printer's versatility and ability to overcome some printing challenges, suggesting that while it may struggle with certain aspects, it excels in others. Understanding these strengths and weaknesses can inform future printing projects and guide optimization efforts to maximize the printer's performance across various printing tasks.
