Summit Hood Service Co.  
Austin, TX | 24/7 dispatch

# Sample Restaurant Group

| Report ID | HDS-SAMPLE-0424 |

| Record type | Kitchen exhaust service report PDF copy |

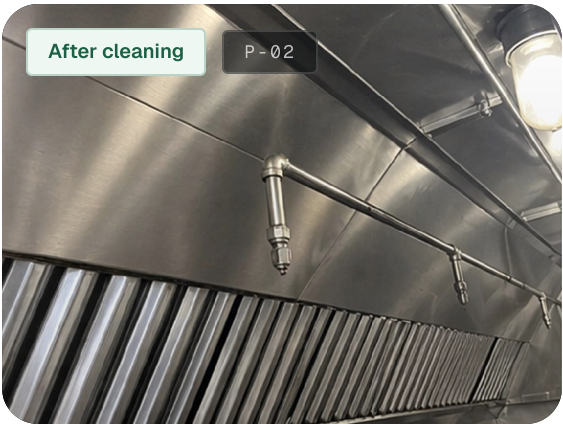
| Hood after | <div>P-02</div> | <div>Captured</div> |

| <b>Hood canopy interior</b> | Work recorded for this section. | <div>Cleaned</div> |

**Hood interior after clean**

Field photo captured after reachable surfaces were cleaned. Local field photo: sample-hood-after.jpg.

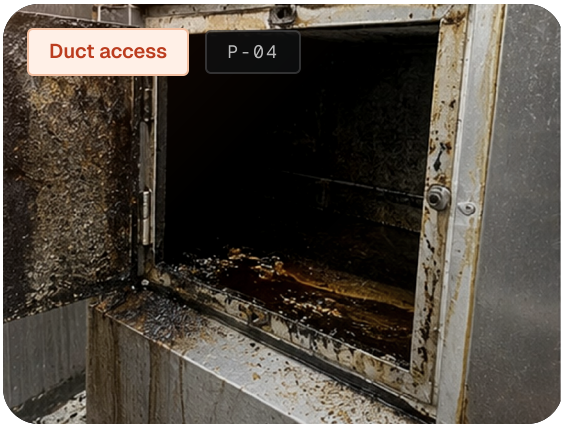
| Access condition | <div>P-04</div> | <div>Captured</div> |

| Deficiencies / exceptions | Stored equipment blocked full access at service time. |

| <b>Plenum / reachable duct path</b> | Accessible path cleaned; rear access remains blocked. | <div>Reachable cleaned</div> |
| <b>Rear duct access panel</b> | Stored items blocked access; not represented as cleaned. | <div>Access blocked</div> |

**Duct access condition**

Access, blocked section, or exception condition tied to the report.  
Local field photo: sample-access-condition.jpg.

| Customer action | Clear rear access and reply |
