Proceedings of the 8th International Pipeline Conference IPC2010
September 27-October 1, 2010, Calgary, Alberta, Canada

MANAGING INTEGRITY OF UNDERGROUND FIBERGLASS PIPELINES

Chuntao Deng* Husky Energy, Calgary, AB, Canada Gabriel Salamanca Husky Energy, Calgary, AB, Canada Monica Santander Husky Energy, Calgary, AB, Canada

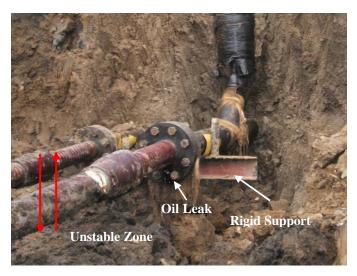
A root cause analysis conducted by Husky in 2007 showed that about 50% of Husky's fiberglass pipeline failures were mechanical type of failures. Close to 90% of these failures were in delayed failure mode within 3 years of its initial backfill due to external interference. The failures typically showed a structural break of the pipe body initiated from 6 or 12 O' clock position of the pipe, due to the excessive localized bending near risers, and transitions between steel and fiberglass tie-ins. A typical bending type of failure is shown in Figure 1.

From the failure analysis reports, the failure mechanism implied that these bending types of failures mostly resulted from the initial settlement of the fiberglass line pipe after the backfill; or in some cases where the piling structure is used to support the steel riser, the transition is too rigid to allow even settlement of the large component flange with the fiberglass line pipe.

Figure 1 Typical Bending Type of Failure near a Tie-in Location

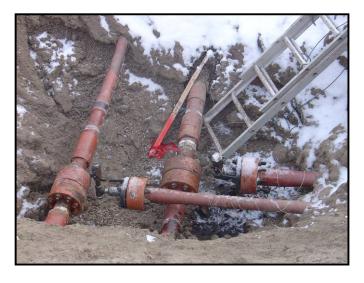
This procedure was issued for a complex backfill at a multiple pipeline-crossing, see Figure 9. It was noted that the vertical distance between pipes shown in Figure 9 is less than 300 mm on the pipe cross-over.

Figure 9: Pipe Configuration and Trench Bottom of an Example Backfill at Crossing
