Inventory of Hazardous Materials Part I

Fjordvik – IMO 7423249

Version: 1.0
Date: 03-10-2018
Client: SMT Shipping
Project number: M2018.0415
Survey location: Gdynia, Poland

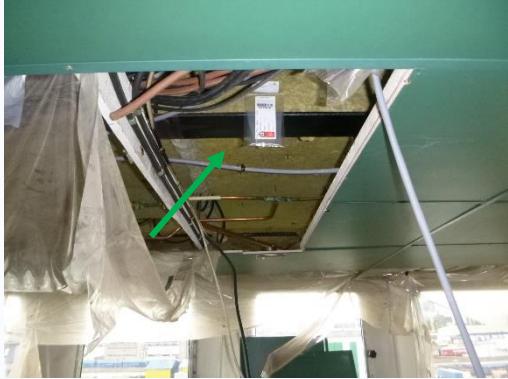
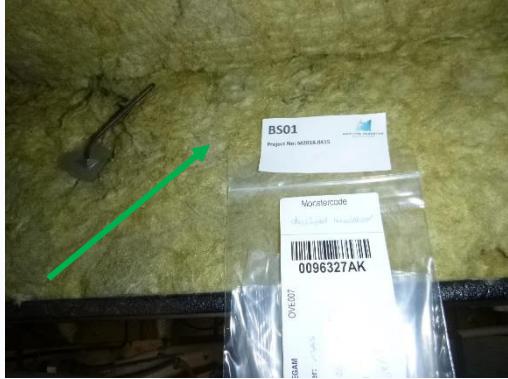
Source number:	01						
Sample number:	BS01	Type/% Asbestos:	Not contained				
Application:	Deckhead insulation	Also analysed for:	-				
Location:	Throughout vessel, several decks	Analysing method:	PLM according NEN 5896				
Quantity:	-	Above threshold level:	No				
Documentation / remarks:	-						
Source description							
This source concerns bulkhead and deckhead insulation used throughout the vessel on several decks. Sample is taken from the deckhead insulation in the wheelhouse on navigation deck.

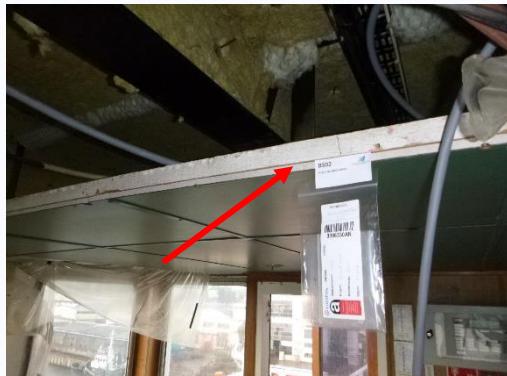
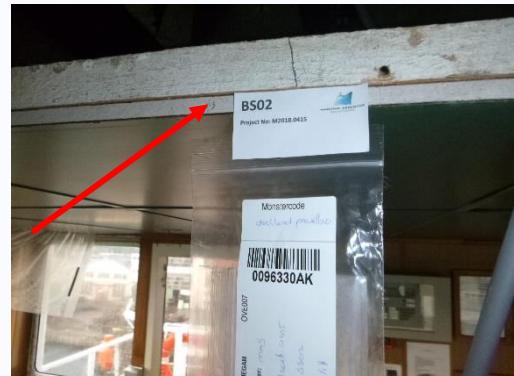
Source number:	02		
Sample number:	BS02	Type/% Asbestos:	Chrysotile, 2-5% Amosite, 30-60%
Application:	Panelling	Also analysed for:	-
Location:	Throughout vessel, several decks	Analysing method:	PLM according NEN 5896
Quantity:	± 5 kg per m ²	Above threshold level:	Yes
Documentation / remarks:	-

This source concerns deckhead panels used throughout the vessel on several decks. Sample is taken in the wheelhouse on nav. deck.

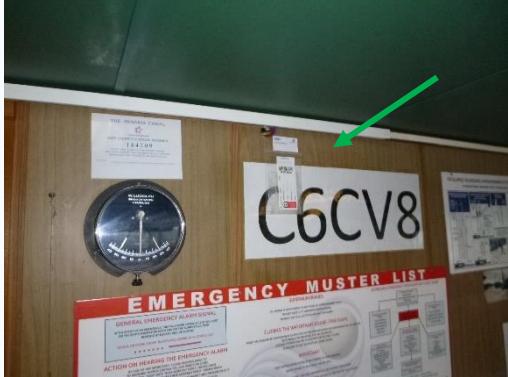
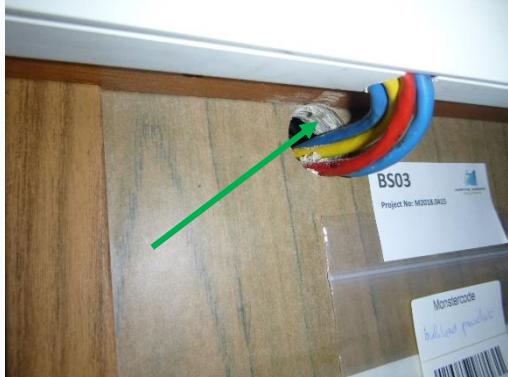
Source number:	03				
Sample number:	BS03	Type/% Asbestos:	Not contained		
Application:	Panelling	Also analysed for:	-		
Location:	Throughout vessel, several decks	Analysing method:	PLM according NEN 5896		
Quantity:	-	Above threshold level:	No		
Documentation / remarks:	-				
Source description					
This source concerns bulkhead panels used throughout the vessel on several decks. Sample is taken in the wheelhouse on nav. deck.

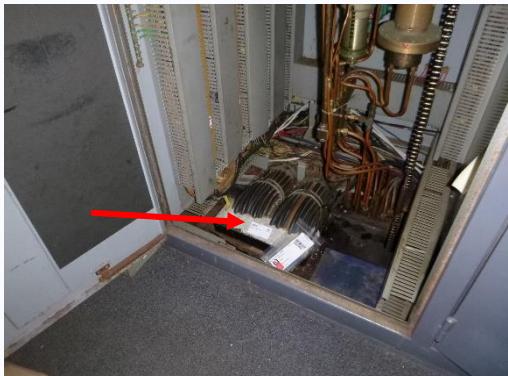
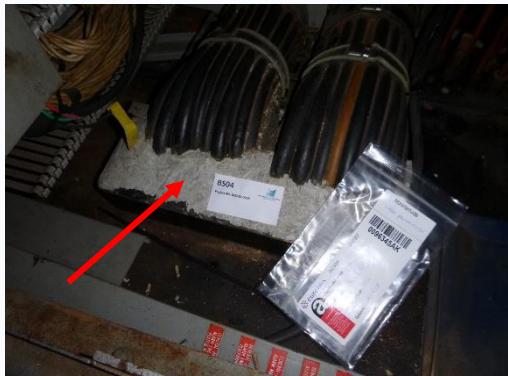
Source number:	04				
Sample number:	BS04	Type/% Asbestos:	Chrysotile, 15-30%		
Application:	Cable penetration	Also analysed for:	-		
Location:	Throughout vessel, several decks	Analysing method:	PLM according NEN 5896		
Quantity:	± 10 kg per pc	Above threshold level:	Yes		
Documentation / remarks:	-				
Source description					
This source concerns cement used in cable penetration throughout the vessel on several decks. Sample is taken in the wheelhouse on nav. deck.

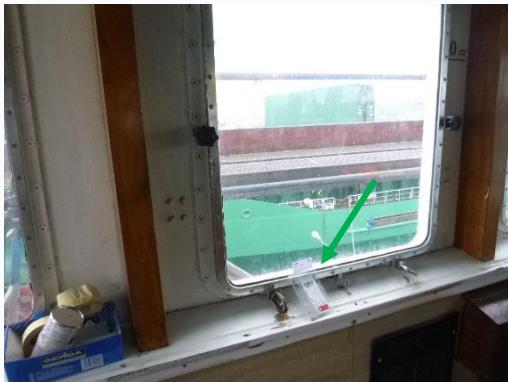
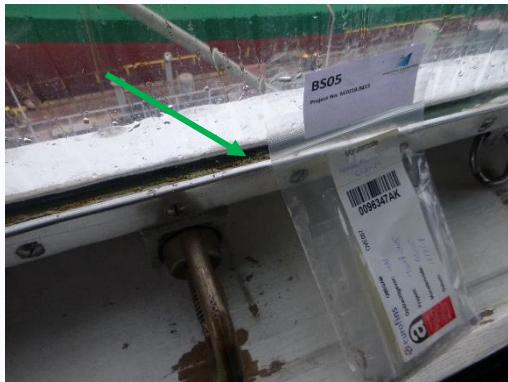
Source number:	05				
Sample number:	BS05	Type/% Asbestos:	Not contained		
Application:	Sealant	Also analysed for:	-		
Location:	Throughout vessel, several decks	Analysing method:	PLM according NEN 5896		
Quantity:	-	Above threshold level:	No		
Documentation / remarks:	-				
Source description					
This source concerns sealant used in window frames throughout the vessel on several decks. Sample is taken in the wheelhouse on nav. deck.

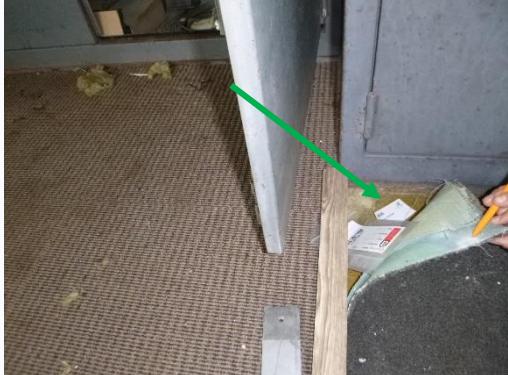
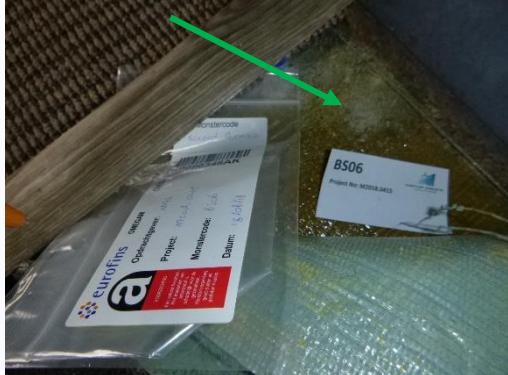
Source number:	06				
Sample number:	BS06	Type/% Asbestos:	Not contained		
Application:	Screed flooring	Also analysed for:	-		
Location:	Throughout vessel, several decks	Analysing method:	PLM according NEN 5896		
Quantity:	-	Above threshold level:	No		
Documentation / remarks:	-				
Source description					
This source concerns screed flooring used throughout the vessel on several decks. Sample is taken in the wheelhouse on nav. deck.

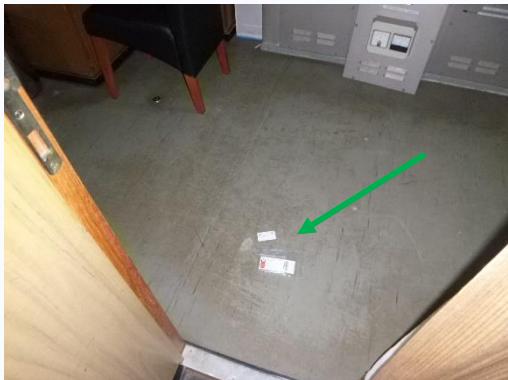
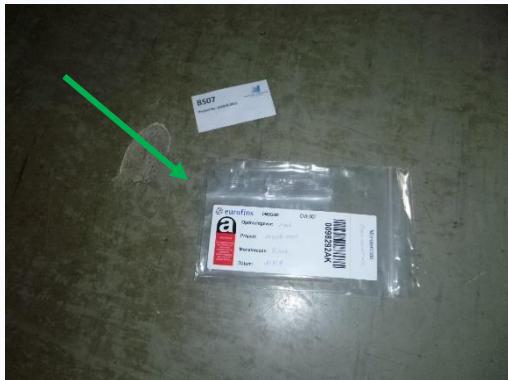
Source number:	07				
Sample number:	BS07	Type/% Asbestos:	Not contained		
Application:	Floorcovering	Also analysed for:	-		
Location:	Accommodation, several decks	Analysing method:	PLM according NEN 5896		
Quantity:	-	Above threshold level:	No		
Documentation / remarks:	-				
Source description					
This source concerns floorcovering used throughout the accommodation on several decks. Sample is taken in the radio room on nav. deck.

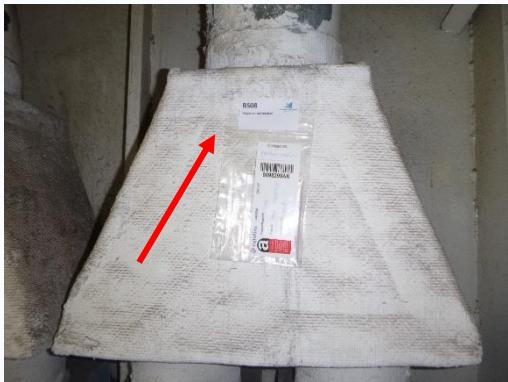
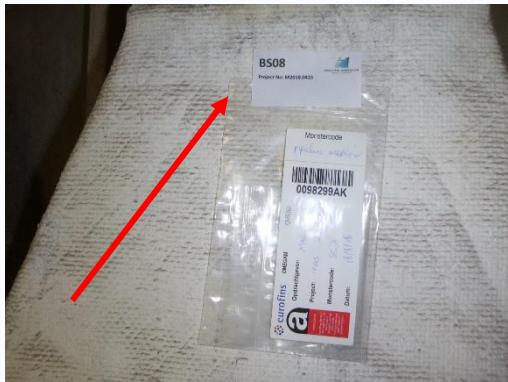
Source number:	08		
Sample number:	BS08	Type/% Asbestos:	Chrysotile, 60-100%
Application:	Insulation material	Also analysed for:	-
Location:	Throughout vessel, several decks	Analysing method:	PLM according NEN 5896
Quantity:	± 5 kg per m ²	Above threshold level:	Yes
Documentation / remarks:	-		
Source description			
This source concerns insulation material used on air ducts and pipelines throughout the vessel on several decks. Sample is taken in the AC room on nav. deck.

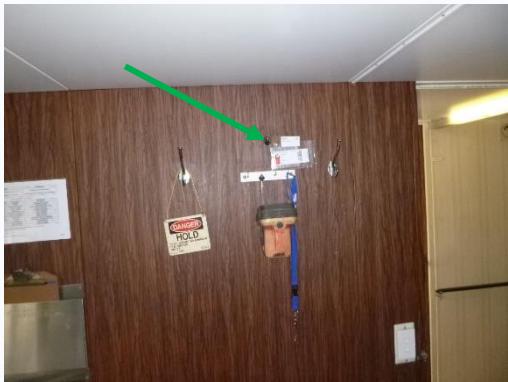
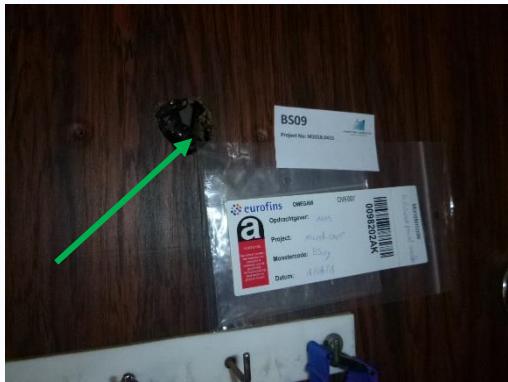
Source number:	09				
Sample number:	BS09	Type/% Asbestos:	Not contained		
Application:	Insulation material	Also analysed for:	-		
Location:	Accommodation, several decks	Analysing method:	PLM according NEN 5896		
Quantity:	-	Above threshold level:	No		
Documentation / remarks:	-				
Source description					
This source concerns insulation material used in bulkhead panels throughout the accommodation on several decks. Sample is taken from the bulkhead panel in the II engineer cabin on officers deck.

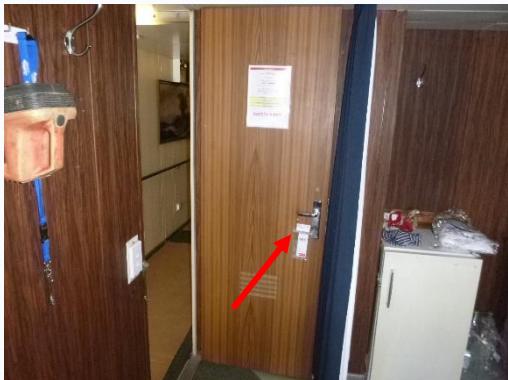
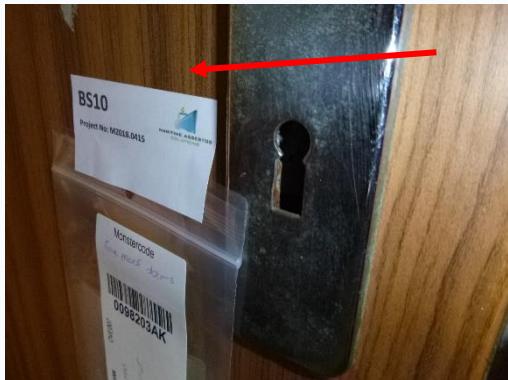
Source number:	10				
Sample number:	BS10	Type/% Asbestos:	Amosite, 30-60%		
Application:	Fire door	Also analysed for:	-		
Location:	Accommodation, several decks	Analysing method:	PLM according NEN 5896		
Quantity:	± 10 kg per door	Above threshold level:	Yes		
Documentation / remarks:	-				
Source description					
This source concerns fibre board used in fire retardent doors throughout the accommodation on several decks. Sample is taken from the II engineers cabin door on officers deck.

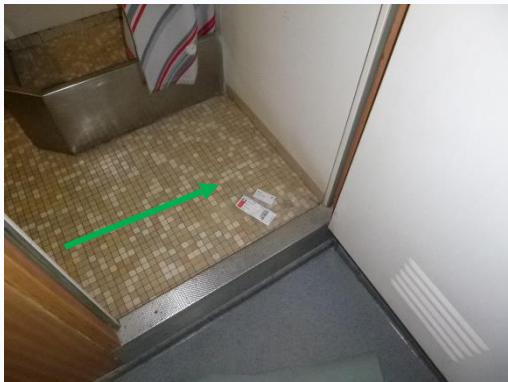
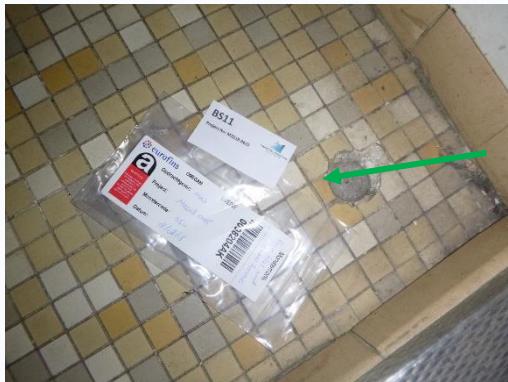
Source number:	11				
Sample number:	BS11	Type/% Asbestos:	Not contained		
Application:	Floor tiles/ screed flooring	Also analysed for:	-		
Location:	Accommodation, several decks	Analysing method:	PLM according NEN 5896		
Quantity:	-	Above threshold level:	No		
Documentation / remarks:	-				
Source description					
This source concerns floor tiles and glue (screed flooring) used in shower units throughout the accommodation on several decks. Sample is taken from the II engineers shower unit on officers deck.

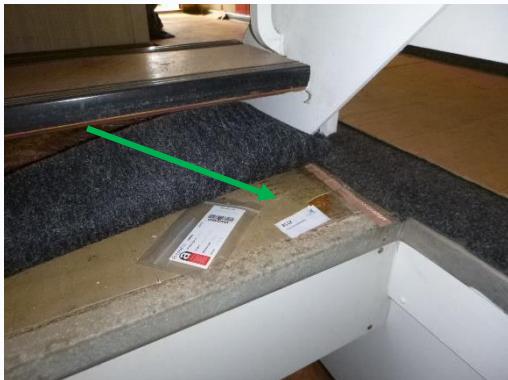
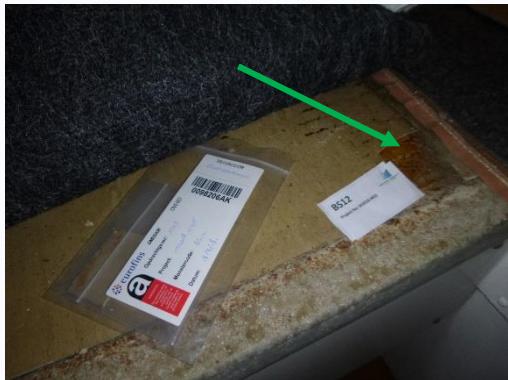
Source number:	12				
Sample number:	BS12	Type/% Asbestos:	Not contained		
Application:	Floorcovering	Also analysed for:	-		
Location:	Accommodation, several decks	Analysing method:	PLM according NEN 5896		
Quantity:	-	Above threshold level:	No		
Documentation / remarks:	-				
Source description					
This source concerns floorcovering used underneath carpet throughout the accommodation on several decks. Sample is taken in the corridor on officers deck.

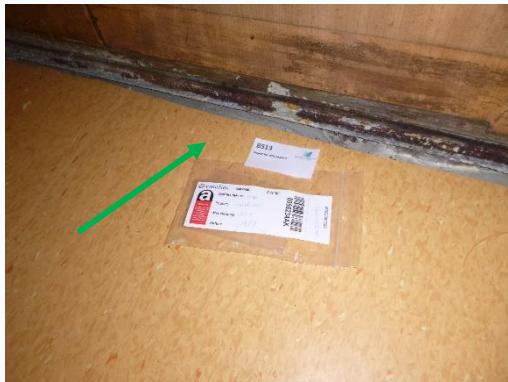
Source number:	13		
Sample number:	BS13	Type/% Asbestos:	Not contained
Application:	Floorcovering	Also analysed for:	-
Location:	Accommodation, several decks	Analysing method:	PLM according NEN 5896
Quantity:	-	Above threshold level:	No
Documentation / remarks:	-		
Source description			
This source concerns floorcovering (new installed) used throughout the accommodation on several decks. Sample is taken in the crews mess room on poop deck.

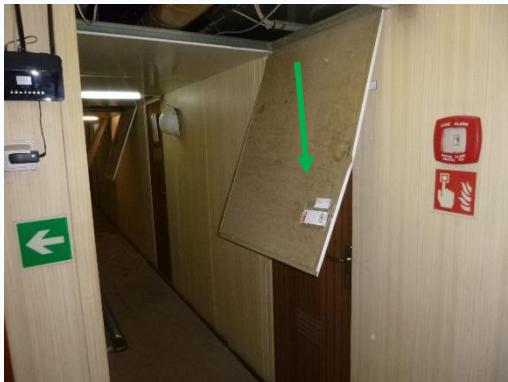
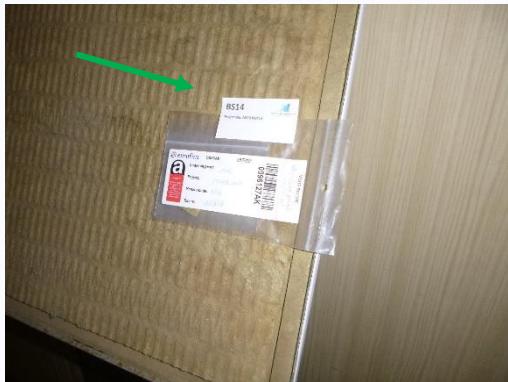
Source number:	14				
Sample number:	BS14	Type/% Asbestos:	Not contained		
Application:	Insulation material	Also analysed for:	-		
Location:	Throughout vessel, several decks	Analysing method:	PLM according NEN 5896		
Quantity:	-	Above threshold level:	No		
Documentation / remarks:	-				
Source description					
This source concerns deckhead panel insulation used throughout the vessel on several decks. Sample is taken in the corridor on main deck.

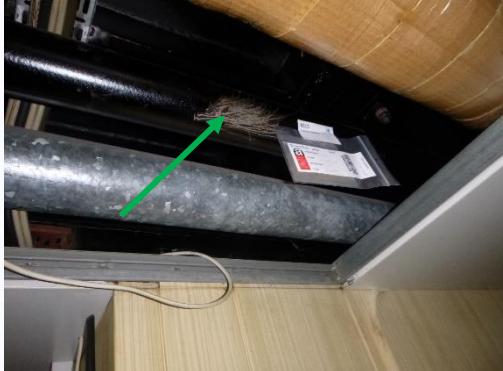
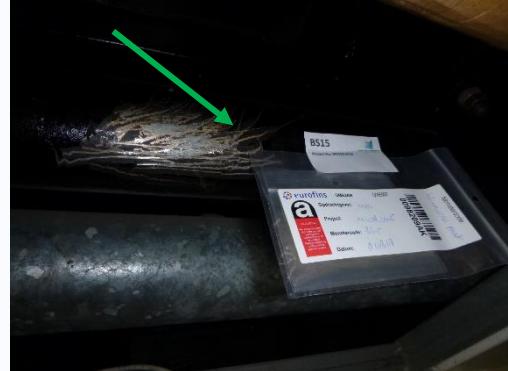
Source number:	15				
Sample number:	BS15	Type/% Asbestos:	Not contained		
Application:	Bituminous paint	Also analysed for:	-		
Location:	Accommodation, several decks	Analysing method:	PLM according NEN 5896		
Quantity:	-	Above threshold level:	No		
Documentation / remarks:	-				
Source description					
This source concerns black bituminous paint used on steel bulkheads and deckheads throughout the accommodation on several decks. Sample is taken in the corridor on main deck.

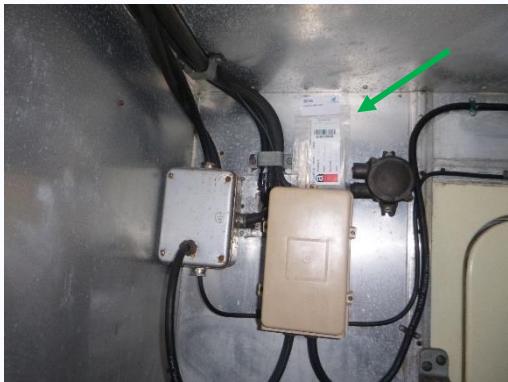
Source number:	16					
Sample number:	BS16	Type/% Asbestos:	Not contained			
Application:	Insulation	Also analysed for:	-			
Location:	Cold provision stores, main deck	Analysing method:	PLM according NEN 5896			
Quantity:	-	Above threshold level:	No			
Documentation / remarks:	-					
Source description						
This source concerns insulation material used in deckhead and bulkhead panels of the cold provision stores on main deck. Sample is taken in the cold store.

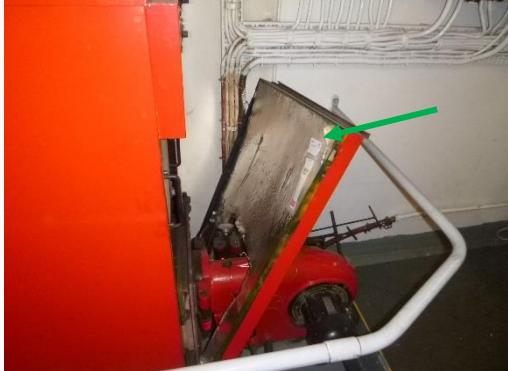
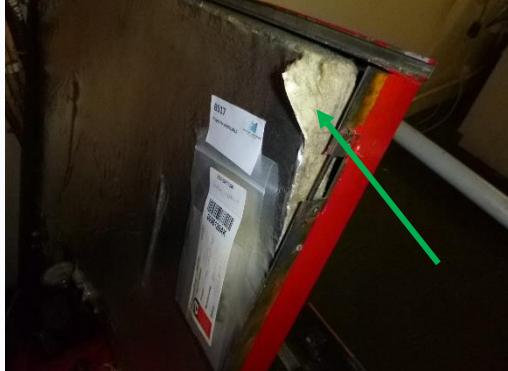
Source number:	17				
Sample number:	BS17	Type/% Asbestos:	Not contained		
Application:	Insulation material	Also analysed for:	-		
Location:	Engine room, main deck	Analysing method:	PLM according NEN 5896		
Quantity:	-	Above threshold level:	No		
Documentation / remarks:	-				
Source description					
This source concerns insulation material used on the boiler in the engine room on main deck.

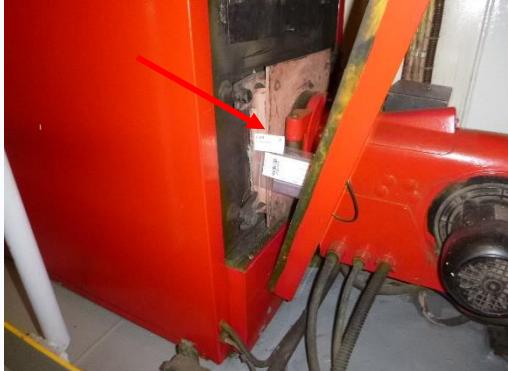
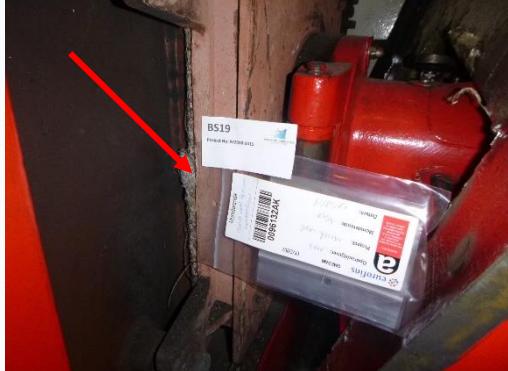
Source number:	19					
Sample number:	BS19	Type/% Asbestos:	Chrysotile, 60-100%			
Application:	Seal	Also analysed for:	-			
Location:	Engine room, main deck	Analysing method:	PLM according NEN 5896			
Quantity:	± 3 kg	Above threshold level:	Yes			
Documentation / remarks:	-					
Source description						
This source concerns cord seal used in hatch of the burner to the boile rin the engine room on main deck.

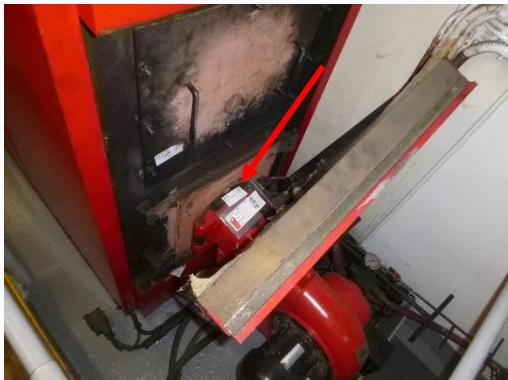
Source number:	20					
Sample number:	BS20	Type/% Asbestos:	Chrysotile, 30-60%			
Application:	Gasket	Also analysed for:	-			
Location:	Engine room, main deck	Analysing method:	PLM according NEN 5896			
Quantity:	± 100 gr. per gasket	Above threshold level:	Yes			
Documentation / remarks:	-					
Source description						
This source concerns a gasket used in the burner connection to the boiler in the engine room on main deck.

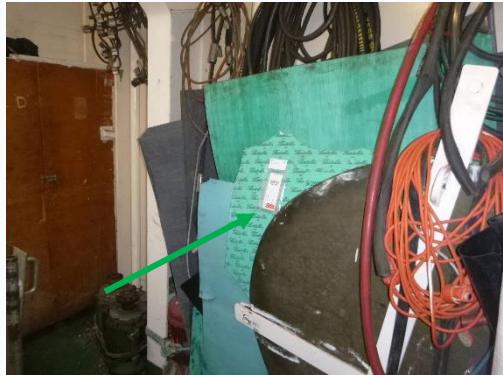
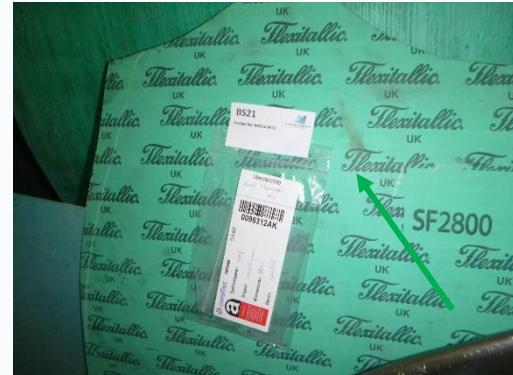
BS21

Source number:	21		
Sample number:	BS21, BS22, BS23	Type/% Asbestos:	Not contained
Application:	Gasket	Also analysed for:	-
Location:	Engine store, main deck	Analysing method:	PLM according NEN 5896
Quantity:	-	Above threshold level:	No
Documentation / remarks:	-

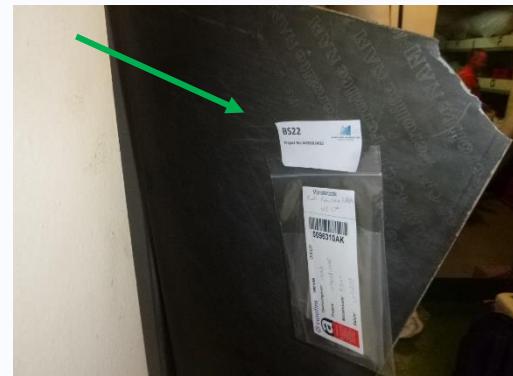
BS22 – 2 sheets of gasket material with brand "Ferolite NAM 45 CF".

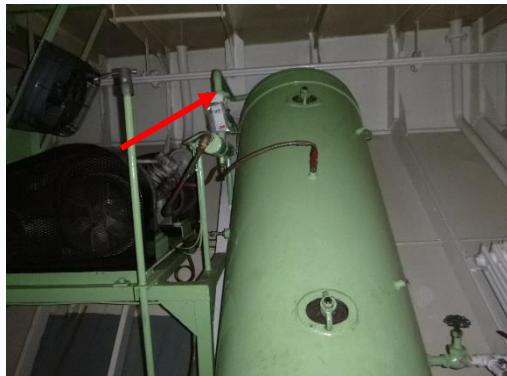
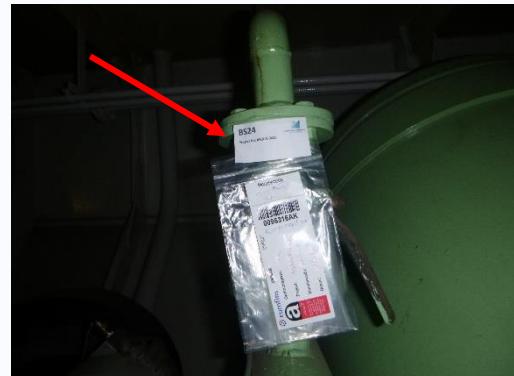
Source number:	22		
Sample number:	BS24	Type/% Asbestos:	Chrysotile, 30-60%
Application:	Gasket	Also analysed for:	-
Location:	Engine room, platform deck	Analysing method:	PLM according NEN 5896
Quantity:	± 100 gr. per gasket	Above threshold level:	Yes
Documentation / remarks:	-

This source concerns a flange gasket used in compressed air line connected to the air compressor in the engine room on platform deck.

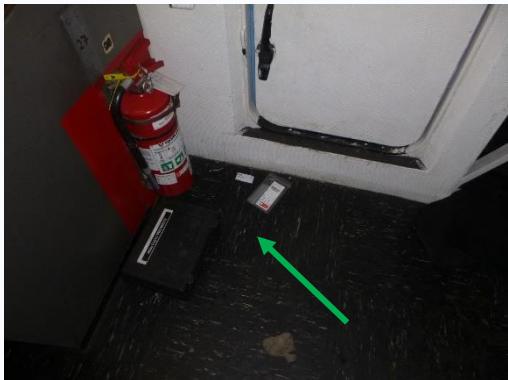
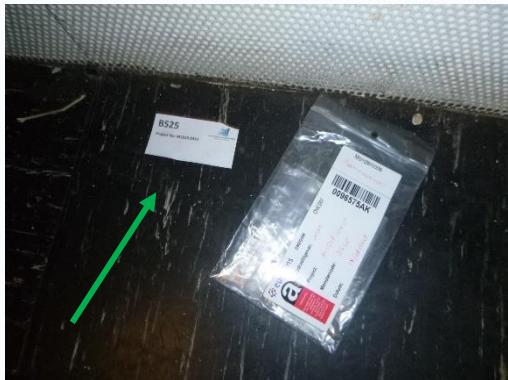
Source number:	23				
Sample number:	BS25	Type/% Asbestos:	Not contained		
Application:	Floorcovering	Also analysed for:	-		
Location:	Engine control room, platform deck	Analysing method:	PLM according NEN 5896		
Quantity:	-	Above threshold level:	No		
Documentation / remarks:	-				
Source description					
This source concerns floorcovering used in the engine control room on platform deck.

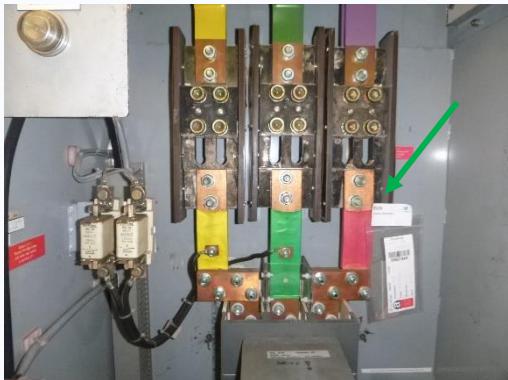
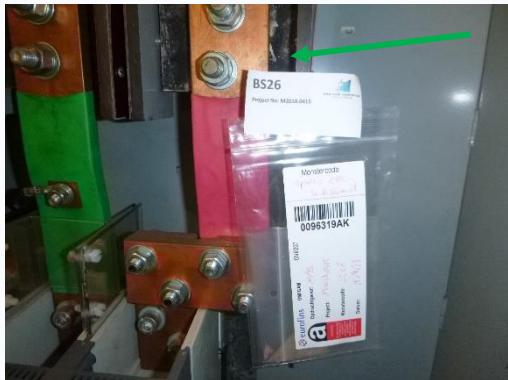
Source number:	24				
Sample number:	BS26	Type/% Asbestos:	Not contained		
Application:	Spark barrier	Also analysed for:	-		
Location:	Engine control room, platform deck	Analysing method:	PLM according NEN 5896		
Quantity:	-	Above threshold level:	No		
Documentation / remarks:	-				
Source description					
This source concerns spark barriers used in electrical switchboards in the engine control room on platform deck.

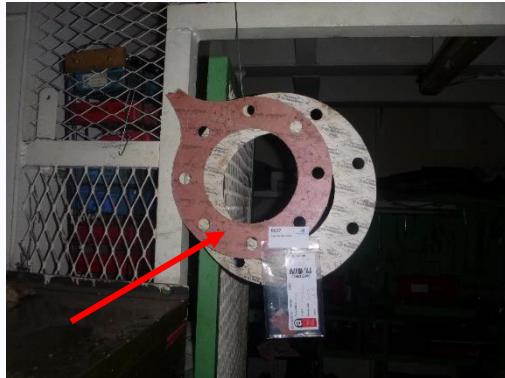
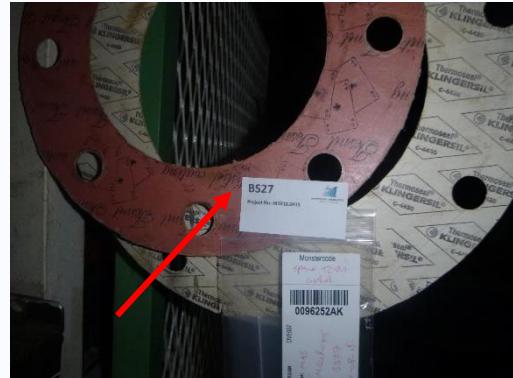
Source number:	25		
Sample number:	BS27, BS28	Type/% Asbestos:	Chrysotile, 60-100% (BS27)
Application:	Gasket	Also analysed for:	-
Location:	Engine store, platform deck	Analysing method:	PLM according NEN 5896
Quantity:	± 100 gr. per gasket	Above threshold level:	Yes (BS27)
Documentation / remarks:	-

BS27 – Spare red gasket with brand "Tesnit".

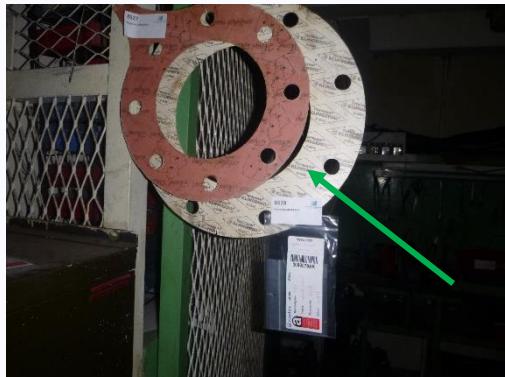
BS28 – Spare gasket with brand "Klingersil C4430".

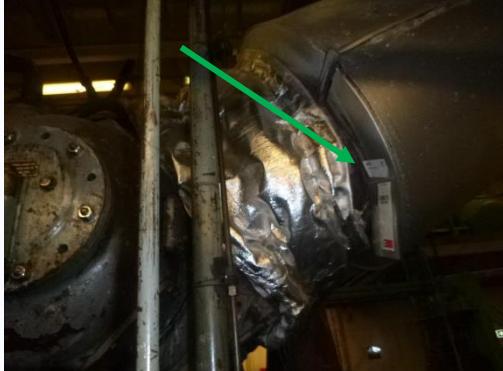
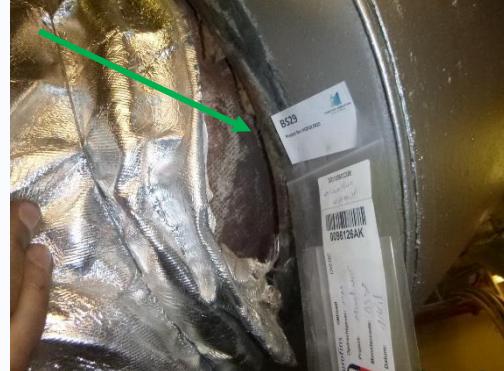
Source number:	26				
Sample number:	BS29	Type/% Asbestos:	Not contained		
Application:	Insulation material	Also analysed for:	-		
Location:	Throughout vessel, several decks	Analysing method:	PLM according NEN 5896		
Quantity:	-	Above threshold level:	No		
Documentation / remarks:	-				
Source description					
This source concerns insulation material used on exhaust lines throughout the vessel on several decks. Sample is taken in the engine room from PS main engine exhaust line on storage deck.

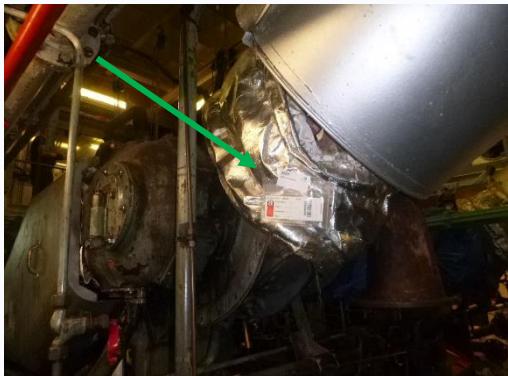
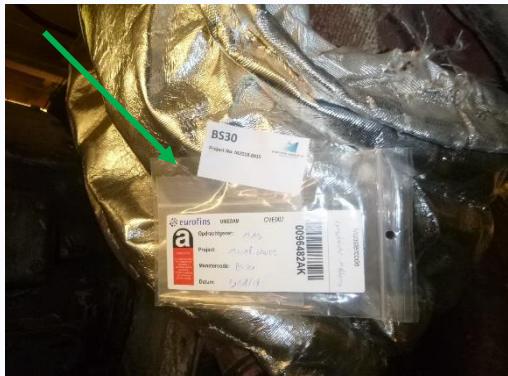
Source number:	27				
Sample number:	BS30	Type/% Asbestos:	Not contained		
Application:	Insulation mattress	Also analysed for:	-		
Location:	Throughout vessel, several decks	Analysing method:	PLM according NEN 5896		
Quantity:	-	Above threshold level:	No		
Documentation / remarks:	-				
Source description					
This source concerns insulation mattresses used throughout the vessel on several decks. Sample is taken from PS main engine on storage deck.

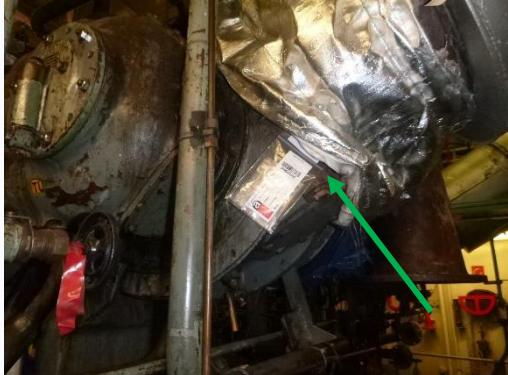
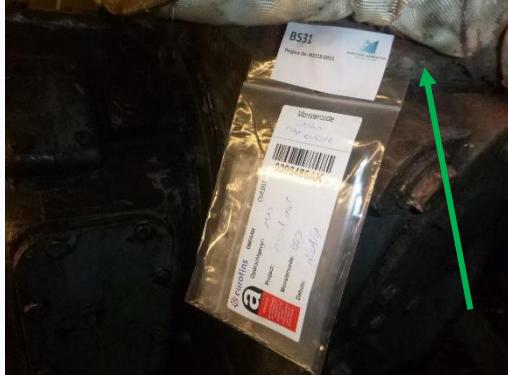
Source number:	28				
Sample number:	BS31	Type/% Asbestos:	Not contained		
Application:	Gasket	Also analysed for:	-		
Location:	Engine room, storage deck	Analysing method:	PLM according NEN 5896		
Quantity:	-	Above threshold level:	No		
Documentation / remarks:	-				
Source description					
This source concerns a flange gasket used in the exhaust line connection to the PS main engine in the engine room on storage deck.

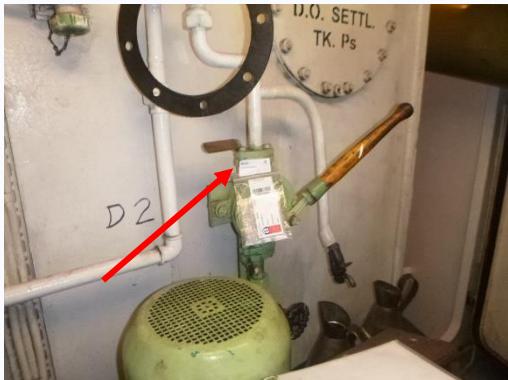
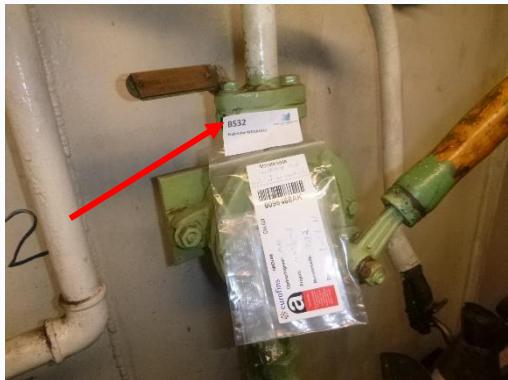
Source number:	29					
Sample number:	BS32	Type/% Asbestos:	Chrysotile, 30-60%			
Application:	Gasket	Also analysed for:	-			
Location:	Engine room, storage deck	Analysing method:	PLM according NEN 5896			
Quantity:	± 100 gr. per gasket	Above threshold level:	Yes			
Documentation / remarks:	-					
Source description						
This source concerns a gasket used in handpump connected to the main engine lub oil line to the stern tube in the engine room on storage deck.

23	06. Main deck	Emergency generator room	Batteries	Lead	Visual	Pb17	Contained	± 240 kg	8 pcs of 30 kg.
24	06. Main deck	Engine room	Boiler burner cord seal	Asbestos	Sampling	BS19	Contained	± 3 kg	Sample contains Chrysotile 60-100%.
25	06. Main deck	Engine room	Boiler burner gasket	Asbestos	Sampling	BS20	Contained	± 100 gr. per gasket	Sample contains Chrysotile 30-60%.
26	06. Main deck	Cargo generator rooms	Batteries for cargo generator	Lead	Visual	Pb16	Contained	± 240 kg	4 pcs of 60 kg.
27	07. Platform deck	Engine room	Gasket compressed air system	Asbestos	Sampling	BS24	Contained	± 100 gr. per gasket	Sample contains Chrysotile 30-60%.
28	07. Platform deck	Store	Spare gasket	Asbestos	Sampling	BS27	Contained	± 100 gr. per gasket	Brand: "Tesnit". Sample contains Chrysotile 60-100%.
29	08. Stowage	Engine room	Gasket lub oil system	Asbestos	Sampling	BS32	Contained	± 100 gr. per gasket	Sample contains Chrysotile 30-60%.

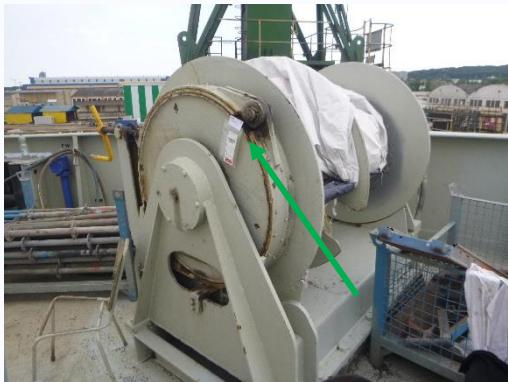
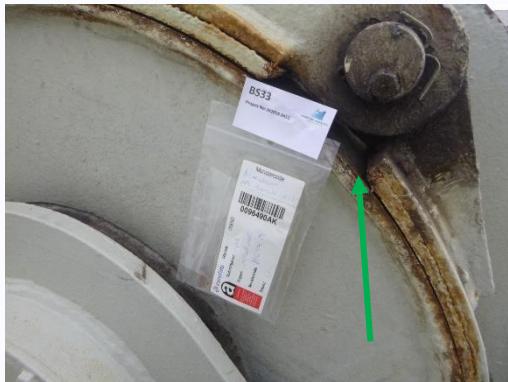
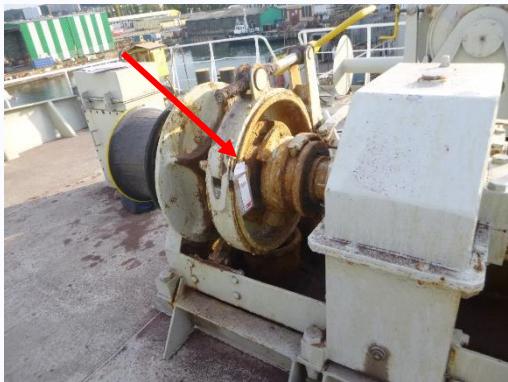
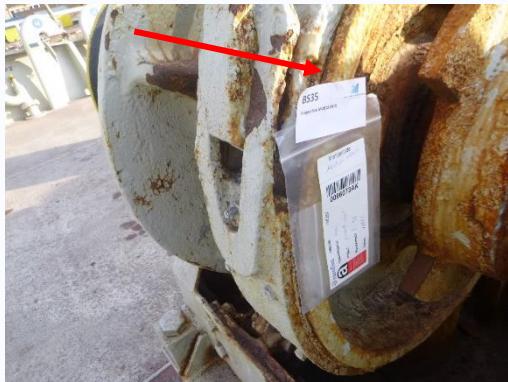
Source number:	30				
Sample number:	BS33, BS35	Type/% Asbestos:	Chrysotile, 30-60% (BS35)		
Application:	Brake lining	Also analysed for:	-		
Location:	Throughout vessel, several decks	Analysing method:	PLM according NEN 5896		
Quantity:	± 10 kg per pc	Above threshold level:	Yes		
Documentation / remarks:	-				
Source description					
This source concerns brake linings used in various winches throughout the vessel on several decks. BS33 – Brake lining AFT PS mooring winch outside on poop deck. BS35 – Brake linings anchor winch outside on forecastle deck.

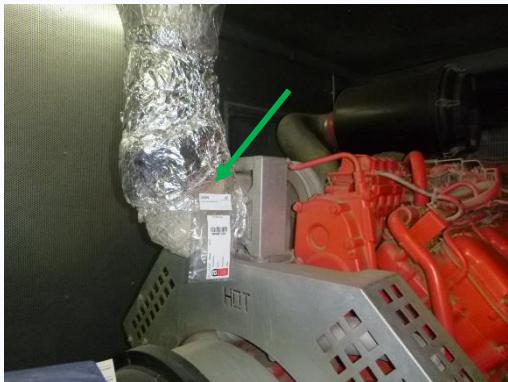
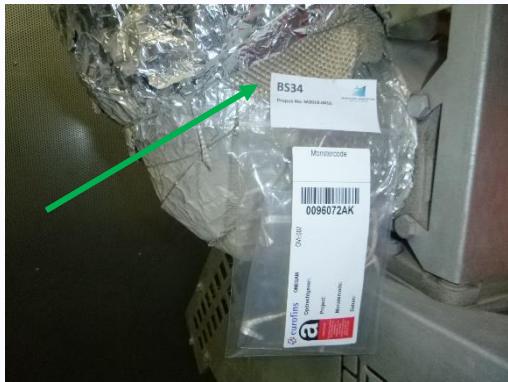
Source number:	31					
Sample number:	BS34	Type/% Asbestos:	Not contained			
Application:	Lagging	Also analysed for:	-			
Location:	Cargo generator room, main deck	Analysing method:	PLM according NEN 5896			
Quantity:	-	Above threshold level:	No			
Documentation / remarks:	-					
Source description						
This source concerns lagging material used on exhaust lines of the cargo generators in the cargo generator room on main deck. Sample is taken in the PS cargo generator room on main deck.

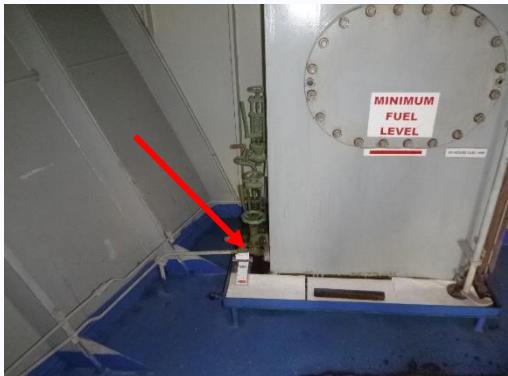
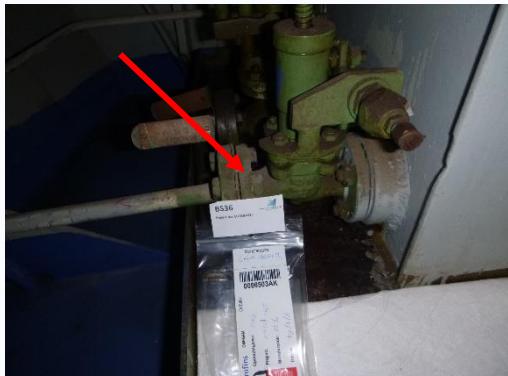
Source number:	32					
Sample number:	BS36	Type/% Asbestos:	Chrysotile, 30-60%			
Application:	Gasket	Also analysed for:	-			
Location:	Emergency generator room, main deck	Analysing method:	PLM according NEN 5896			
Quantity:	± 100 gr. per gasket	Above threshold level:	Yes			
Documentation / remarks:	-					
Source description						
This source concerns gaskets used in pipeline connected to the diesel tank in the emergency generator room on main deck.

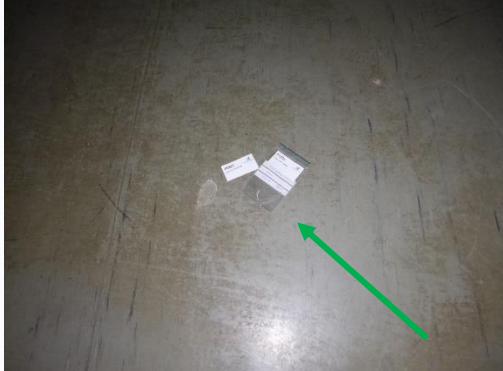
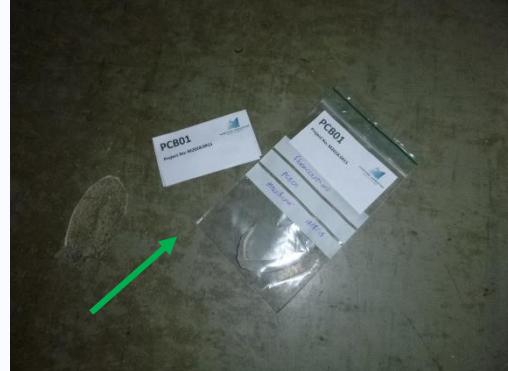
Source number:	33						
Sample number:	PCB01	PCB results:	Not contained				
Application:	Floorcovering	Also analysed for:	-				
Location:	Accommodation, several decks	Analysing method:	See Appendix D				
Quantity:	-	Above threshold level:	No				
Documentation / remarks:	-						
Source description							
This source concerns pvc floorcovering used throughout the vessel on several decks. Sample is taken in the radio room on nav. deck.

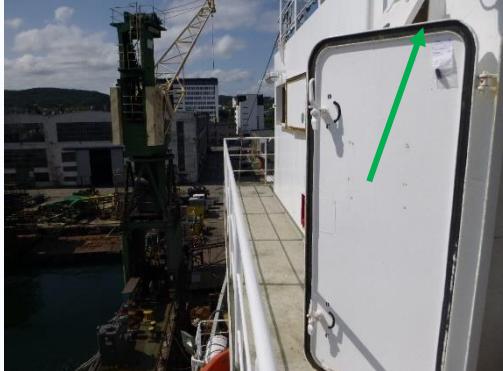
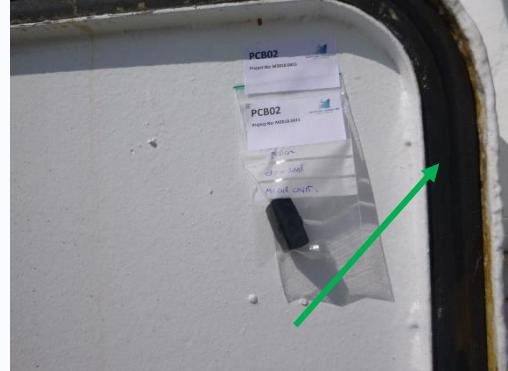
Source number:	34				
Sample number:	PCB02	PCB results:	Not contained		
Application:	Door seal	Also analysed for:	-		
Location:	Throughout vessel, several decks	Analysing method:	See Appendix D		
Quantity:	-	Above threshold level:	No		
Documentation / remarks:	-				
Source description					
This source concerns rubber door seal used in door frames of water tight doors throughout the vessel on several decks. Sample is taken from the battery room door outside on nav. deck.

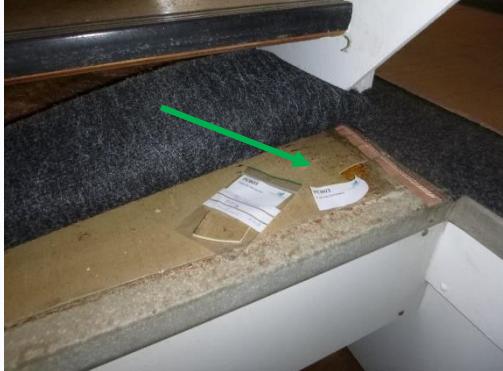
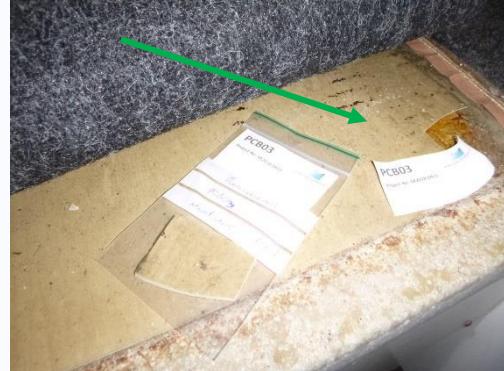
Source number:	35				
Sample number:	PCB03	PCB results:	Not contained		
Application:	Floorcovering	Also analysed for:	-		
Location:	Accommodation, several decks	Analysing method:	See Appendix D		
Quantity:	-	Above threshold level:	No		
Documentation / remarks:	-				
Source description					
This source concerns floorcovering used underneath carpet throughout the accommodation on several decks. Sample is taken in the corridor on officers deck.

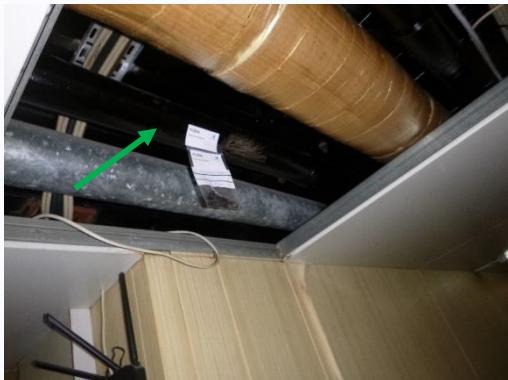
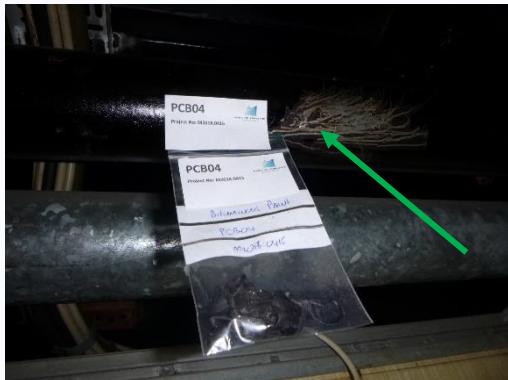
Source number:	36				
Sample number:	PCB04	PCB results:	Not contained		
Application:	Bituminous paint	Also analysed for: - Lead:	225 mg/kg		
Location:	Accommodation, several decks	Analysing method:	See Appendix D		
Quantity:	-	Above threshold level:	No		
Documentation / remarks:	-				
Source description					
This source concerns black bituminous paint used on steel bulkheads and deckheads throughout the accommodation on several decks. Sample is taken in the corridor on main deck.

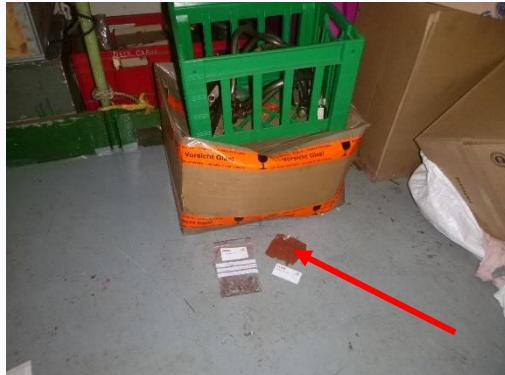
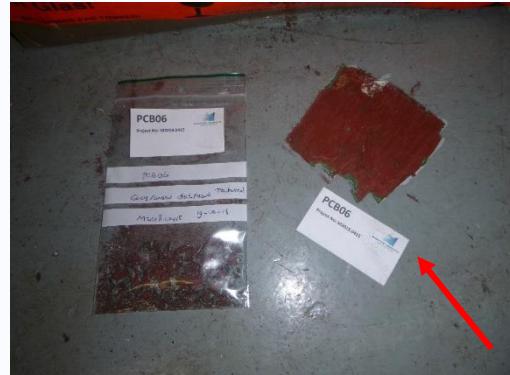
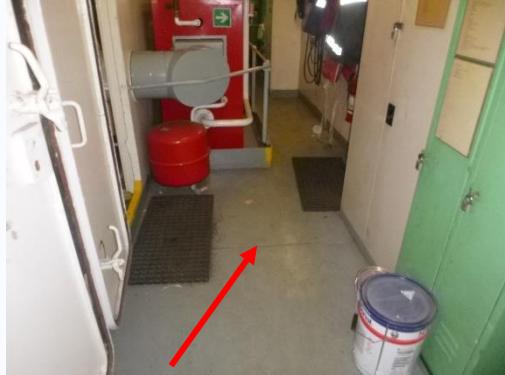
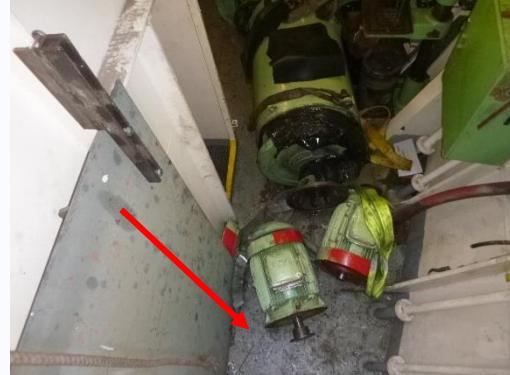
Source number:	38		
Sample number:	PCB06	PCB results:	10,3 mg/kg
Application:	Deck paint	Also analysed for: - Lead: - Cadmium: - Chromium: - PBB:	52825 mg/kg Not contained 58 mg/kg Not contained
Location:	Throughout vessel, several decks	Analysing method:	See Appendix D
Quantity:	± 750 kg	Above threshold level:	Yes (lead)
Documentation / remarks:	-

This source concerns grey/green deck paint used in technical areas throughout the vessel on several decks. Sample is taken in the engine store on main deck.

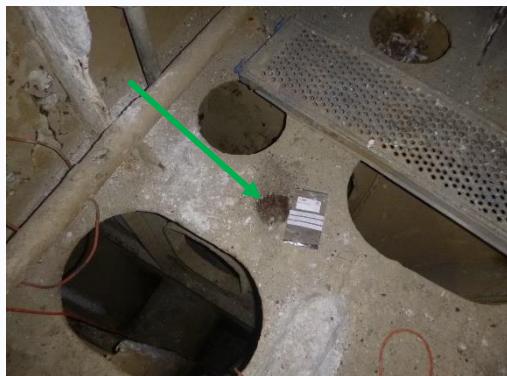
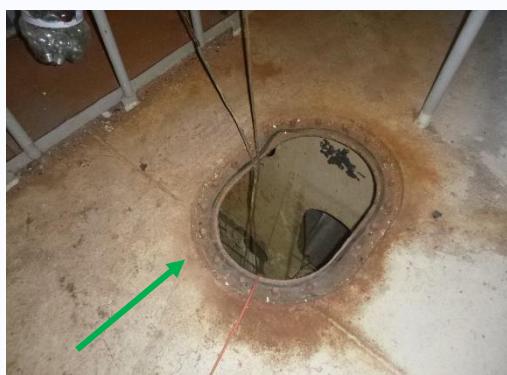
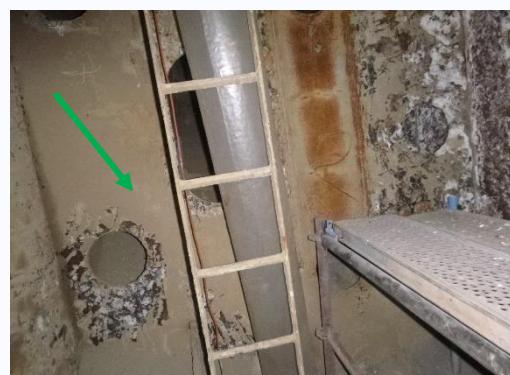
Source number:	39		
Sample number:	PCB07	PCB results:	Not contained
Application:	Coating	Also analysed for: - Lead: - Chromium:	98 mg/kg Not contained
Location:	Throughout vessel, several decks	Analysing method:	See Appendix D
Quantity:	-	Above threshold level:	No
Documentation / remarks:	-

This source concerns coating used in the ballast tanks throughout the vessel on several decks. Sample is taken in the SB AFT peak on storage deck.

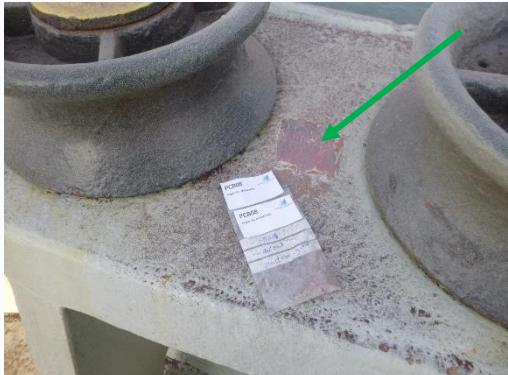
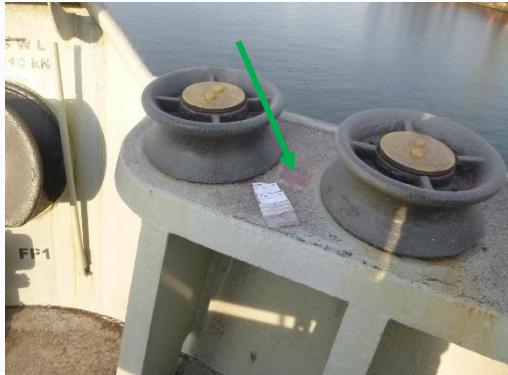
PCB08	PCB08

Source number:	40				
Sample number:	PCB08	PCB results:	Not contained		
Application:	Hull paint	Also analysed for: - Lead: - Cadmium: - Chromium:	396 mg/kg Not contained Not contained		
Location:	Hull, outside	Analysing method:	See Appendix D		
Quantity:	-	Above threshold level:	No		
Documentation / remarks:	-				
Source description					
This source concerns grey paint used on the hull above the water line. Sample is taken outside on forecastle deck.

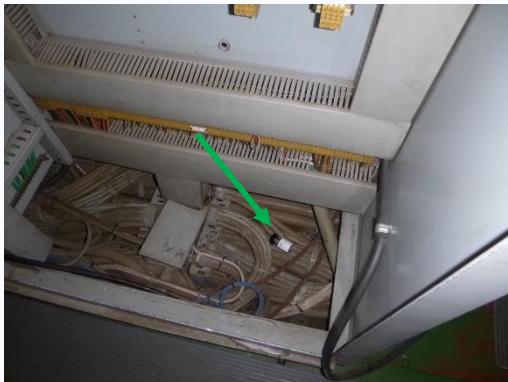
Source number:	41				
Sample number:	SS01	PCB results:	Not contained		
Application:	Electrical cables	Also analysed for:	-		
Location:	Throughout vessel, several decks	Analysing method:	See Appendix D		
Quantity:	-	Above threshold level:	No		
Documentation / remarks:	-				
Source description					
This source concerns electrical cables used throughout the vessel on several decks. Swipe sample is taken in the engine control room on platform deck.

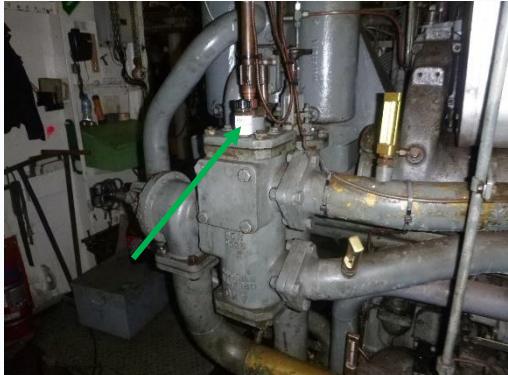
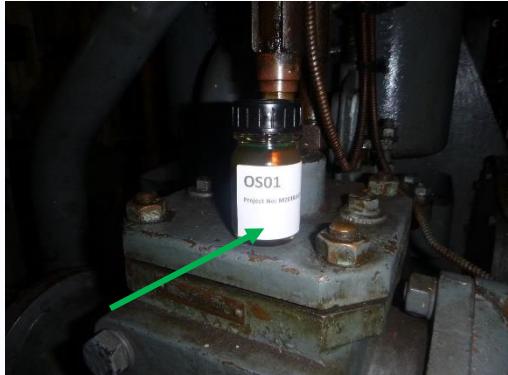
Source number:	42				
Sample number:	OS01, OS02, OS03	PCB results:	Not contained		
Application:	Oils	Also analysed for:	-		
Location:	Throughout vessel, several decks	Analysing method:	See Appendix D		
Quantity:	-	Above threshold level:	No		
Documentation / remarks:	-				
Source description					
This source concerns oils used in various systems and equipment throughout the vessel on several decks.					
OS01 – Lub oil for main engine in the engine room on storage deck. OS02 – Hydraulic oil for main system in the engine room on storage deck. OS03 – Hydraulic oil for steering gear in the steering gear room on main deck.

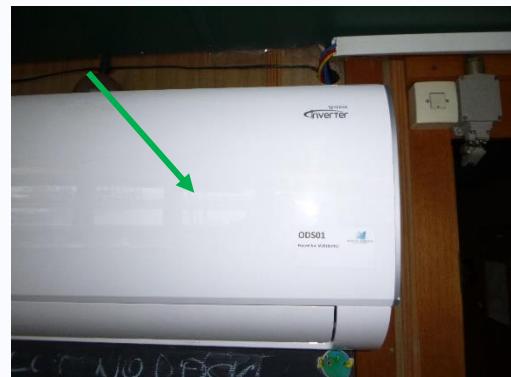
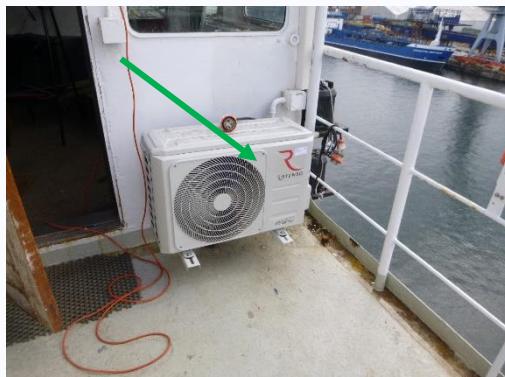
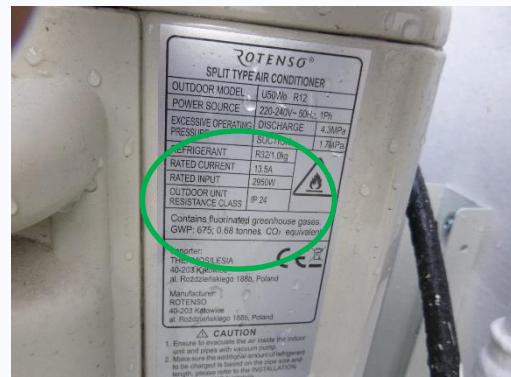
Source number:	43	Type of ODS:	R32
Sample number:	ODS01	Also analysed for:	-
Application:	Refrigerant	Analysing method:	Visual check
Location:	Wheelhouse, nav. deck	Above threshold level:	No
Quantity:	-		
Documentation / remarks:	<p>Brand: Rotenso Inverter. Indoor model: U50WI. Outdoor model: U50Wa.</p> <p>No ozone depleting potential.</p>

This source concerns refrigerant R32 used in AC split unit for the wheelhouse on nav. deck.

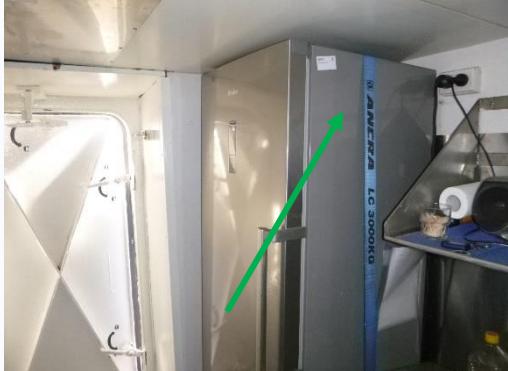
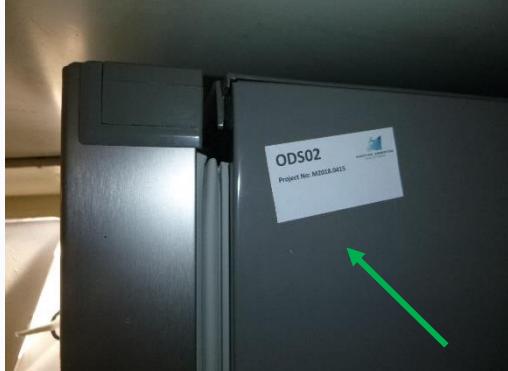
Source number:	44					
Sample number:	ODS02	Type of ODS:	R600a			
Application:	Refrigerant	Also analysed for:	-			
Location:	Galley/duty mess, poop deck	Analysing method:	Visual check			
Quantity:	-	Above threshold level:	No			
Documentation / remarks:	No ozone depleting potential.					
Source description						
This source concerns refrigerant R600a used in refrigerators in the galley and duty mess on poop deck.
