Inventory of Hazardous Materials Part I

Fjordvik – IMO 7423249

Version: 1.0
Date: 03-10-2018
Client: SMT Shipping
Project number: M2018.0415
Survey location: Gdynia, Poland

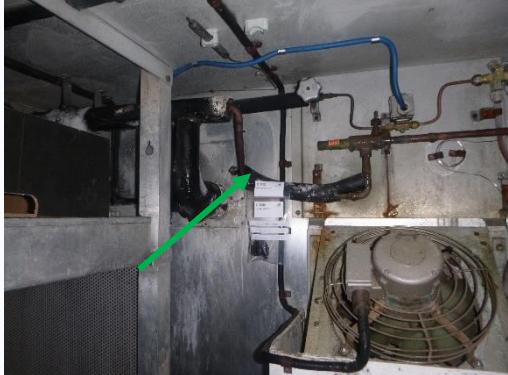
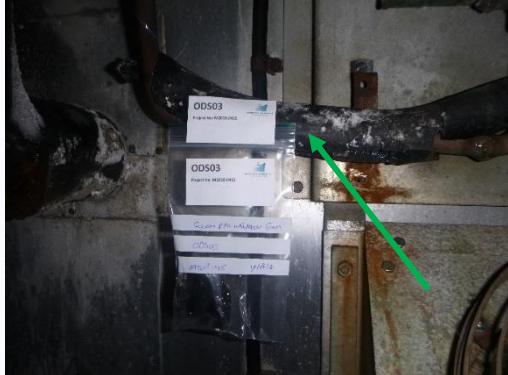
Source number:	45				
Sample number:	ODS03	Type of ODS:	Not contained		
Application:	Insulation foam	Also analysed for:	-		
Location:	Throughout vessel, several decks	Analysing method:	See Appendix D		
Quantity:	-	Above threshold level:	No		
Documentation / remarks:	-				
Source description					
This source concerns black insulation foam used on cooling pipes throughout the vessel on several decks. Sample is taken in the cold store on main deck.

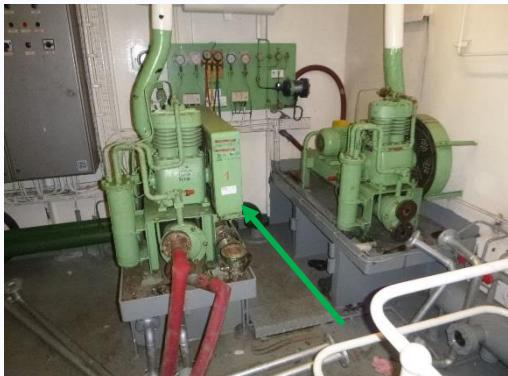
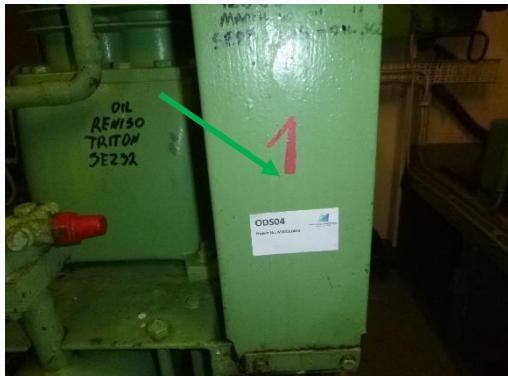
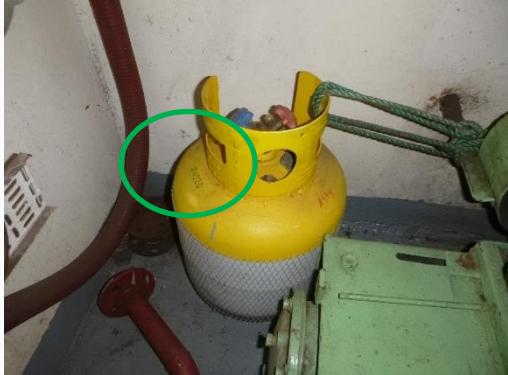
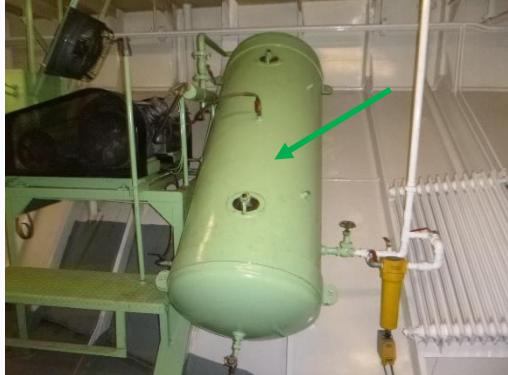
ODS04	ODS04

Source number:	46		
Sample number:	ODS04	Type of ODS:	R422D
Application:	Refrigerant	Also analysed for:	-
Location:	Engine room, main deck	Analysing method:	Visual check
Quantity:	-	Above threshold level:	No
Documentation / remarks:	No ozone depleting potential.

This source concerns refrigerant R422D used in AC compressors for the accommodation and cold provision stores in the engine room on main deck.

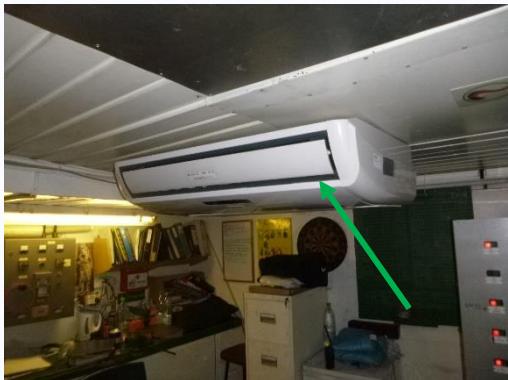
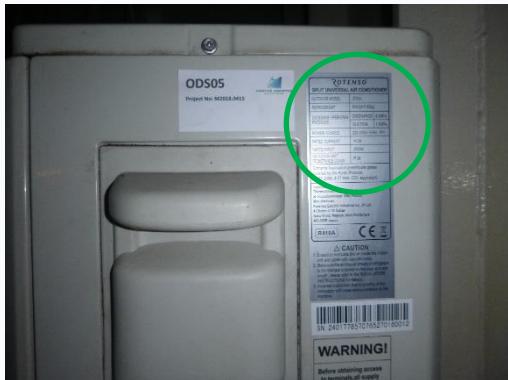
Source number:	47					
Sample number:	ODS05	Type of ODS:	R410a			
Application:	Refrigerant	Also analysed for:	-			
Location:	Engine control room, platform deck	Analysing method:	Visual check			
Quantity:	-	Above threshold level:	No			
Documentation / remarks:	No ozone depleting potential.					
Source description						
This source concerns refrigerant R410a used in AC split unit in the engine control room on platform deck.

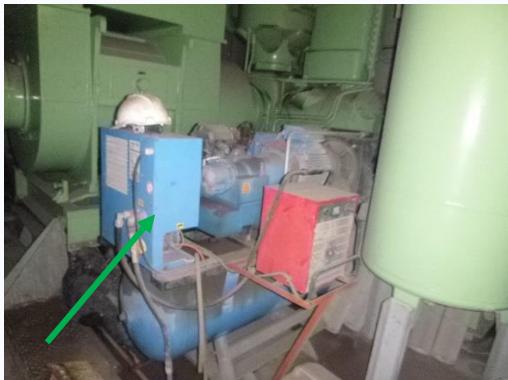
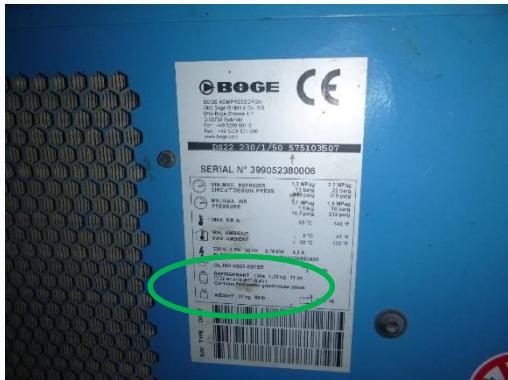
Source number:	48					
Sample number:	ODS06	Type of ODS:	R134a			
Application:	Refrigerant	Also analysed for:	-			
Location:	Compressor room, main deck	Analysing method:	Visual check			
Quantity:	-	Above threshold level:	No			
Documentation / remarks:	No ozone depleting potential.					
Source description						
This source concerns refrigerant R134a used in compressor for dryer in the compressor room on main deck.

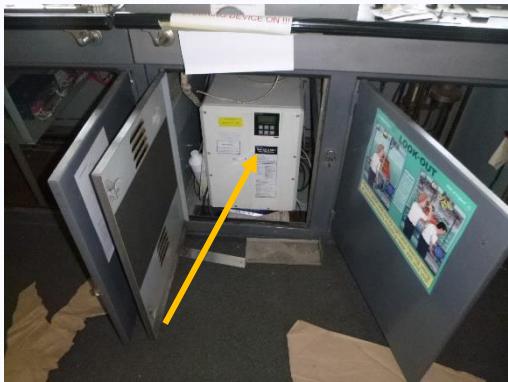
Source number:	49			
Sample number:	Pb01	Lead results:	PCHM	
Application:	Digital gyrocompass	Also analysed for: - Mercury:	PCHM	
Location:	Wheelhouse, nav. deck	Analysing method:	Visual check	
Quantity:	Unknown	Above threshold level:	Unknown	
Documentation / remarks:	Brand: Sperry Marine. Type: Navigat X MK 1.			
Source description				
This source concerns a digital gyrocompass located in the wheelhouse on nav. deck. No information is available regarding the use of lead and/or mercury within this gyrocompass and therefore it needs to be considered as PCHM.

In the wheelhouse on nav. deck a gyrocompass is present. There is no documentation available about the use of lead in this equipment. Therefore the gyrocompass is considered as Potentially Containing Hazardous Material (PCHM).

In the wheelhouse on nav. deck a gyrocompass is present. There is no documentation available about the use of mercury in this equipment. Therefore the gyrocompass is considered as Potentially Containing Hazardous Material (PCHM).

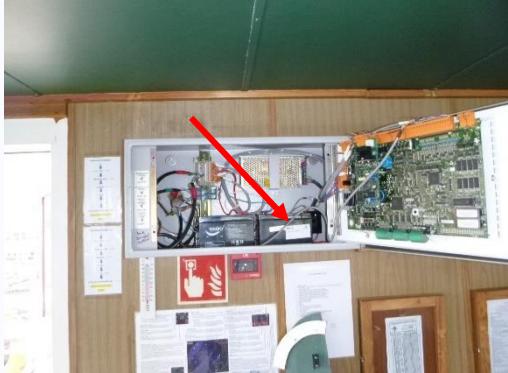
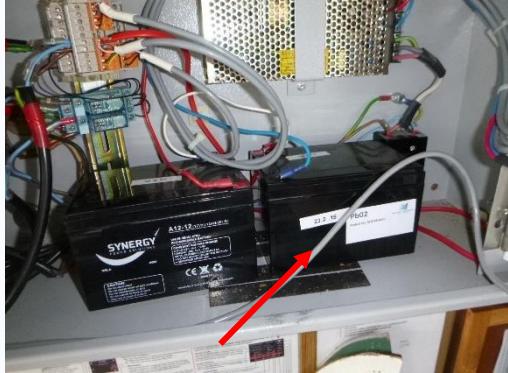
Source number:	50				
Sample number:	Pb02 till Pb17	Lead results:	Contained		
Application:	Batteries	Also analysed for:	-		
Location:	Throughout vessel, several decks	Analysing method:	Visual check		
Quantity:	± 780 kg	Above threshold level:	Yes		
Documentation / remarks:	-				
Source description					
This source concerns batteries used in various systems and equipment throughout the vessel on several decks.					
Pb02 – Batteries for fire alarm in the wheelhouse on nav. deck. Pb03 – Batteries for back-up UPS in the wheelhouse on nav. deck (PCHM). Pb04 – Batteries for discharge system in the wheelhouse on nav. deck. Pb05 – Batteries for UPS radar autopilot in the wheelhouse on nav. deck (PCHM). Pb06 – Batteries for UPS ecdis in the wheelhouse on nav. deck (PCHM). Pb07 – Batteries for VDR in the chart room on nav. deck. Pb08 – Batteries for UPS VDS in the chart room on nav. deck (PCHM). Pb09 – Batteries for emergency in the battery room on nav. deck. Pb10 – Batteries for emergency in the battery room on nav. deck. Pb11 – Batteries for PS rescue boat outside on boat deck. Pb11 – Batteries for SB rescue boat in the wheelhouse on nav. deck. Pb12 – Batteries for UPS in the captains cabin, chief engineer cabin and chief officers cabin on officiers deck (PCHM). Pb13 – Batteries for UPS in ships office on officers deck (PCHM). Pb14 – Batteries for fbb in radio room on nav. deck (PCHM). Pb15 – Batteries for UPS in the engine control room on platform deck (PCHM). Pb16 – Batteries for cargo generator on main deck. Pb17 – Batteries for emergency generator in the emergency generator room on main deck.

No.	Zone / Deck level	Area	Description	Hazardous Material	Visual/ sampling	Sample ID	Sample result	Approx. quantity	Result of doc. Checking / remarks
1	02. Navigation deck	Battery room	Batteries for GMDSS	Lead	Visual	Pb10	Contained	± 120 kg	4 pcs of 30 kg.
2	02. Navigation deck	Chart room	Batteries for VDR	Lead	Visual	Pb07	Contained	± 5 kg	1 pc of 5 kg.
3	02. Navigation deck	Battery room	Batteries for emergency light	Lead	Visual	Pb09	Contained	± 120 kg	4 pcs of 30 kg.
4	02. Navigation deck	Wheelhouse	Gyrocompass	Mercury	Visual	Pb01	PCHM	Unknown	Brand: Sperry Marine. Type: Navigat X MK 11.
5	02. Navigation deck	Wheelhouse	Gyrocompass	Lead	Visual	Pb01	PCHM	Unknown	Brand: Sperry Marine. Type: Navigat X MK 11.
6	02. Navigation deck	Wheelhouse	UPS for radar auto pilot	Lead	Visual	Pb05	PCHM	Unknown	UPS unit of brand Blue walker GmbH, Model VFI 1000 TG.
7	02. Navigation deck	Wheelhouse	Batteries for fire alarm system	Lead	Visual	Pb02	Contained	± 15 kg	2 pcs of 7,5 kg.

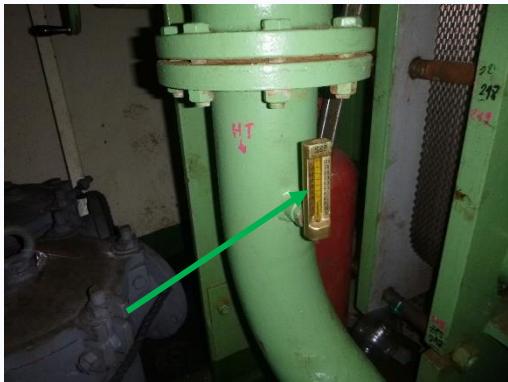
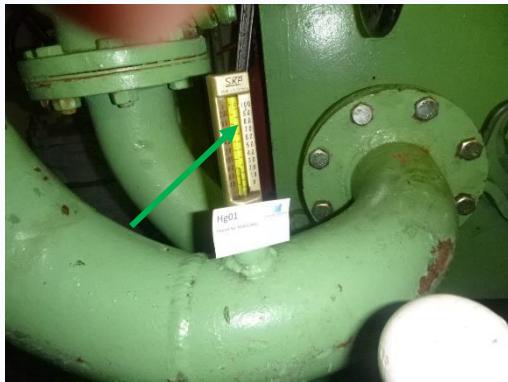
Source number:	51							
Sample number:	Hg01	Mercury results:	Not contained					
Application:	Temperature gauge	Also analysed for:	-					
Location:	Throughout vessel, several decks	Analysing method:	Visual check					
Quantity:	-	Above threshold level:	No					
Documentation / remarks:	Based on manufactured declaration of SIKA.							
Source description								
This source concerns temperature gauges of brand SIKA/Econosto used throughout the vessel on several decks.

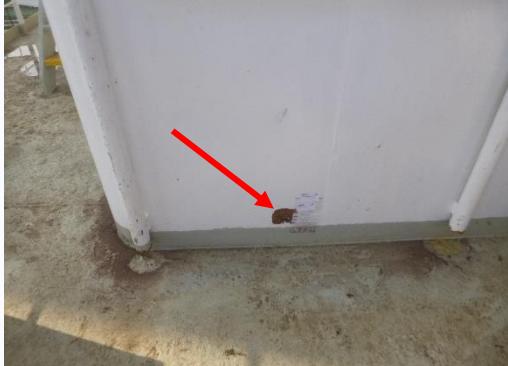
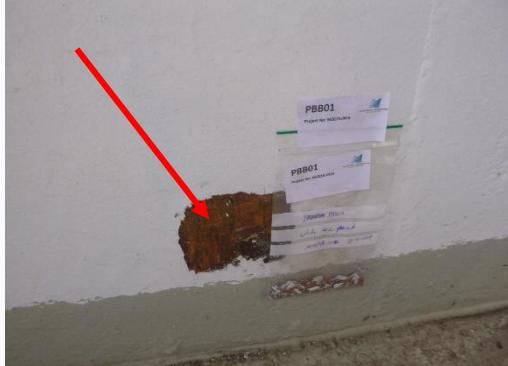
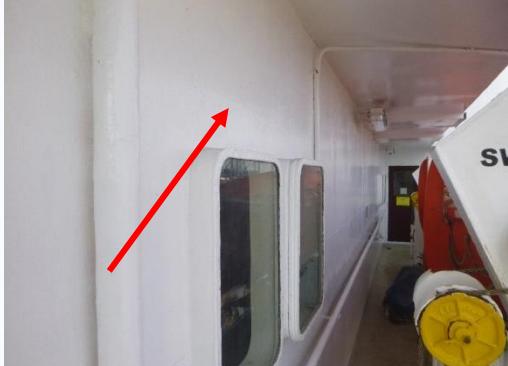
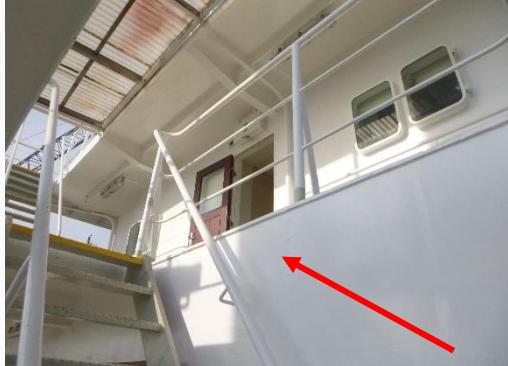
Source number:	52				
Sample number:	PBB01	PBB results:	Not contained		
Application:	Accommodation paint	Also analysed for: - PCB: - Lead: - Cadmium: - Chromium:	Not contained 24540 mg/kg Not contained Not contained		
Location:	Throughout vessel, several decks	Analysing method:	See Appendix D		
Quantity:	± 910 kg	Above threshold level:	Yes		
Documentation / remarks:	-				
Source description					
This source concerns white paint used on the outside of the accommodation and funnel on several decks. Sample is taken outside on boat deck.

No.	Zone / Deck level	Area	Description	Hazardous Material	Visual/ sampling	Sample ID	Sample result	Approx. quantity	Result of doc. Checking / remarks
1	04. Boat deck	Outside	Grey deck paint	Lead	Sampling	CSCP01	Contained	± 1820 kg	Sample contains 4514 mg/kg.
2	04. Boat deck	Outside	Funnel paint	Lead	Visual	-	Contained	± 910 kg	Based on sample PBB01.
3	06. Main deck	Engine store	Deck paint	Lead	Sampling	PCB06	Contained	± 750 kg	Sample contains 52625 mg/kg.
4	06. Main deck	Engine room	Paint bulkheads	Lead	Sampling	PCN01	Contained	± 1600 kg	Sample contains 32570 mg/kg.
5	05. Poop deck	Outside	Accommodation paint	Lead	Sampling	PBB01	Contained	± 910 kg	Sample contains 24540 mg/kg.

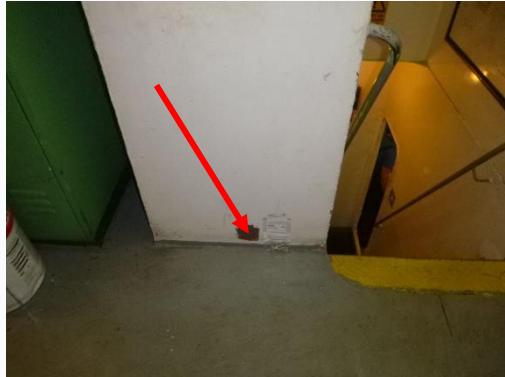
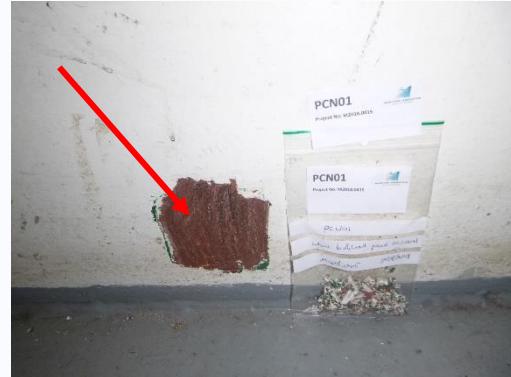
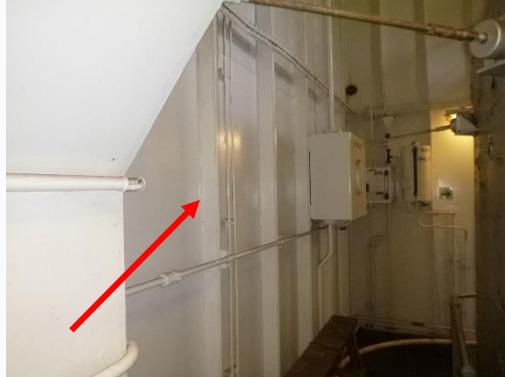
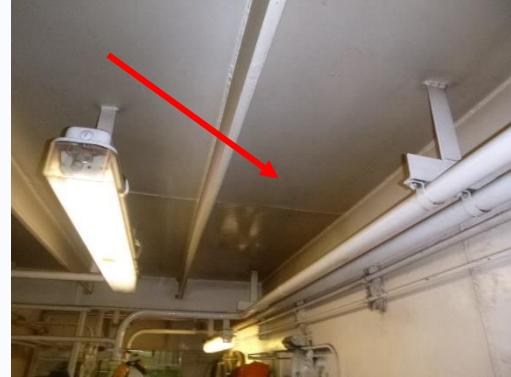
PCN01

This source concerns white bulkhead paint used in technical areas throughout the vessel on several decks. Sample is taken in the engine room on main deck.

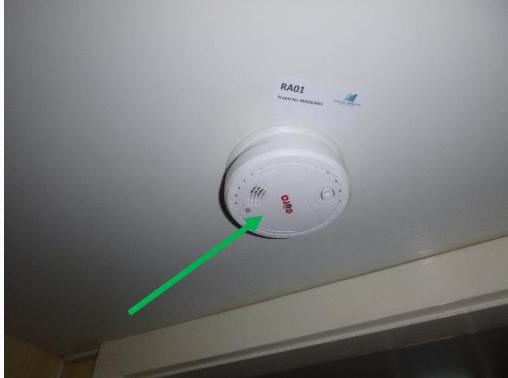
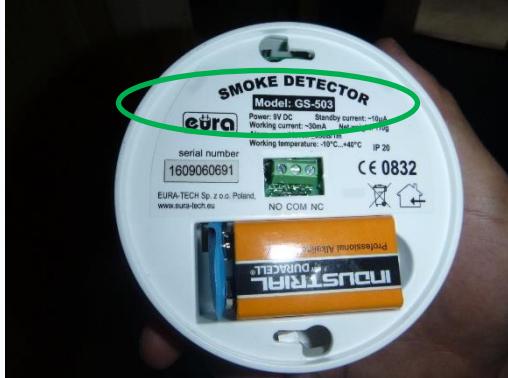
RA01	RA01

Source number:	54			
Sample number:	RA01, RA02	Radioactive results:	Not contained	
Application:	Smoke detectors	Also analysed for:	-	
Location:	Throughout vessel, several decks	Analysing method:	Visual check	
Quantity:	-	Above threshold level:	No	
Documentation / remarks:	-			
Source description				
This source concerns smoke detectors used throughout the vessel on several decks.				
RA01 – Smoke detector with brand “EURA, GS-503”. RA02 – Smoke detector with brand “Cerberus AG”.

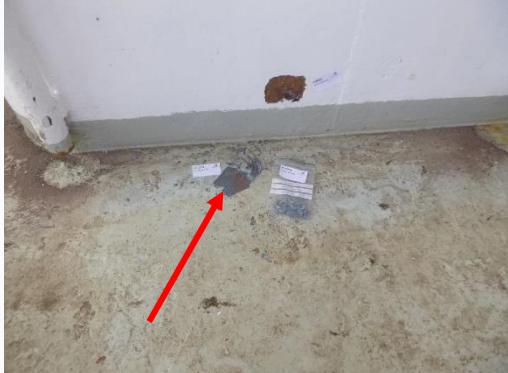
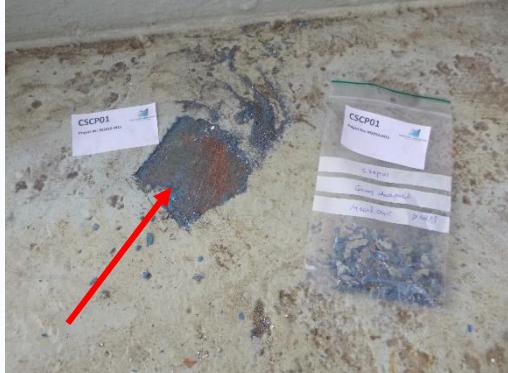
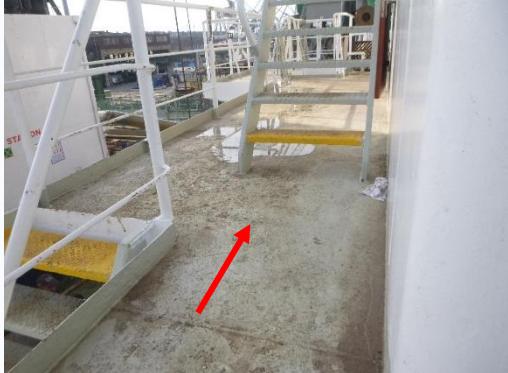
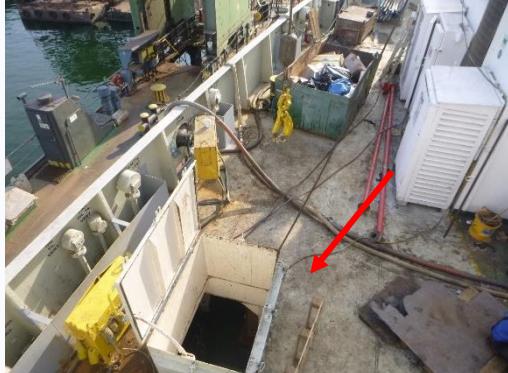
CSCP01	CSCP01

Source number:	55						
Sample number:	CSCP01	CSCP results:	Not contained				
Application:	Deck paint	Also analysed for: - PCB: - PCN: - Lead: - Cadmium: - Chromium:	Not contained Not contained 4514 mg/kg Not contained Not contained				
Location:	Throughout vessel, several decks	Analysing method:	See Appendix D				
Quantity:	± 1820 kg	Above threshold level:	Yes				
Documentation / remarks:	-						
Source description							
This source concerns grey deck paint used throughout the vessel on several decks. Sample is taken outside on boat deck.

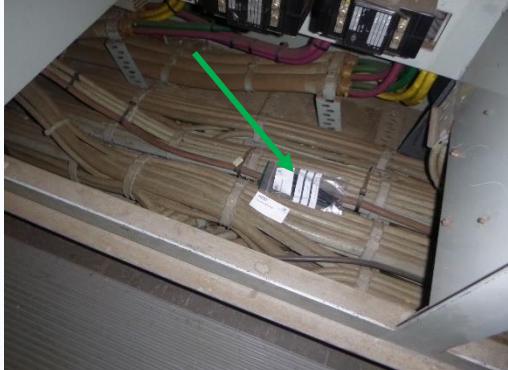
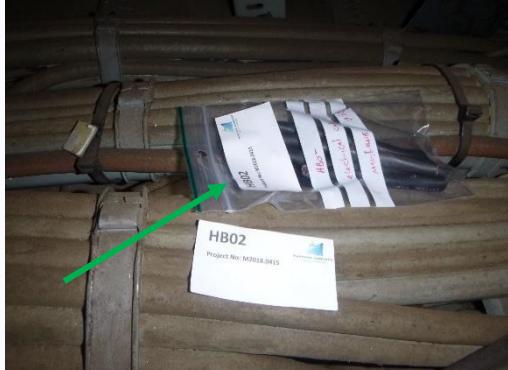
HB02		HB02

Source number:	57				
Sample number:	HB02	HBCDD results:	Not contained		
Application:	Electrical cables	Also analysed for: - PCB: - Lead: - PCN: - CSCP:	Not contained Not contained Not contained Not contained		
Location:	Throughout vessel, several decks	Analysing method:	See Appendix D		
Quantity:	-	Above threshold level:	No		
Documentation / remarks:	-				
Source description					
This source concerns electrical cables used throughout the vessel on several decks. Sample is taken in the engine control room on platform deck.

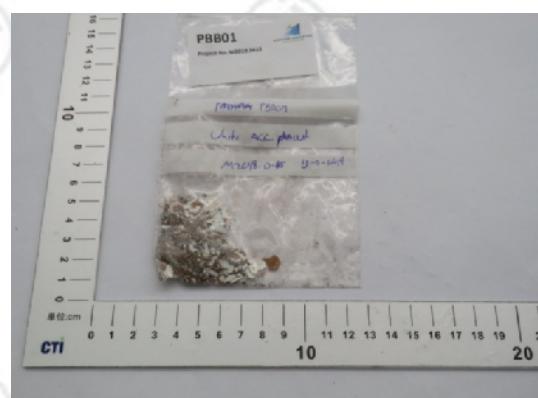
No.	Zone / Deck level	Area	Description	Hazardous Material	Visual/ sampling	Sample ID	Sample result	Approx. quantity	Result of doc. Checking / remarks
1	04. Boat deck	Outside	Grey deck paint	Lead	Sampling	CSCP01	Contained	± 1820 kg	Sample contains 4514 mg/kg.
2	04. Boat deck	Outside	Funnel paint	Lead	Visual	-	Contained	± 910 kg	Based on sample PBB01.
3	06. Main deck	Engine store	Deck paint	Lead	Sampling	PCB06	Contained	± 750 kg	Sample contains 52625 mg/kg.
4	06. Main deck	Engine room	Paint bulkheads	Lead	Sampling	PCN01	Contained	± 1600 kg	Sample contains 32570 mg/kg.
5	05. Poop deck	Outside	Accommodation paint	Lead	Sampling	PBB01	Contained	± 910 kg	Sample contains 24540 mg/kg.
