Erosion mechanism of refractories in a pyro-processing furnace for recycling lithium-ion secondary batteries

Yoshiki Murakami^{a,b}, Yutaka Matsuzaki^b, Takeshi Kamimura^b, Takato Nishiura^b, Koichi Masuda^b, Atsushi Shibayama^a, Ryo Inoue^{a,*}

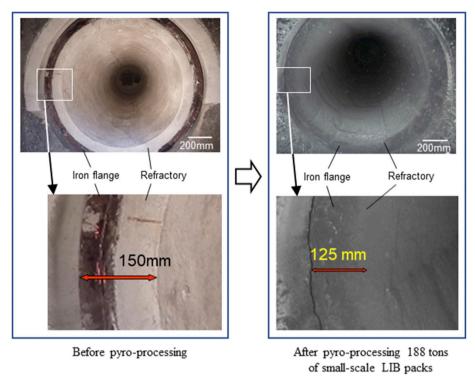
Fig. 2 shows the changes in the refractory thickness inside the kiln before and after conducting pyro-processing. The left side of this figure shows the refractory thickness prior to pyro-processing, whereas the right side shows the refractory thickness after pyro-processing 188 tons of small-scale LIB packs with an LiCoO₂ positive electrode, graphite negative electrode, and LiPF₆ electrolyte. This pyro-process was continuously carried out for 537 h. By comparing the refractory before and after LIB pyro-processing, the latter was observed to have peeled over the entire surface, and the thickness was reduced to approximately 125 mm. Because of the long continuous operation for 537 h, the time dependence of the change in refractory thickness could not be measured during the process, but an average erosion rate was estimated to be 0.13 mm per 1 ton of small-scale LIB packs. Usually, the refractory surface, which became black after pyro-processing the LIB, as shown in the right picture in Fig. 2, is cleaned and repaired during maintenance of the rotary kiln.

Fig. 2. The changes in refractory thickness inside the kiln before and after conducting pyro-processing.

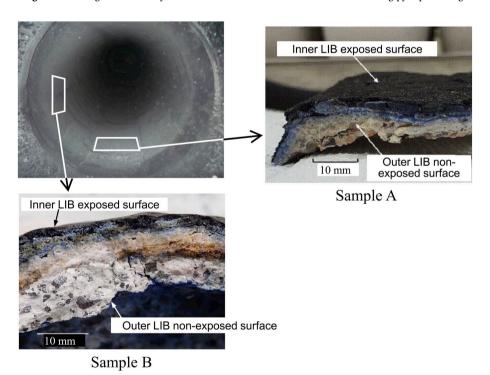
In this study, some parts of the refractory lining were sampled during the maintenance period of the rotary kiln and studied using various analysis techniques. As an example, two refractory specimens are shown in Fig. 3. The color of the inner LIB exposed surface was black, and at a depth of approximately 2–5 mm, the color was blue. These color changes of the refractory material correspond to the formation of various reaction layers.

Fig. 3. Sampled refractory specimens.

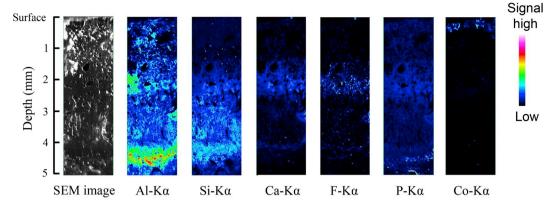
Fig. 7 shows the elementary mapping analysis results from SEM-EDX for the refractory cross section up to a depth of 5 mm from the surface. The concentrations of Al, Si and Ca were reduced up to a depth of approximately 2 mm. In particular, the reductions in the Si and Ca concentrations were significant. Phosphorus and F, which are electrolyte constituents of LIBs, penetrated up to a depth of approximately 5 mm. Fluorine was observed to be present in high concentration up to a depth of approximately 2 mm, and P was observed to be relatively uniformly dispersed up to a depth of approximately 5 mm. In particular, some concentrated parts were observed between depths of 4 mm and 5 mm. Cobalt, an active constituent of LIBs, was observed to be present up to a depth of 0.2 mm from the surface, but beyond that depth, it was not detected.

Fig. 7. SEM image and EDX elementary mappings for the refractory cross-section up to a depth of 5 mm.

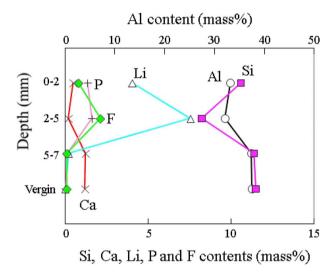
Fig. 9 shows the chemical analysis results of the refractory surface in the depth direction from ICP-AES and ion chromatography. Lithium, P and F, which were not present at depths of 5–7 mm or in the unused refractory, were observed up to a depth of approximately 5 mm from the surface, and Al, Si, and Ca were found to be lower in concentration compared with those in the unused refractory. In the specimens at depths of 2–5 mm, Li, P, and F were more prevalent than at the surface, and the Si and Ca concentrations reduced significantly.

Fig. 9. Results of chemical analysis of the refractory in the depth direction.

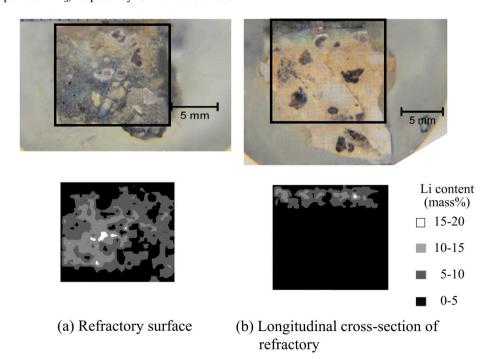
The Li analysis results of the refractory surface using LIBS are shown in Fig. 8(a). Clearly, Li was present throughout the surface, and the Li concentration was as high at approximately 15–20 mass%. The Li concentrations on the longitudinal cross section of the refractory material are shown in Fig. 8(b). Lithium penetrated up to a depth of approximately 3 mm. Most of the area has a concentration of 5–10 mass%, but there were also areas with a high concentration of 15–20 mass%.

Fig. 8. Li concentration mappings on the refractory surface (a) and the longitudinal cross-section (b) of the refractory sample A obtained by LIBS.

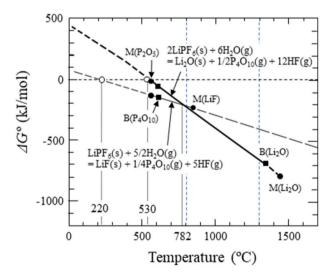
Fig.~11. Standard Gibbs free energies of reactions (4) and (5) plotted against temperature.

Fig. 11 shows the standard Gibbs free energy of reactions (4) and (5) with respect to the temperature obtained by combining the respective

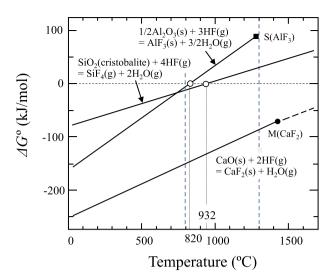
Fig.~12. Standard Gibbs free energies of reactions (6) to (8) plotted against temperature.

The temperature dependence of the standard free energies of reactions (6) to (8) obtained from thermodynamic data [24] are shown in Fig. 12, where $M(CaF_2)$ and $S(AlF_3)$ denote the melting points of CaF_2 and the sublimation point of AlF_3 , respectively. Similar to the data

shown in Fig. 11, assuming that each reactant and product are in the standard state (pure substances), equations (6) and (7) proceed to the right below 820 °C and 932 °C, respectively. Equations (8) can always occur in the temperature range indicated in Fig. 12. This means that during heating to an operating temperature of 800 °C, equations (6)–(8) could occur. Additionally, CaF_2 may vaporize upon the formation of an azeotropic compound with AlF_3 and/or SiF_4 . Presumably, this refractory erosive reaction occurs because of a mechanism similar to that observed during the damage to the refractory by fluorine gas in waste incinerators, as reported by Yamamoto [26]. This damage mechanism is schematically shown for the refractory surface part shown in Fig. 13(a).

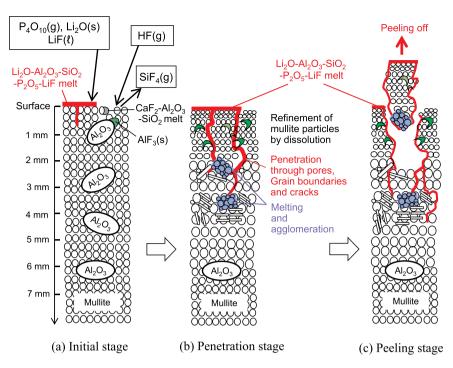
As shown in Figs. 5(c) and 6(b), at a depth of approximately 4 mm from the surface of the refractory, the particles generated appeared to have melted and solidified, and a high concentration of P was detected at this depth. Moreover, Li was observed to have penetrated to a depth of approximately 3 mm, as shown in Fig. 8(b), and up to a depth of approximately 5 mm, as shown in Fig. 9. The temperature inside the kiln increased to approximately 1300 °C, as shown in Fig. 10. Consequently, as a second mechanism of refractory damage, erosion occurred because the refractory melting point was lowered by Li₂O, P₂O₅ and fluorides that formed via reactions (4) to (8). Thus, at high temperature, an Li₂O-Al₂O₃-SiO₂-P₂O₅(-LiF) melt can generate (Fig. 13(a)), and this low-melting-point melt penetrates easily into the refractory through pores, grain boundaries, and cracks (Fig. 13(b)), causing a peeling phenomenon (Fig. 13(c)). To confirm this hypothesis, the phase diagrams of the Li₂O-Al₂O₃-SiO₂-P₂O₅(-LiF) system should be studied. From another point of view, it is expected to be preferable to use an MgO refractory with a gradient composition, which has been recently indicated to be resistant to the erosion of the Al₂O₃-SiO₂-CaO-CaF₂ melt by Han et al. [27].

Fig. 13. Schematic illustration of refractory damage mechanism.
