DI23I-10

DTC B2620 ECU Power Source Circuit Malfunction

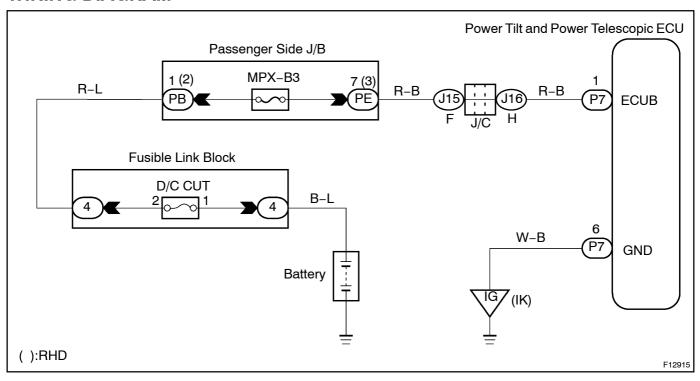
## **WIRING DIAGRAM**

ECU power source circuit supply the battery voltage to power tilt and power telescopic ECU.

DTC No.	DTC Detecting Condition	Trouble Area
B2620	The condition that the voltage of the ECU Power Source circuit drop to be 9V or less continues for 10 seconds or	Battery ECU power source circuit
	•	Power tilt and power telescopic ECU
