DI23H-10

DTC B2611 Telescopic Position Sensor or Telescopic Motor Circuit Malfunction

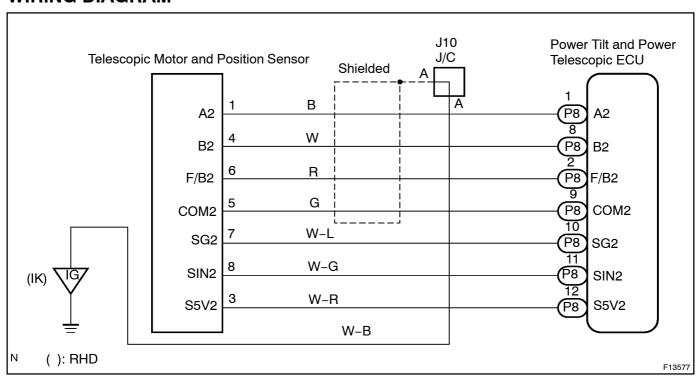
WIRING DIAGRAM

Telescopic motor is operated by the power voltage supplied from power tilt and power telescopic ECU and makes the steering column slide forward and rearward. Telescopic position sensor (Hole IC) in the telescopic motor detects the sliding position of the forward and rearward direction of the steering column and outputs the signal to the CPU in response to that sliding amount.
