DTC	B2233	FRONT LEFT CENTER SENSOR MALFUNCTION	
-----	-------	--------------------------------------	--

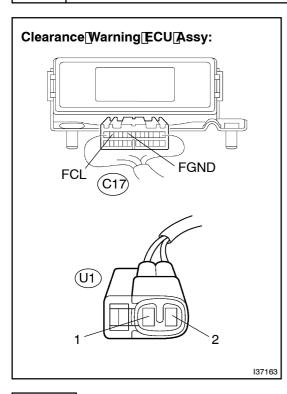
2 | CHECK[HARNESS[AND[CONNECTOR(CLEARANCE[WARNING[ECU[ASSY - ULTRASONIC[\$ENSOR[NO.[2])

Testertonnection (Symbols)	Condition	Specified[]value
C17-12[[FCL] -[U1-2	Always	Below[] [Ω
C17-8[[FGND] -[[]J1-1	Always	Below[] [Ω
C17–12[[FCL) – Body[ground	Always	10[kք][þr[ʃhigher
C17–8[[FGND) – Body[ground	Always	10[kքի[þigher

REPAIR OR REPLACE HARNESS OR CONNECTOR

REPLACE[CLEARANCE[WARNING[ECU[ASSY[SEE[PAGE[67-30]
