inVenTs High-Power Rocketry

Virginia Polytechnic Institute
and State University

Wednesday, May 9, 2018

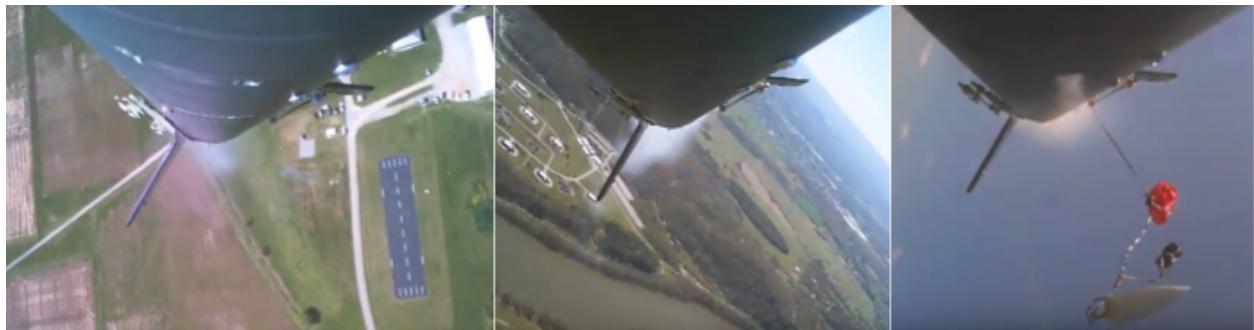
Figure 8: Video footage screenshots from the launch showing ascent, turning, and apogee.

While the team did not have any data logging to capture the results of our rolling or orientation during flight, analysis of the video, as documented in *Figure 8*, allowed for determination of whether or not the program worked as intended. Examining the footage, one of the ailerons appears to have been at an angle from the beginning, which caused the rocket to pitch after leaving the launch rail. The ailerons appear to move out to the angle to start rolling, but there is no evidence that they returned to zero degrees or changed to be the opposite angle in order to counter the roll of the rocket. After further inspection, the counter roll was disabled due to a power disconnection from the power supply in the bottom of the rocket.
