# Badger Ballistics

University of Wisconsin - Madison

## 1.0 FLIGHT PERFORMANCE COMPARISON SHEET

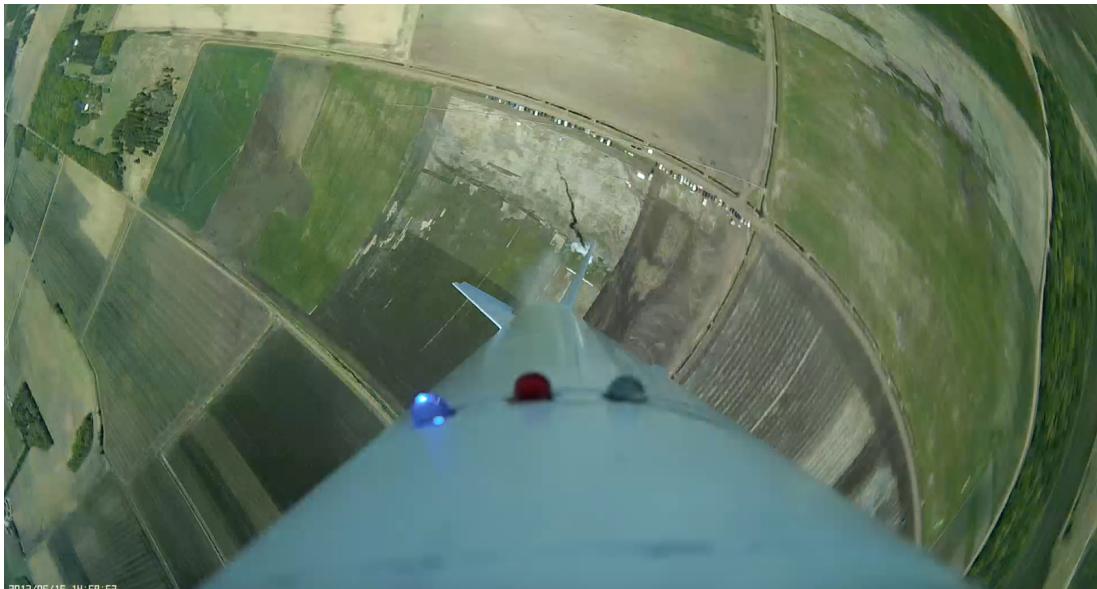
**Figure 1.** The rocket is rolling counter-clockwise. The blue LED corresponds to deflection of control surface that applies a counter-clockwise torque to rocket (can be visually seen by looking closely at fin/control surface).

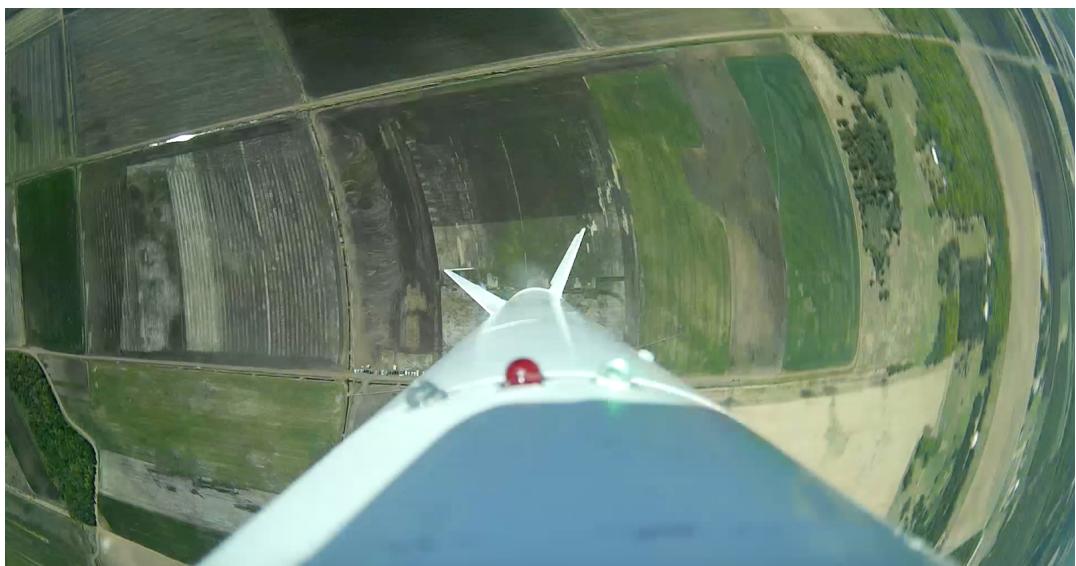
**Figure 2.** The rocket is rolling clockwise. The green LED corresponds to control surface deflection that applies clockwise torque to rocket.

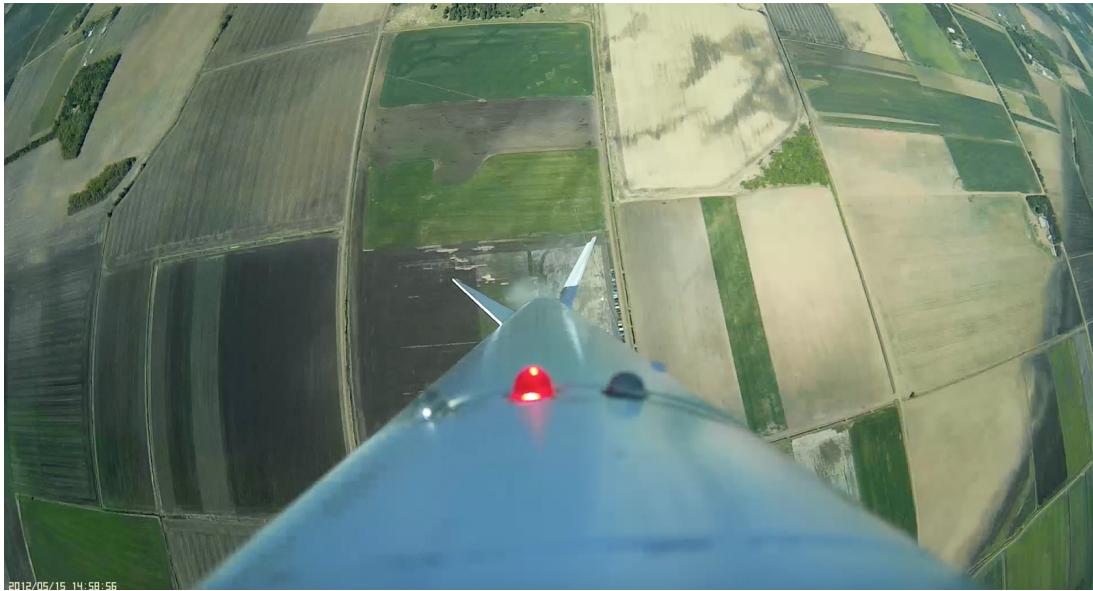
**Figure 3.** The red LED corresponds to small adjustments in control surfaces to hold rocket steady, note that the control surfaces appear flush with fin.

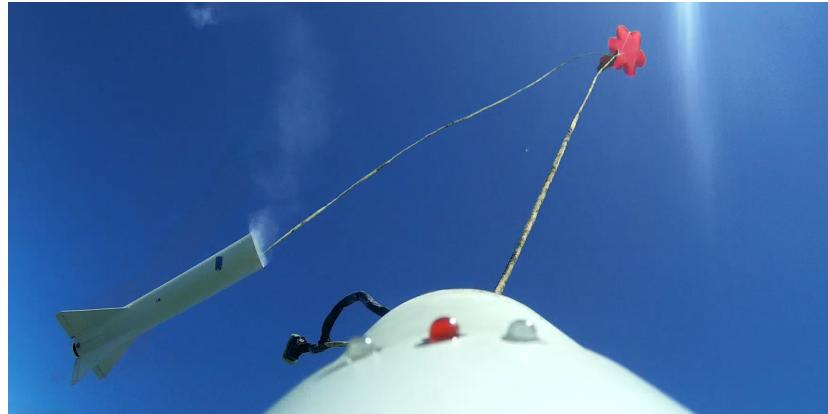
**Figure 5.** Drogue deployment, note that the two sections of the rocket are no longer in danger of contacting each-other

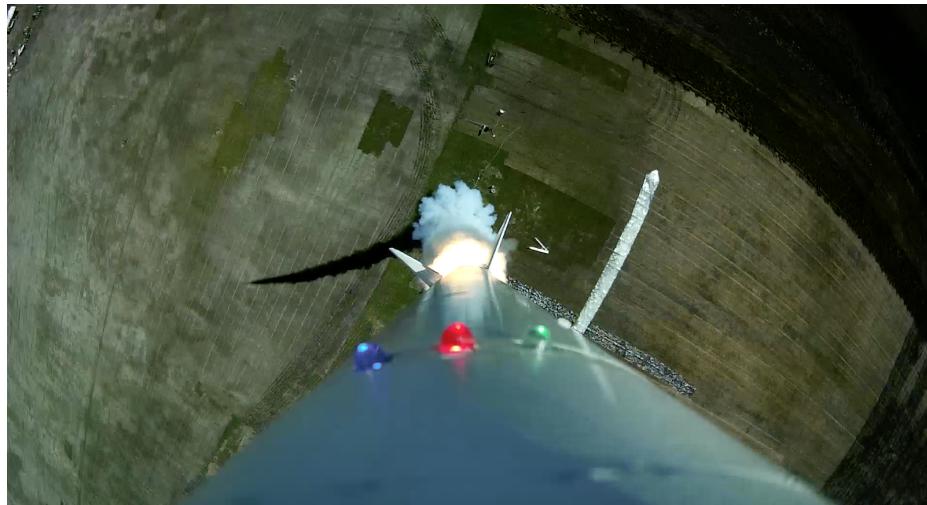
**Figure 9.** Downward video shows LEDs solid during boost phase
