Figure 17

Seventeenth Floor Plan

255 Riverside Drive, Windsor, Ontario

Designated Substances Survey

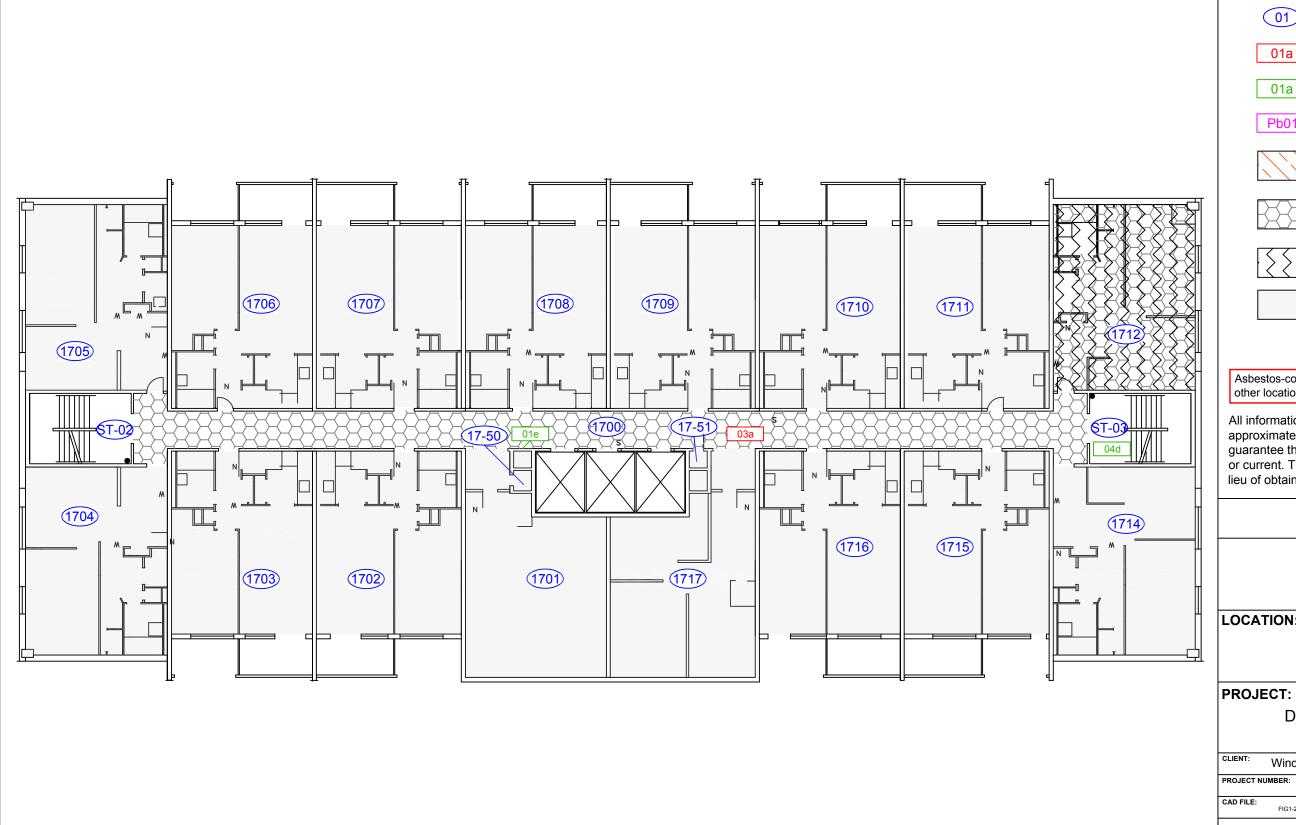
Asbestos-containing vinyl floor tile mastic may be present in other location not identified on this drawing
