Fifteenth Floor Plan

255 Riverside Drive, Windsor, Ontario

**Designated Substances Survey**

Windsor Essex Community Housing Corporation

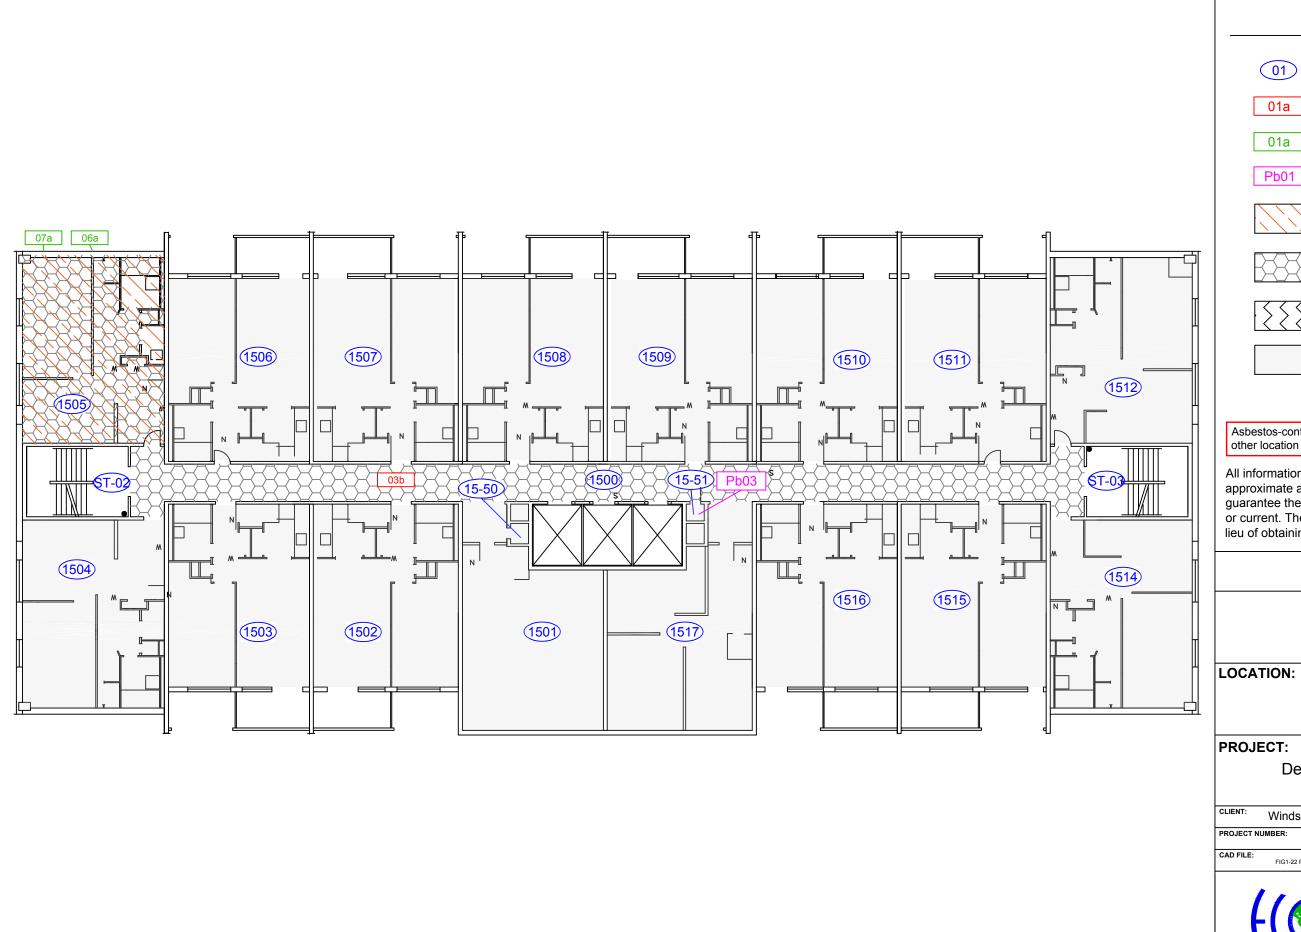
## Figure 15

Asbestos-containing vinyl floor tile mastic may be present in other location not identified on this drawing
