Figure 20

Twentieth Floor Plan

255 Riverside Drive, Windsor, Ontario

Designated Substances Survey

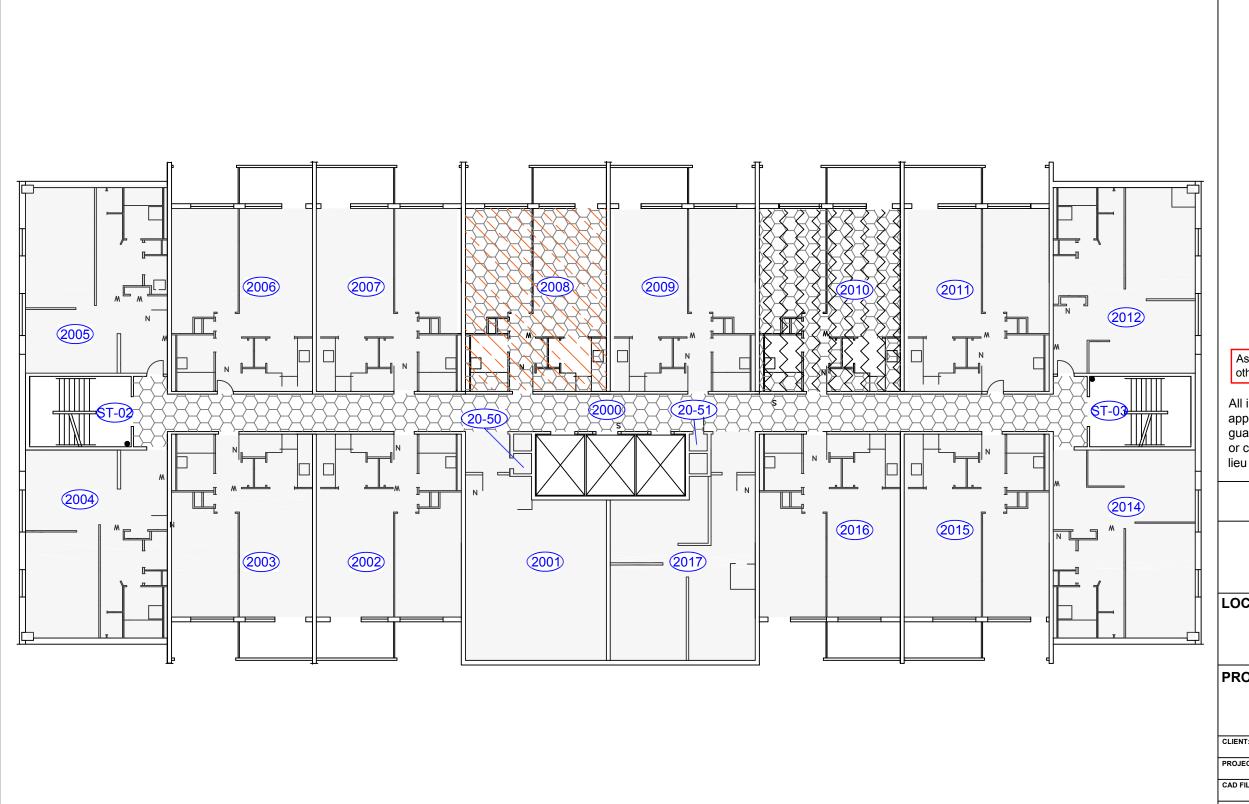
Asbestos-containing vinyl floor tile mastic may be present in other location not identified on this drawing
