Figure 7

Sixth Floor Plan

255 Riverside Drive, Windsor, Ontario

Designated Substances Survey

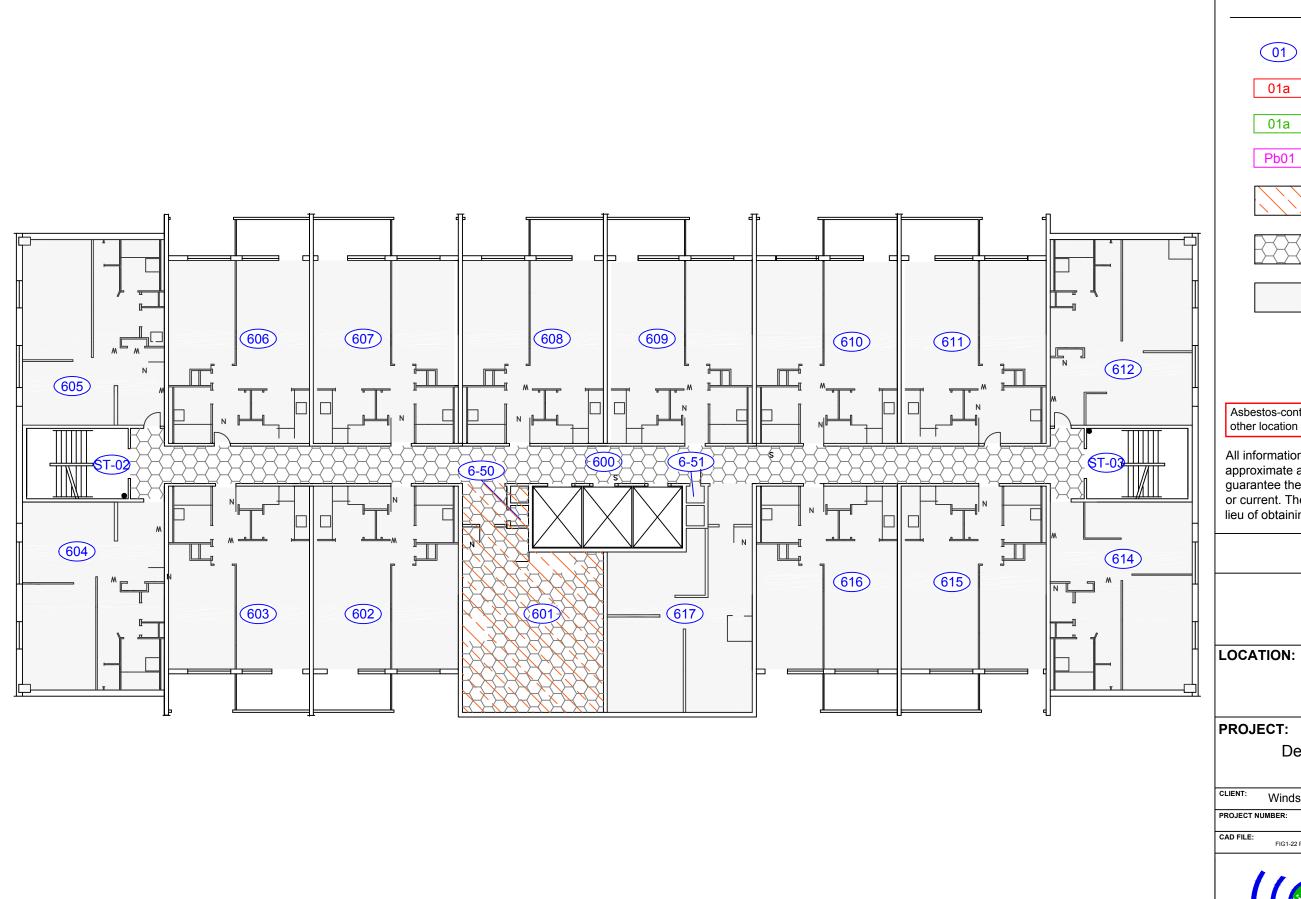
Asbestos-Containing Vinyl Floor Tiles & Mastic

Asbestos-Containing Texture Finish (Friable)

Asbestos-containing vinyl floor tile mastic may be present in other location not identified on this drawing
