Figure 4

Third Floor Plan

255 Riverside Drive, Windsor, Ontario

Designated Substances Survey

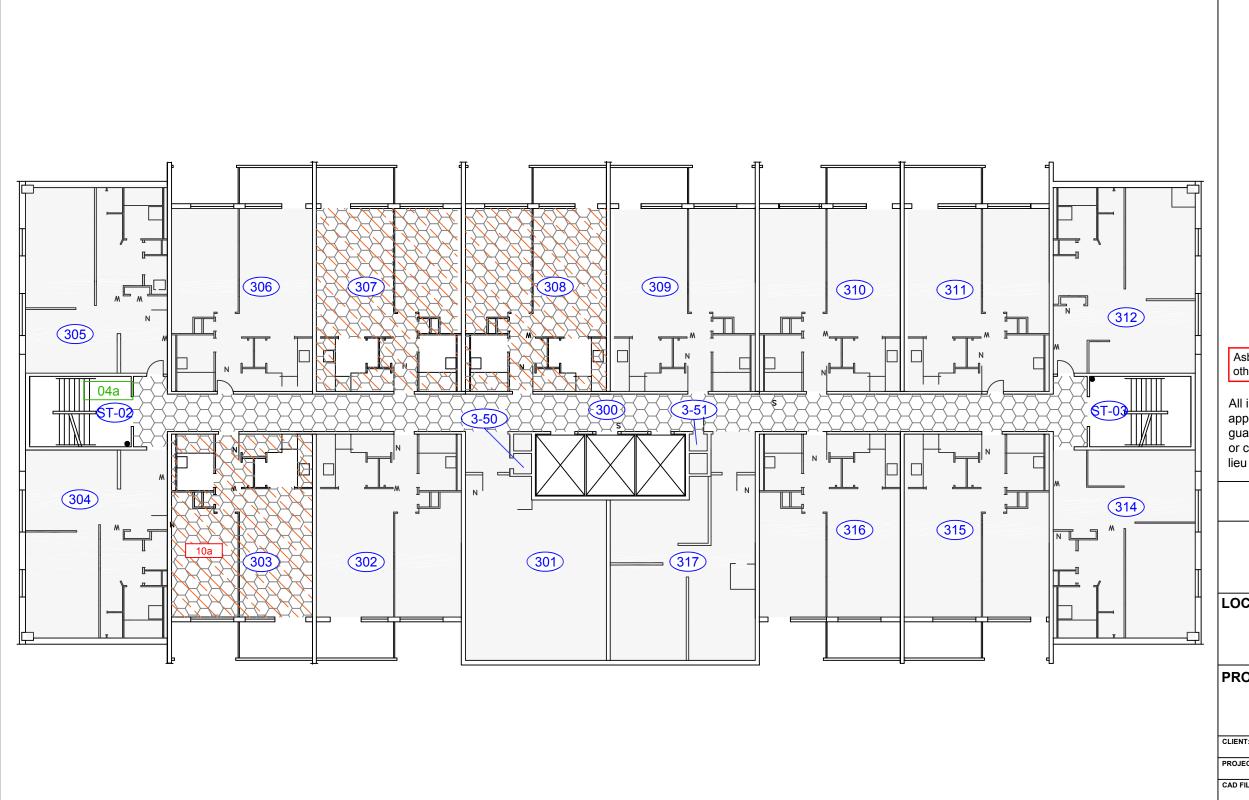
Asbestos-Containing Vinyl Floor Tiles & Mastic

Asbestos-Containing Texture Finish

Asbestos-containing vinyl floor tile mastic may be present in other location not identified on this drawing
