## **DESIGNATED SUBSTANCES ASSESSMENT**

**Ashgrove Manor Building– District #5  
140 Bridge Avenue  
Windsor, Ontario**

**RFP No.: RFP 15-09  
Building Code: 41  
ECOH Project No.: 16313**

**November 29, 2016**

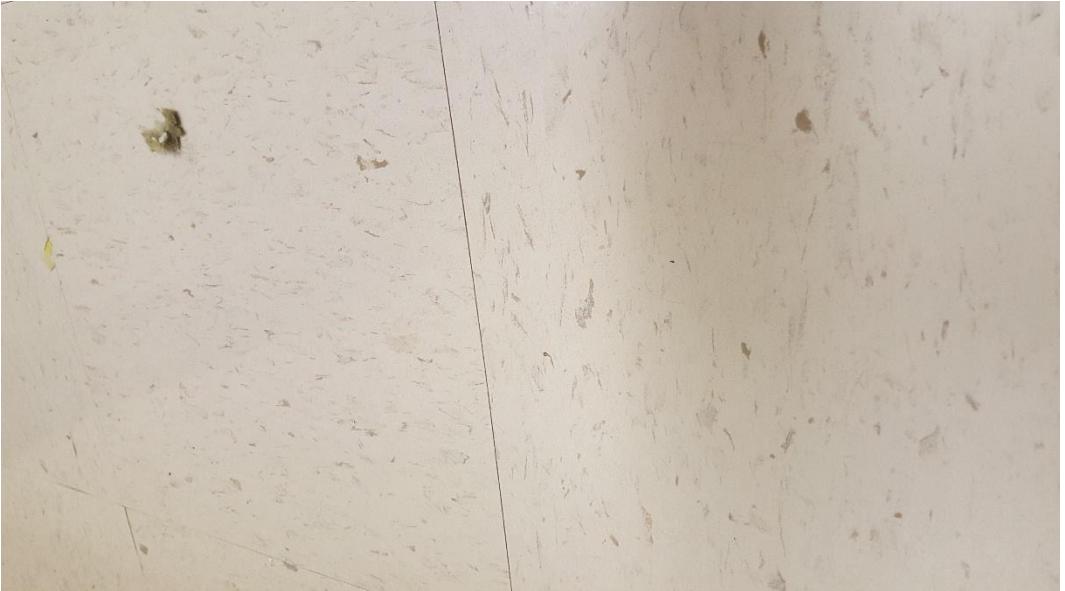
<b>Photo No. 3.</b>  <b>Date:</b> August 9, 2016  <b>Location:</b> Washroom (Loc. 41-118)  <b>Description:</b> Non-asbestos Vinyl Floor Tile 3 (VFT3) – 12"x12" Beige with Brown and Grey Flecks. <b>Asbestos-containing</b> mastic may be present.

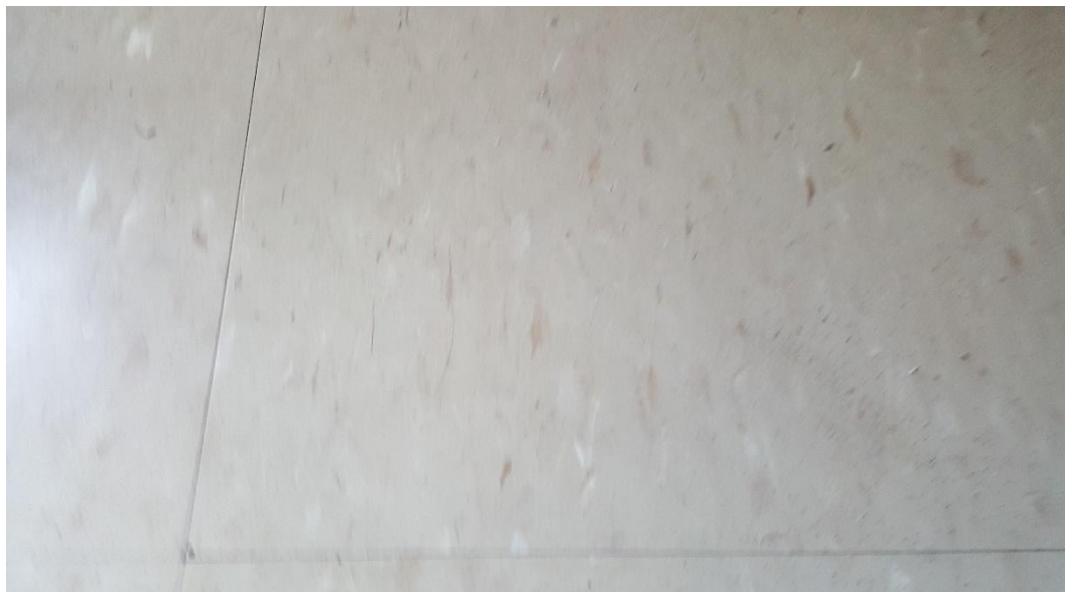
<b>Photo No. 5.</b>  <b>Date:</b> August 9, 2016  <b>Location:</b> Unit 1110 (Loc. 41-1110)  <b>Description:</b> Non-asbestos Vinyl Floor Tile 6 (VFT6) – 12"x12" Beige with Sparse Tan and White Flecks. <b>Asbestos-containing</b> mastic may be present.

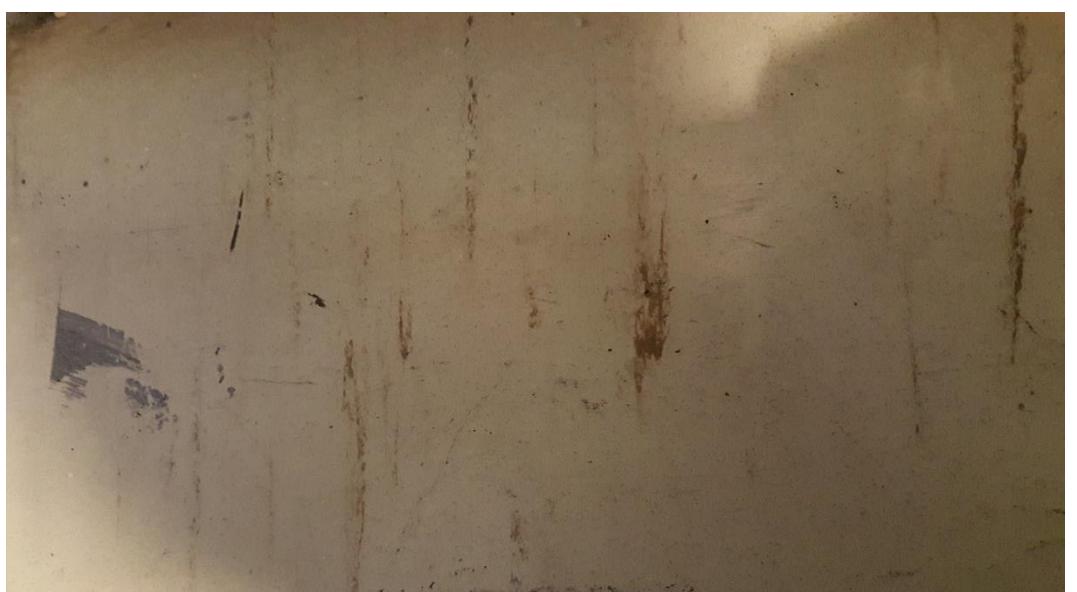
<b>Photo No. 6.</b>  <b>Date:</b> August 9, 2016  <b>Location:</b> Craft Room (Loc. 41-115)  <b>Description:</b> <b>Asbestos-containing</b> Vinyl Floor Tile 7 (VFT7) – 12"x12" Beige with Brown Streaks (2% Chrysotile). <b>Asbestos-containing</b> mastic may be present.

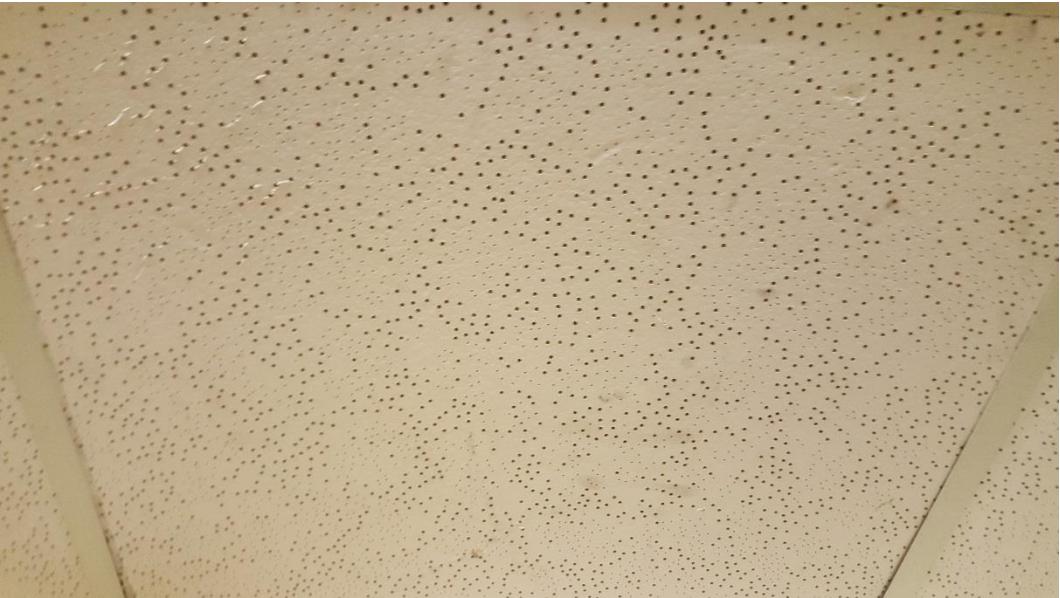
<b>Photo No. 7.</b>  <b>Date:</b> August 9, 2016  <b>Location:</b> Office Area (Loc. 41-108)  <b>Description:</b> Non-asbestos Ceiling Tile 1 (CT1) – 2'x4' Small and Medium Random Pinholes

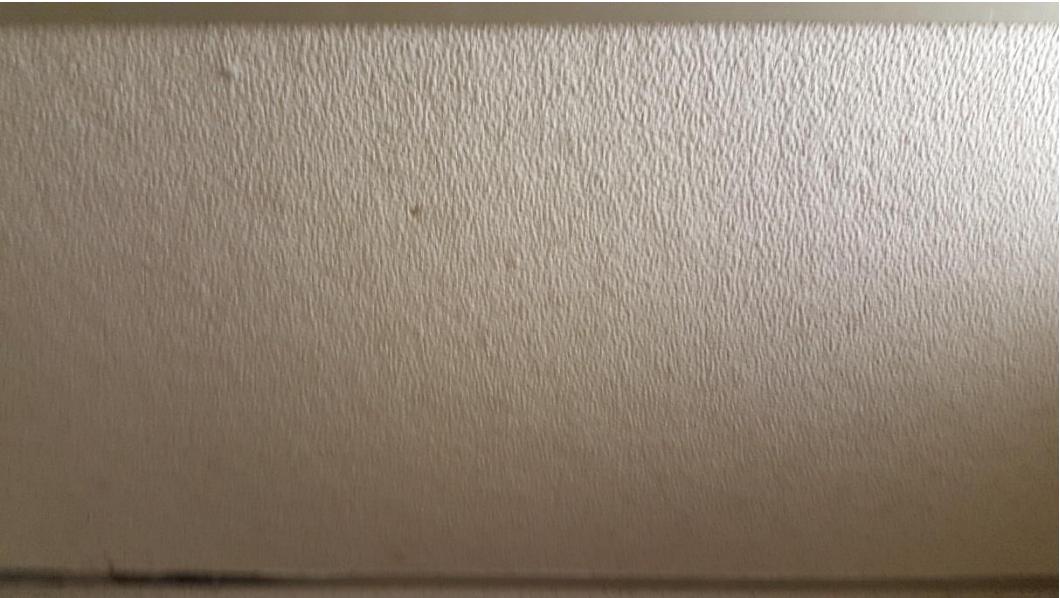
<b>Photo No. 8.</b>  <b>Date:</b> August 9, 2016  <b>Location:</b> 15 <sup>th</sup> Floor Corridor (Loc. 41-1500)  <b>Description:</b> Non-asbestos Ceiling Tile 2 (CT2) – 2'x4' Textured

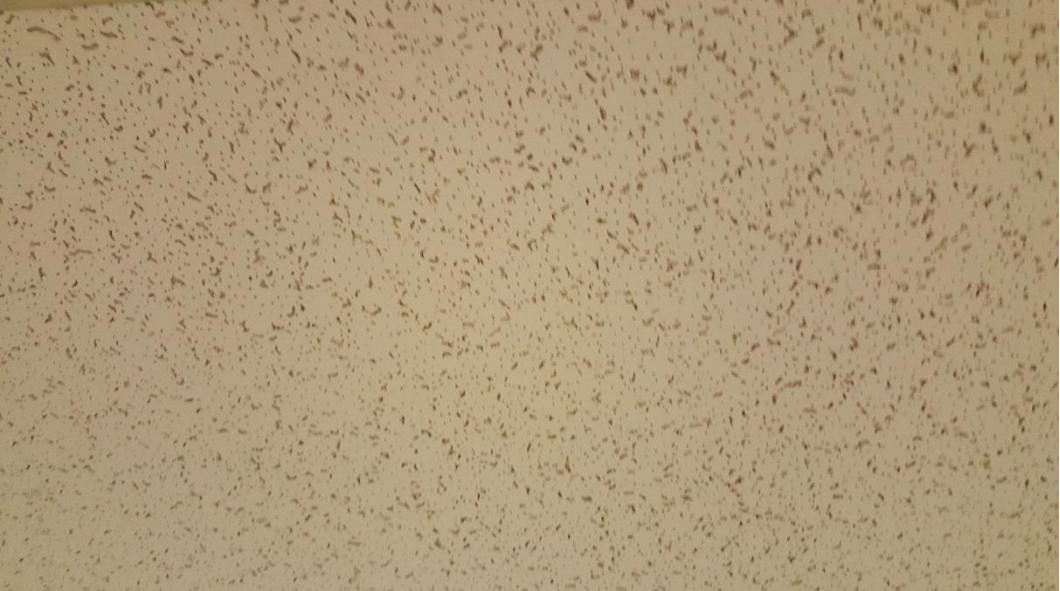
<b>Photo No. 9.</b>  <b>Date:</b> August 9, 2016  <b>Location:</b> First Floor Corridor (Loc. 41-100)  <b>Description:</b> Non-asbestos Ceiling Tile 3 (CT3) – 2'x4' Short Hooked Random Fleck and Pinhole

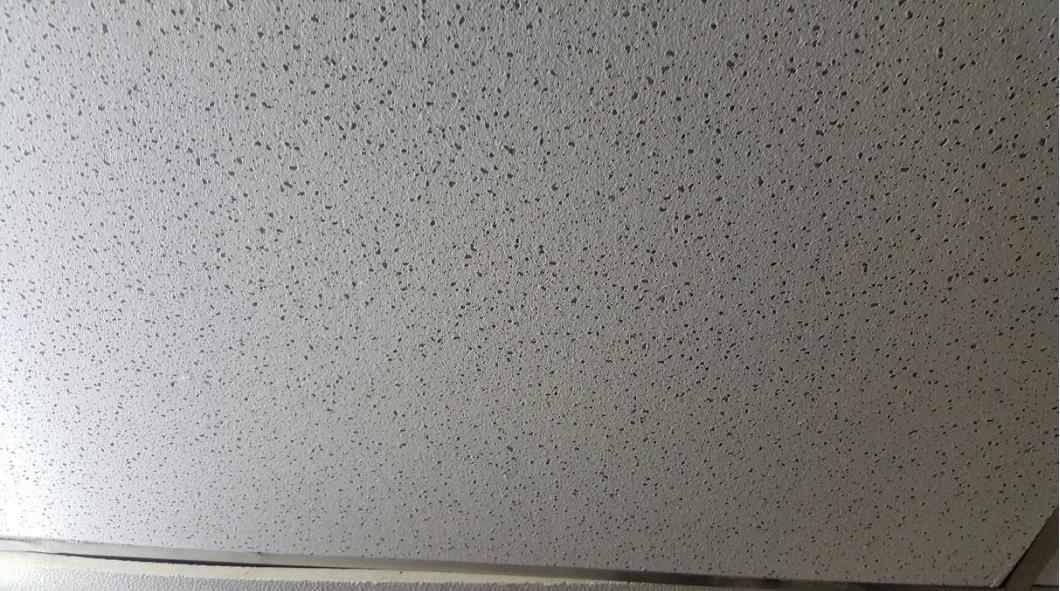
<b>Photo No. 10.</b>  <b>Date:</b> August 9, 2016  <b>Location:</b> Office Area (Loc. 41-108)  <b>Description:</b> Non-asbestos Ceiling Tile 4 (CT4) – 2"x4" Small and Medium Dimple

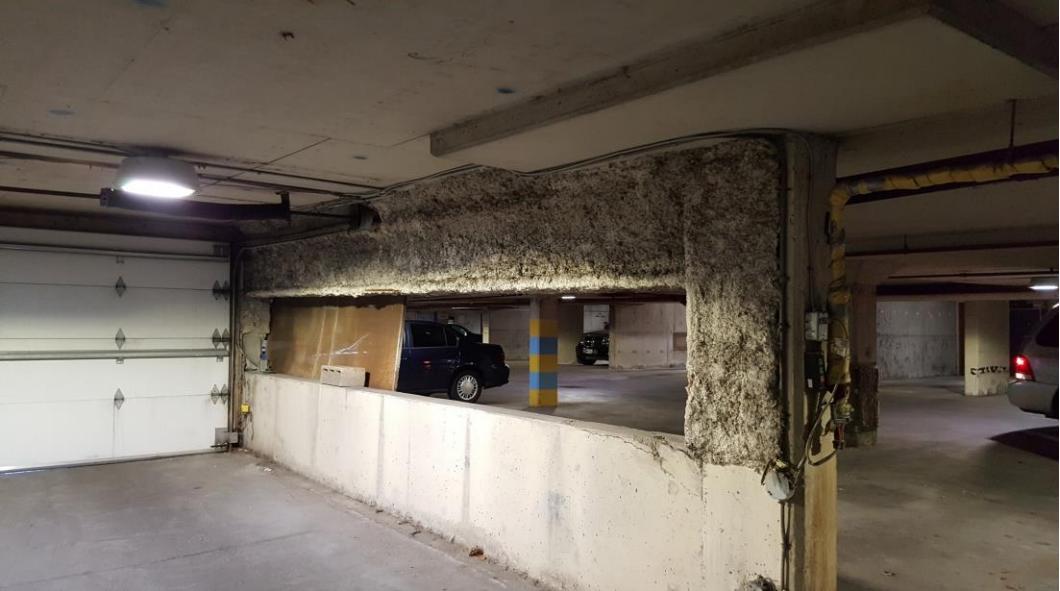
<b>Photo No. 11.</b>  <b>Date:</b> August 9, 2016  <b>Location:</b> Parking Garage (Loc. 41-004)  <b>Description:</b> Non-asbestos sprayed fireproofing
