## Figure 11

255 Riverside Drive, Windsor, Ontario

**Designated Substances Survey**

Windsor Essex Community Housing Corporation

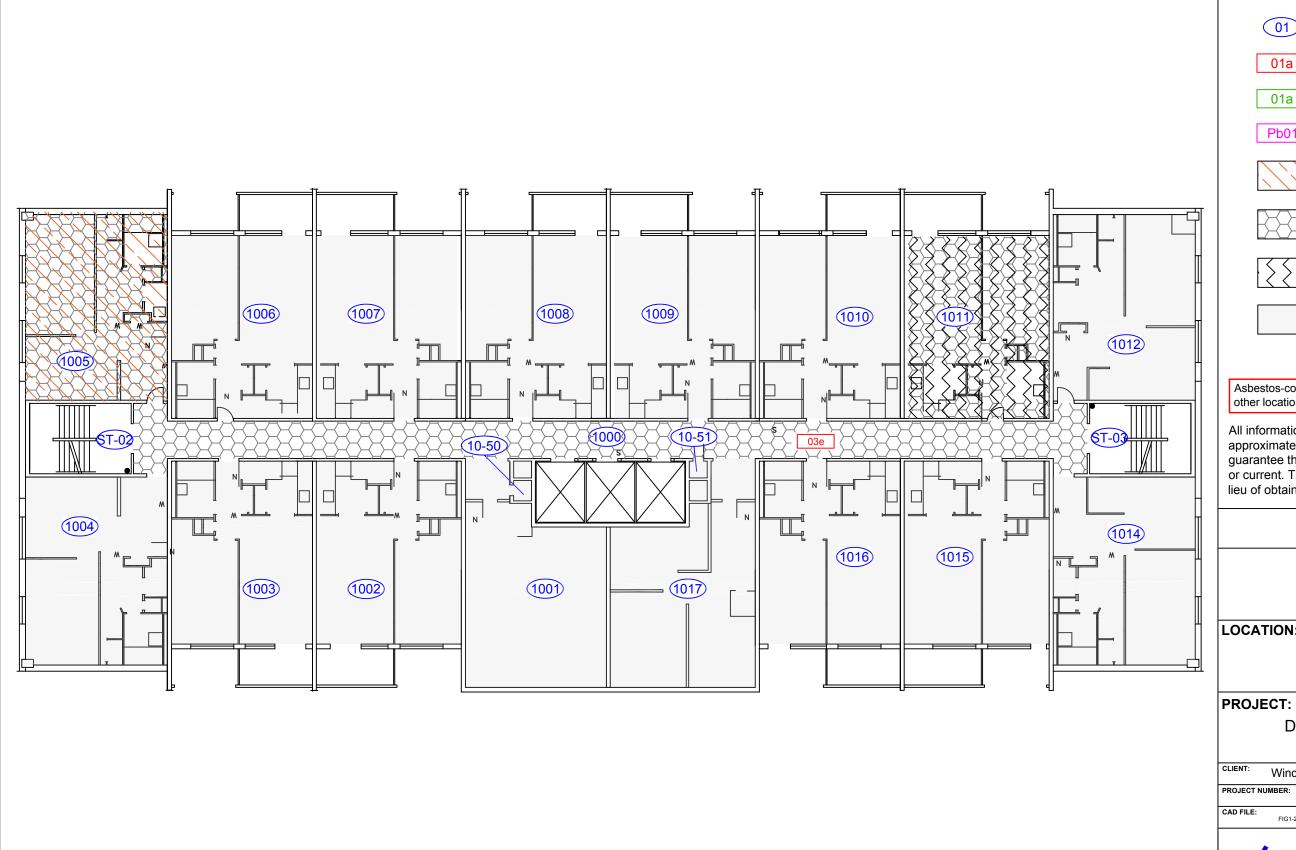
Asbestos-Containing Vinyl Floor Tiles & Mastic

Asbestos-Containing Texture Finish (Friable)

Asbestos-Containing Mastic (Non-Friable)

Asbestos-containing vinyl floor tile mastic may be present in other location not identified on this drawing
