## Figure 12

Eleventh Floor Plan

255 Riverside Drive, Windsor, Ontario

**Designated Substances Survey**

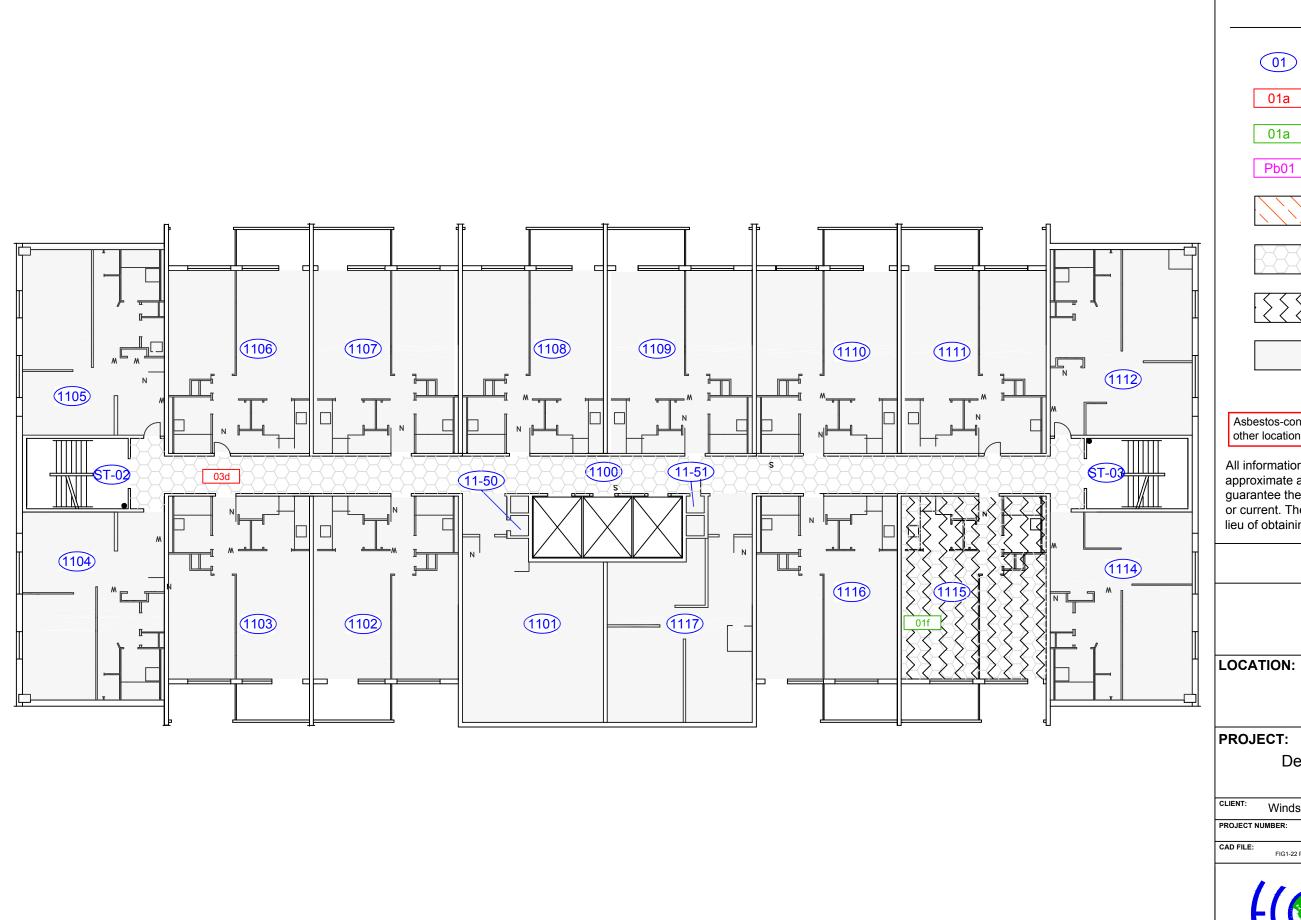
Asbestos-Containing Vinyl Floor Tiles & Mastic

Asbestos-Containing Texture Finish

Asbestos-Containing Mastic (Non-Friable)

Asbestos-containing vinyl floor tile mastic may be present in other location not identified on this drawing
