Vehicle Inspection Report

JOB-000297

| Car Make | HONDA |
| Car Model | CITY |

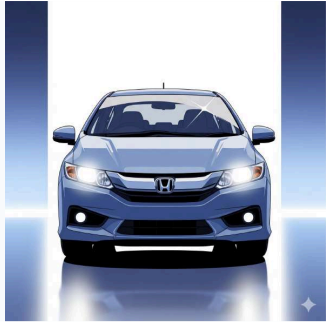
1. Car front image

Front Body Panels: Bonnet & front bumper replaced → Previous front-end impact repair indicated.

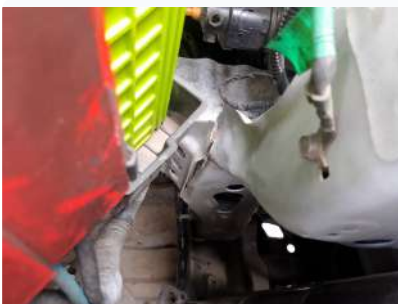
8. Left Apron Leg Image

Chassis Structure: Front apron and chassis legs repaired → Indicates major front accident repair.

| Left Apron Leg | Repaired |

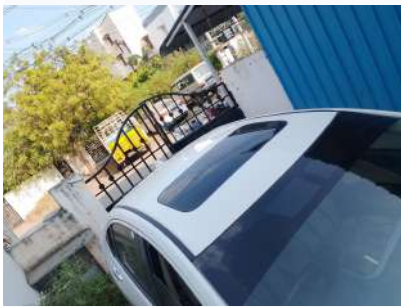
13. Roof Outer Image

Roof: Roof repaired → Major bodywork previously carried out.

| Roof Outer | Repaired |
