# Assessment of Dam Safety of Coal Combustion Surface Impoundments

**Coletto LP, LLC**

**Fannin, Texas**

**August 4, 2010**

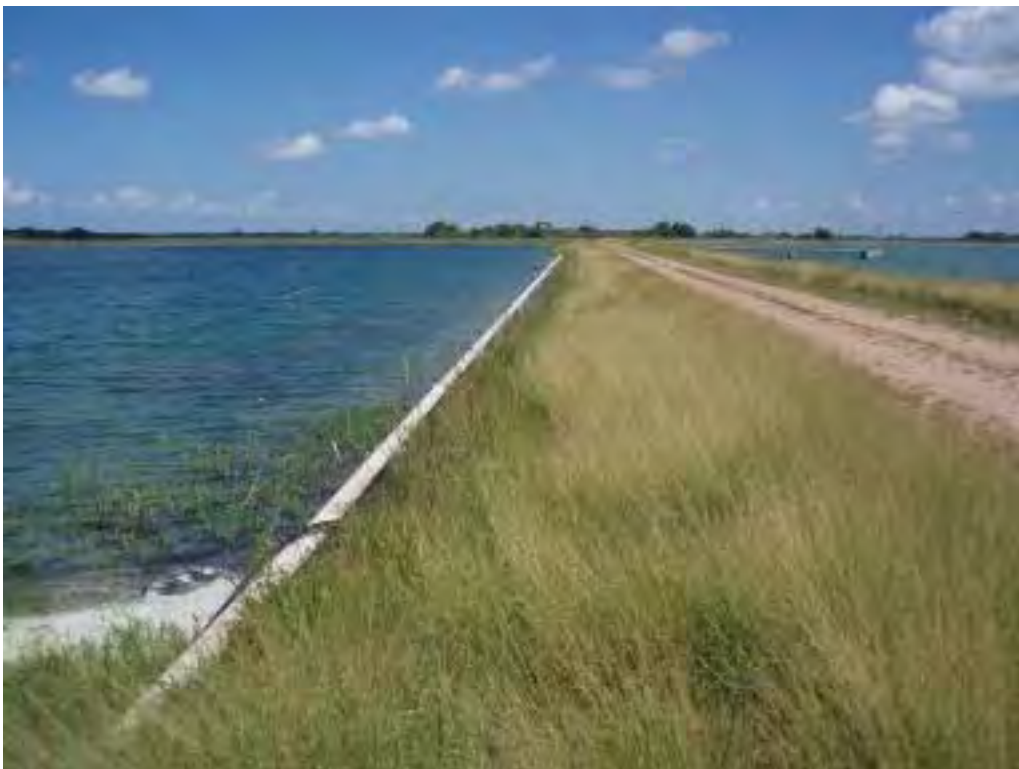
The exterior slopes appear to be in fair condition. The exterior slopes on the north, southern, west, and east embankments were approximately 2.5H:1V (Photos 49, 52, 53, 56, 62, 66, 67, 72, 76, 79, 82, 86, 90, 91, 96, 99, 104, 111, and 114). The northeast slope of the divider embankment between the Primary Ash Pond and Secondary Pond was approximately 3H: 1V (Photos 1 and 15).

Photo No. 1: Secondary Pond - Northeast slope of divider embankment from northwest corner, looking southeast.

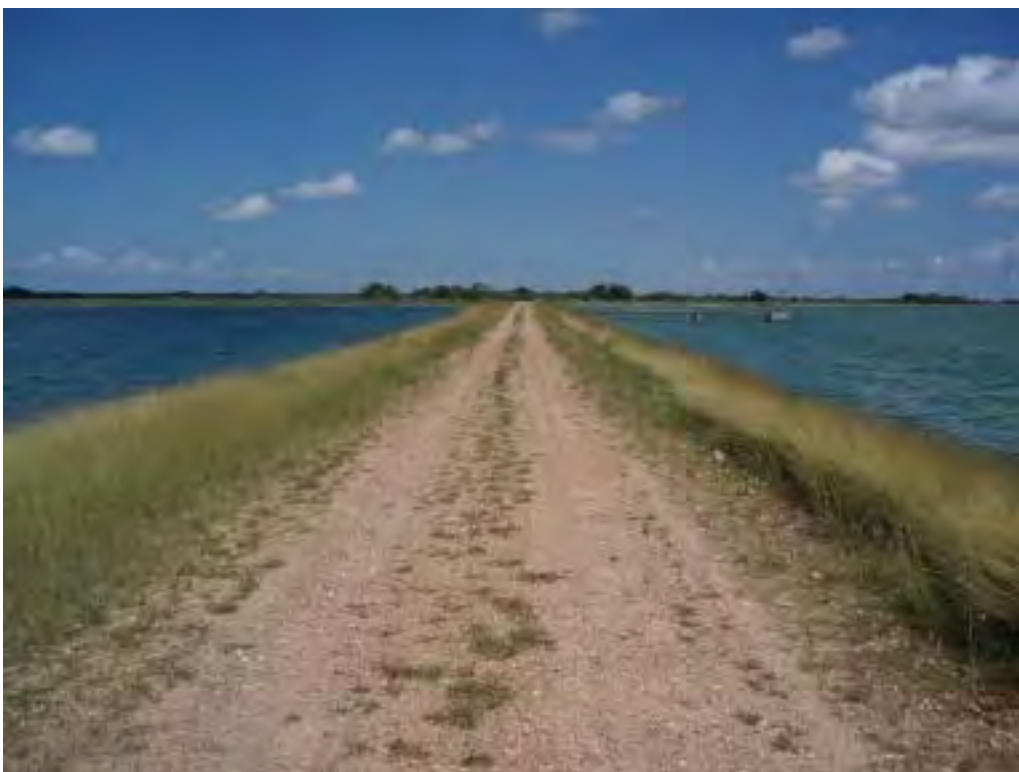
The crest of the Primary Ash Pond generally appeared to be in fair condition (Photos 2, 14, 50, 57, 63, 73, 77, 79, 82, 85, 86, 87, 89, 92, 95, 100, 103, 112, and 115). The crest was approximately 20 feet wide. The crest is surfaced with compacted gravel and is used as an access road. Sparse vegetation was growing in the middle and on both sides of the roadway. Desiccation cracks approximately a ¼ inch wide were observed at various locations on the crest (Photo 68). Observed freeboard at the time of the visit was approximately three feet with an approximate water level at El. 137.

Photo No. 2: Crest of divider embankment from northwest corner, looking southeast.

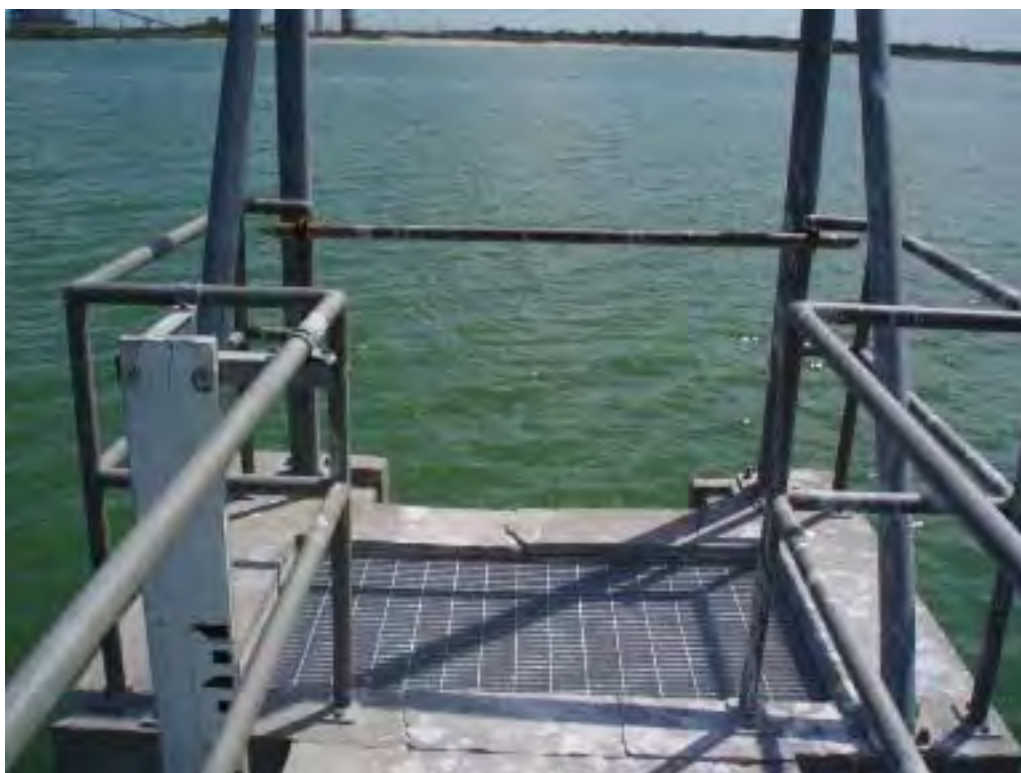
The inlet structure in the Primary Ash Pond appeared to be in fair condition (Photo 6, 7, and 8). The inlet structure was clear of debris. Some cracking in the concrete around the top of the intake structure was observed (Photo 7). The remainder of the structure above the water level and the catwalk appeared to be good condition.

Photo No. 8: Close-up of inlet structure, looking southwest.

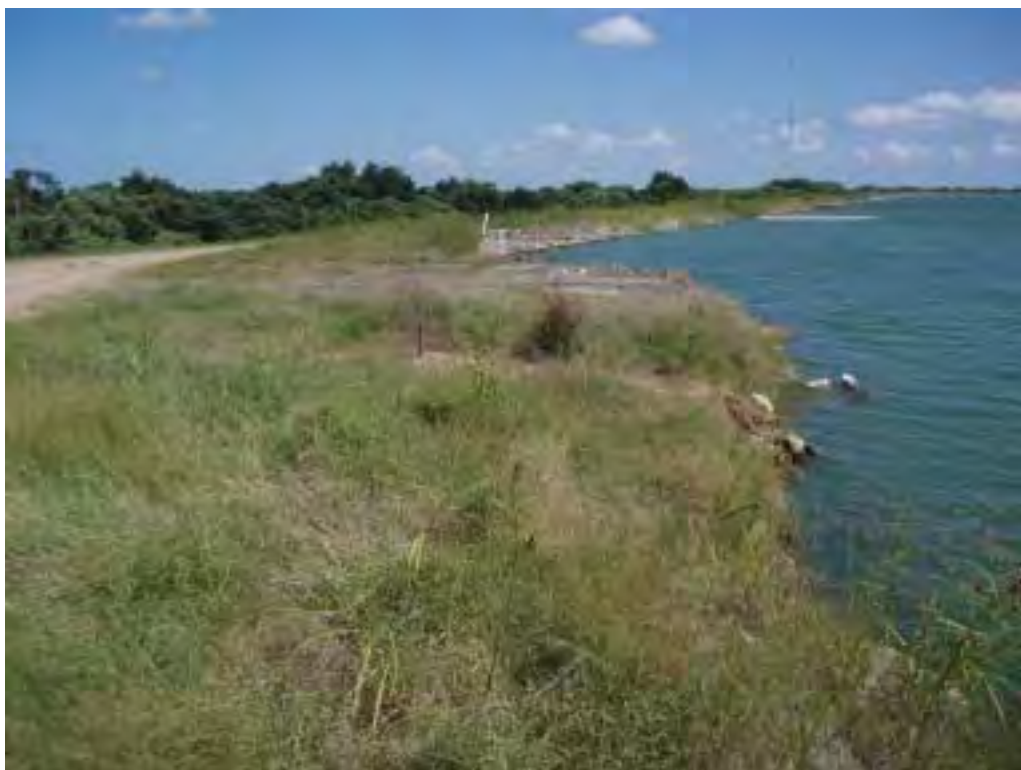
Two areas on the east embankment were observed where BMT has dumped excess flyash and bottom ash and pushed the material into the Primary Ash Pond (Photo 12). No riprap erosion protection was present in these areas.

Photo No. 12: Primary Ash Pond - East interior slope, looking southeast. Note areas where Boral trucks have dumped excess material on the interior slope.

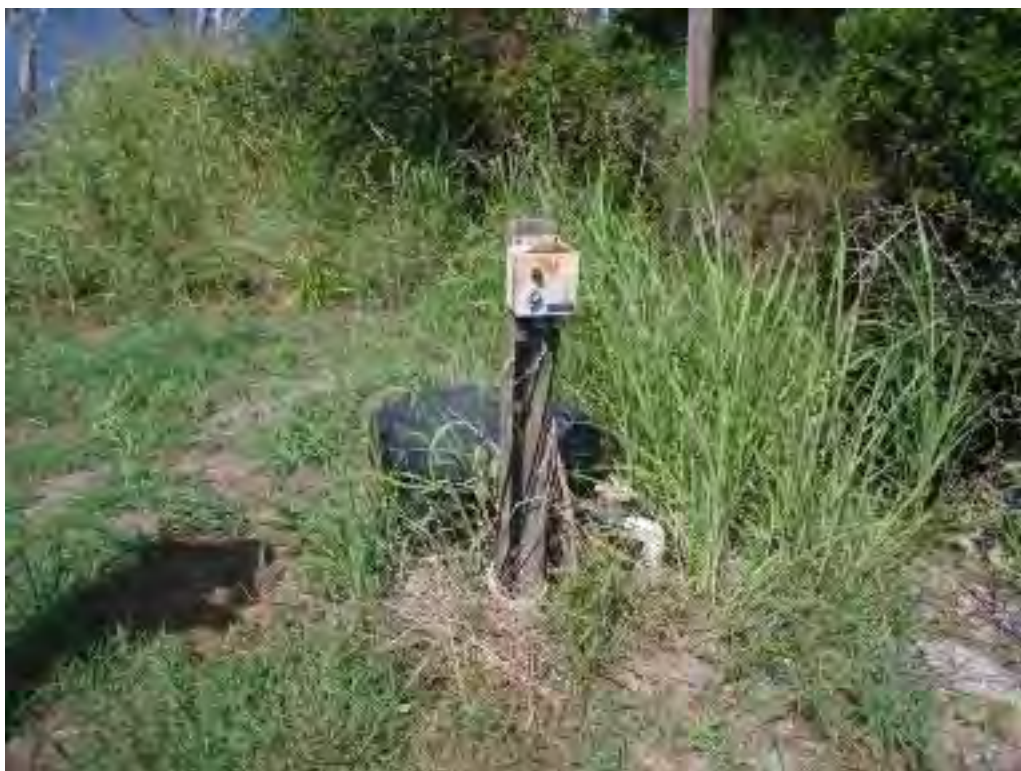
Seepage was observed at the toe of the east embankment exterior toe. The discharge sump for the subsurface drain seepage collection system was observed adjacent to the recirculating pump station (Photo 23). Flow was estimated to be approximately 5 gpm in the sump through a 2-inch-diameter pipe.

Photo No. 23: French drain discharge sump at toe of Secondary Pond near outfall. Estimated flow approximately 5 gpm through a 2-inch-diameter PVC pipe.

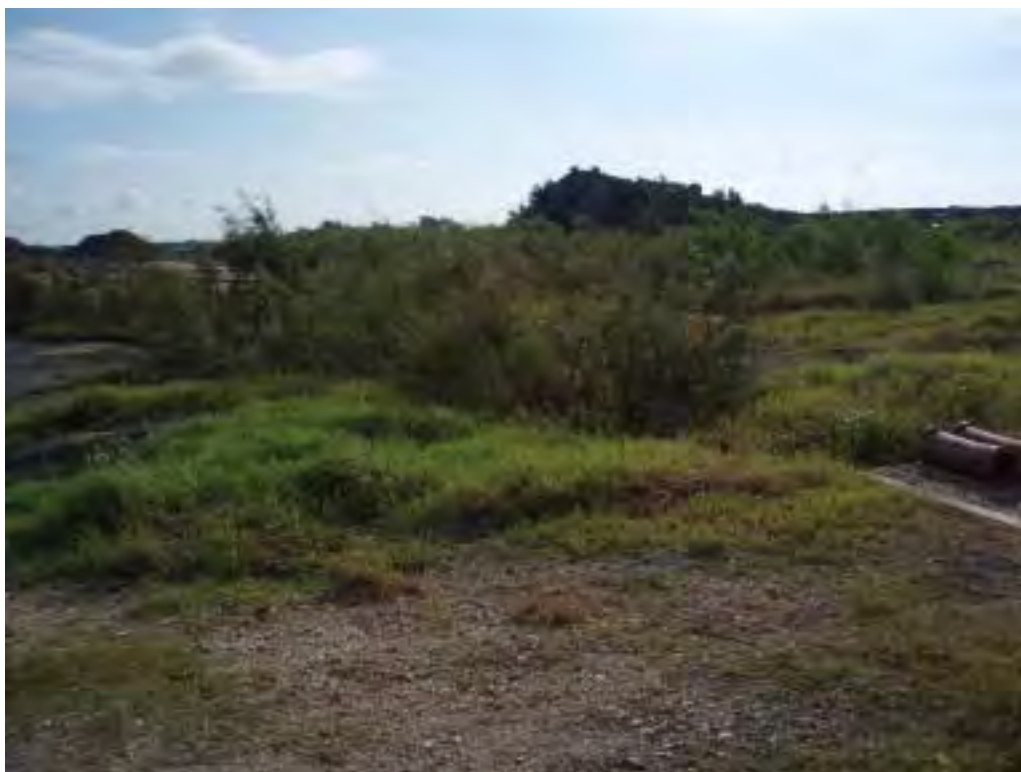
During the site visit, four sets of sluice pipes were observed. The two CCW sluice pipes on the southeast and south embankment appeared to be in fair condition (Photos 80, 81, 83, and 84). The boiler area sump sluice pipe on the west embankment and the demineralizer effluent sluice pipe on the southeast embankment also appeared to be in fair condition (Photos 75 and 85). No seepage was observed where the pipes penetrated through the embankment.

Photo No. 80: Primary Ash Pond – Southwest embankment, looking northeast at fly ash silo sluice area.

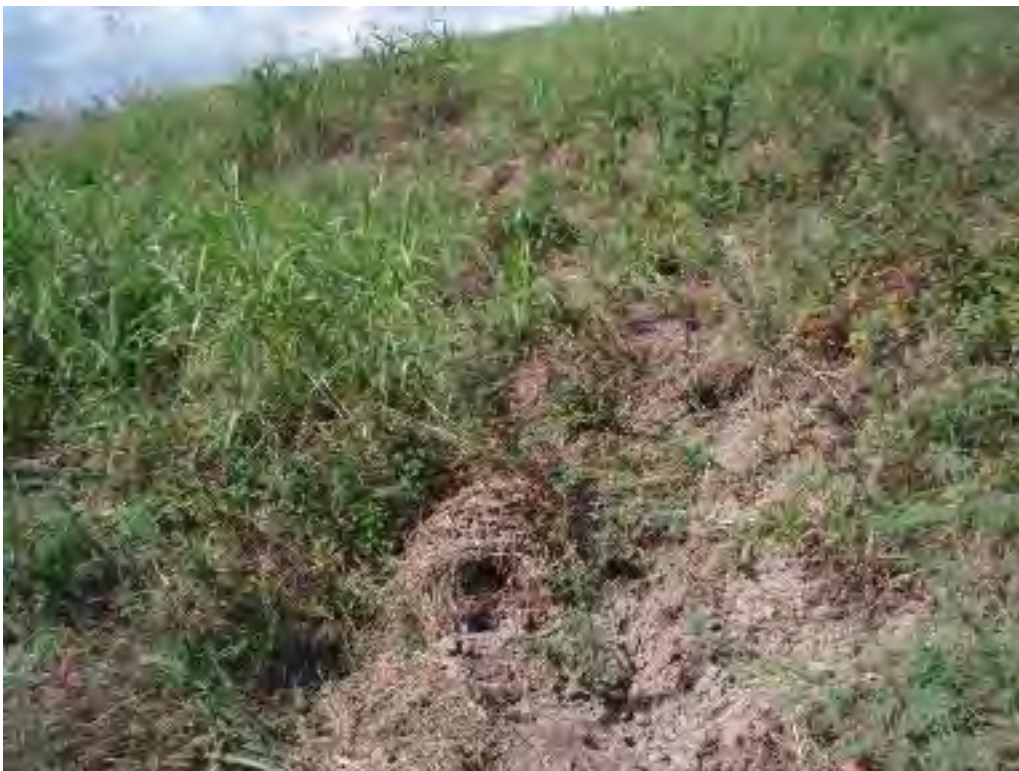
Photo No. 109: Primary Ash Pond - East embankment exterior slope, looking at an area disturbed by animal activity.
