# **Assessment of Dam Safety of Coal Combustion Surface Impoundments**

**Coletto LP, LLC**

**Coletto Creek Power, LP**

**March 11, 2011**

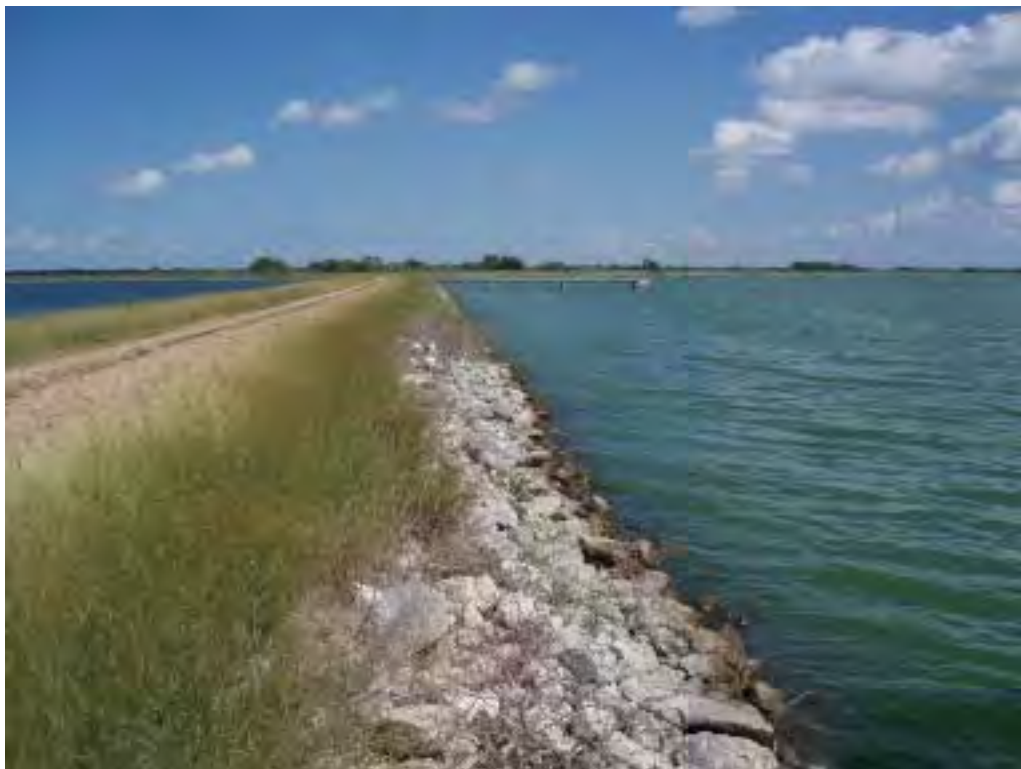
The visible portions of the interior slope generally appeared to be in fair condition (Photos 3, 9, 10, 12, 13, 51, 54, 58, 61, 64, 70, 74, 78, 79, 85, 87, 88, 93, 94, 101, 102, 110, 113, and 116). The north, east, and west interior slope and southwest slope of the divider embankment generally appeared to be armored with a layer of riprap. No riprap was observed on the southern embankments. Grass and brush approximately 24 to 36 inches tall was observed growing in the riprap. An 8-inch-diameter mesquite tree was observed on west end of the north embankment (Photo 54).

Photo No. 3: Primary Ash Pond - Southwest slope of divider embankment from northwest corner, looking southeast.

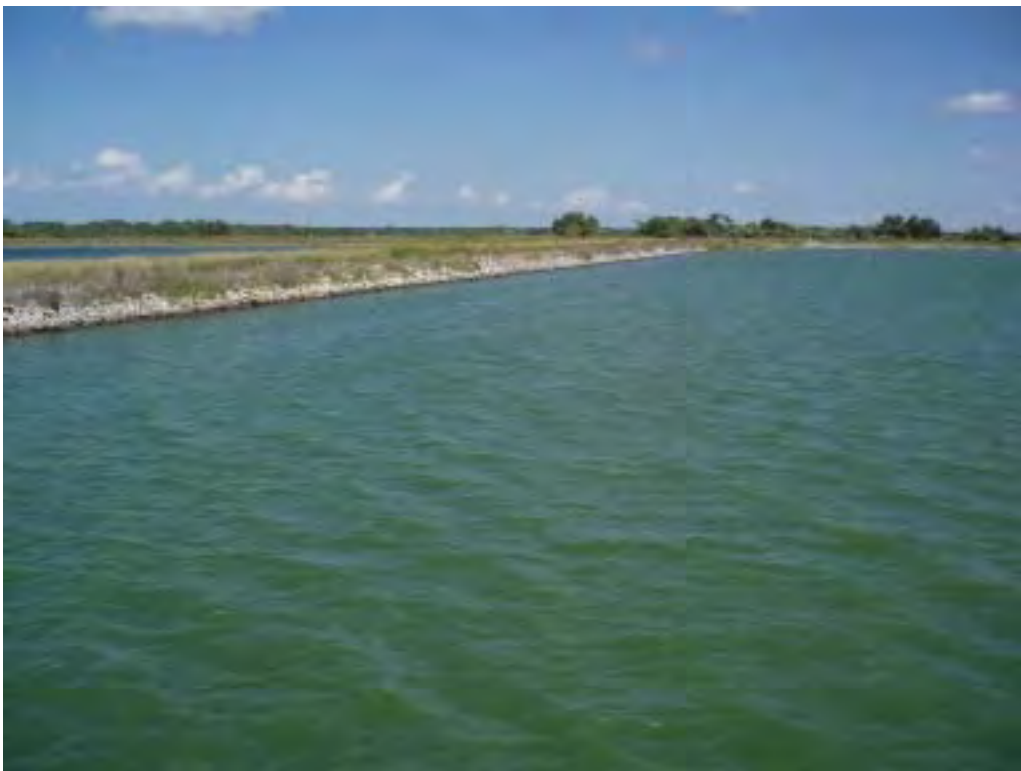
Photo No. 9: Primary Ash Pond - Southwest slope of divider embankment, looking southeast.

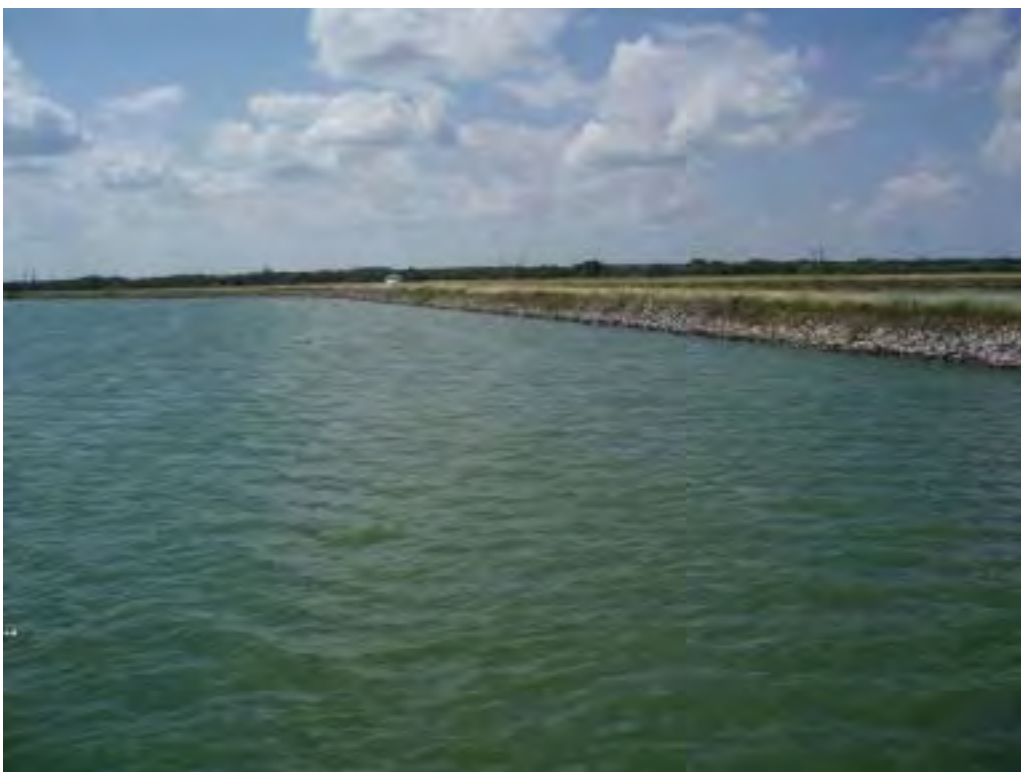
Photo No. 10: Primary Ash Pond - Southwest slope of divider embankment, looking northwest.

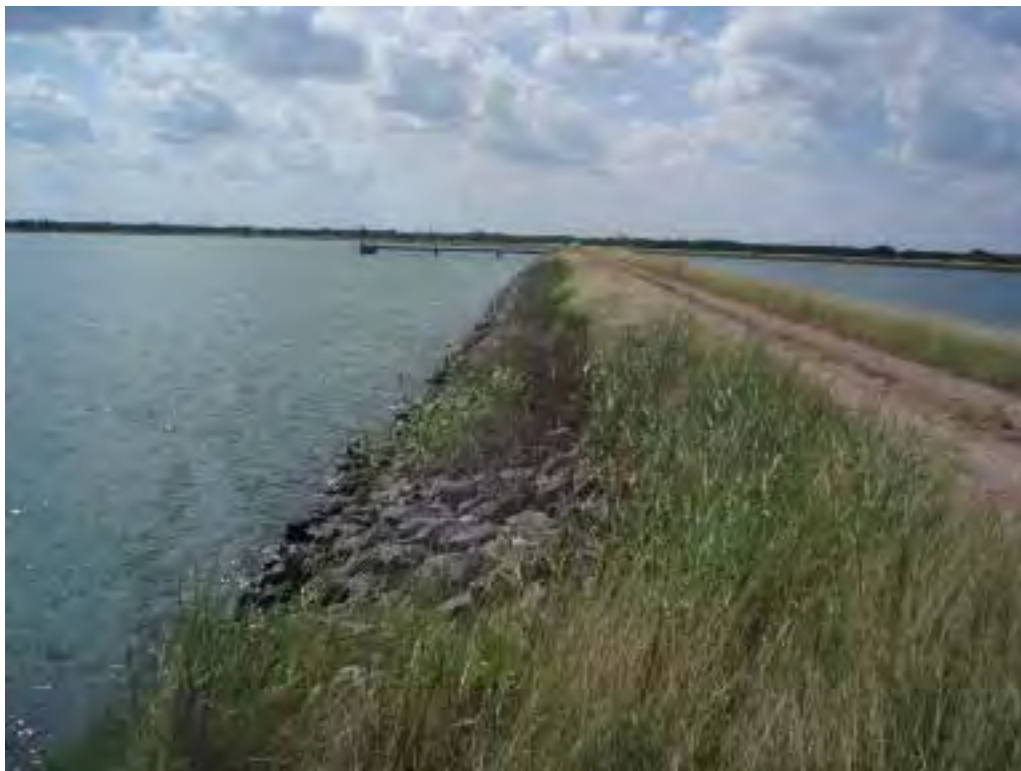
Photo No. 13: Primary Ash Pond - Southwest slope of divider embankment from southeast corner, looking northwest.

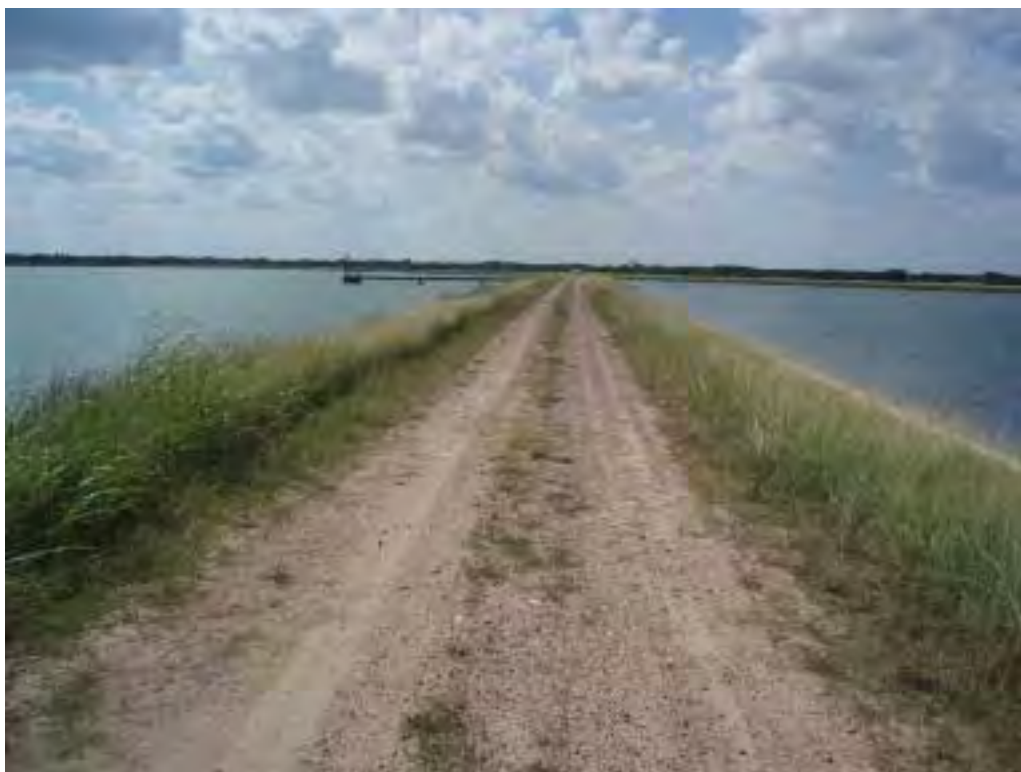
The crest of the Primary Ash Pond generally appeared to be in fair condition (Photos 2, 14, 50, 57, 63, 73, 77, 79, 82, 85, 86, 87, 89, 92, 95, 100, 103, 112, and 115). The crest was approximately 20 feet wide. The crest is surfaced with compacted gravel and is used as an access road. Sparse vegetation was growing in the middle and on both sides of the roadway. Desiccation cracks approximately a ¼ inch wide were observed at various locations on the crest (Photo 68). Observed freeboard at the time of the visit was approximately three feet with an approximate water level at El. 137.

Photo No. 14: Crest of divider embankment, looking northwest.

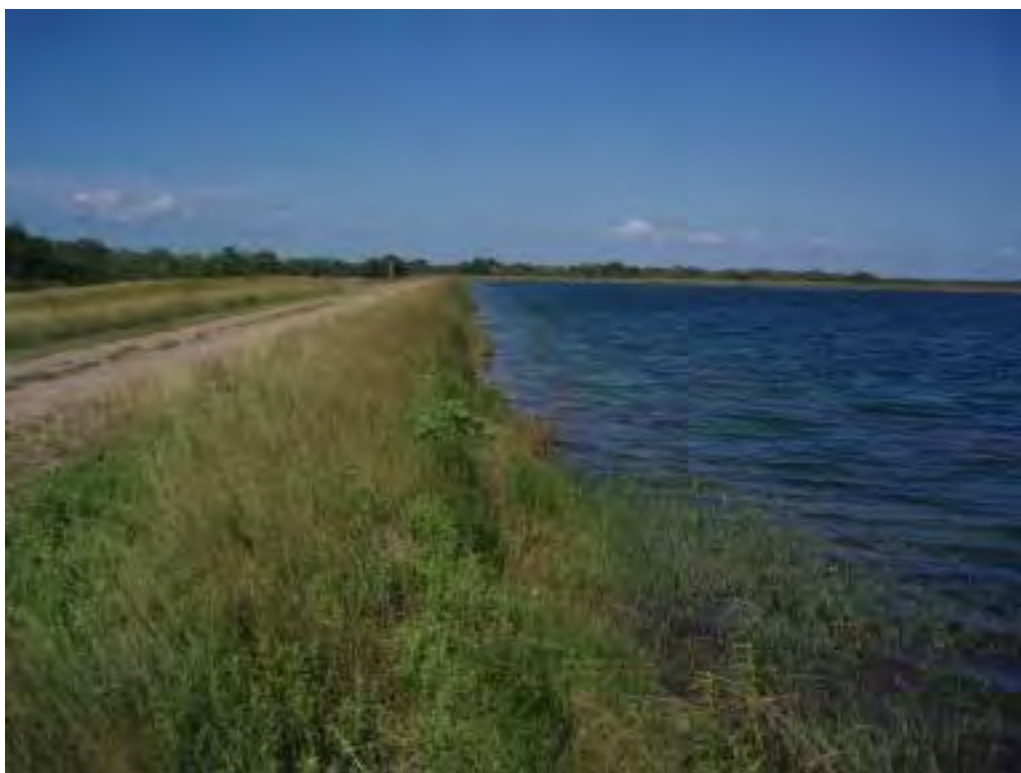
Photo No. 42: Secondary Pond - North embankment interior slope, looking east.

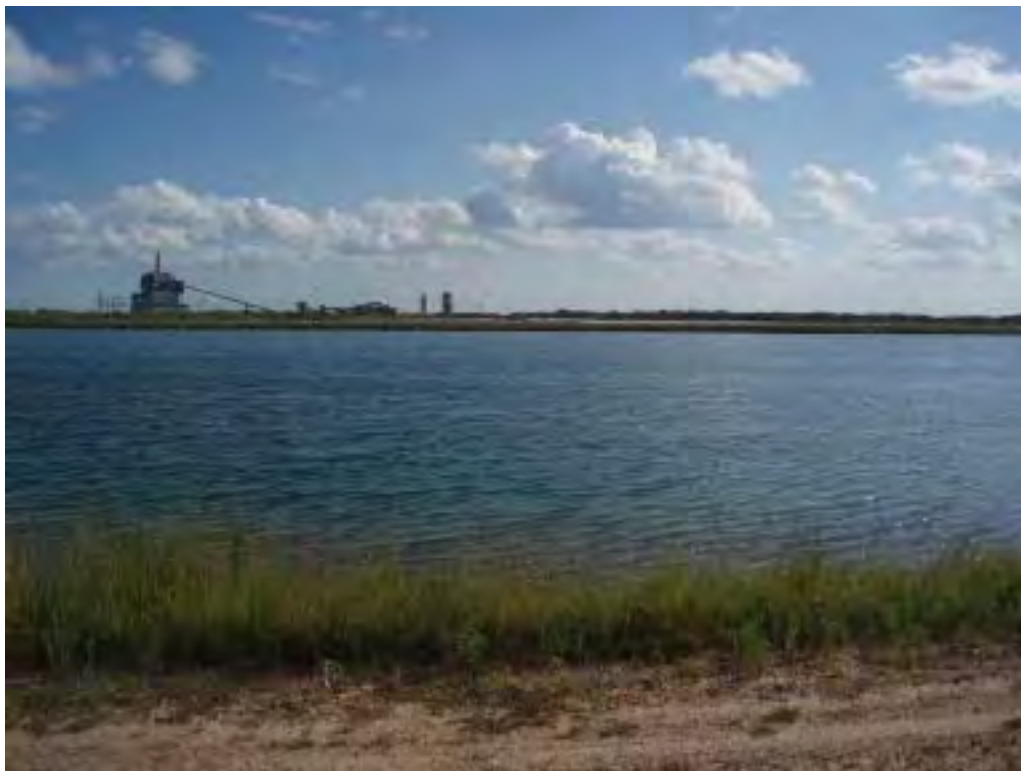
Photo No. 45: Secondary Pond - Looking southwest from north embankment at interior slope of divider embankment.

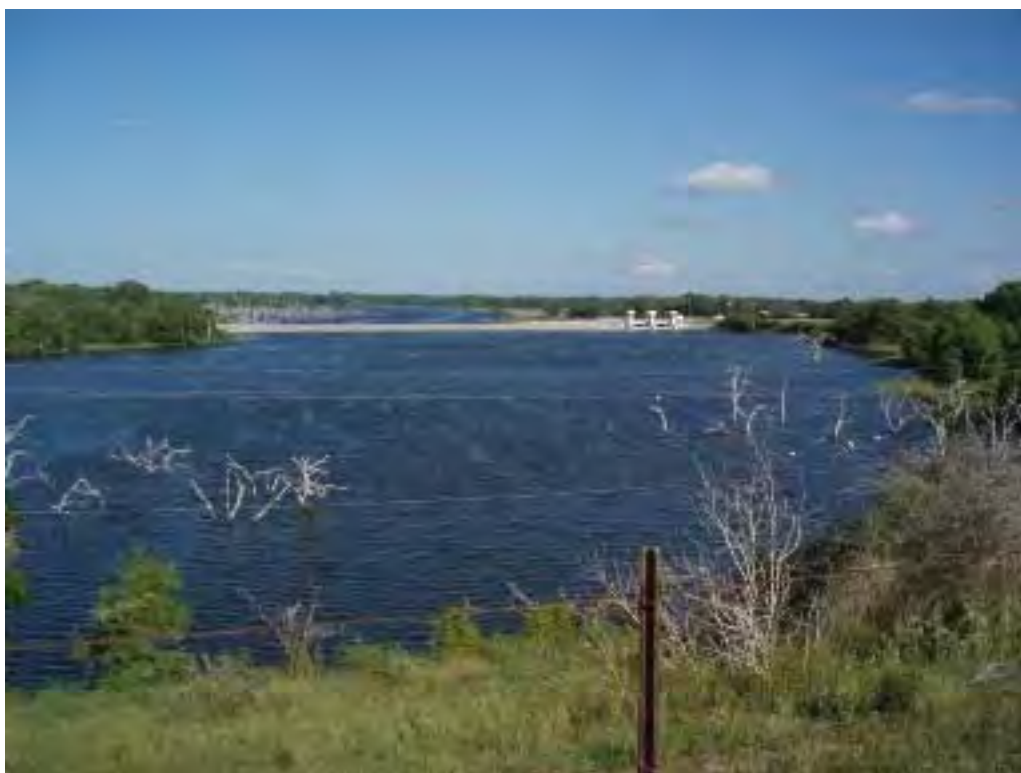
Photo No. 48: Secondary Pond - East embankment, looking east at Coletto Creek Reservoir at toe of embankment.

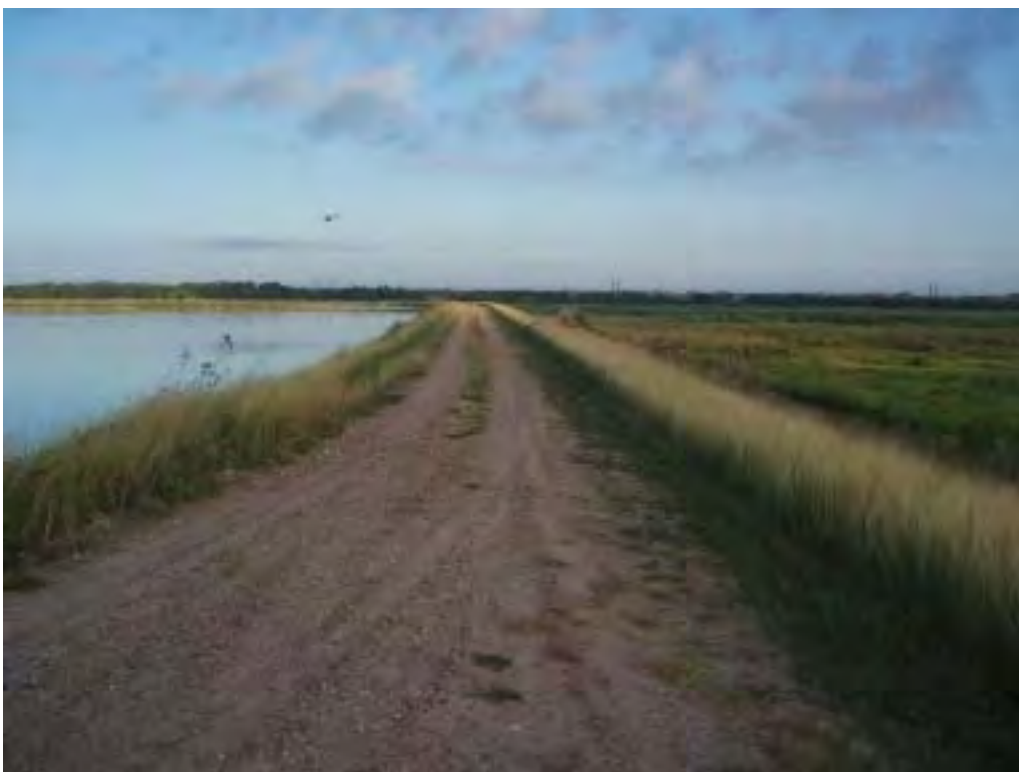
Photo No. 50: Primary Ash Pond - North embankment crest, looking west.

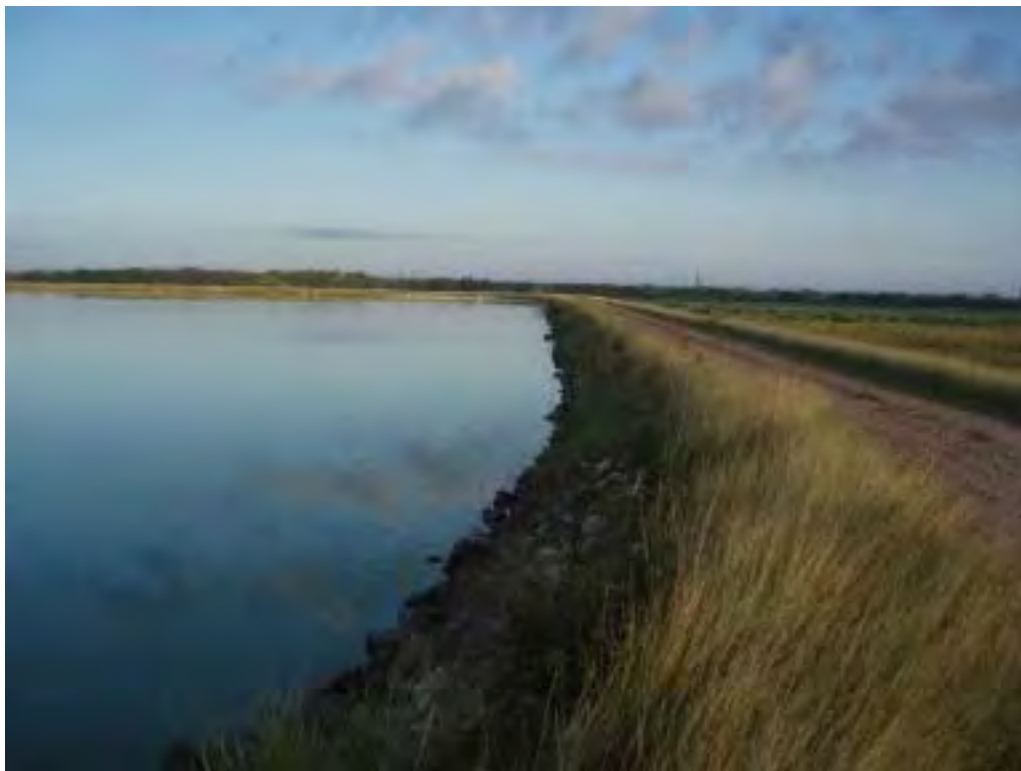
Photo No. 51: Primary Ash Pond - North embankment interior slope, looking west.

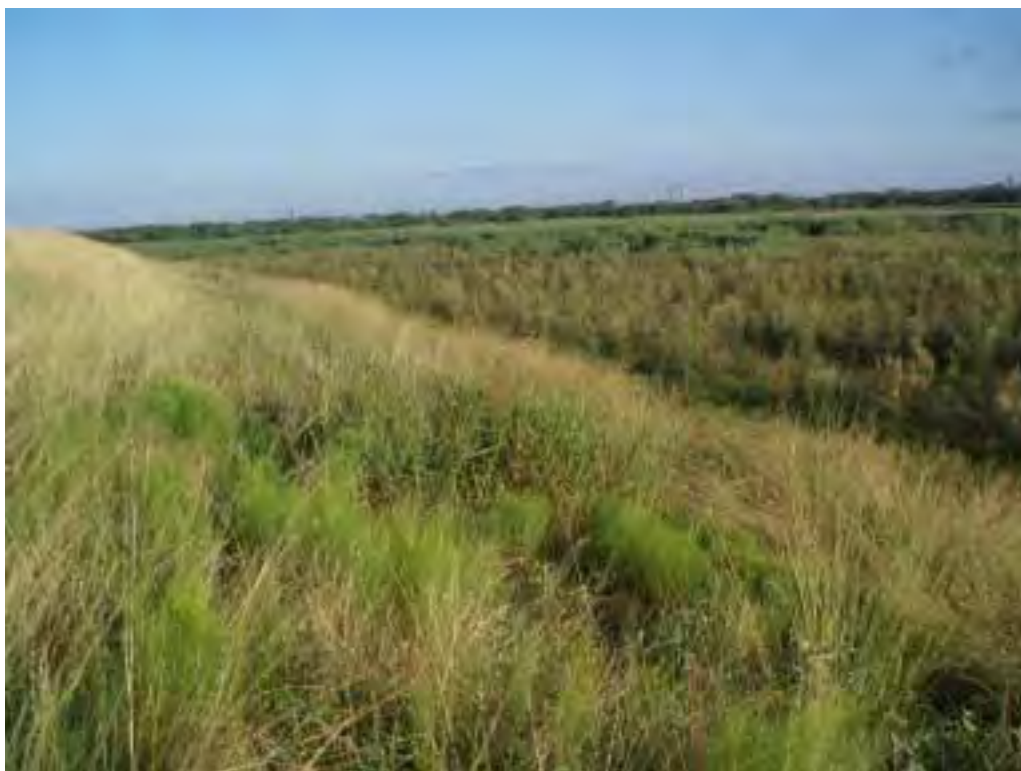
Photo No. 53: Primary Ash Pond – North embankment exterior slope, looking west at lush vegetation.

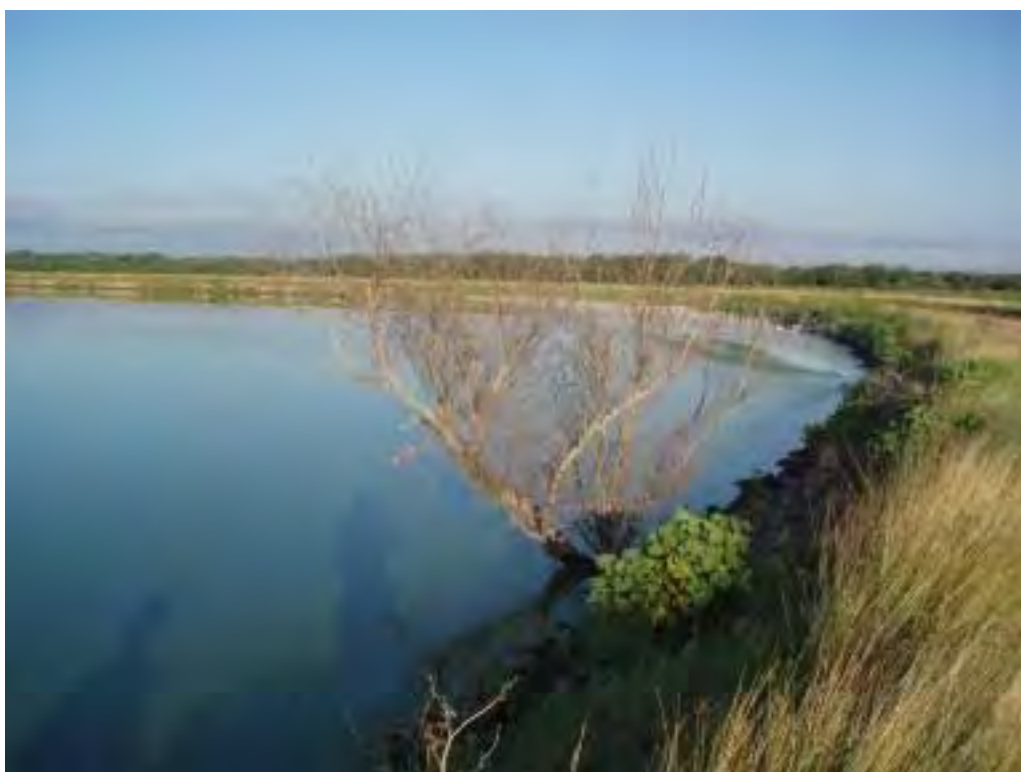
Photo No. 54: Primary Ash Pond – North embankment interior slope, looking west at a dead 8-inch-diameter mesquite tree.

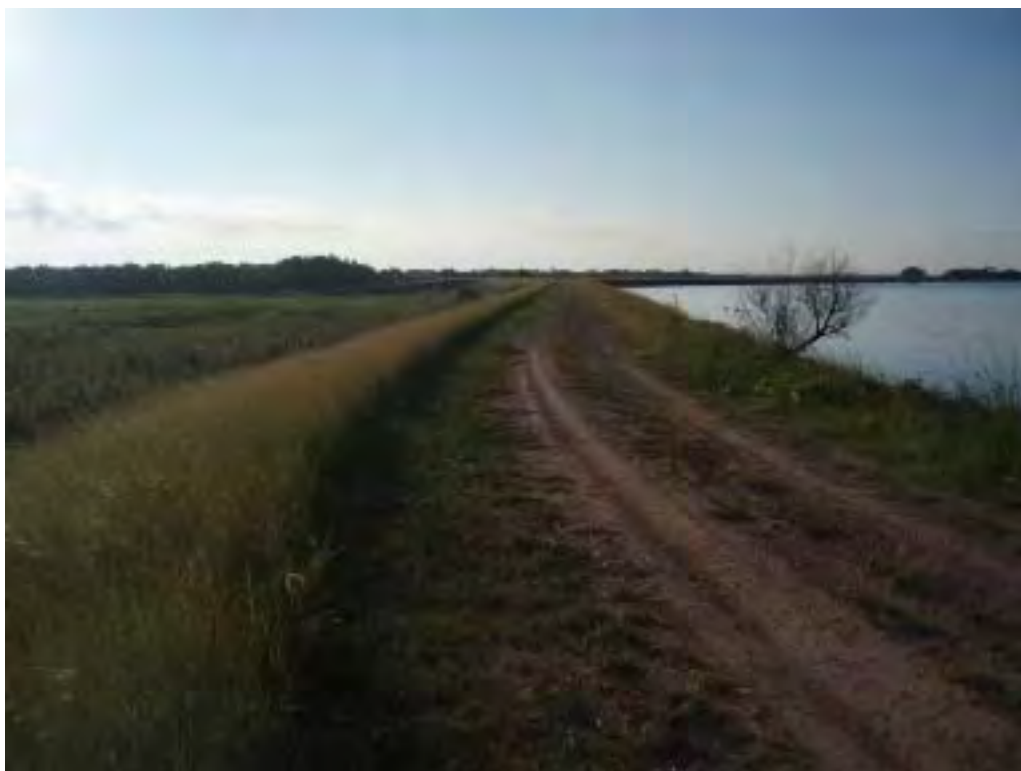
Photo No. 57: Primary Ash Pond - North embankment crest, looking east.

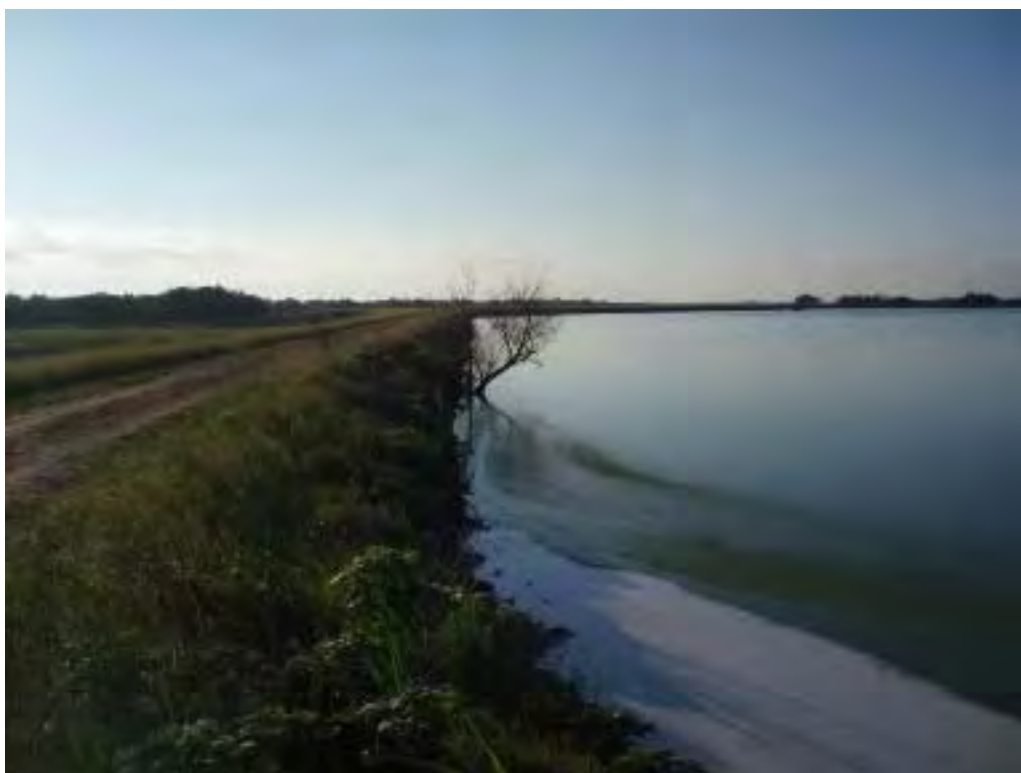
Photo No. 58: Primary Ash Pond - North embankment interior slope, looking east.

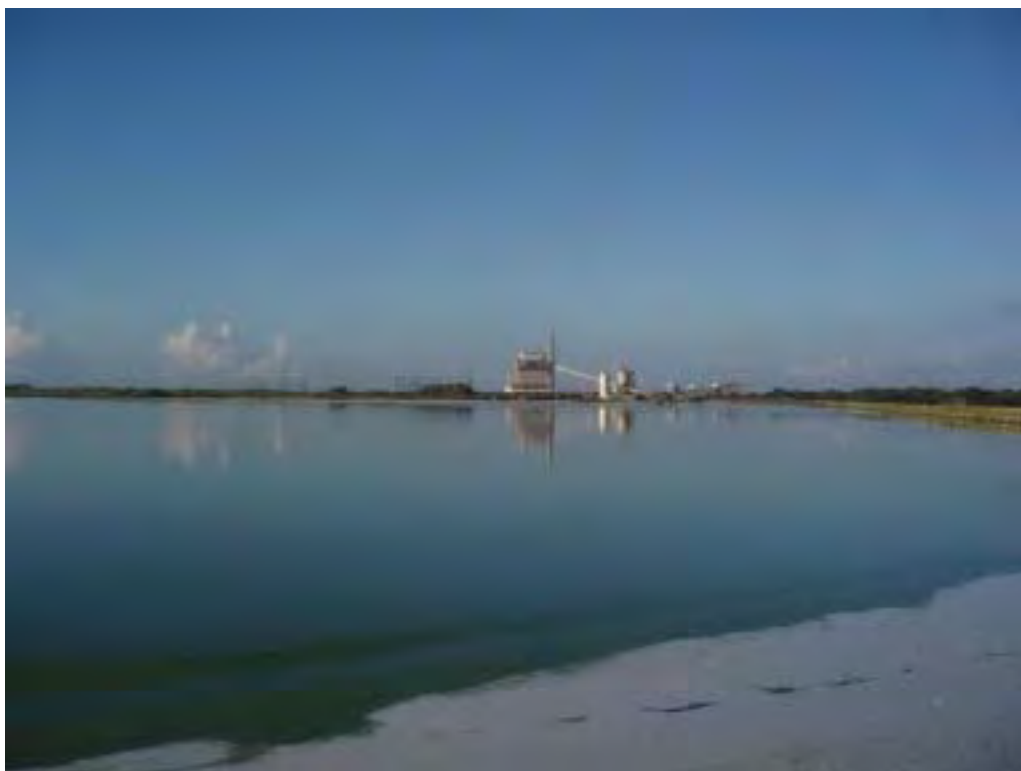
Photo No. 59: Primary Ash Pond – Overview of impoundment of power plant, looking south from the north embankment.

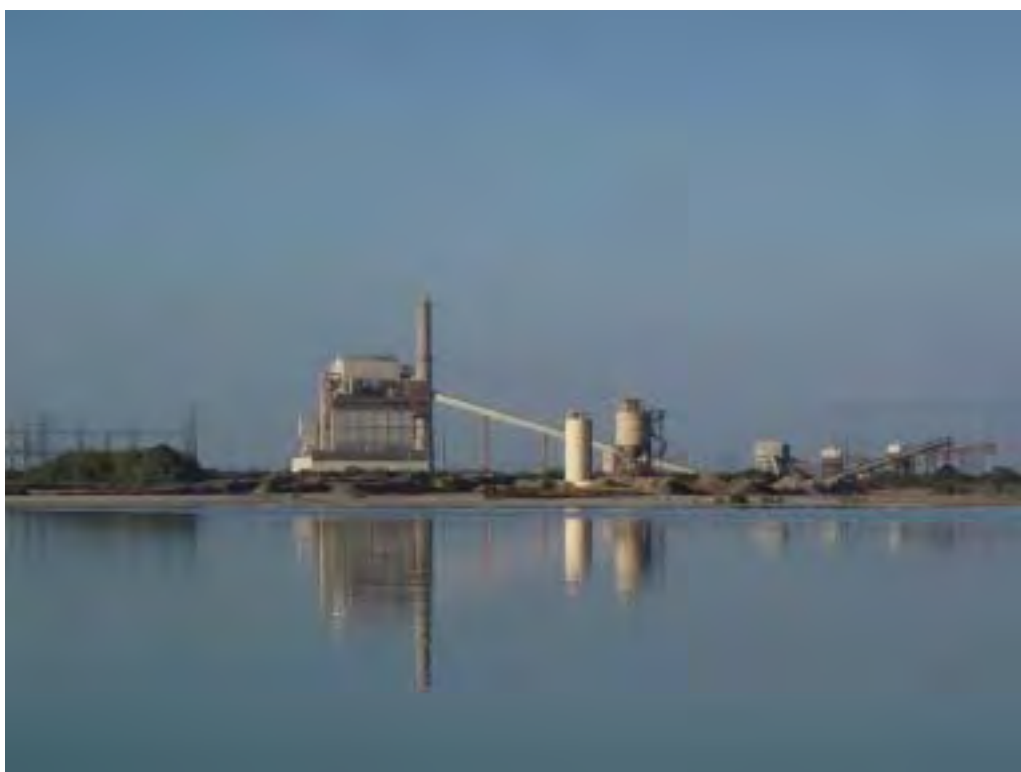
Photo No. 60: Primary Ash Pond – Close up power plant, looking south from the north embankment.

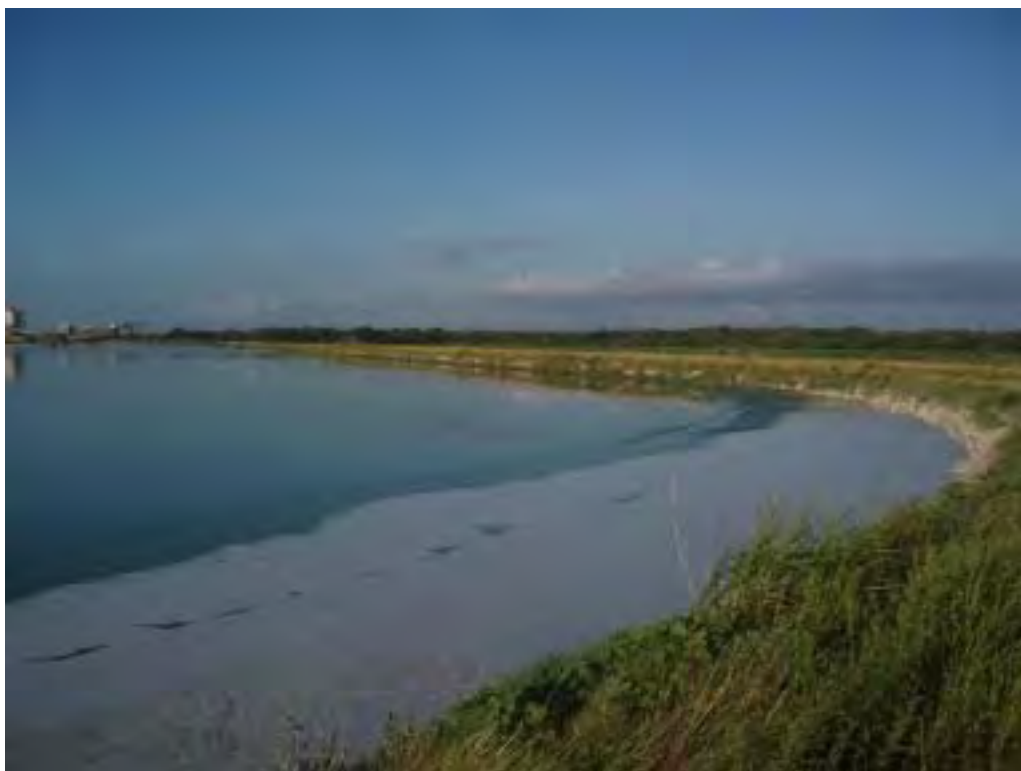
Photo No. 61: Primary Ash Pond - Overview of west embankment interior slope, looking southwest from the north embankment.

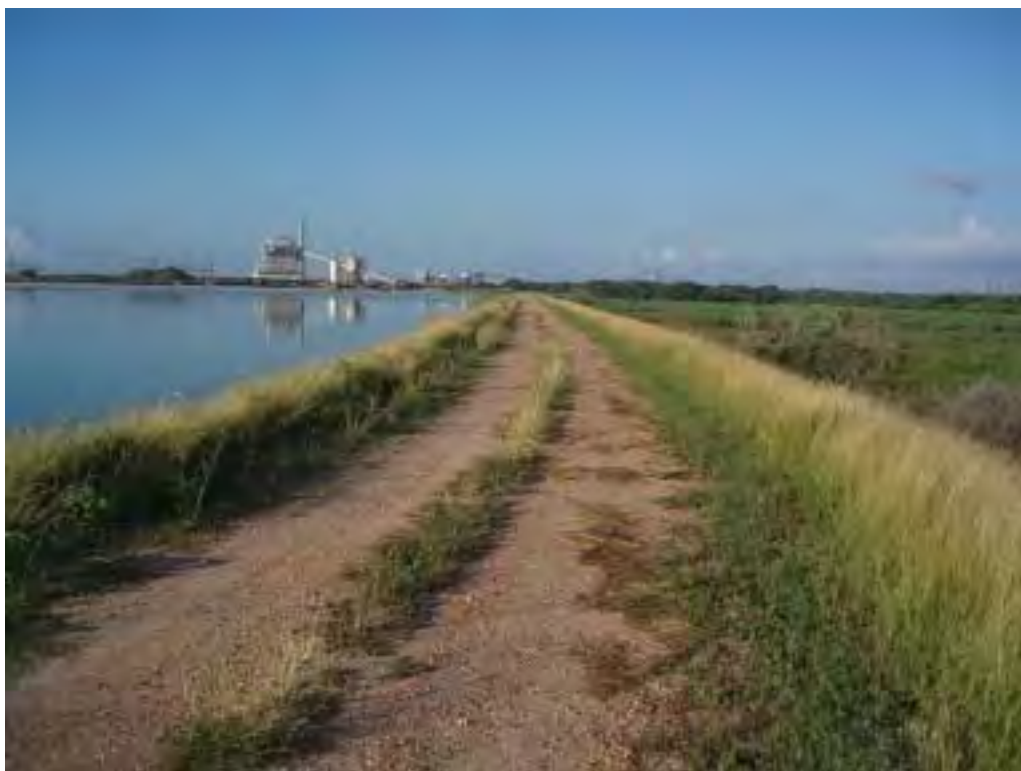
Photo No. 63: Primary Ash Pond - West embankment crest, looking south.

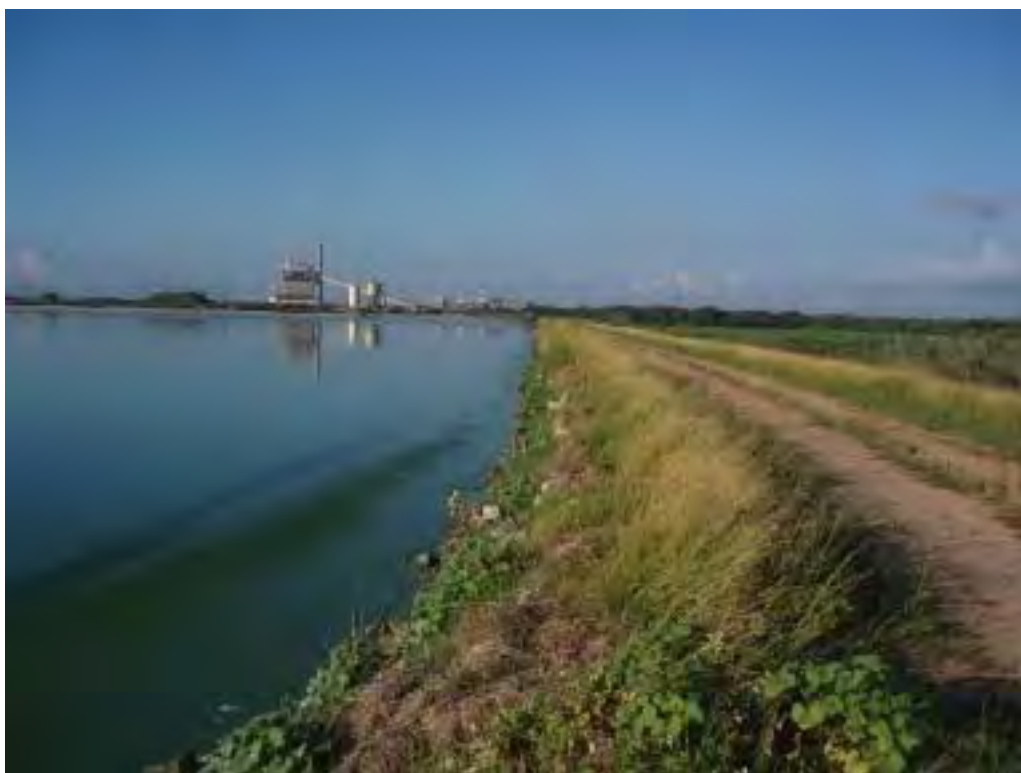
Photo No. 64: Primary Ash Pond - West embankment interior slope, looking south.

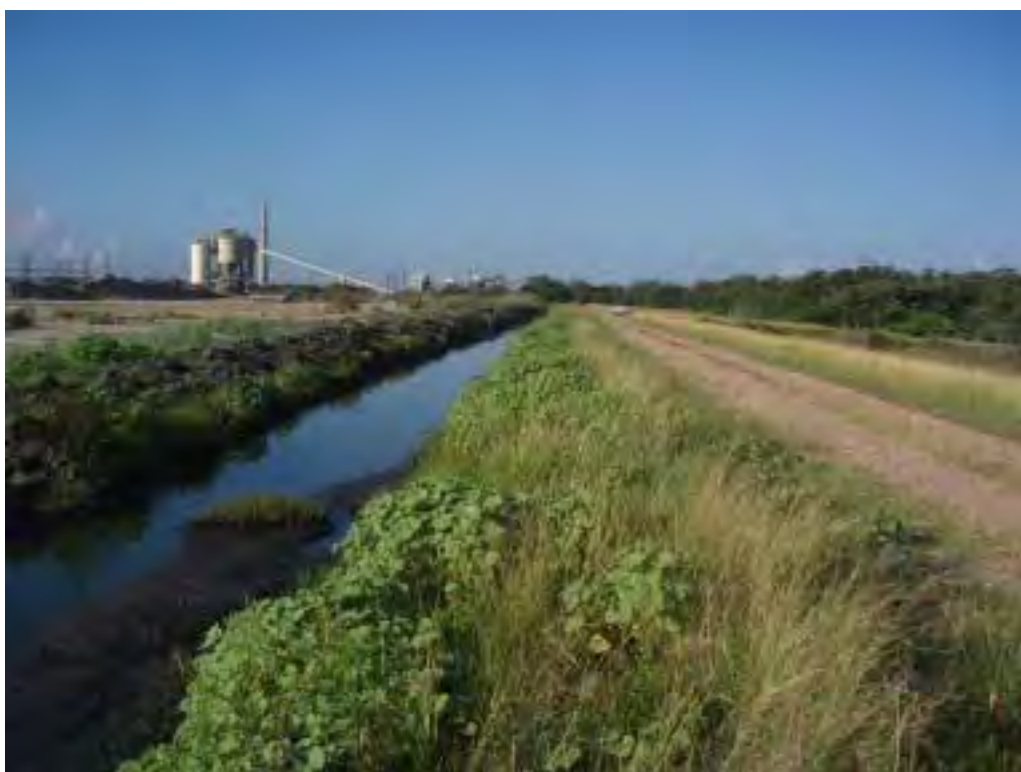
Photo No. 70: Primary Ash Pond – West embankment interior slope, looking south at surface water drainage ditch.

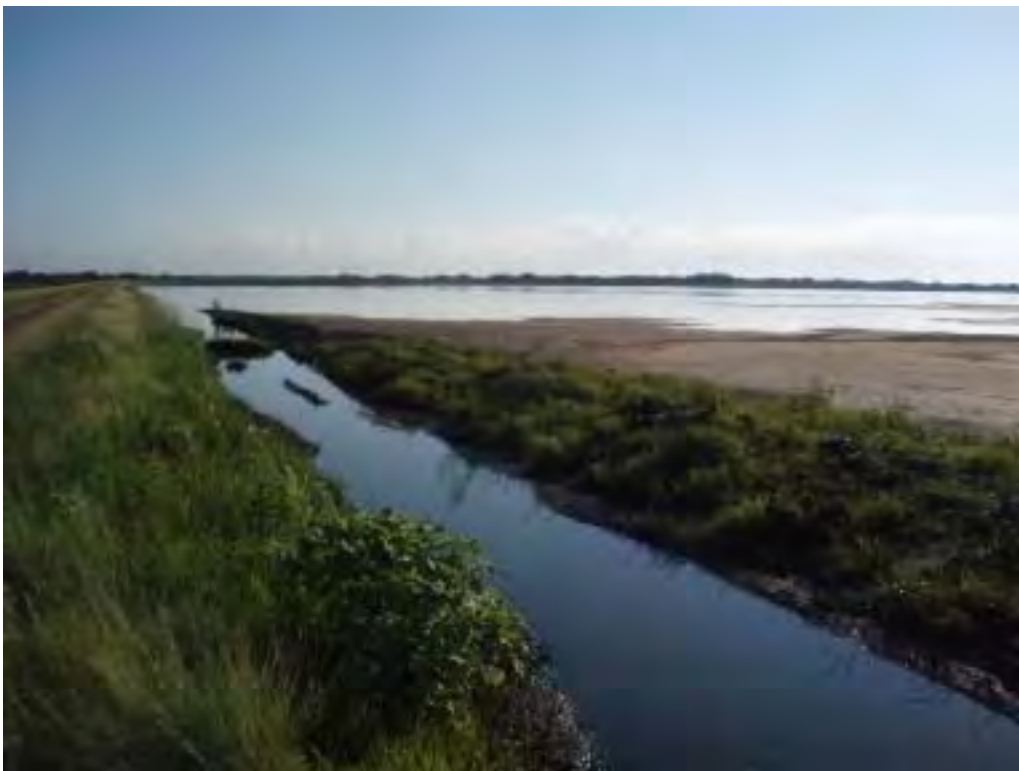
Photo No. 71: Primary Ash Pond – Interior slope looking northeast at impoundment and surface water drainage ditch.

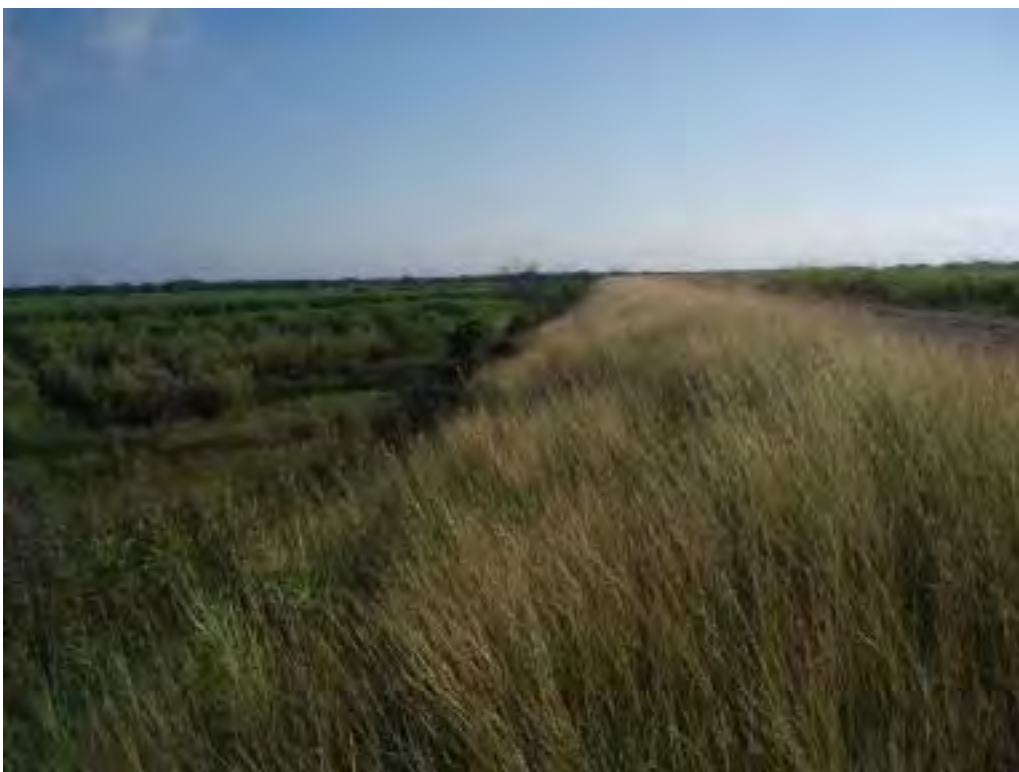
Photo No. 72: Primary Ash Pond – West embankment exterior slope, looking northeast.

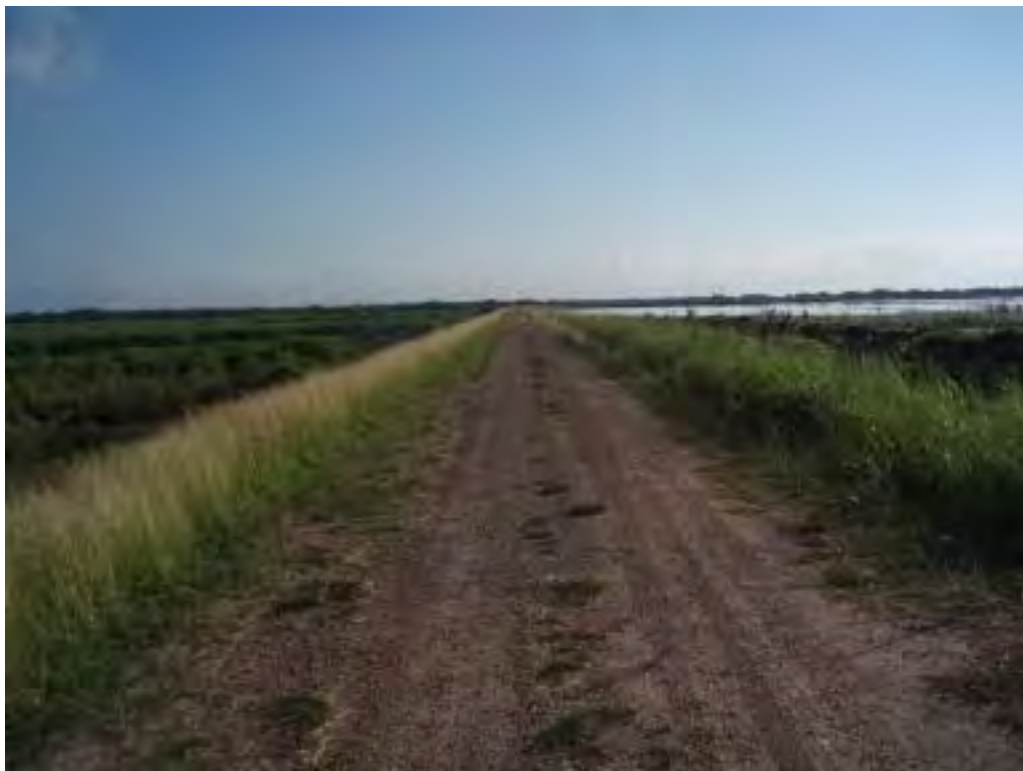
Photo No. 73: Primary Ash Pond - West embankment crest, looking northeast.

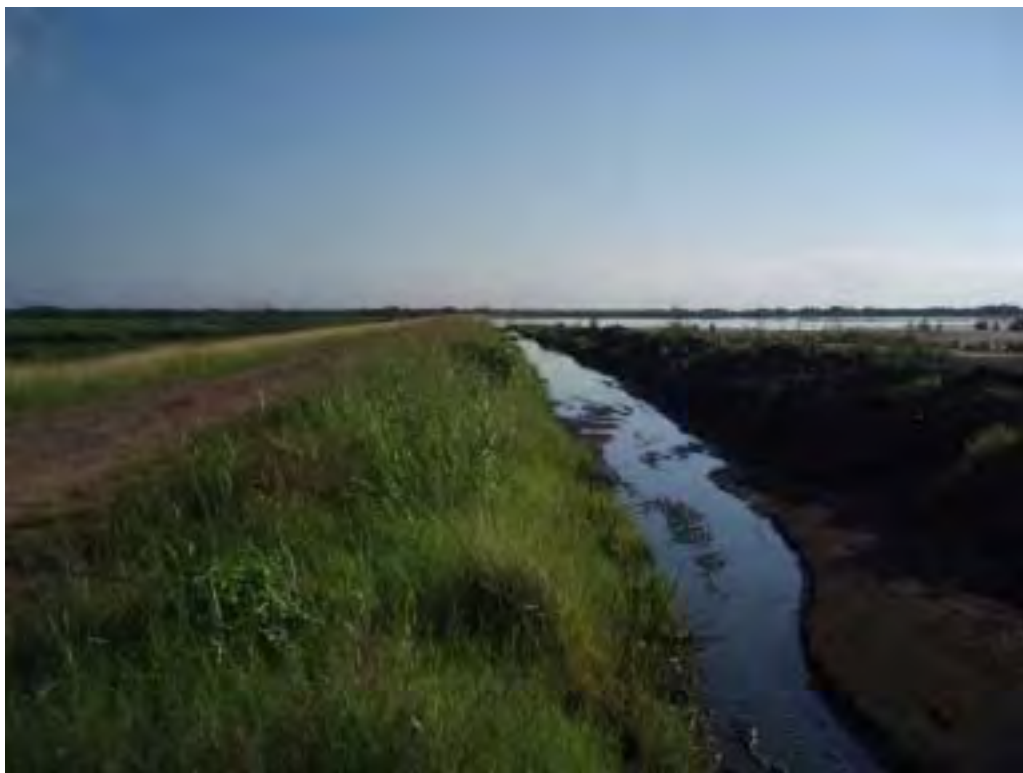
Photo No. 74: Primary Ash Pond - West embankment interior slope, looking northeast.

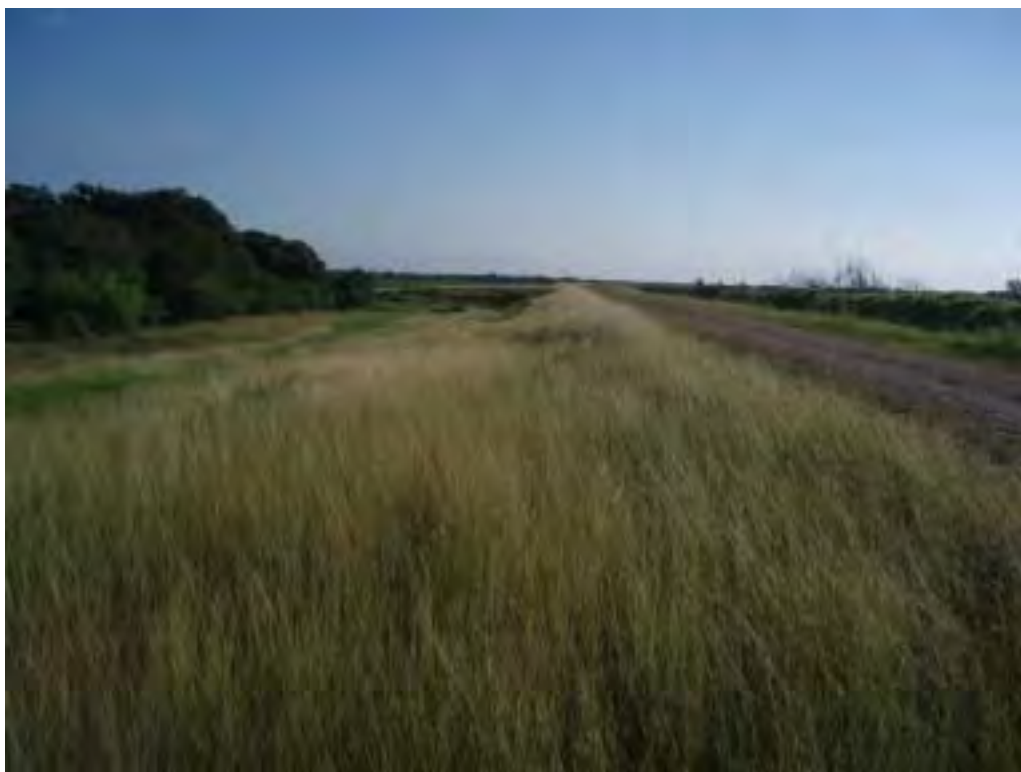
Photo No. 76: Primary Ash Pond - West embankment exterior slope, looking northeast.

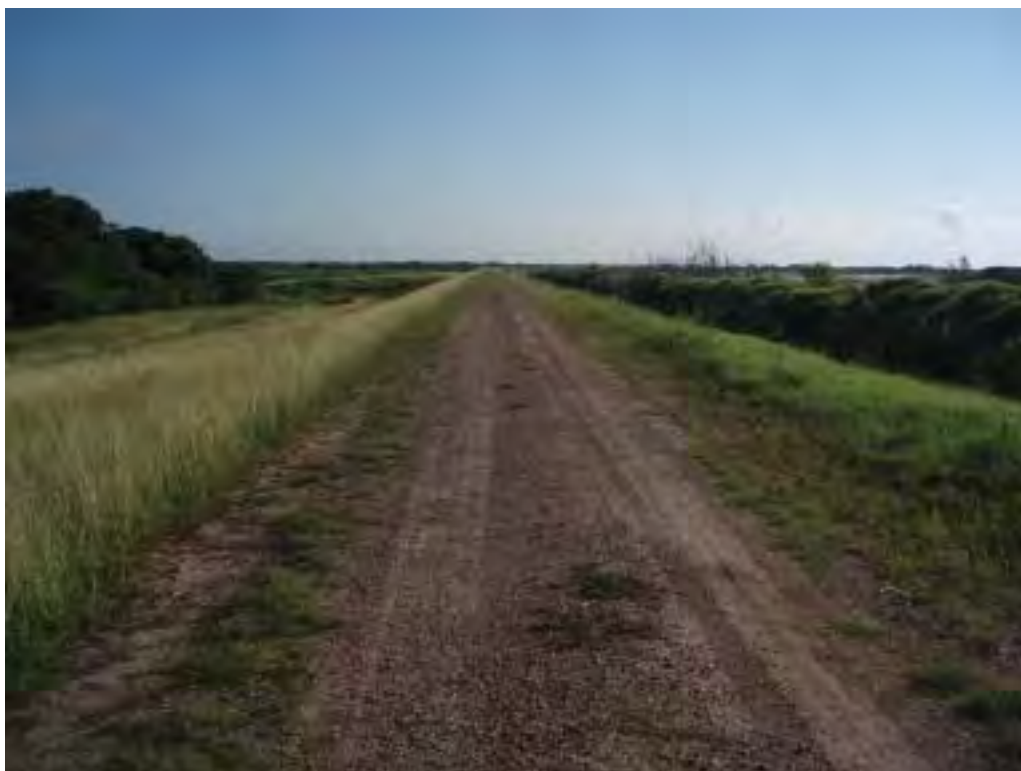
Photo No. 77: Primary Ash Pond – West embankment crest, looking northeast.

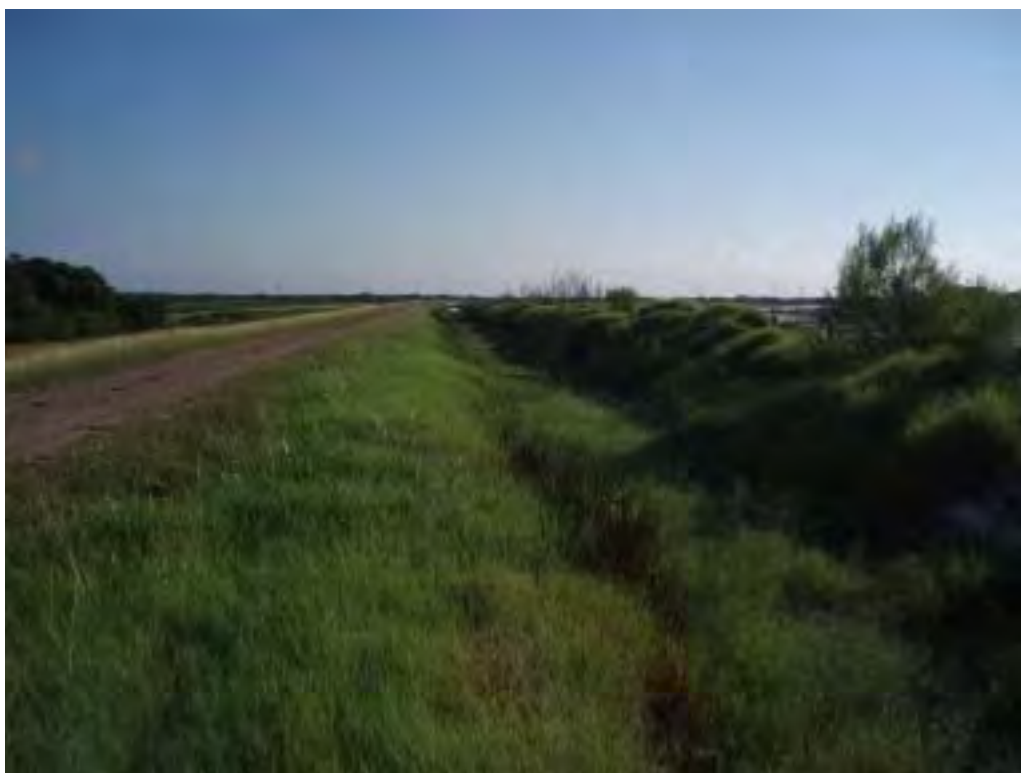
Photo No. 78: Primary Ash Pond – West embankment interior slope, looking northeast.

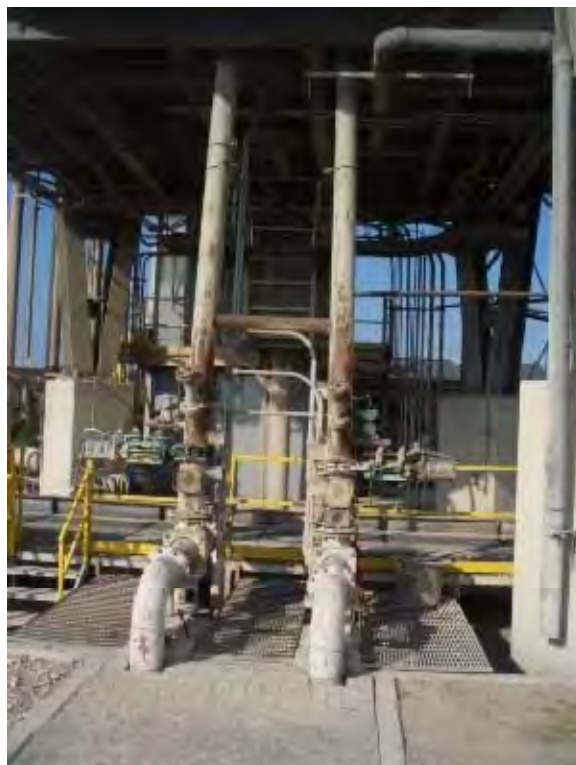
During the site visit, four sets of sluice pipes were observed. The two CCW sluice pipes on the southeast and south embankment appeared to be in fair condition (Photos 80, 81, 83, and 84). The boiler area sump sluice pipe on the west embankment and the demineralizer effluent sluice pipe on the southeast embankment also appeared to be in fair condition (Photos 75 and 85). No seepage was observed where the pipes penetrated through the embankment.

Photo No. 81: Primary Ash Pond - Southwest embankment, looking at two 8-inch-diameter sluices pipes from Boral Material Technologies' silos.
