# **Assessment of Dam Safety of Coal Combustion Surface Impoundments**

**Coletto LP, LLC**

**Coletto Creek Power, LP**

**March 11, 2011**

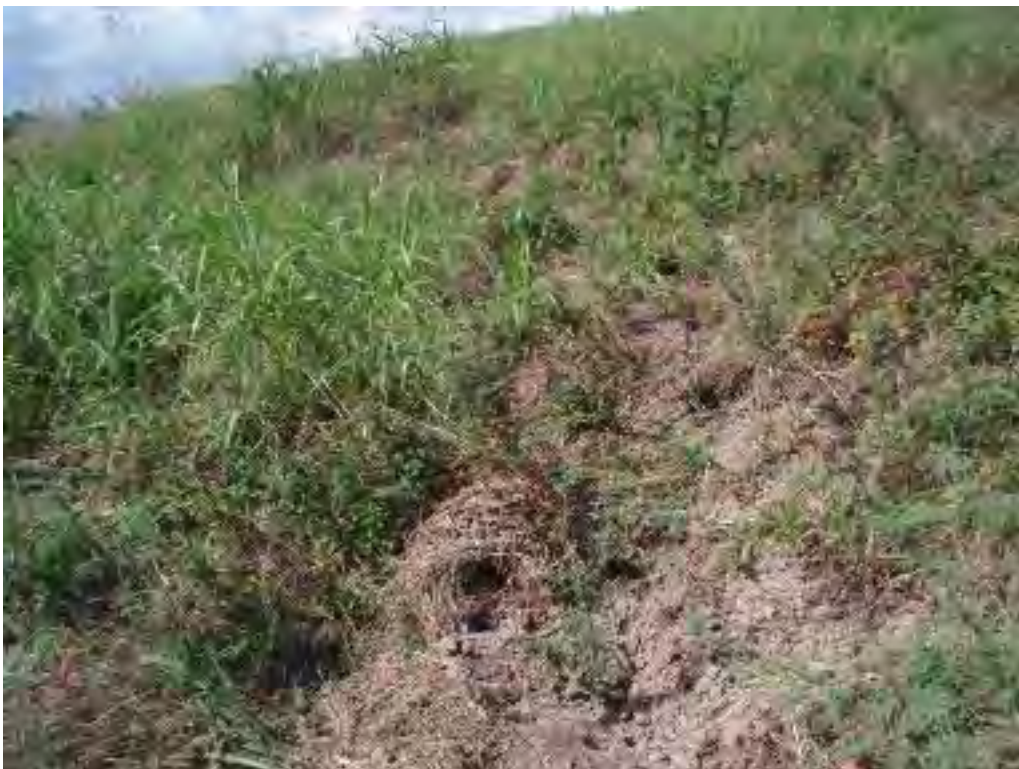
Photo No. 109: Primary Ash Pond - East embankment exterior slope, looking at an area disturbed by animal activity.
