**Coal Combustion Residue Impoundment  
Round 9 - Dam Assessment Report**

***H.F. Lee Steam Electric Plant***

***Active Ash Pond; Ash Pond 1; Ash Pond 2;  
Ash Pond 3***

***Progress Energy Carolinas, Inc.  
Wayne County, North Carolina***

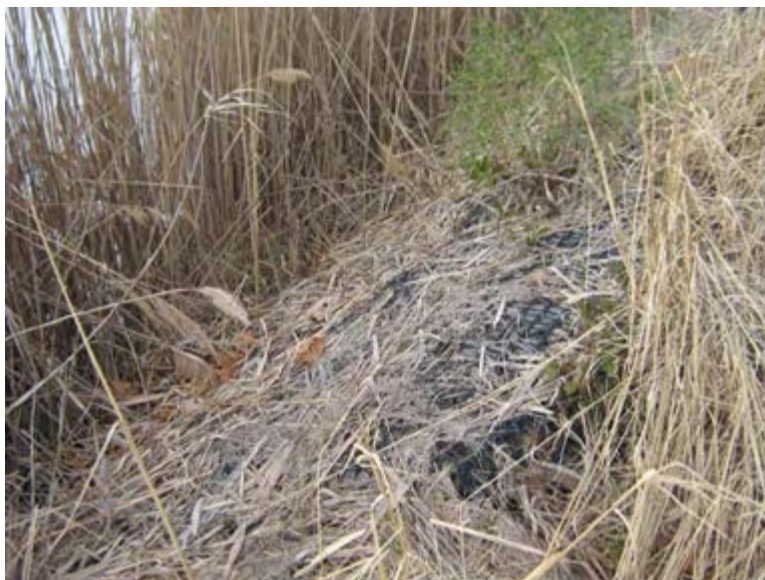
The upstream slopes are mostly vegetated with tall grasses and other wetland vegetation. The upstream slope is also embedded with stone/riprap held down by a geotextile fabric. No scarps, sloughs, depressions, bulging or other indications of slope instability or signs of erosion were observed.

**Riprap and geotextile fabric along upstream slope**

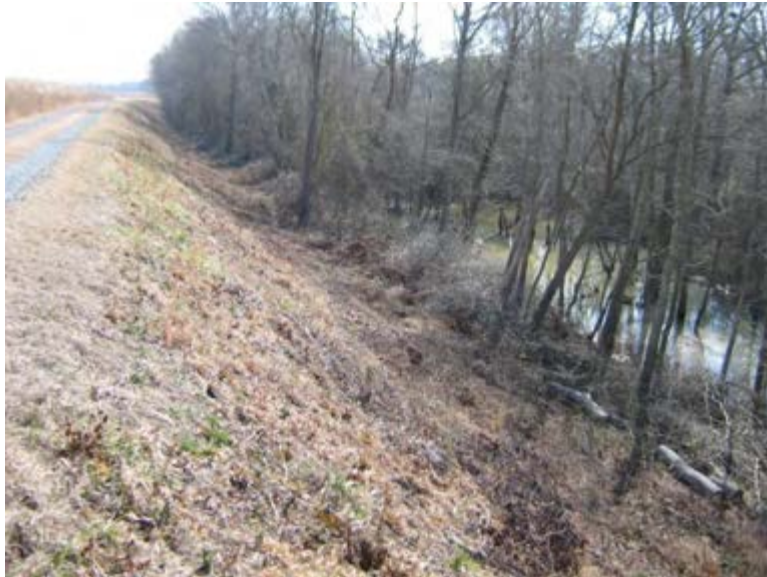
Wetlands along downstream toe

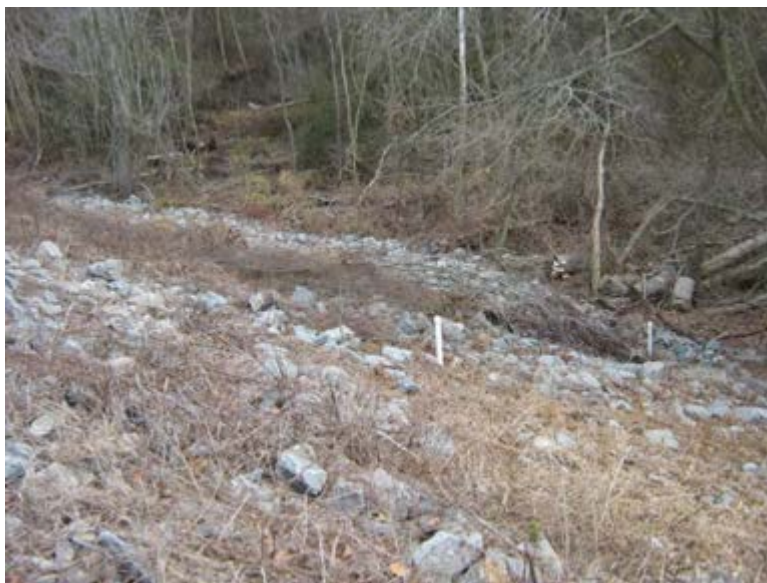
There were no signs of surficial sloughing, rill erosion or cause for concerns along the downstream slope and toe. The repair from 2000 due to seepage is complete and is being monitored. Repairs were made after the initial site visit that addressed seepage along the downstream slope (Appendix A, Doc 11: Approval to Impound and Doc 12: Seepage Repair As-builts). There were areas where a concrete buttress was along the downstream sloped, which was explained by Progress Energy to be a part of the original design. There were wetlands and drainage channels along the toe of the slope in areas.

Riprap at seepage location that was repaired

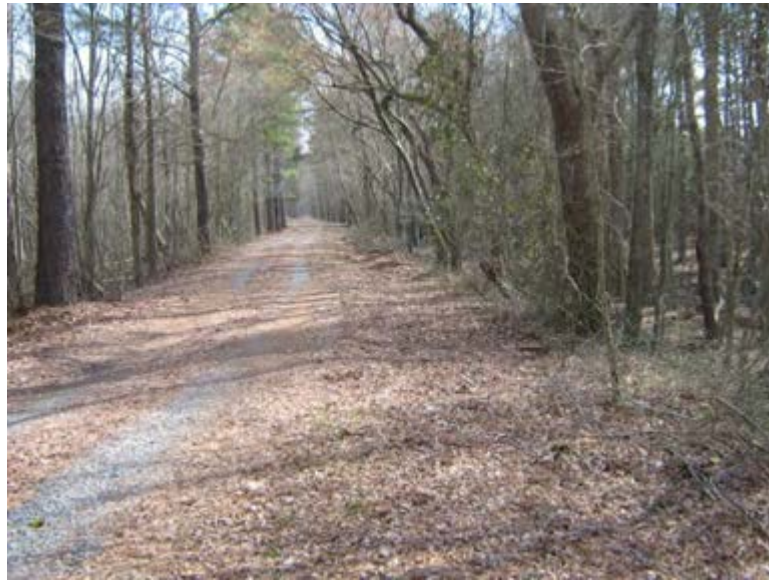
The crest had no signs of depressions, tension cracking, or other indications of settlement or shear failure and appeared to be in satisfactory condition.

Typical view of crest, upstream and downstream slope

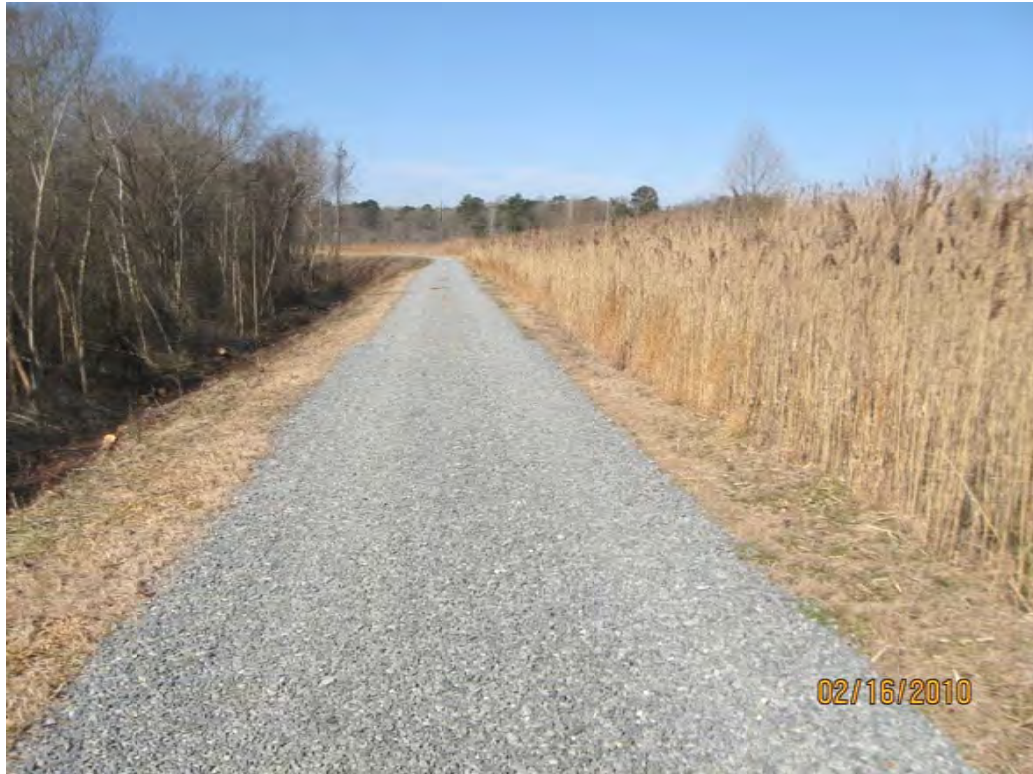
1. Ash Pond Dike – View of crest for south dike looking toward west.

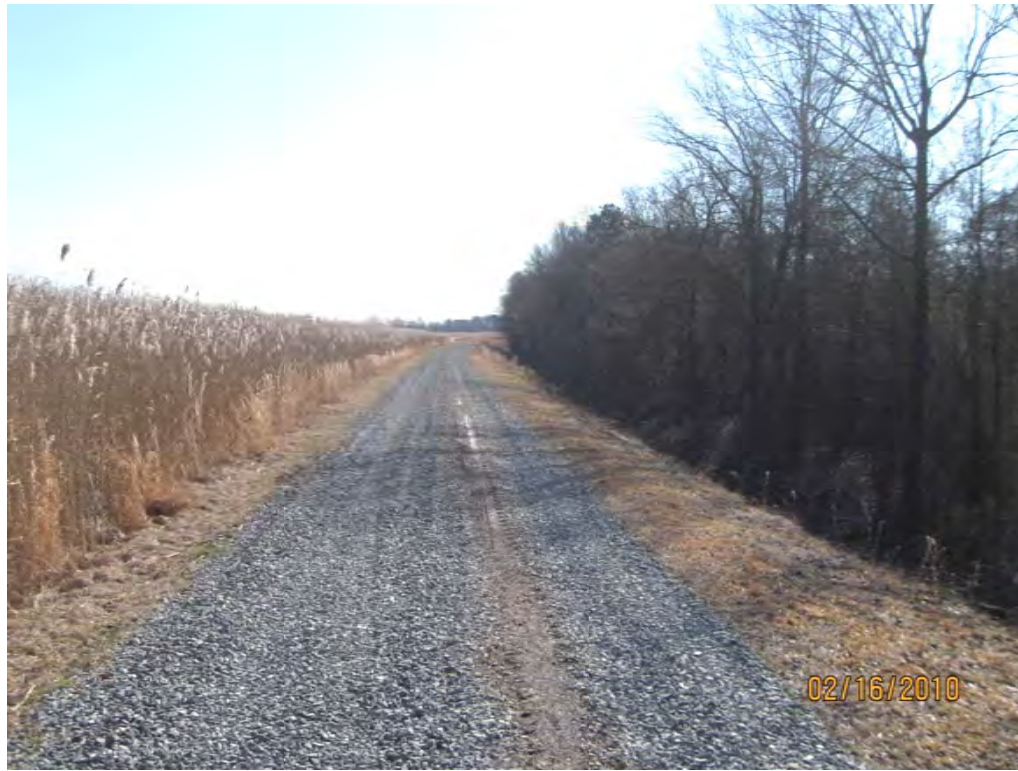
2. Ash Pond Dike – View of crest for south dike looking toward east.

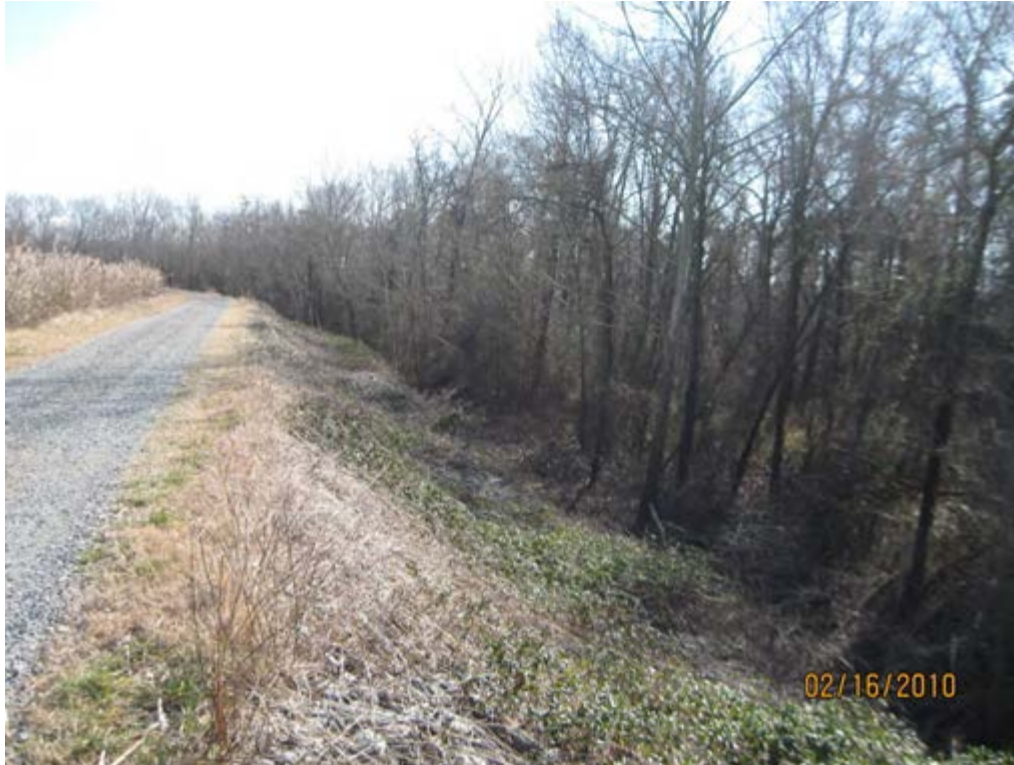
3. Ash Pond Dike – View of crest and outside slope on south dike.

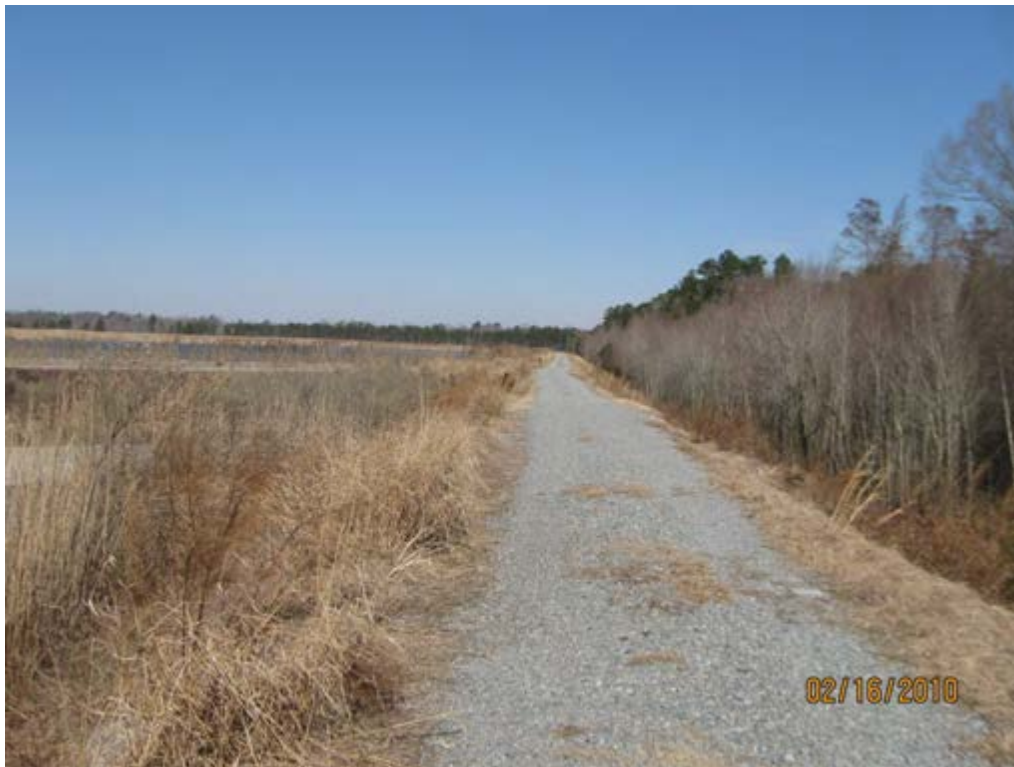
4. Ash Pond Dike – View of crest for east dike.

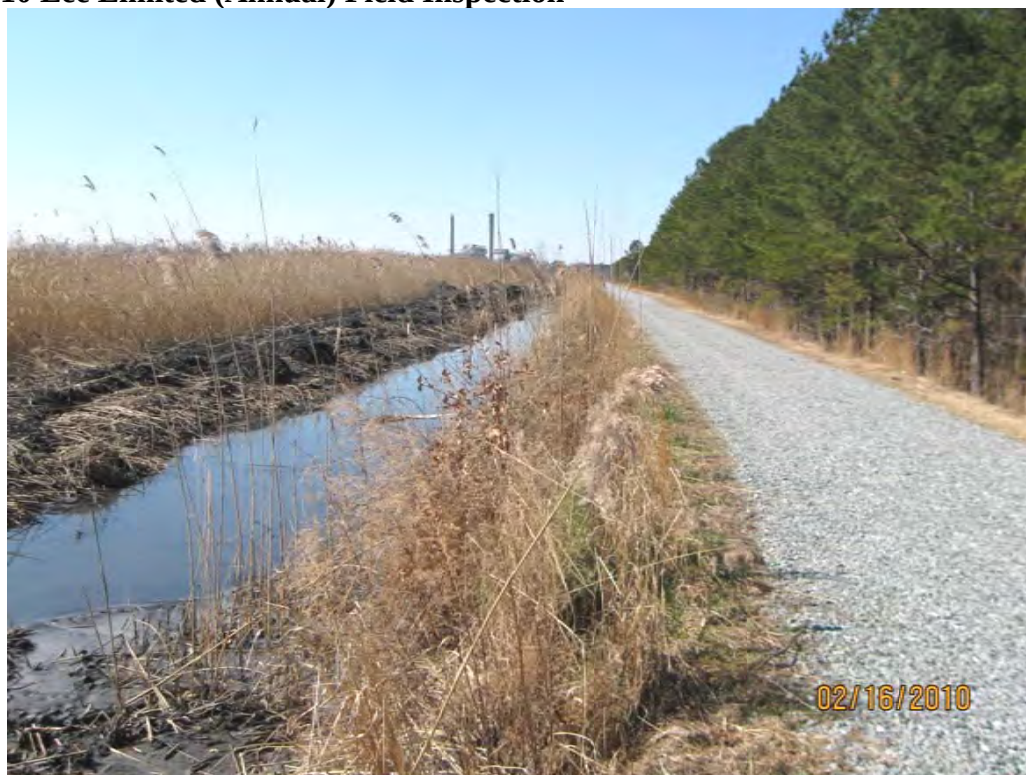
5. 5 Ash Pond Dike – View of crest for north dike.

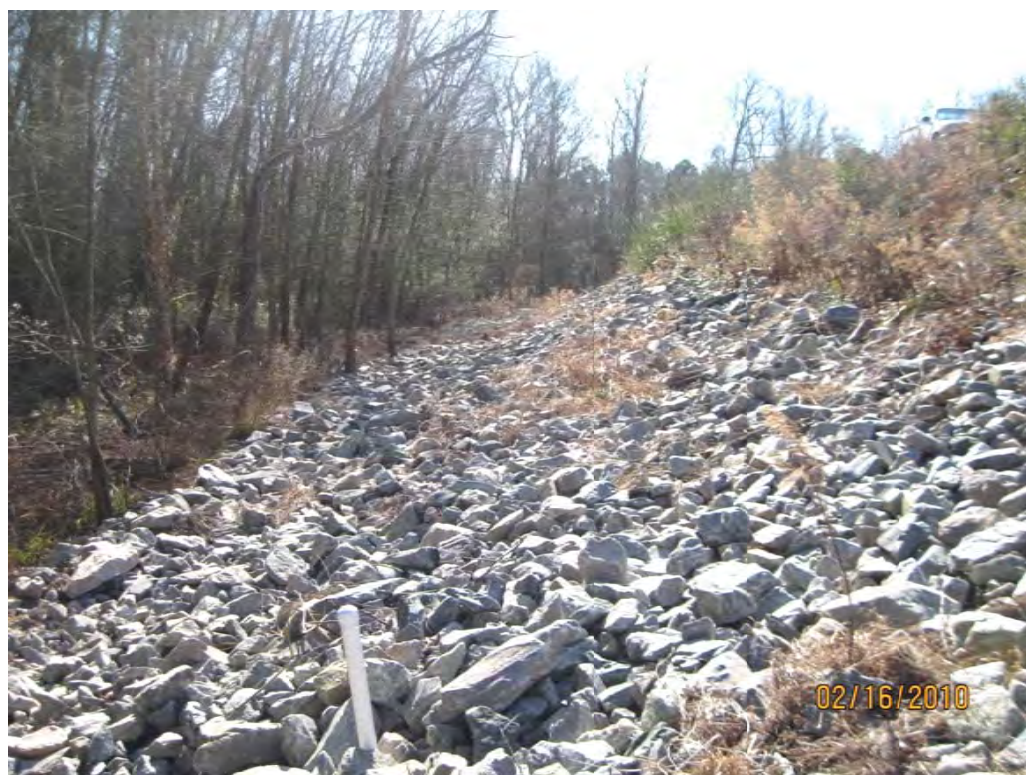
6. 6 Ash Pond Dike – View of riprap placed along toe of outside slope for secondary settling basin.

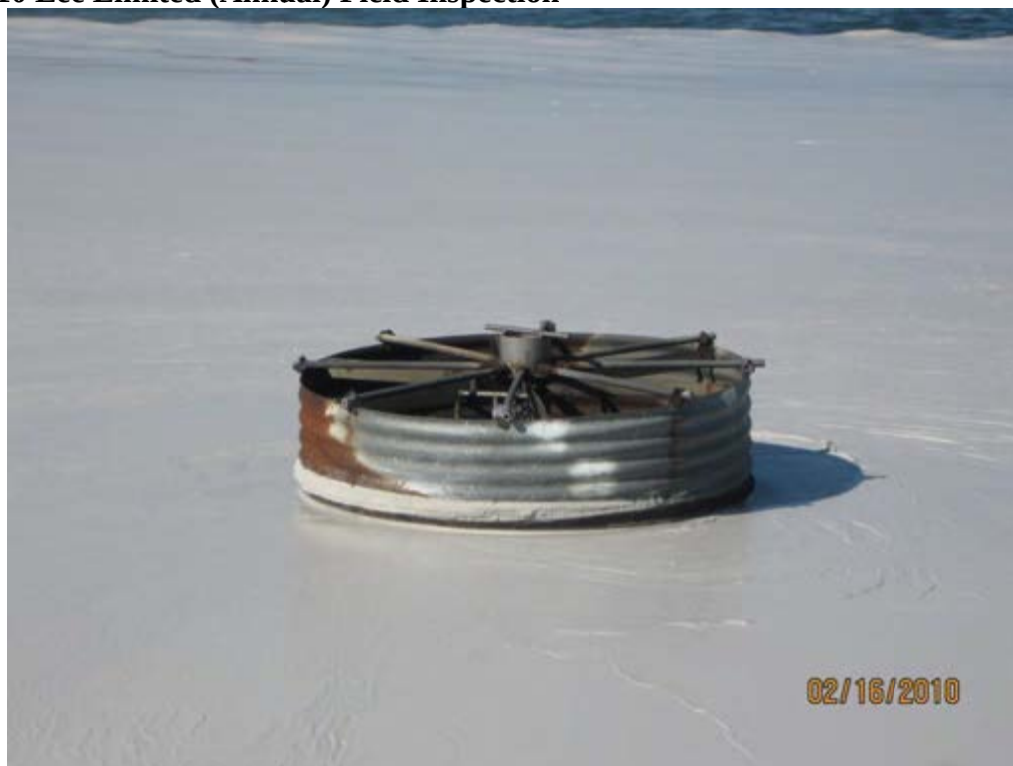
7. Ash Pond Dike – View of skimmer for ash pond discharge.

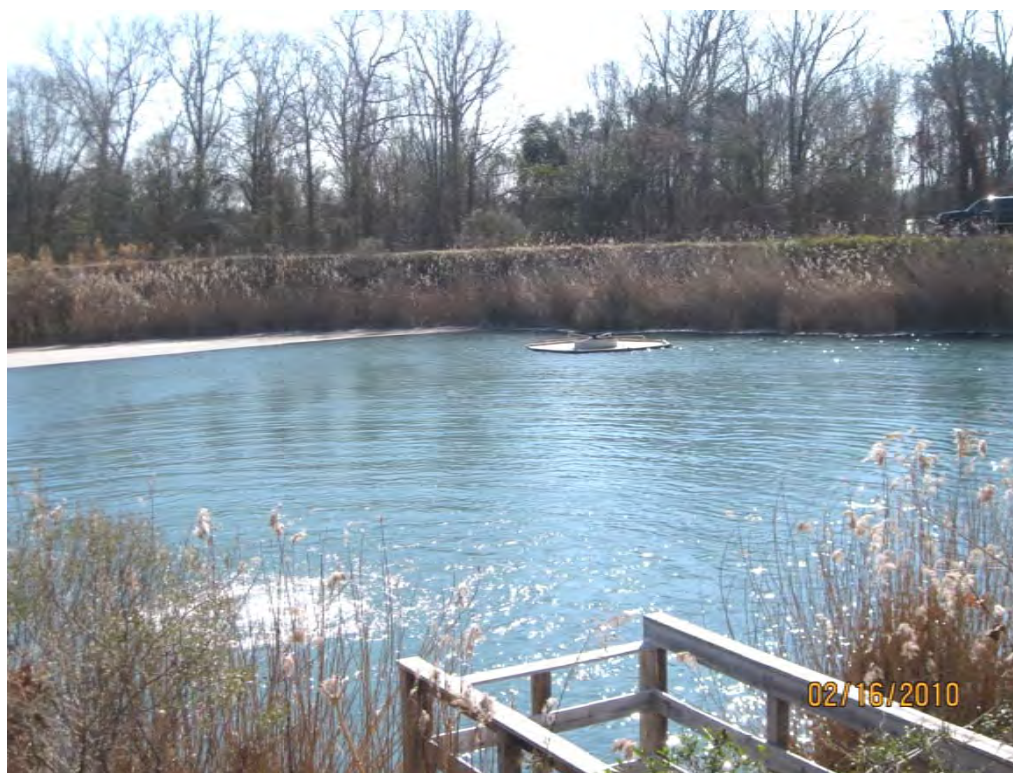
8. Ash Pond Dike – View of secondary settlement basin and skimmer for discharge riser. Turbulence is from ash pond discharge

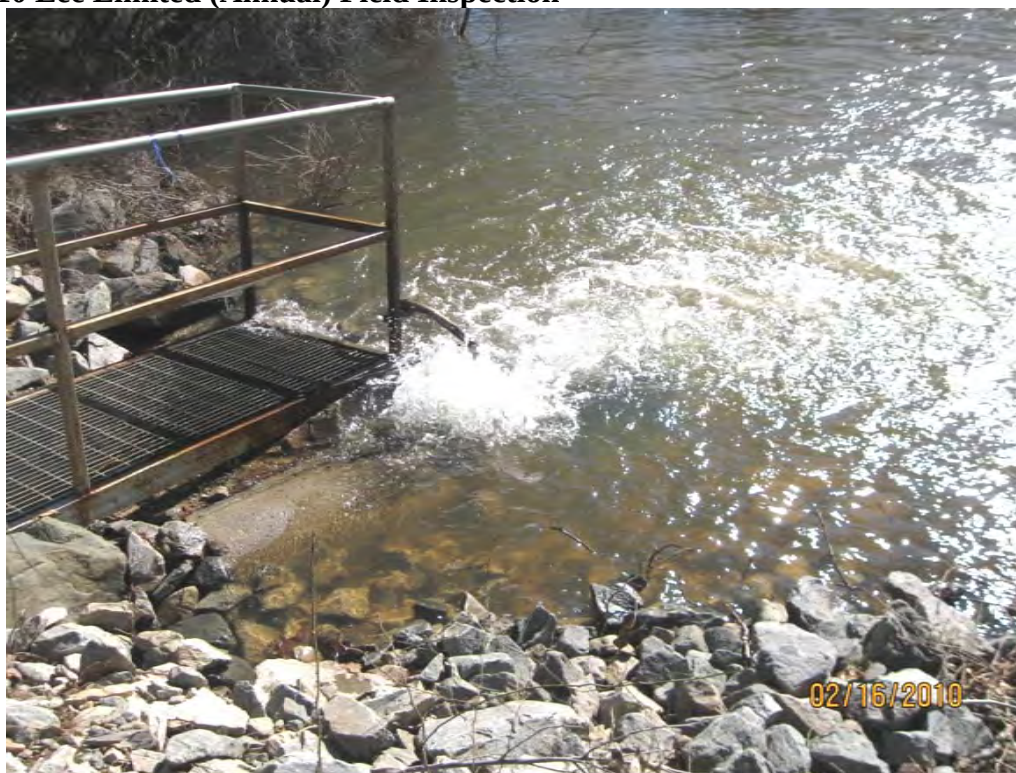
9. Ash Pond Dike – View of discharge from secondary settling basin at Neuse River.

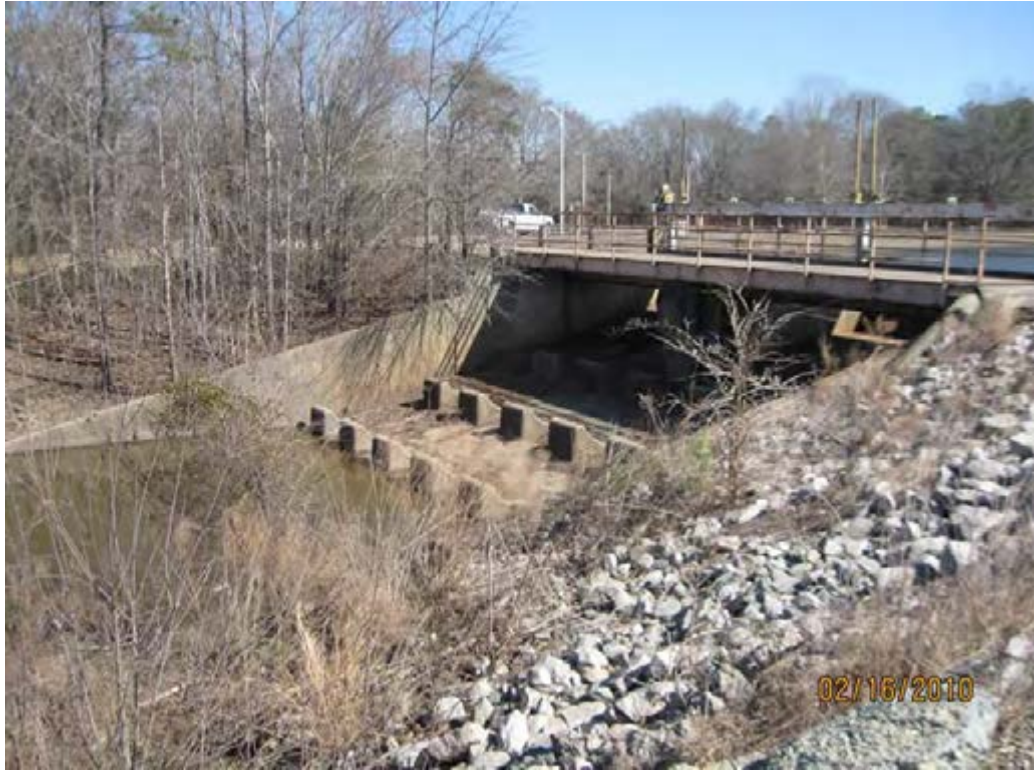
10. Cooling Lake Dike – View of spillway.

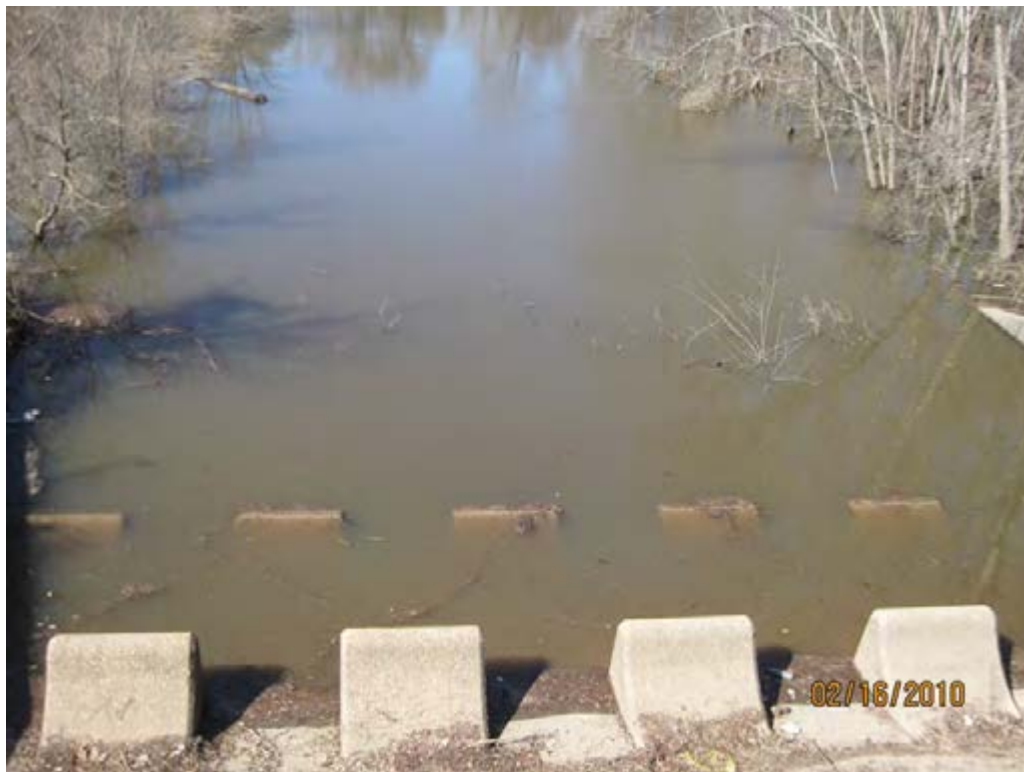
11. Cooling Lake Dike – View of energy dissipation blocks and downstream spillway channel with high tailwater conditions.

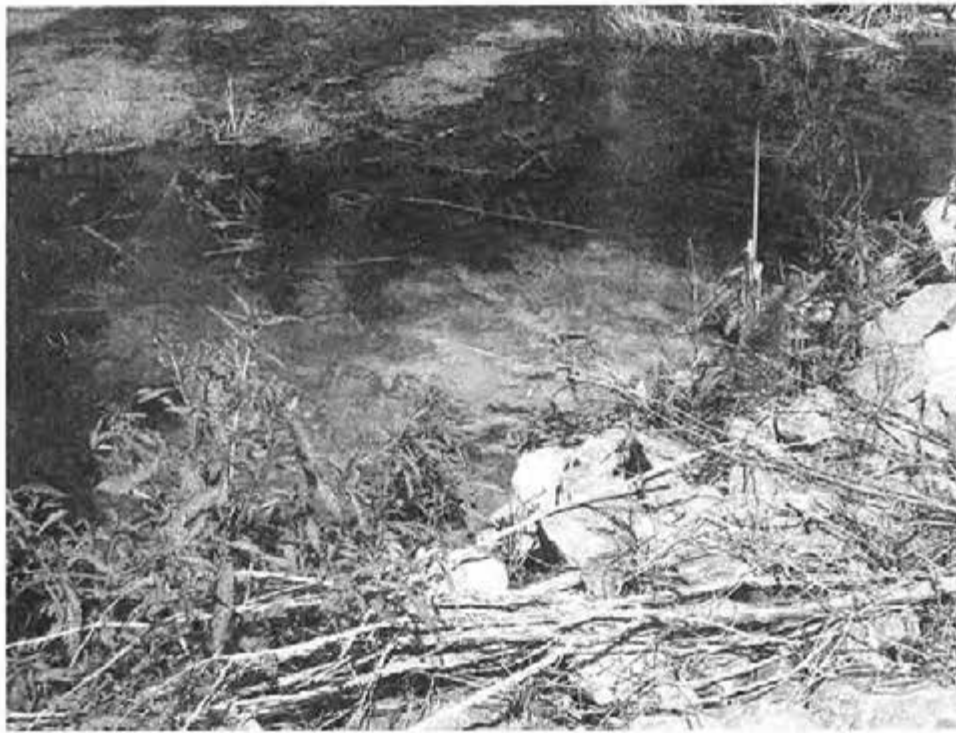
LEE COOLING LAKE NORTH DIKE  
SEEPAGE AREA - REPAIR RECOMMENDATIONS  
FOR SMALL BOIL AREA  
OBSERVED 8-30-10

Photograph 1. Area of sediment deposit around small boil.

STEP 1 - PEEL BACK RIPRAP & NO. 57 STONE TO EXPOSE 12" OF FABRIC

STEP 4 (OPTIONAL)

PLACE NO. 57 STONE ON TOP OF RIPRAP LAYER TO FILL VOIDS

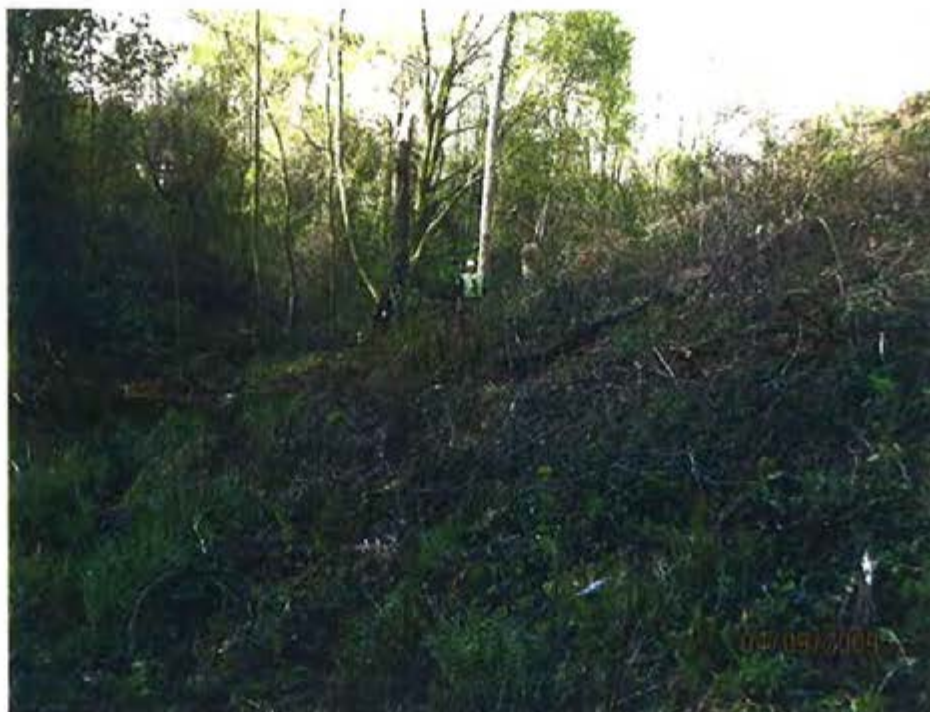
1. Initial slope clearing 4-9-09 – Not accepted; additional clearing done by TransAsh prior to geotextile installation and reviewed by MACTEC.

- April 9, 2009 – Site visit by Al Tice and Mark Blackley (MACTEC senior technician) to check status of clearing and to orient Mr. Blackley as to observation needs. Mr. Tice left after the orientation. Clearing done was not satisfactory (Photograph 1). Additional recommendations for clearing were given to Mr. Wilson. Mr. Blackley remained on site and observed continued clearing work, reporting that it was achieving desired results.

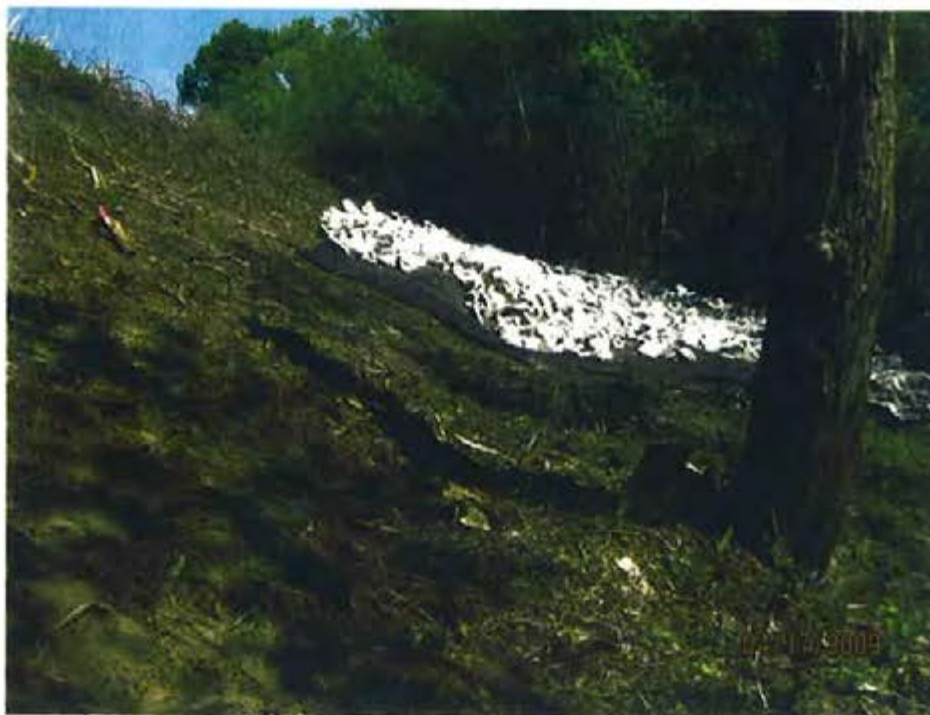
2. Final area for geotextile and riprap placement 4-17-09. Note satisfactory clearing.

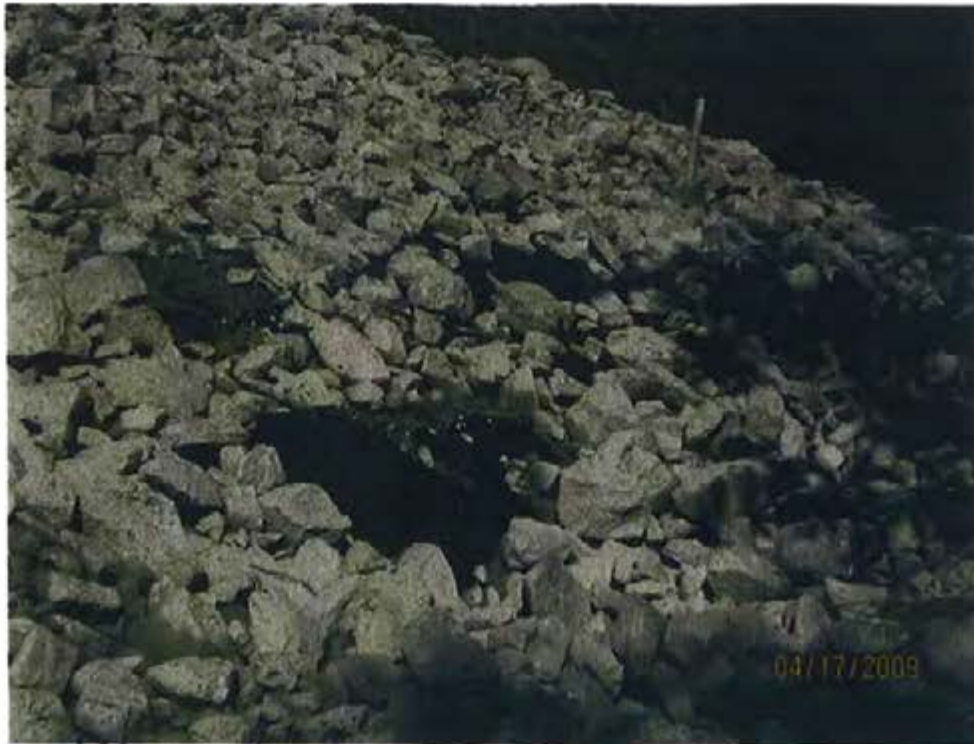
3. Areas within completed rip rap blanket where additional rip rap is needed 4-17-09.

- April 17, 2009 – Tice visited to observe completed work. Geotextile had not arrived at time of visit, but TransAsh was expecting it between 1 and 4 PM. Completed work observed was generally satisfactory with exception of local spots where additional rip rap was needed because the original placement did not fully cover the geotextile (Photographs 2-4). Tice also noticed an area adjacent to the planned eastern end of the rip rap where more geotextile and rip rap needed to be placed. The area was marked in the field and consisted of about a 5-foot eastward extension at the top of the area, tapering to the planned edge at the base of the area. The crest of the dike was observed to have excess rip rap, and some rutting was observed (Photograph 5). Also, excess rip rap was placed on the interior slope and upper portion of the exterior slope. The observations were discussed with Mr. Wilson who had already noted the areas needing more rip rap, and planned to use the excess rip rap on the interior slope to fill in the spots.

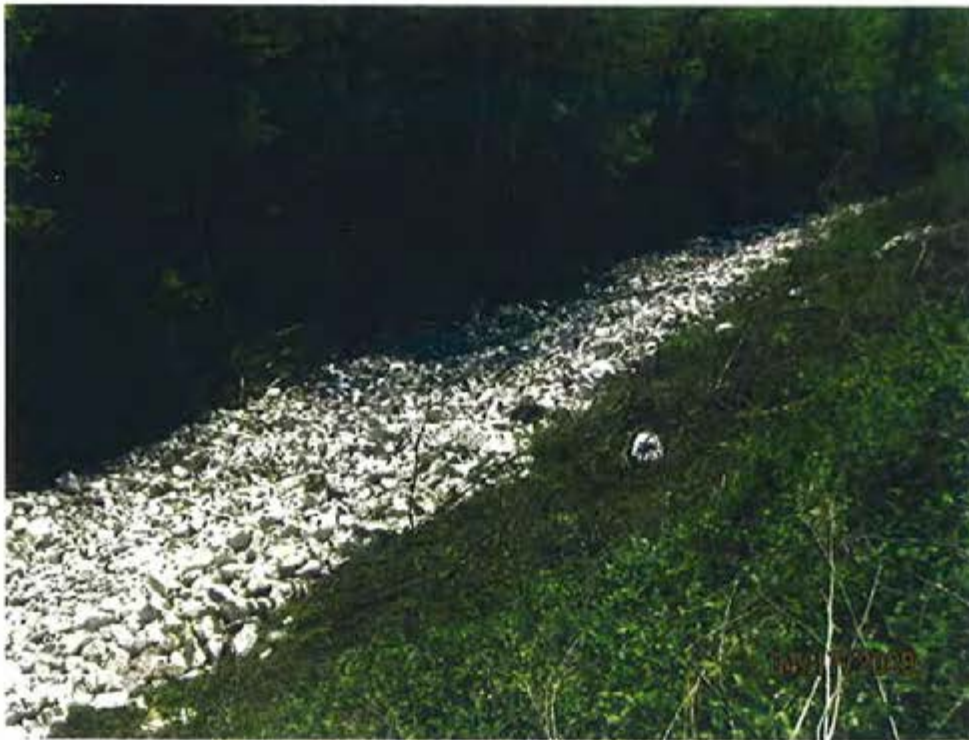
4. Overview of completed blanket 4-17-09.

Based on our observations and the commitment from Mr. Cole to cover the few areas where additional rip rap is needed, MACTEC considers the repairs have been completed satisfactorily.

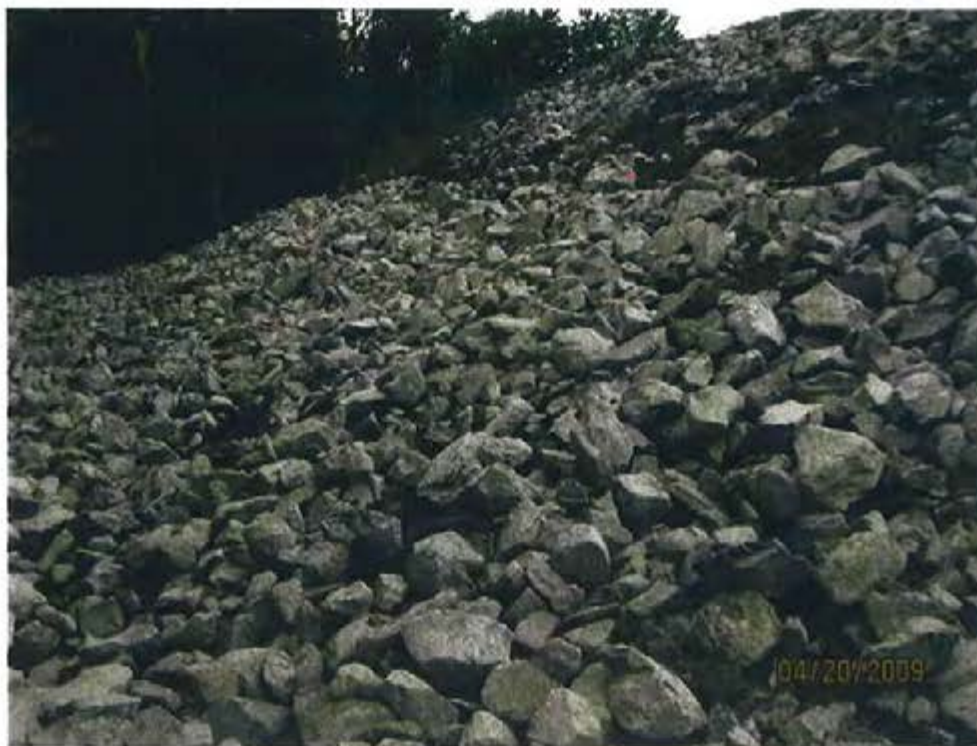
6. Overview 4-20-09. Note a few remaining spots that need more rip rap.

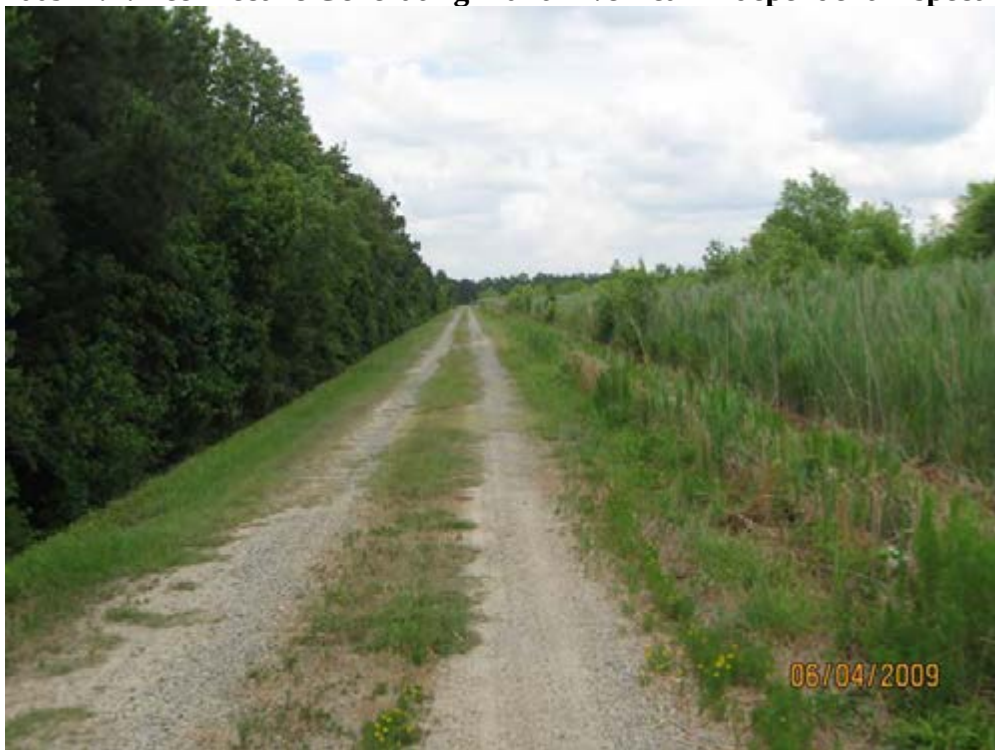
21. ASH POND- Crest of north dike.

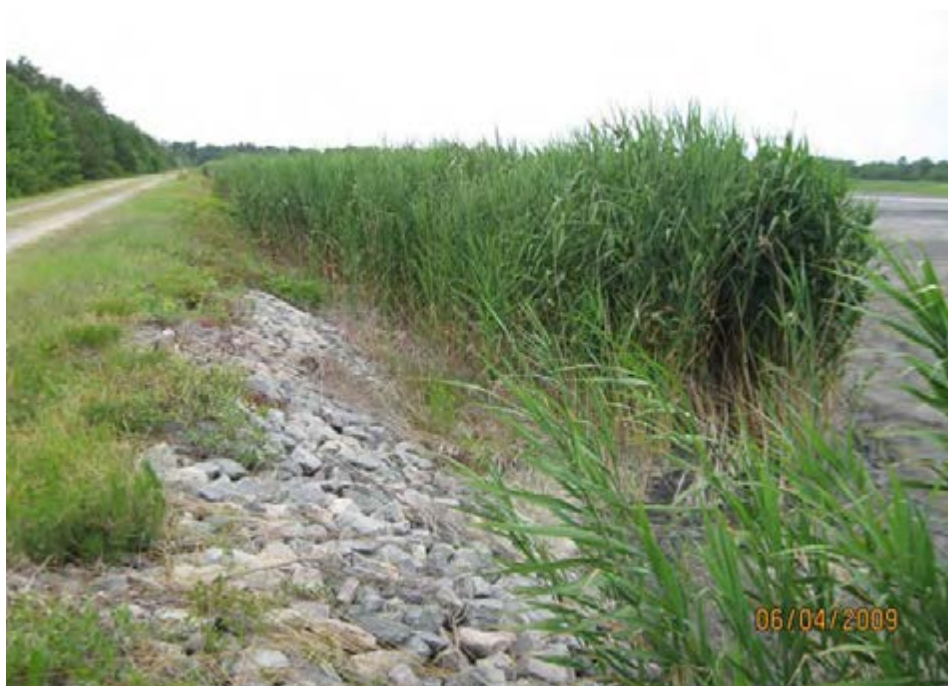
22. ASH POND- Crest and interior slope-east dike. Note good conditions of rip rap repair.

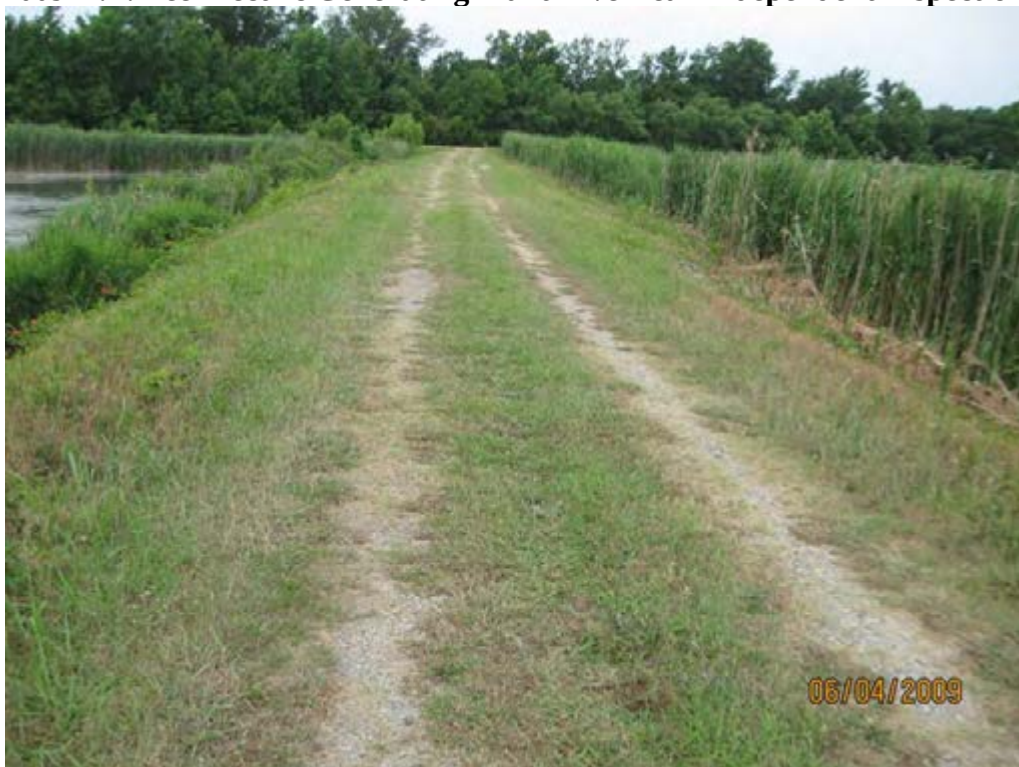
23. ASH POND- Crest of separator dike.

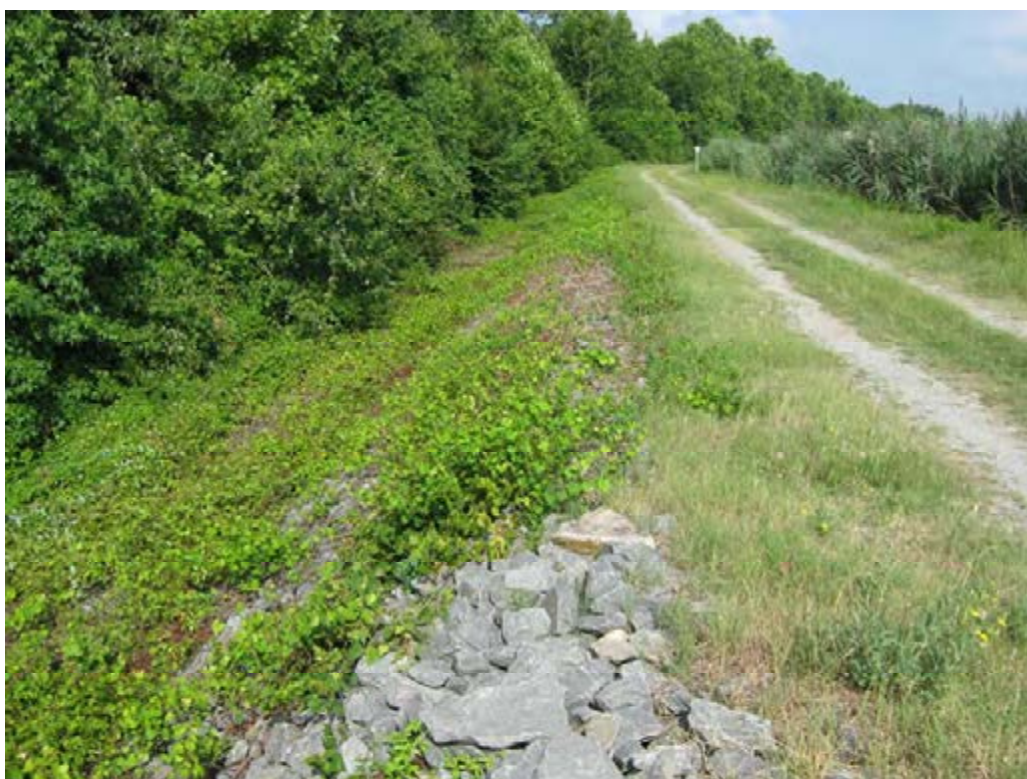
24. ASH POND- Crest and exterior slope of south dike.

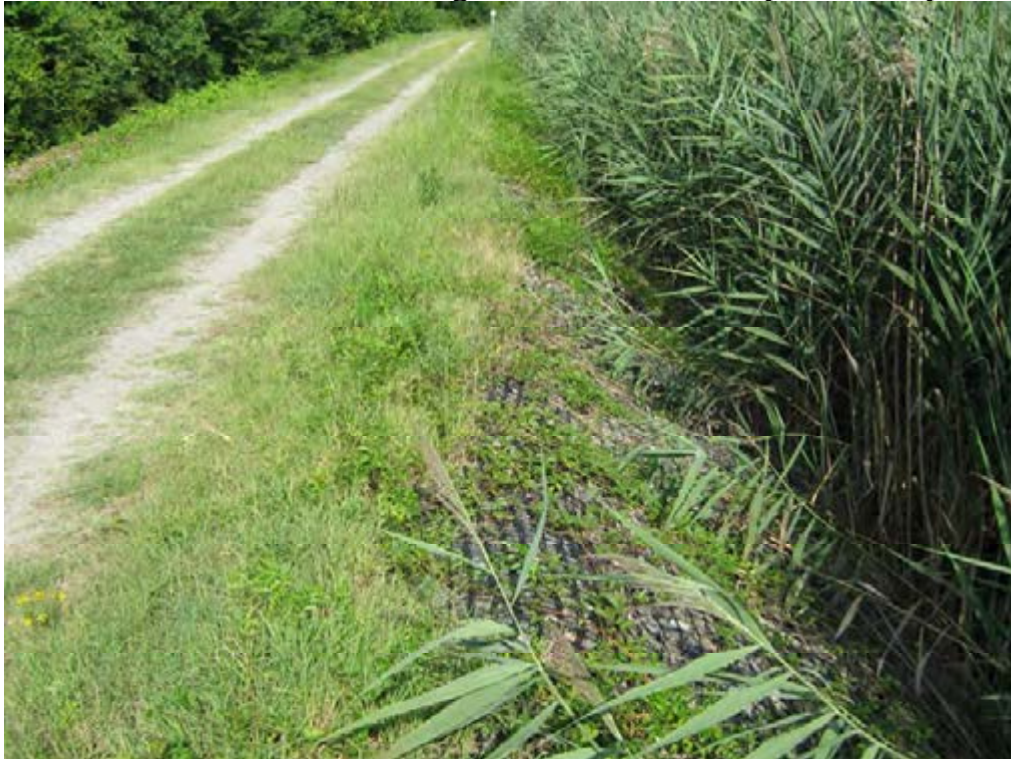
25. ASH POND- Interior slope repair-south dike

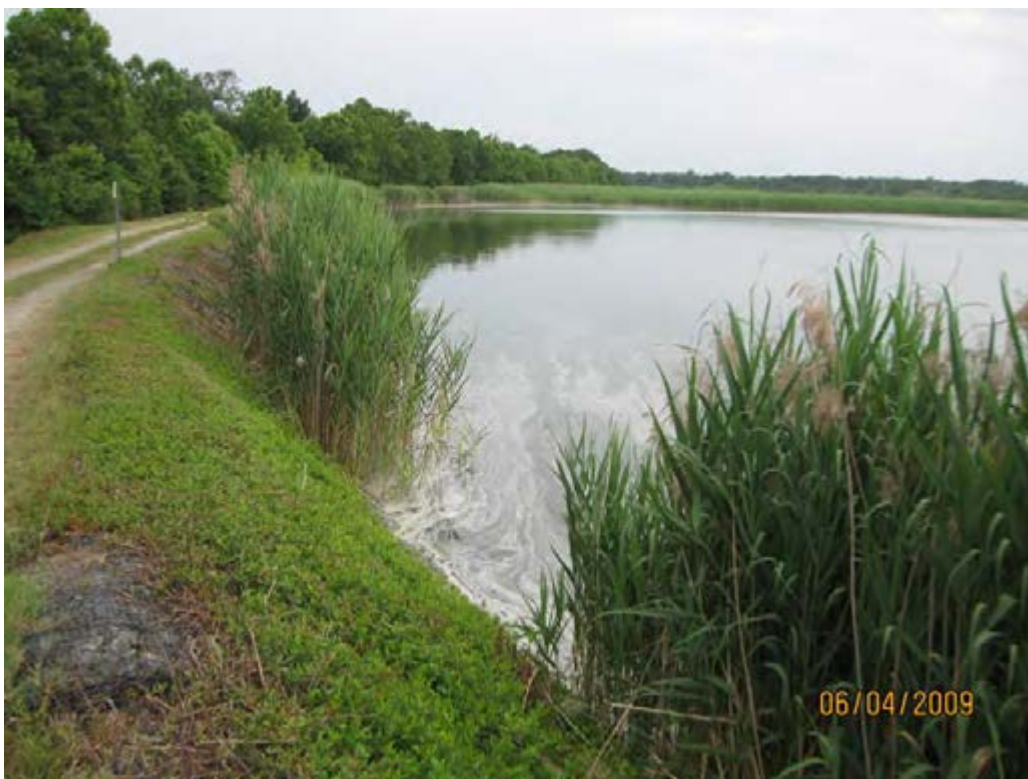
26. ASH POND- Interior slope of south dike. Note vegetation on erosion matting.

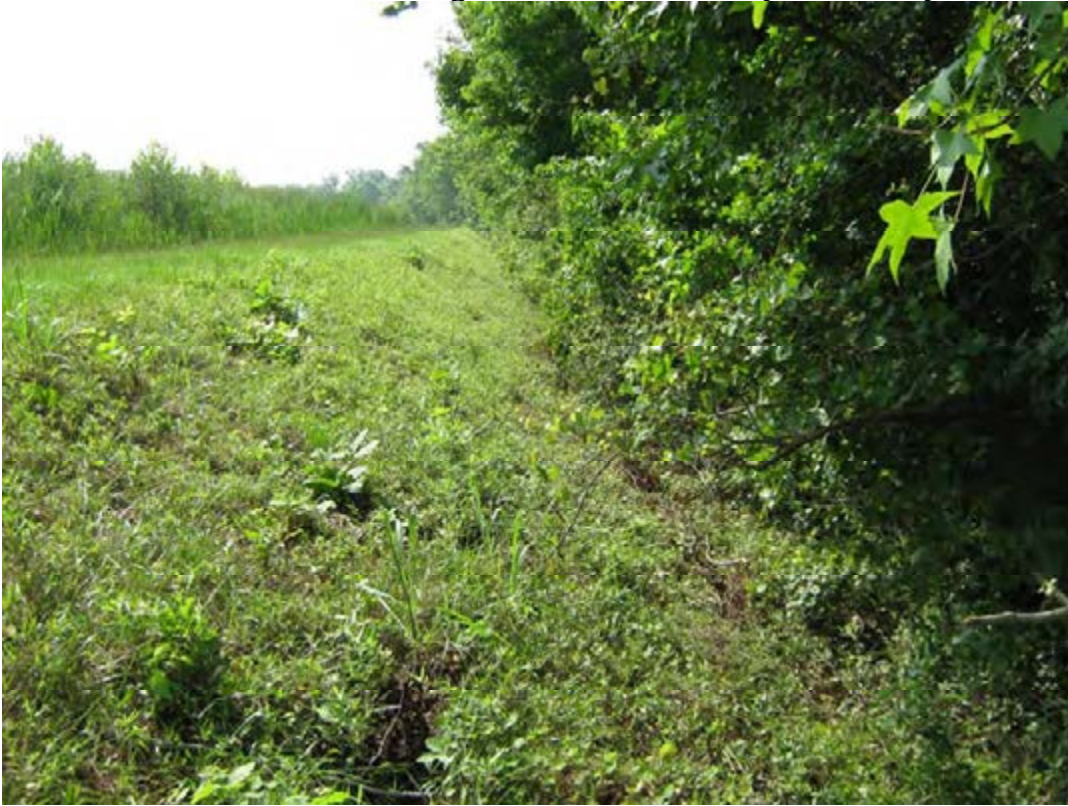
27. ASH POND- Exterior slope of south dike.

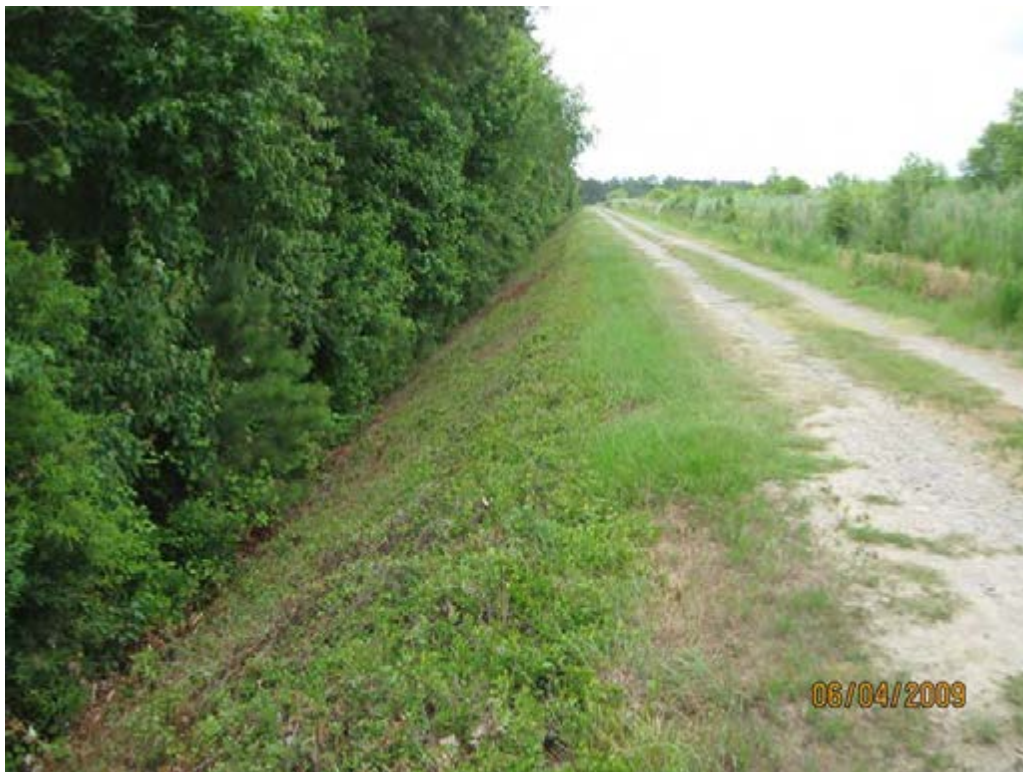
28. ASH POND- Exterior slope south dike.

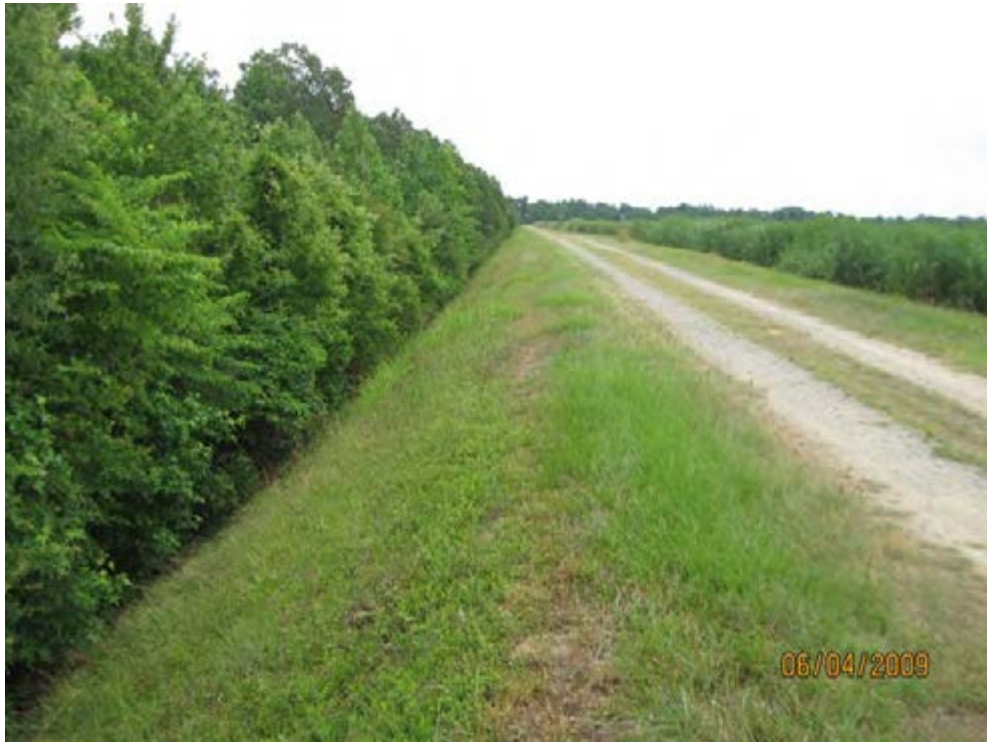
29. ASH POND- Crest and exterior slope-north dike.
