**Coal Combustion Residue Impoundment  
Round 9 - Dam Assessment Report**

***H.F. Lee Steam Electric Plant***

***Active Ash Pond; Ash Pond 1; Ash Pond 2;  
Ash Pond 3***

***Progress Energy Carolinas, Inc.  
Wayne County, North Carolina***

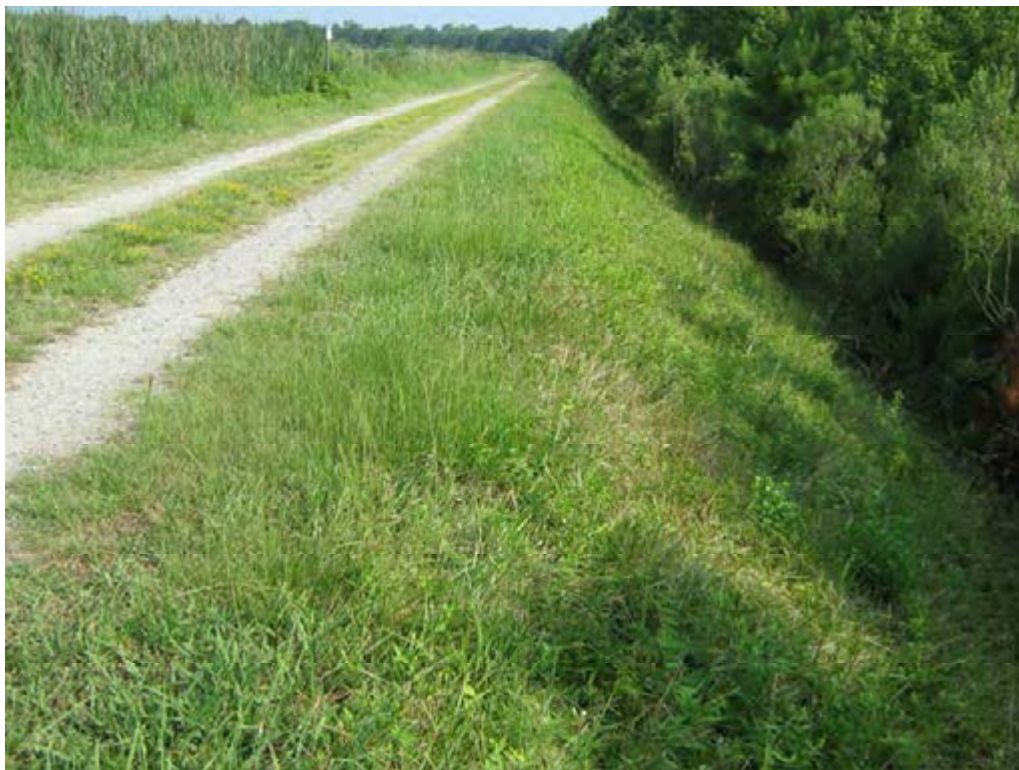
30. ASH POND- Exterior slope - east dike.

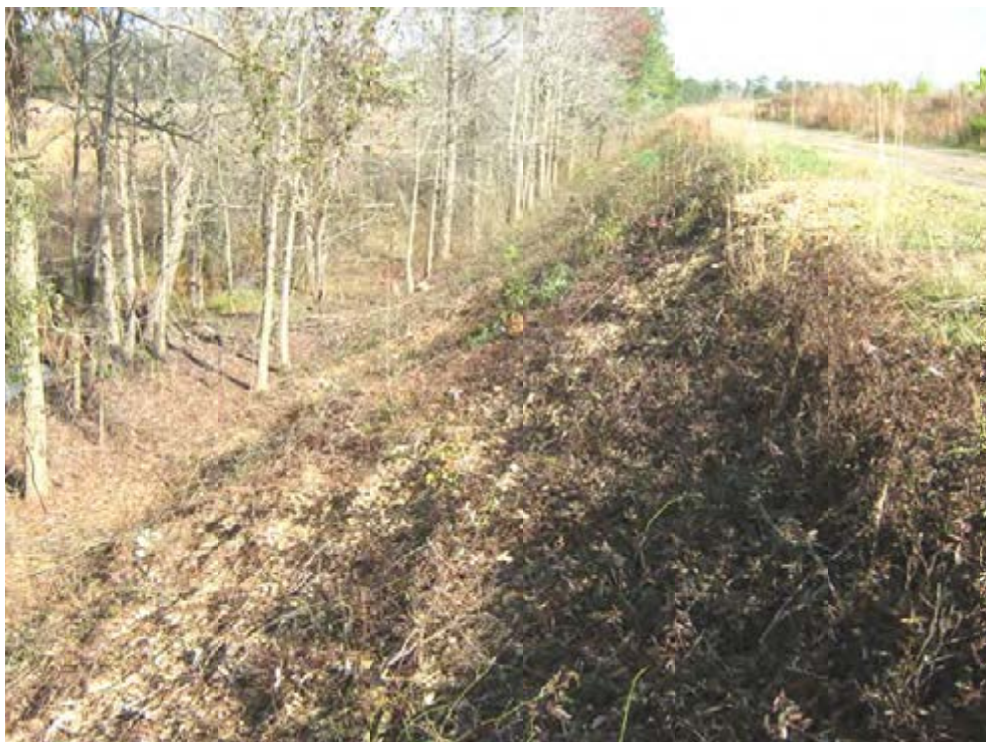
31. ASH POND-Cleared north dike exterior slope (12-3-09).

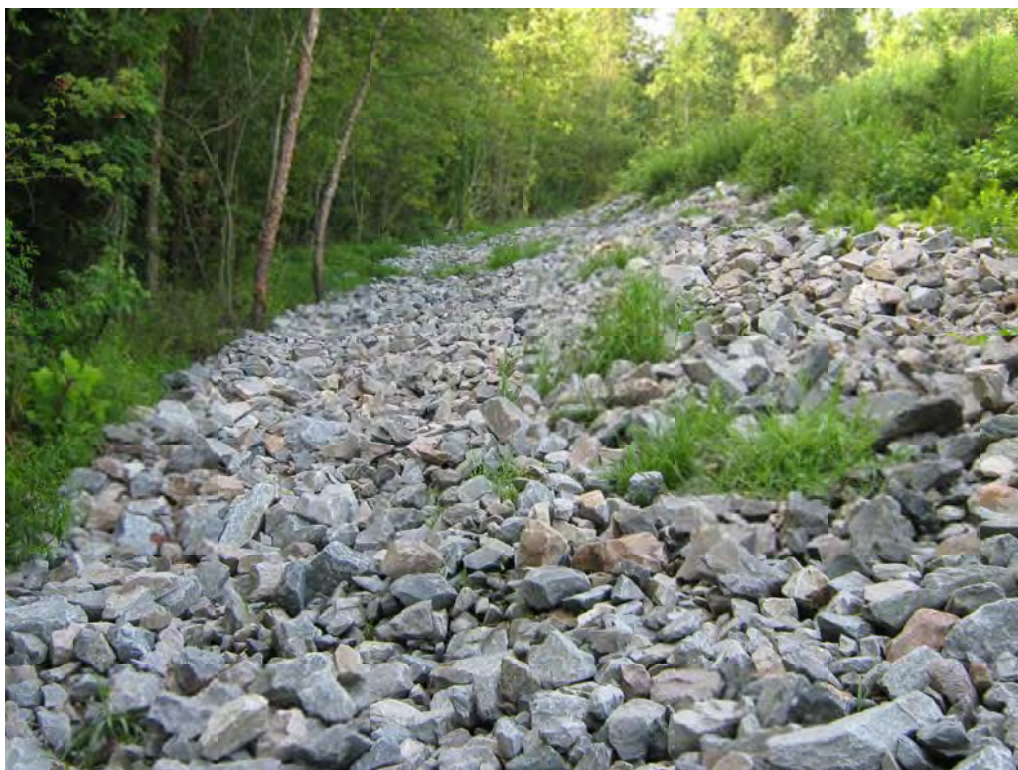
32. ASH POND- Drainage blanket at secondary settling pond-east slope

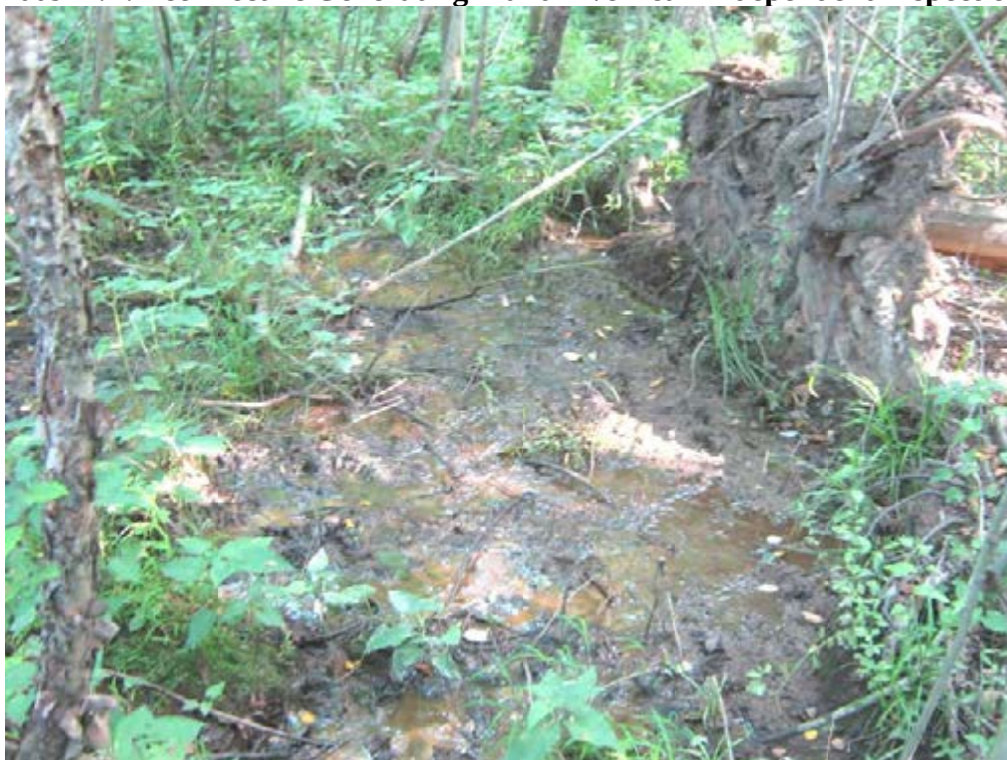
33. ASH POND-Fallen tree and slight seepage at toe of secondary settling pond-north of repair area.

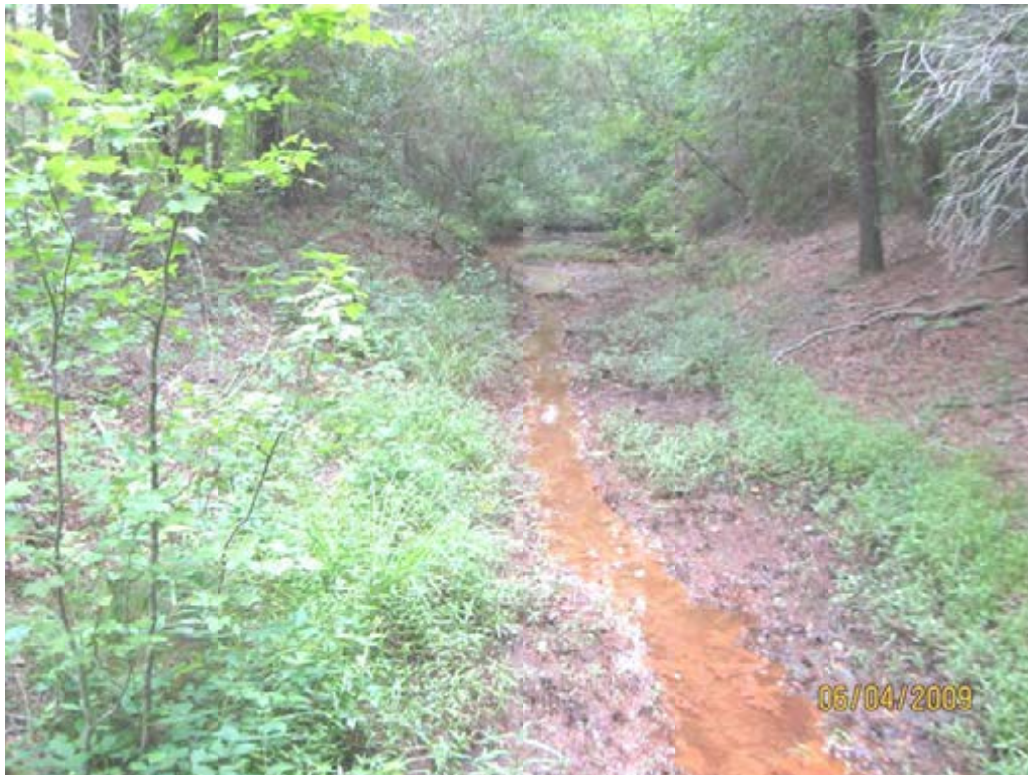
34. ASH POND-Small creek beside north dike.

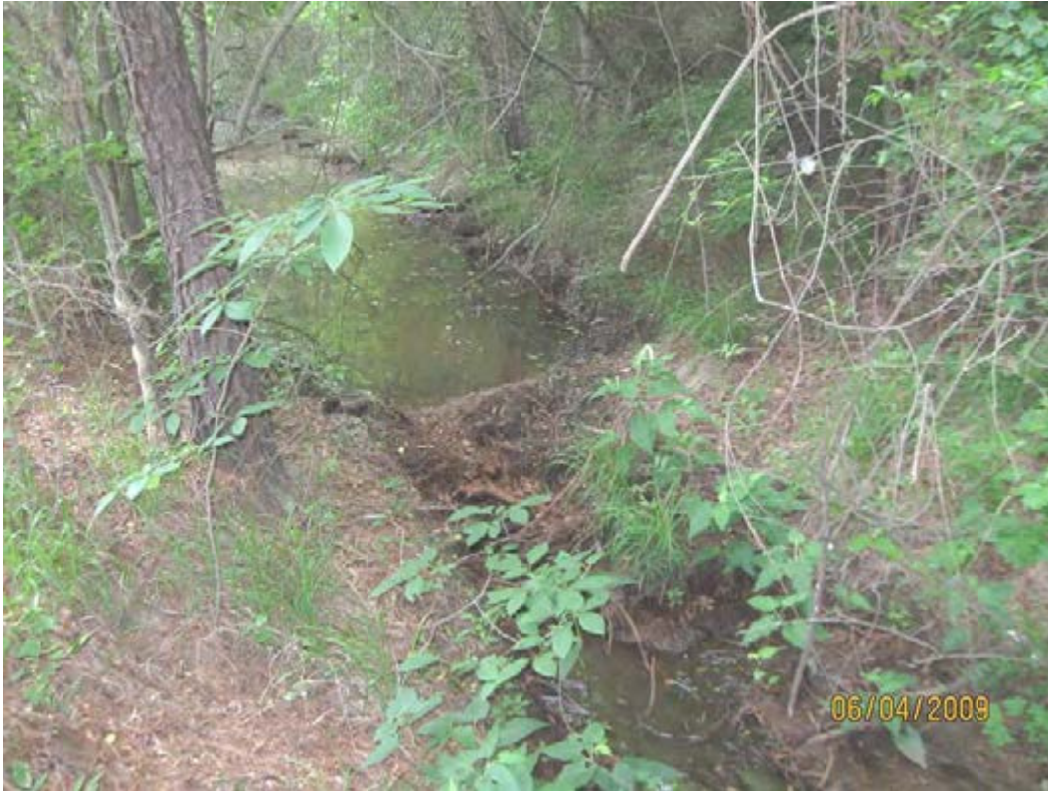
35. ASH POND-Small beaver dam on creek beside north dike.

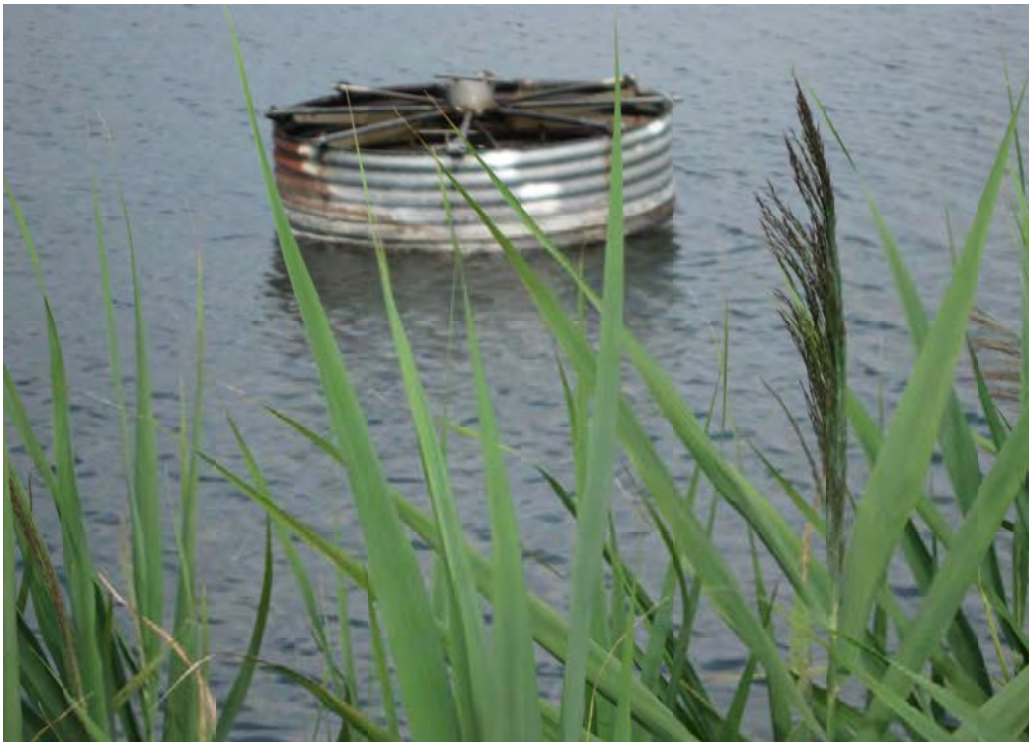
36. ASH POND-Skimmer structure on ash pond riser.

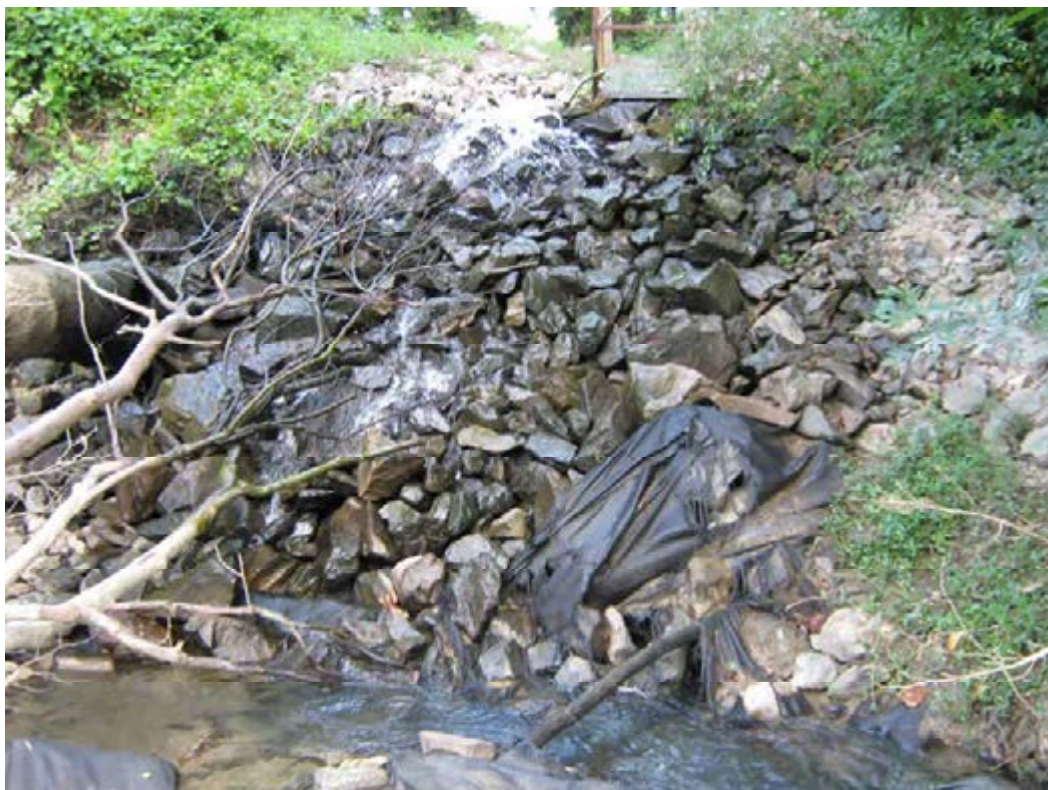
37. ASH POND-Discharge point for secondary settling pond outfall.
