# Assessment of Dam Safety of Coal Combustion Surface Impoundments

**Coletto LP, LLC**

**Fannin, Texas**

**August 4, 2010**

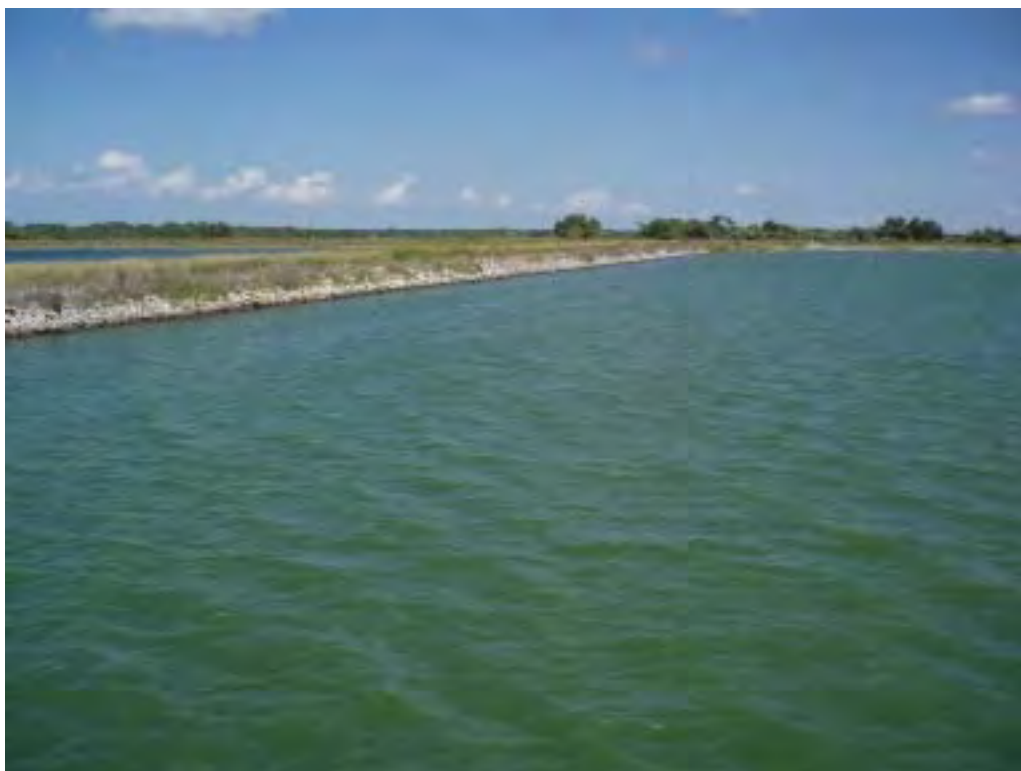
The visible portions of the interior slope generally appeared to be in fair condition (Photos 3, 9, 10, 12, 13, 51, 54, 58, 61, 64, 70, 74, 78, 79, 85, 87, 88, 93, 94, 101, 102, 110, 113, and 116). The north, east, and west interior slope and southwest slope of the divider embankment generally appeared to be armored with a layer of riprap. No riprap was observed on the southern embankments. Grass and brush approximately 24 to 36 inches tall was observed growing in the riprap. An 8-inch-diameter mesquite tree was observed on west end of the north embankment (Photo 54).

Photo No. 9: Primary Ash Pond - Southwest slope of divider embankment, looking southeast.

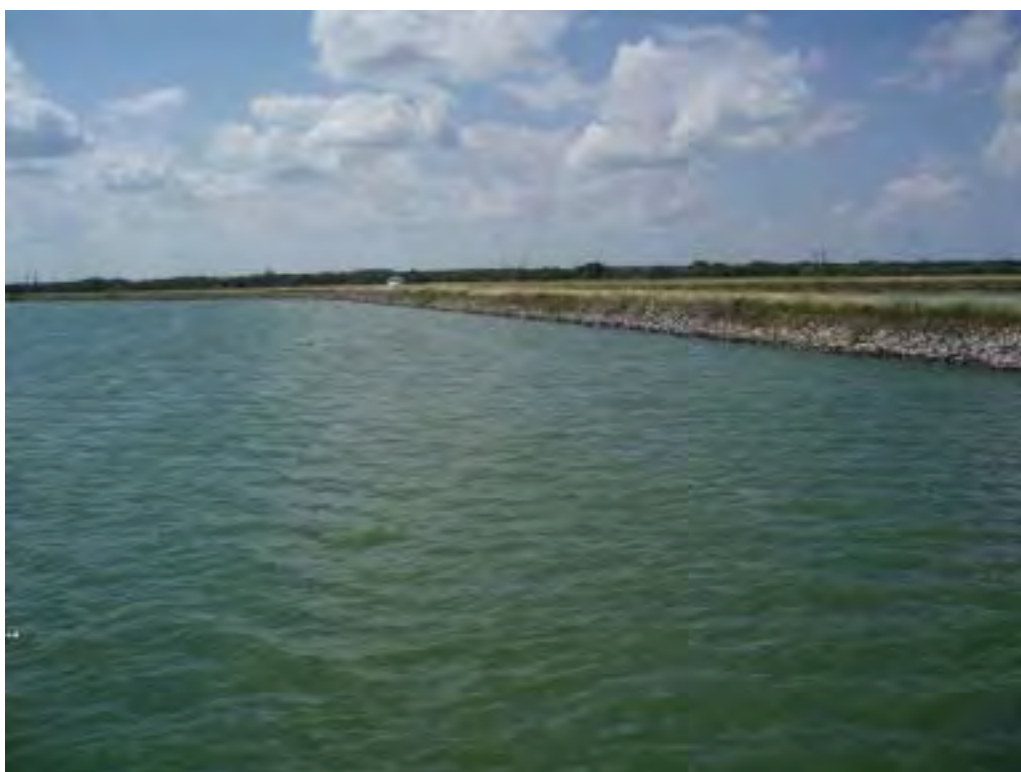
Photo No. 10: Primary Ash Pond - Southwest slope of divider embankment, looking northwest.

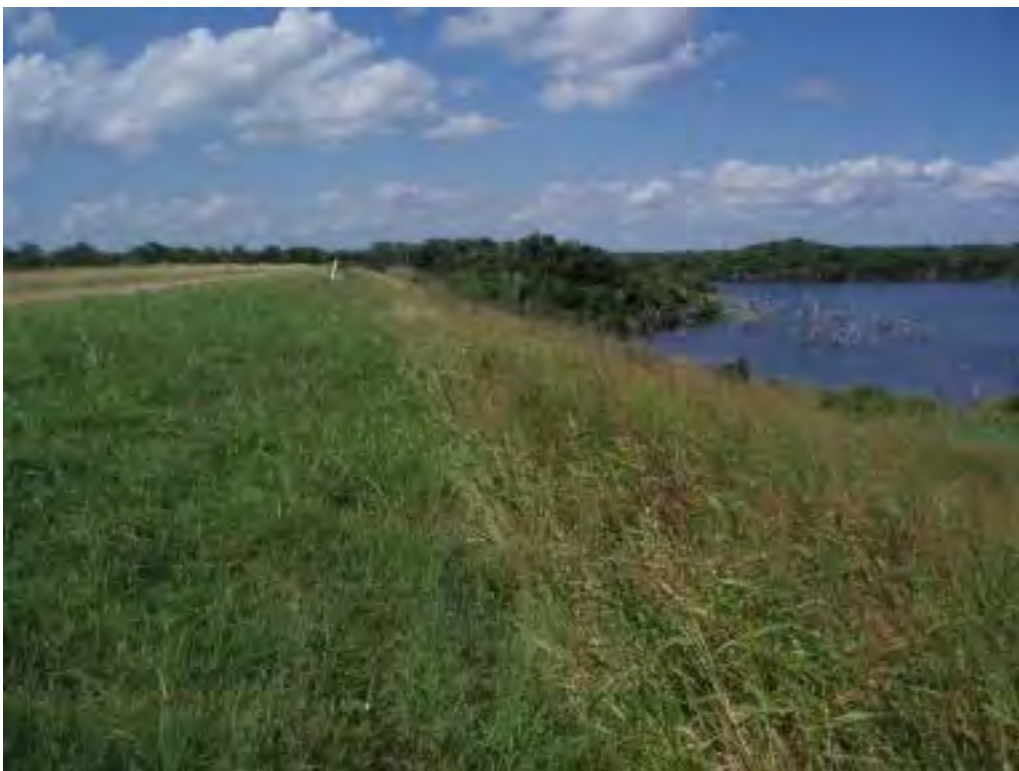
The exterior slopes appear to be in fair condition. The exterior slope on the north and east embankments were approximately 3H: 1V (Photos 18, 27, 29, 32, 35, 37, 38, and 40). Embankment vegetation consisted mainly of grass approximately 36 to 48 inches tall. On the east embankment, 8- to 12-inch-diameter dead mesquite trees and an area of thick brush were observed (Photos 27, 29 and 30). On the north embankment, small brush and mesquite trees less than 2 inches in diameter were observed (Photos 33 and 35).

Photo No. 18: Secondary Pond – East embankment exterior slope, looking northeast.

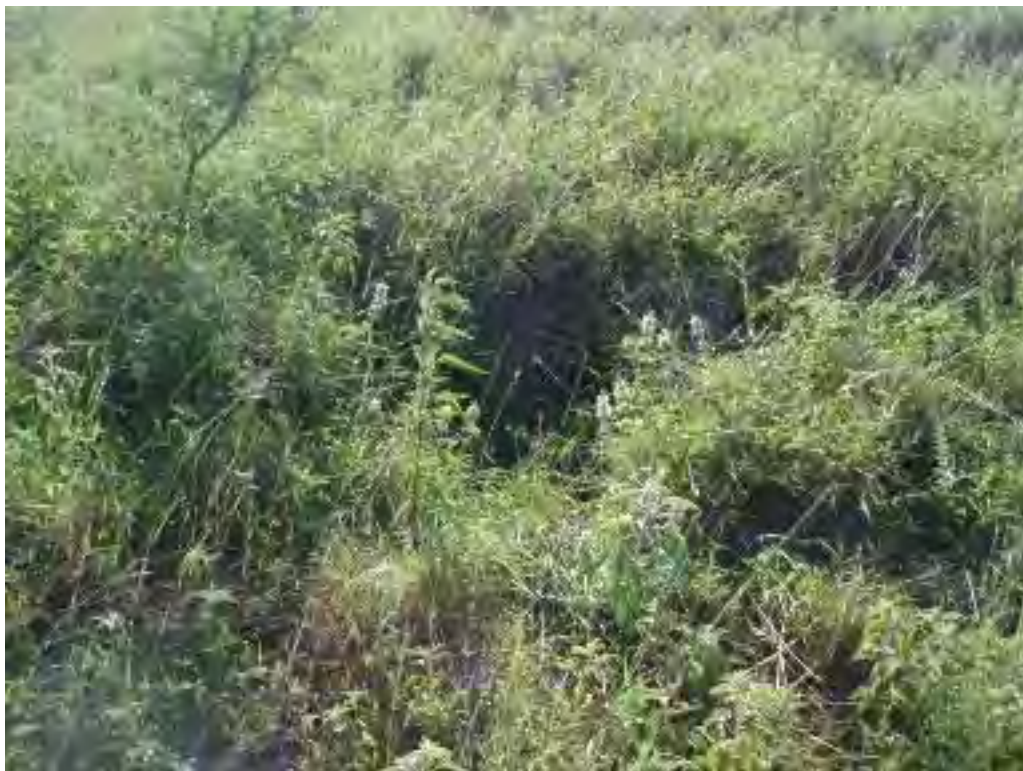
Multiple depressions were observed on the north and east embankment exterior slopes (Photos 28, 30, 31, 32, and 36). The depressions ranged in size from 4 to 8 feet long and up to 3 feet deep. The depressions appear to be grown in erosion rills because no displaced material was observed below the depressions. Multiple erosion rills were observed at the toe of the north embankment exterior slope (Photo 33, 34, and 36). The erosion rills ranged in size from 6 to 10 feet long and up to 3 feet deep.

Photo No. 31: Secondary Pond - East embankment exterior slope, looking at 6'Lx4'Wx3'D depression.

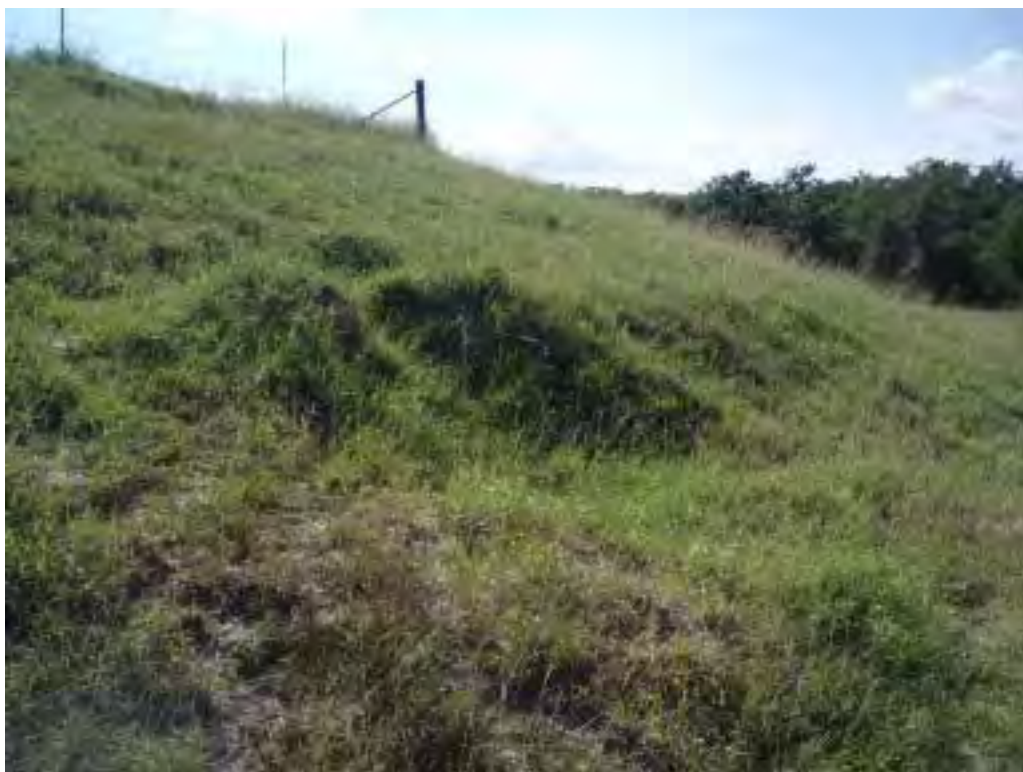
Photo No. 32: Secondary Pond - North embankment exterior slope, looking at 8'Lx8'Wx3'D depression.

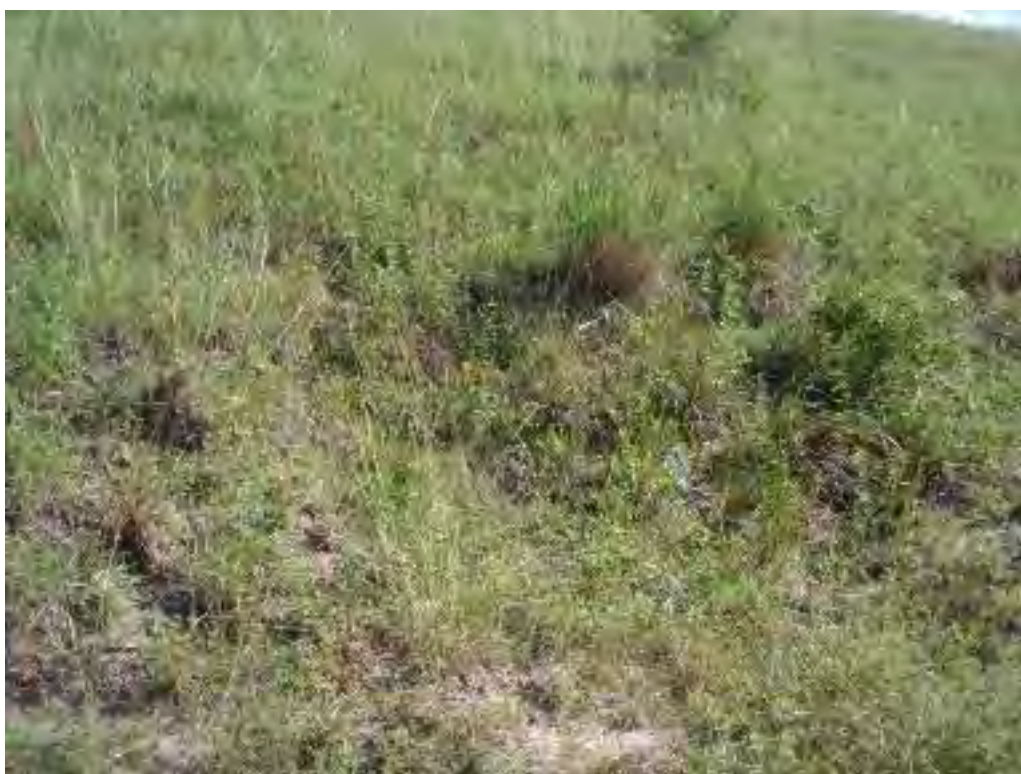
Photo No. 36: Secondary Pond - North embankment exterior slope, looking at 6'Lx4'Wx2'D erosion rill.

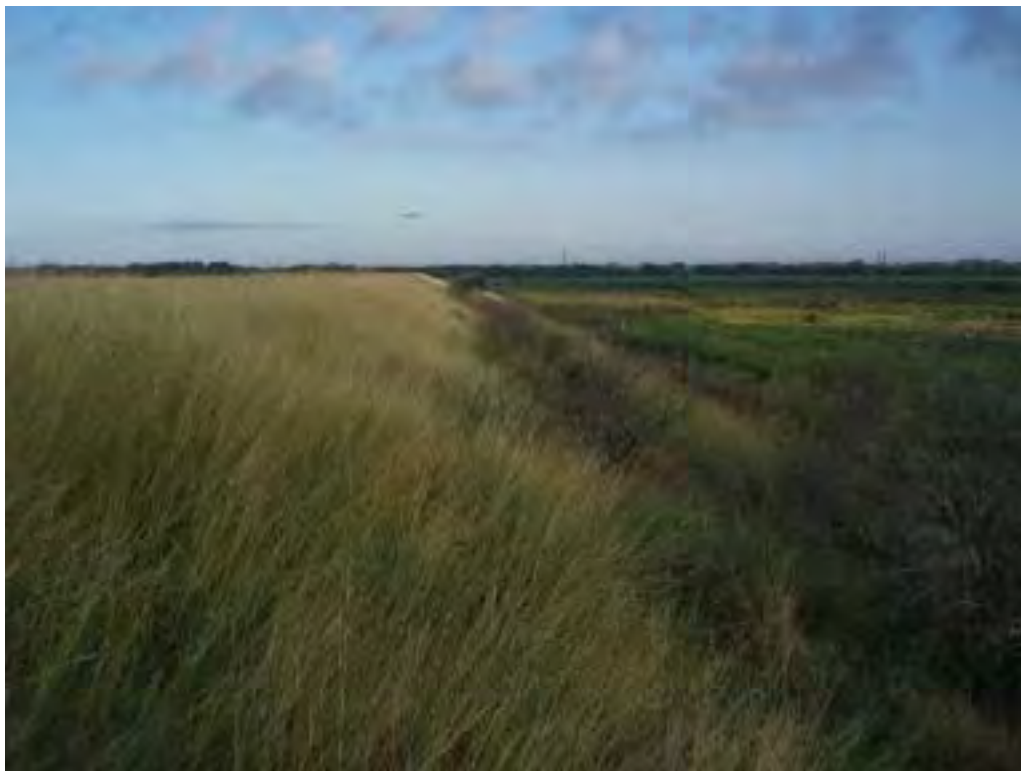
The exterior slopes appear to be in fair condition. The exterior slopes on the north, southern, west, and east embankments were approximately 2.5H:1V (Photos 49, 52, 53, 56, 62, 66, 67, 72, 76, 79, 82, 86, 90, 91, 96, 99, 104, 111, and 114). The northeast slope of the divider embankment between the Primary Ash Pond and Secondary Pond was approximately 3H: 1V (Photos 1 and 15).

Photo No. 49: Primary Ash Pond - North embankment exterior slope, looking west. Note 8- to 12-inch-diameter mesquite trees on slope.
