# ASSESSMENT OF DAM SAFETY OF COAL COMBUSTION SURFACE IMPOUNDMENTS – DRAFT REPORT

**Columbia Power & Light  
Department**

**Columbia Municipal  
Power Plant  
Columbia, Missouri**

Prepared for  
*United States Environmental  
Protection Agency  
Washington, D.C.*

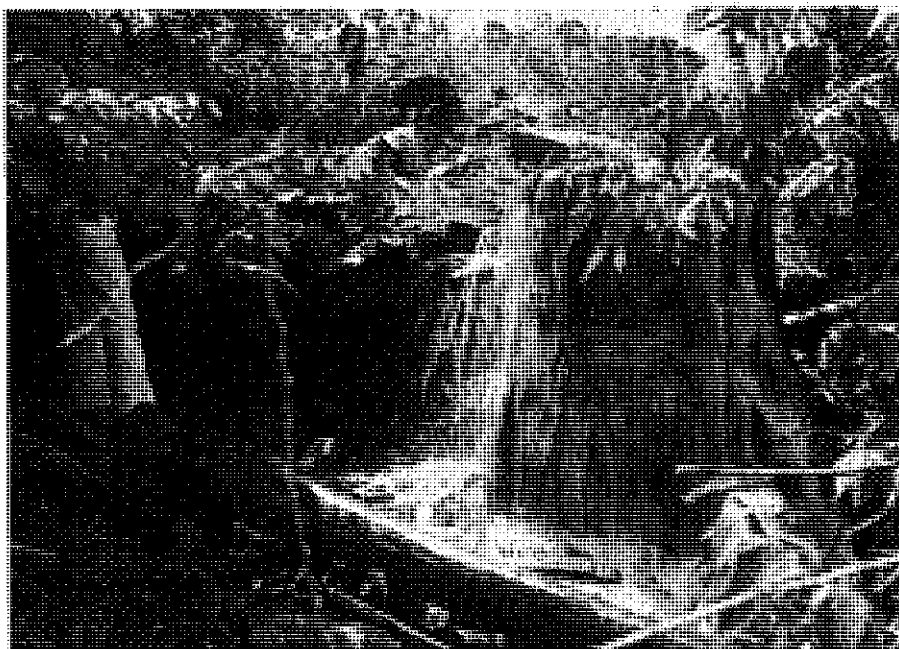
The 4-inch pipe, according to Mr. Anderson, is located at the left abutment of the dam. The pipe was not located on the day of the inspection; however, the outlet structure for the pipe, according to Mr. Anderson, was a manhole on the downstream slope which was observed (see photo 8 and Plate 3). The outlet structure consists of a 2.25-foot wide diameter manhole with the bottom of the manhole located about 7 feet below the top of the manhole, which is also assumed to be the location of the outlet of the 4-inch diameter pipe (see Photo 10). The manhole is of brick and concrete mortar construction. The crest elevation of the pipe is unknown. According to Mr. Anderson, this pipe is controlled by a valve. Therefore, this pipe is considered to be a low level outlet type structure. Nevertheless, the valve was not located on the day of the inspection.

Where the new spillway pipe was installed through the left side of the embankment, there is no vegetative cover on the pipe backfill (see Photo 2). Near the low level outlet manhole, located at the left abutment, the downstream slope is covered with dumped debris such as boulders and concrete block fragments. The downstream toe has been undermined in this area by the water, which

has discharged through the low level outlet pipe (see Photo 8). The discharge channel for the spillway and low level outlet parallels the toe of the western embankment section. Approximately 60 feet to the right of the left abutment, there is a large scarp on the downstream face, which appears to be due to flows through the discharge channel (see Photo 6). The dish shaped, nearly vertical scarp extends from the toe to a point 10 feet above the toe, and is about 15 feet wide. The tall grass growing in the scarp and lack of slough material in the discharge channel indicates that the slough did not occur recently.

- Photo 7 - View of a large erosional gully on the downstream slope.
- Photo 8 - View of the discharge over the top of the manhole of the 4-inch outlet pipe showing the undermining of the toe of the embankment to the left of the manhole (in photo). Note the location of the outlet of the 10-inch pipe above and to the left (in photo) of the manhole.

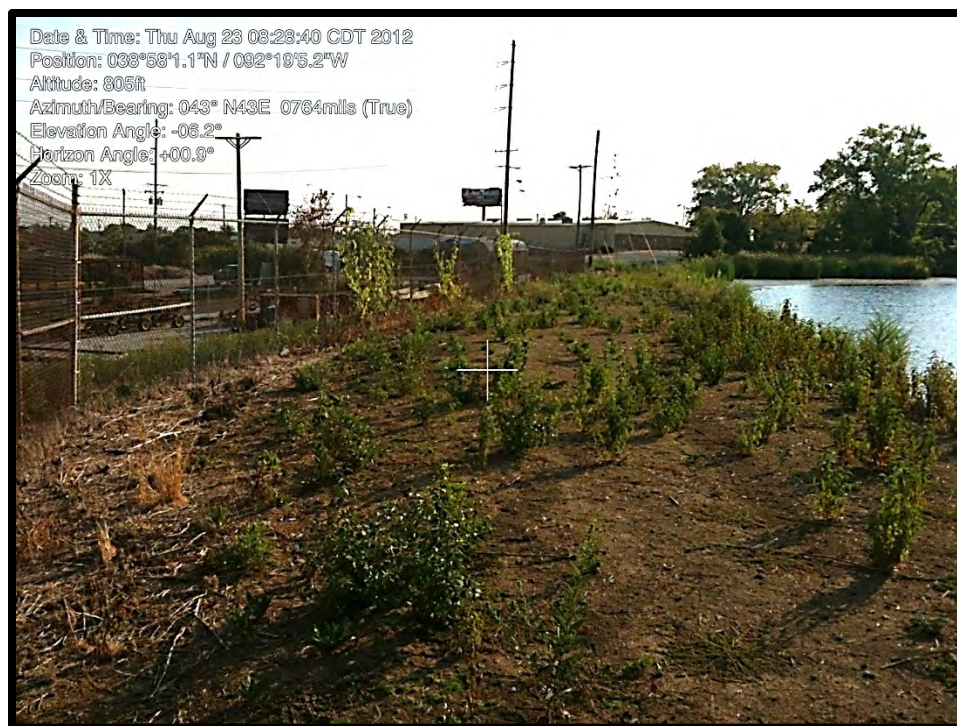
**Photograph 5.1. Crest of Dam Looking Northeast**

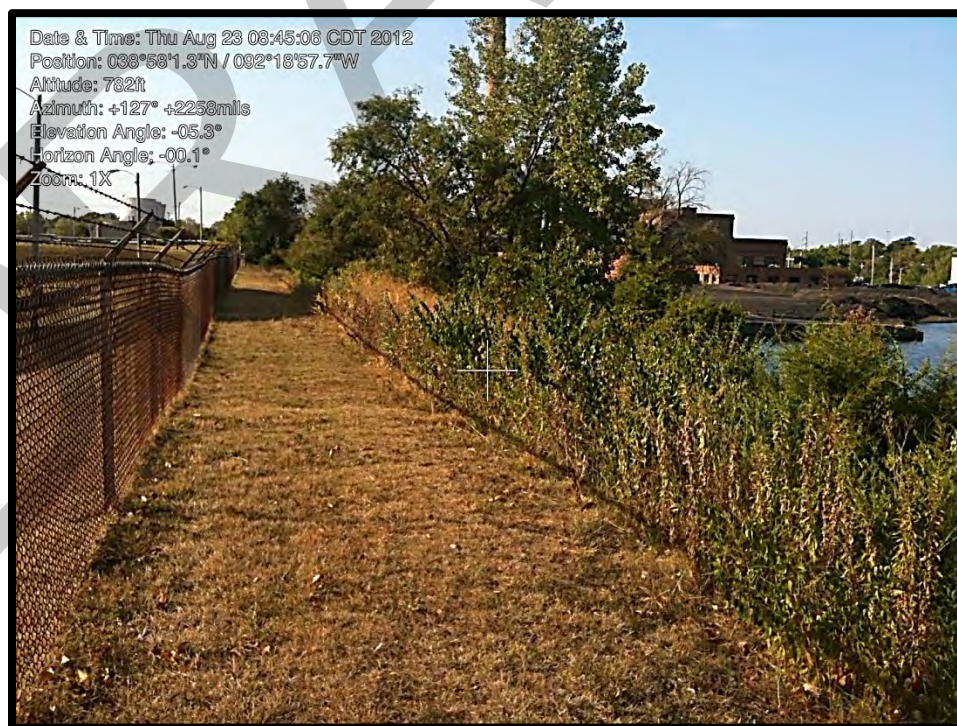
**Photograph 5.2. Crest of East Embankment with Overgrown Vegetation and Tree on Inside Slope Looking South**

- e. The removal of trees, shrubs and bushes on or near the embankment is recommended. The greatest density of this vegetation was observed along the east and north-east portions of the embankment. Vegetation removal should include the majority of roots within the footprint of the embankment. Compacted structural fill should be used to backfill excavations and holes made in the embankment areas before restoring final grades with compacted native materials free of debris and organic materials.

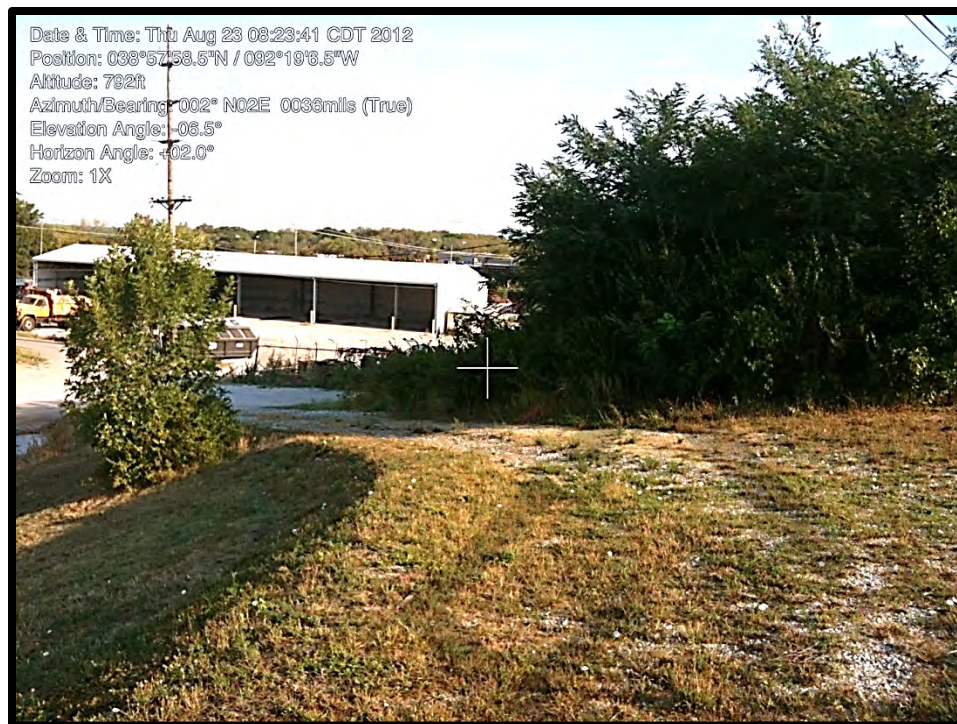
Photograph 5.3. Gravel Road on Downstream Slope of Dam

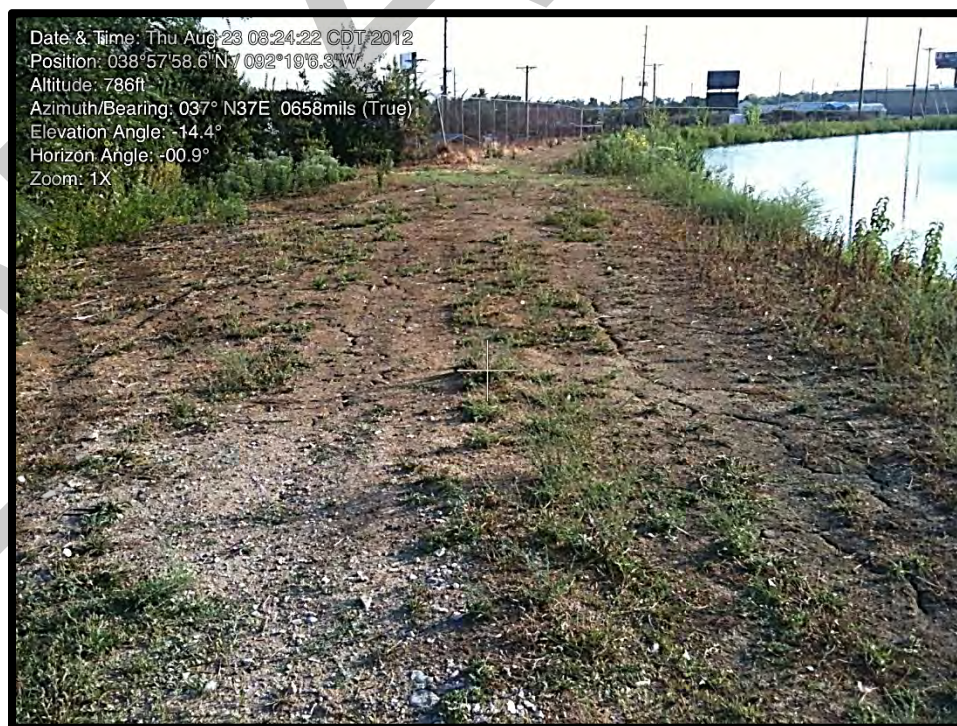
Shrinkage cracks were observed on the crest of the west embankment, and also erosion features on the inside slopes of the west and south embankments. The collection basin for the outfall drain of the impoundment appeared to be in good condition, with water flowing freely through the top of the basin at the time our visit.

Photograph 5.4. Crest of Dam Showing Shrinkage Cracks Looking North

- b. Shrinkage cracks on the crest of the west embankment (dam) should be documented; backfilled and grass cover should be established to protect the surface from shallow erosion and slope failures. Irrigation and periodic inspections should be conducted to maintain these grass covered slopes.

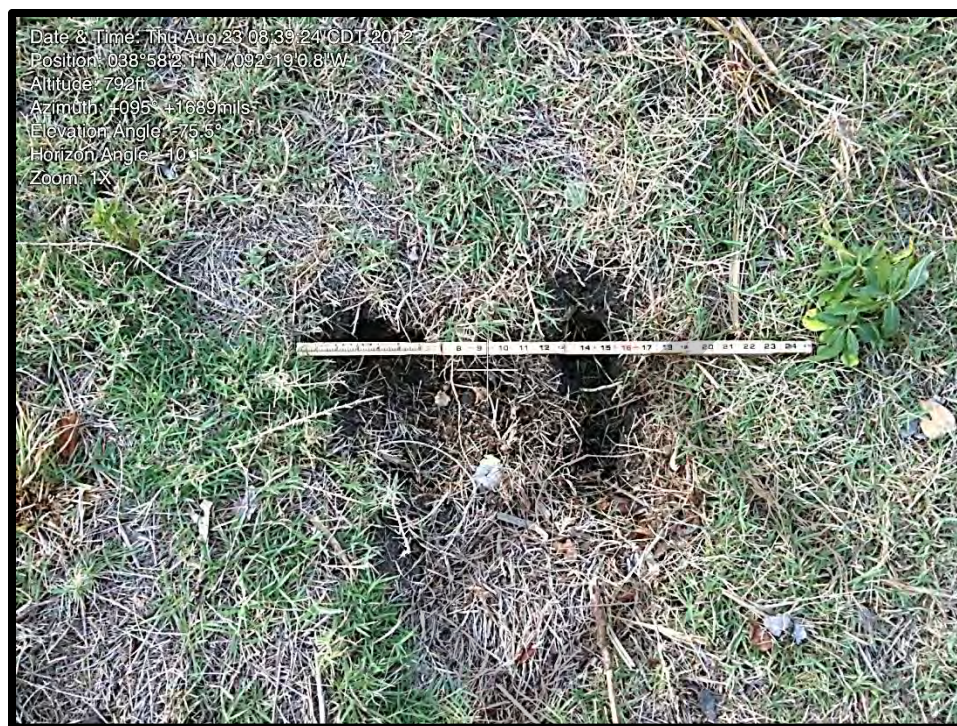
**Photograph 5.5. Animal Burrow on North Embankment**

- d. Animal burrows were observed and have reportedly been an ongoing problem. Areas disturbed by animal activity should be documented, the animals removed, and the burrows backfilled with compacted structural fill to protect the integrity of the embankments.

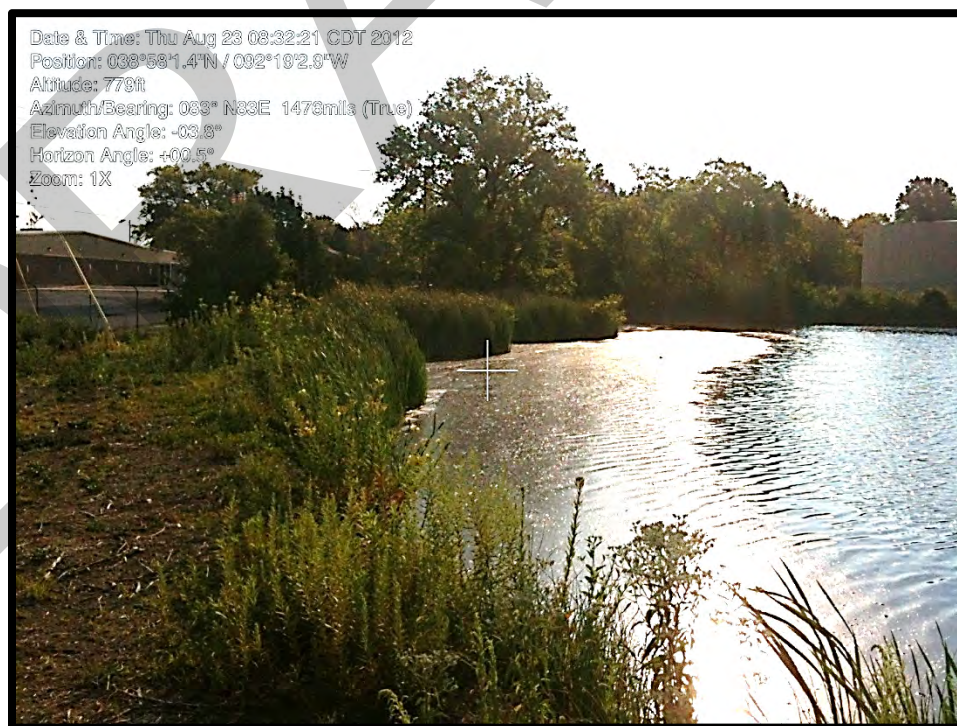
**Photograph 5.6. North Embankment with Trees in Background Looking East**

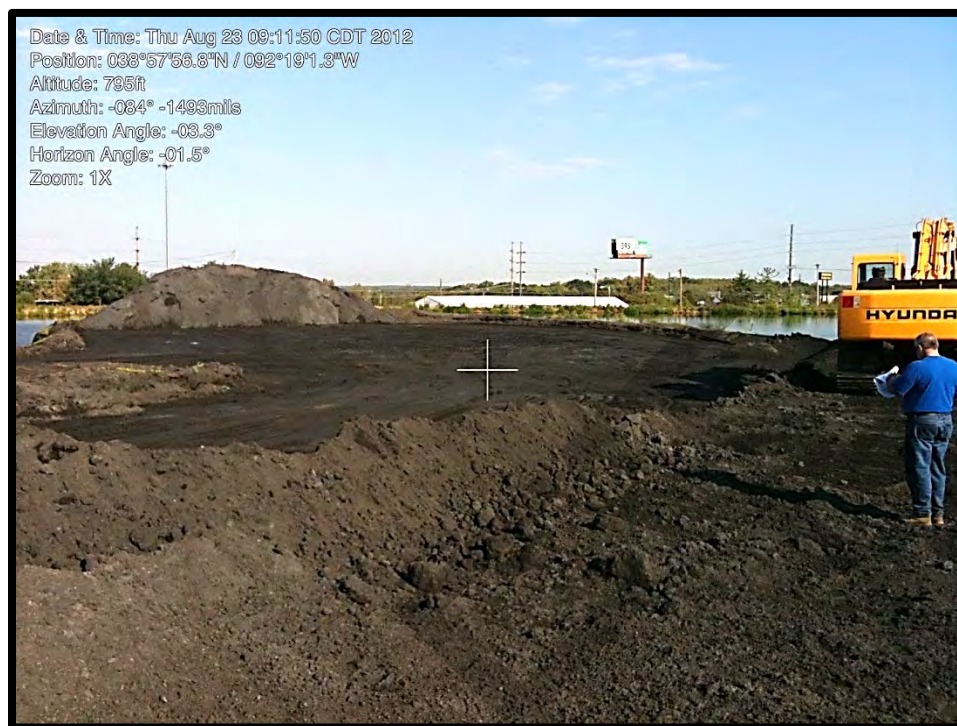
**Photograph 5.7. Drying Coal Ash on South Embankment Looking Northwest**

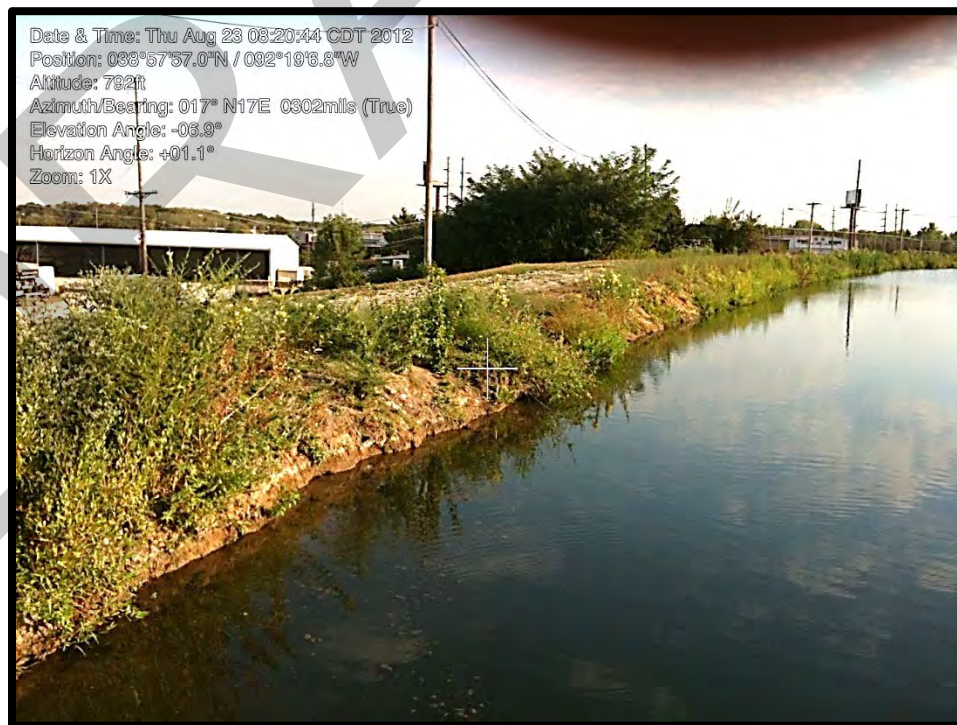
**Photograph 5.8. Erosion Features on Inside Slope of West Embankment Looking North**

- c. Erosion was observed on the inside slopes of the west and south embankments. To restore areas of erosion, it is recommended to place and compact structural fill or riprap in eroded areas and grade to adjacent contours.

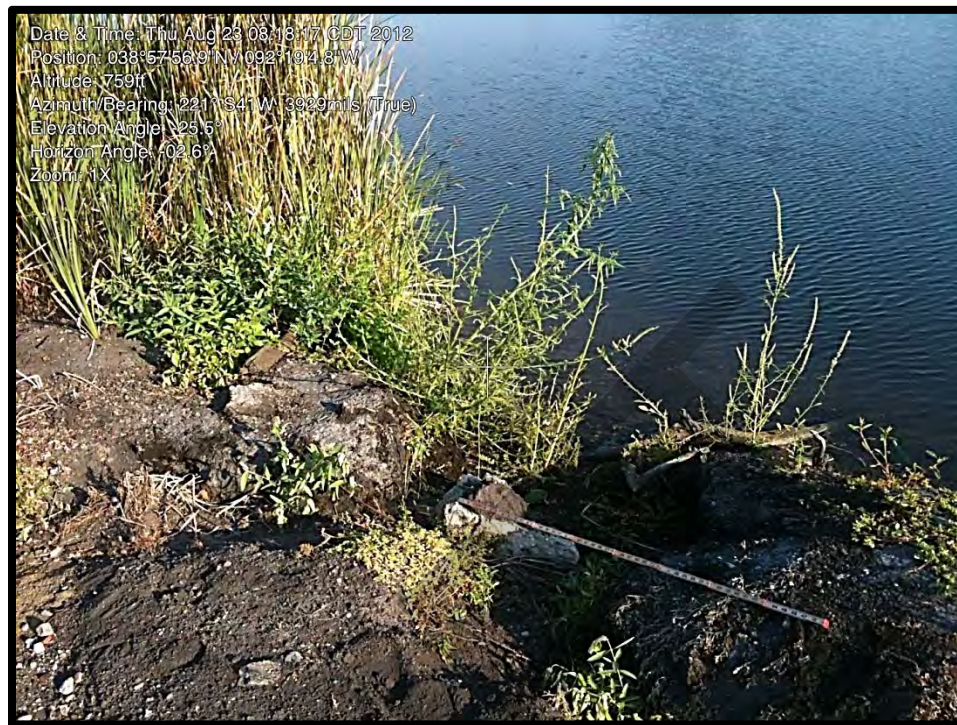
**Photograph 5.9. Erosion Feature on Inside Slope of South Embankment**

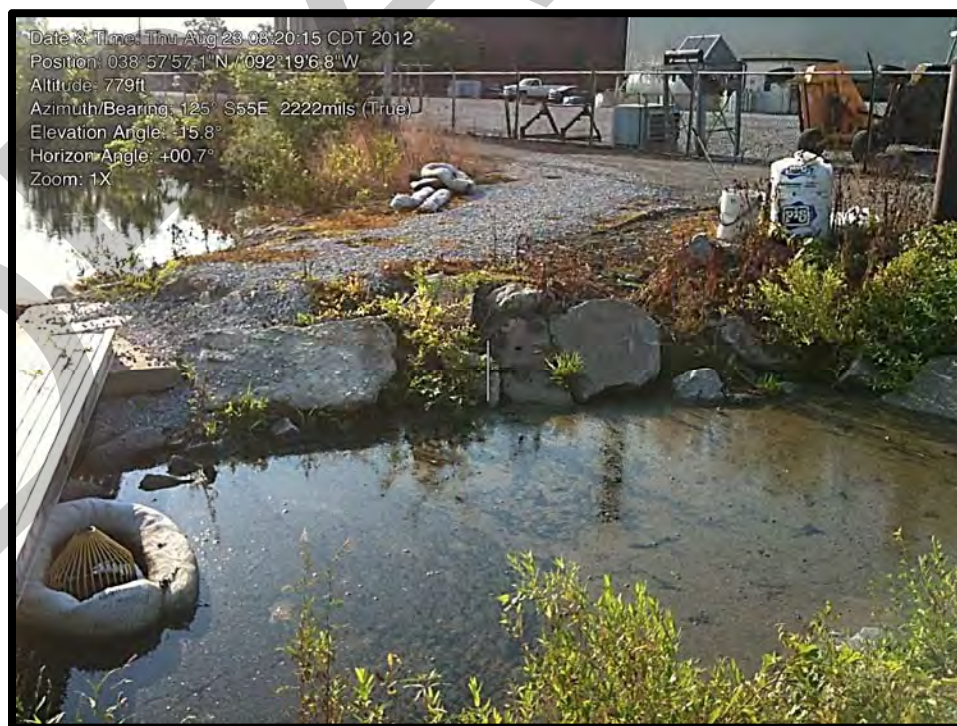
**Photograph 5.10. Riprap near Outfall Drain at Southwest Inside Slope**

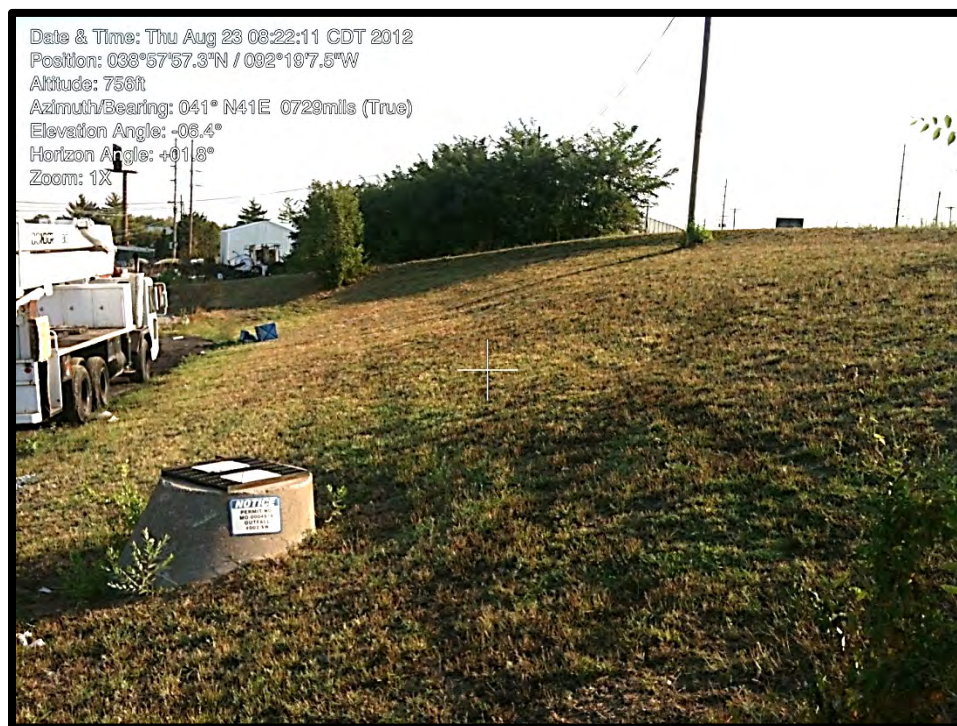
Photograph 5.11. Outside Slope of Dam (West Embankment) Looking North

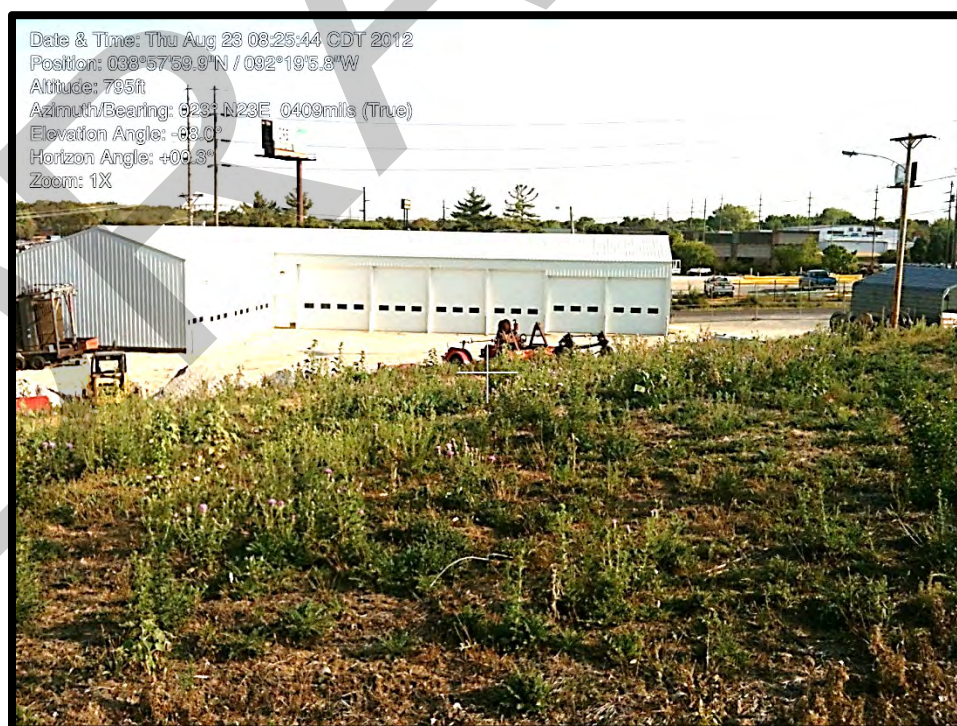
Photograph 5.12. Outside Slope of Dam towards Equipment Storage Yard Looking Northwest

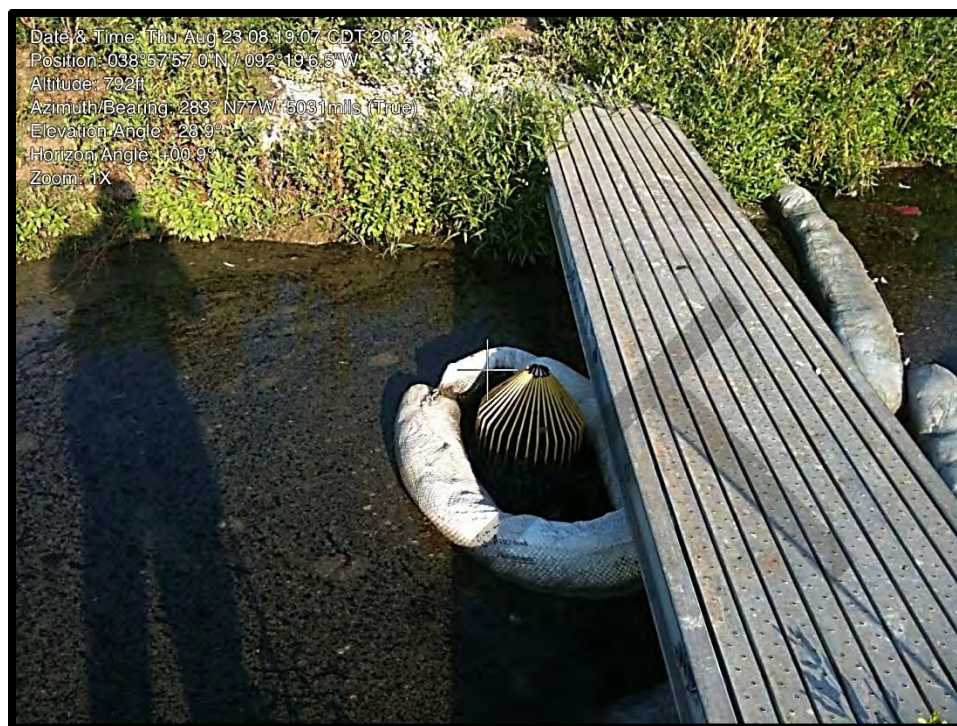
**Photograph 5.13. Overflow Structure Southwest of CCW Impoundment**

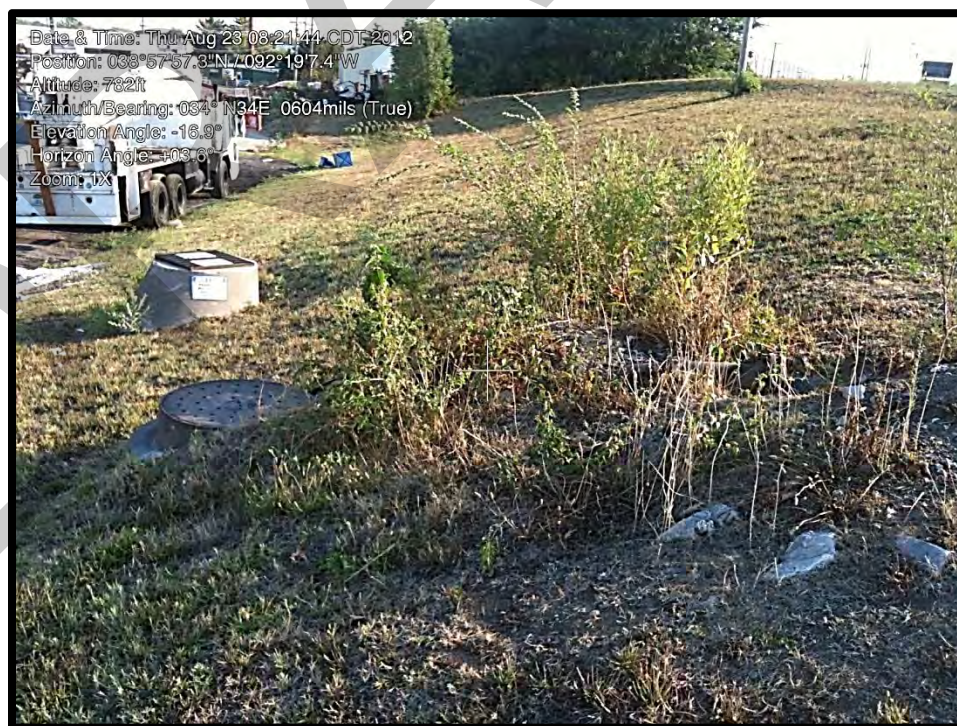
**Photograph 5.14. Manholes for Overflow Structure on Exterior Slope of West Embankment Looking North**
