**DRAFT REPORT  
ROUND 10 DAM ASSESSMENT - MAY 23, 2011  
DYNEGY MIDWEST GENERATION, INC. – HENNEPIN POWER STATION  
ACTIVE EAST ASH POND SYSTEM, EAST ASH POND SYSTEM, WEST ASH POND  
SYSTEM  
HENNEPIN, ILLINOIS**

RE: DRAFT Assessment of Dam Safety of Coal Combustion Surface Impoundments at the  
Hennepin Power Station

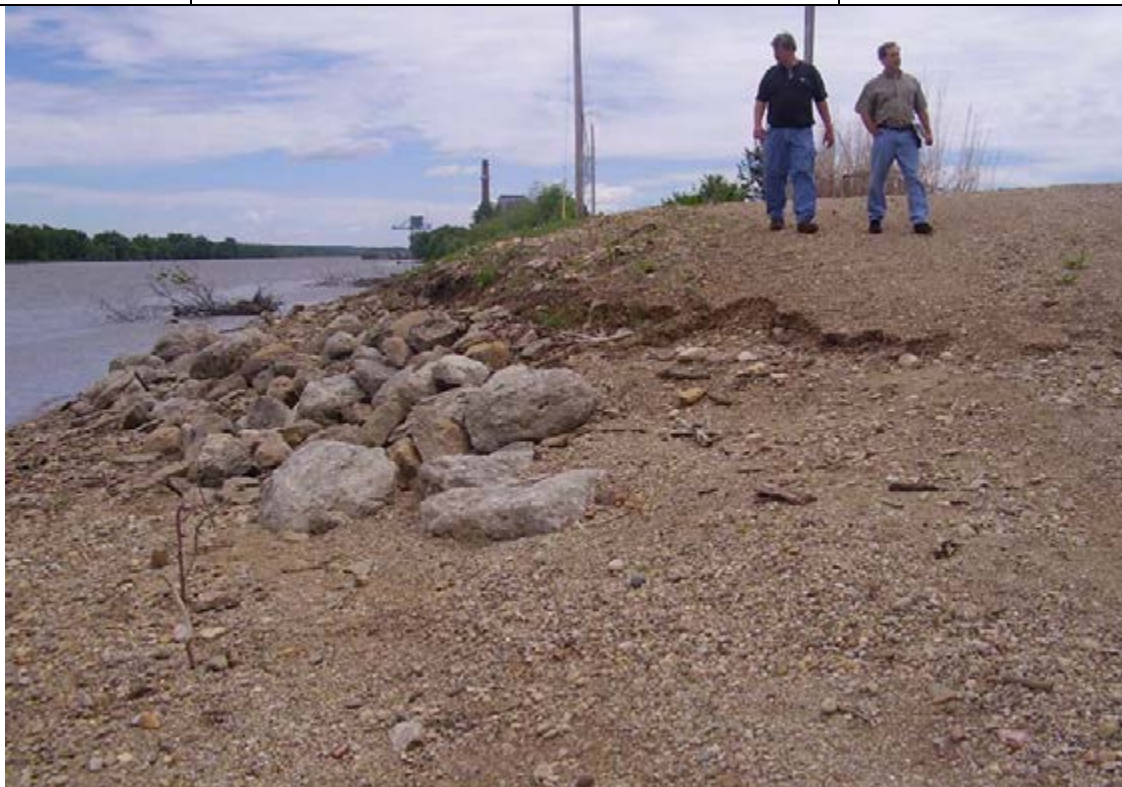
| <b>Description:</b><br>Downstream slope of the West Ash Pond System (WAPS) Impoundment. |

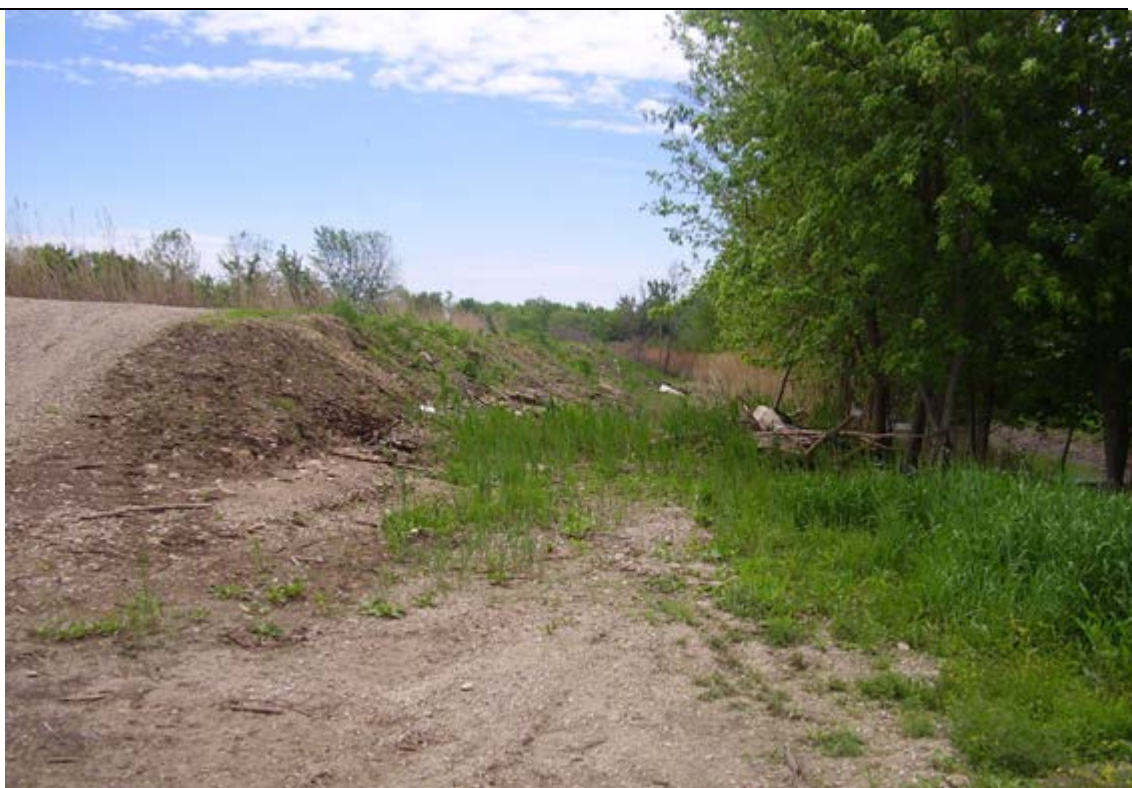
| <b>Photo No.</b><br><b>2</b> | <b>Date:</b><br>5/23/11 |

| <b>Description:</b><br>Downstream slope of the WAPS. |

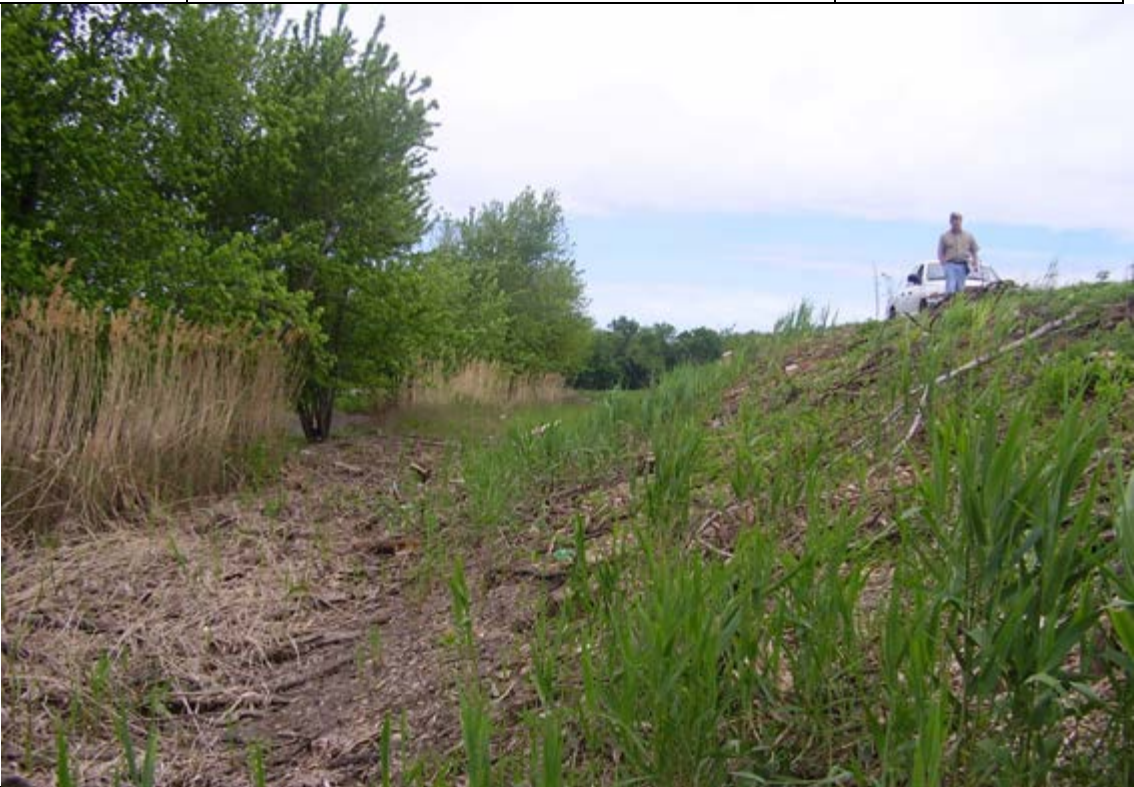
| <b>Photo No.</b><br><b>3</b> | <b>Date:</b><br>5/23/11 | | |

| <b>Description:</b><br>Downstream slope of the WAPS. | | | |

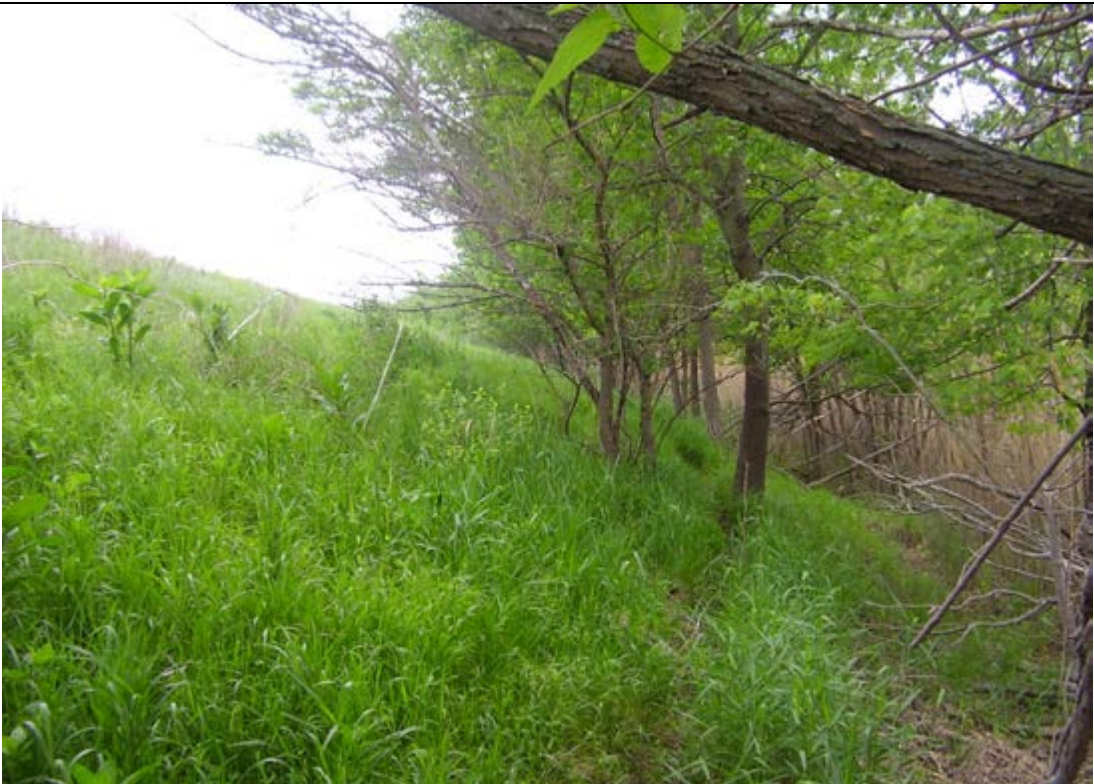
| <b>Photo No.</b><br><b>4</b> | <b>Date:</b><br>5/23/11 | |

| <b>Description:</b><br>Downstream slope of the WAPS. | | |

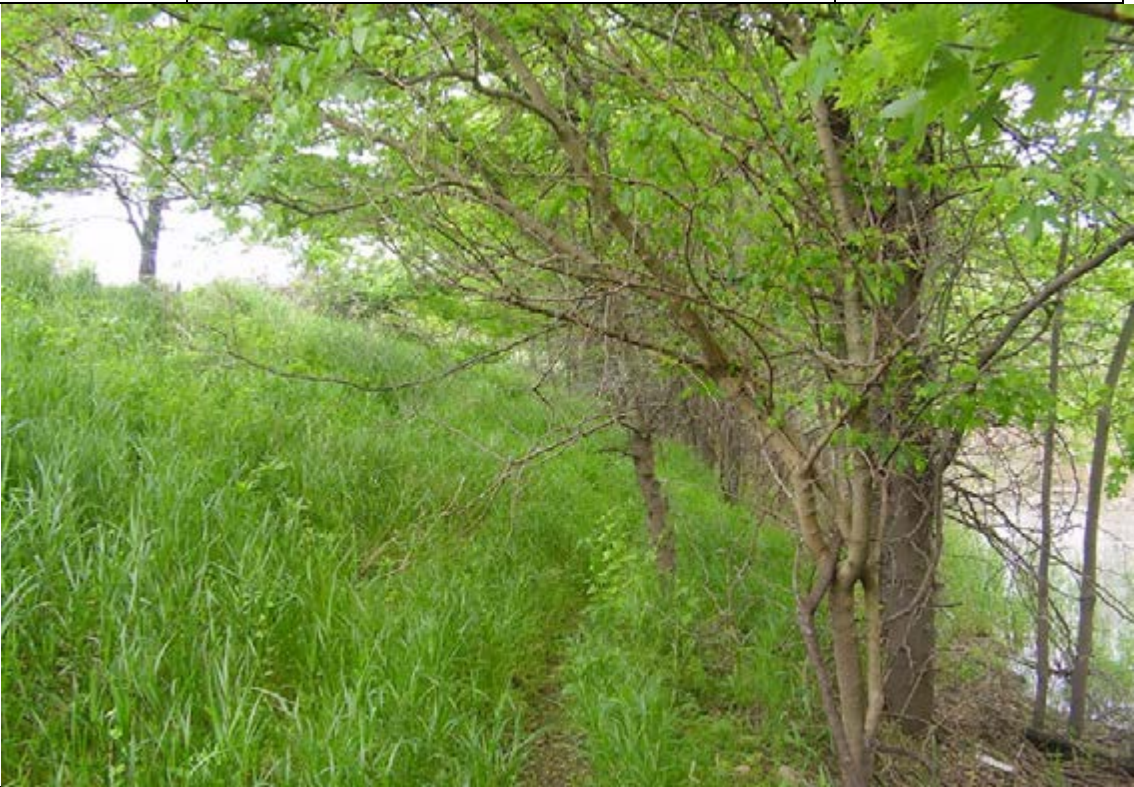
| <b>Photo No.</b><br><b>5</b> | <b>Date:</b><br>5/23/11 | | |

| <b>Description:</b><br>Downstream slope of the WAPS. | | | |

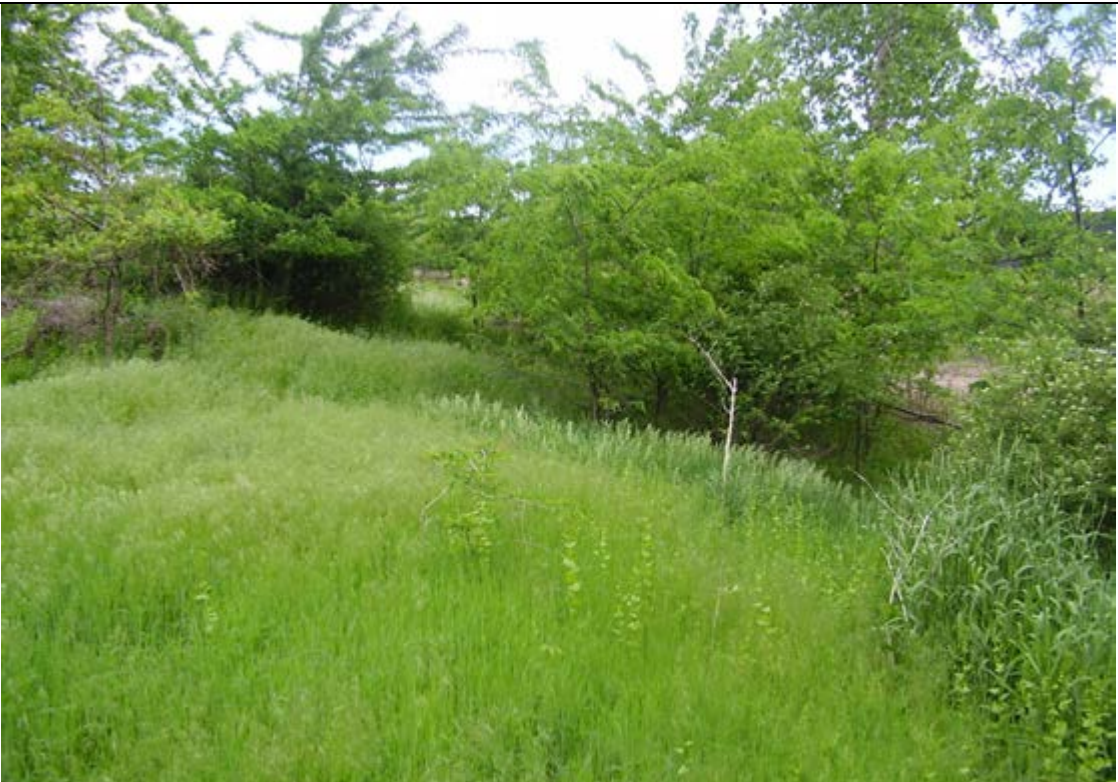
| <b>Photo No.</b><br><b>6</b> | <b>Date:</b><br>5/23/11 | |

| <b>Description:</b><br>Crest and downstream slope of the WAPS. | | |

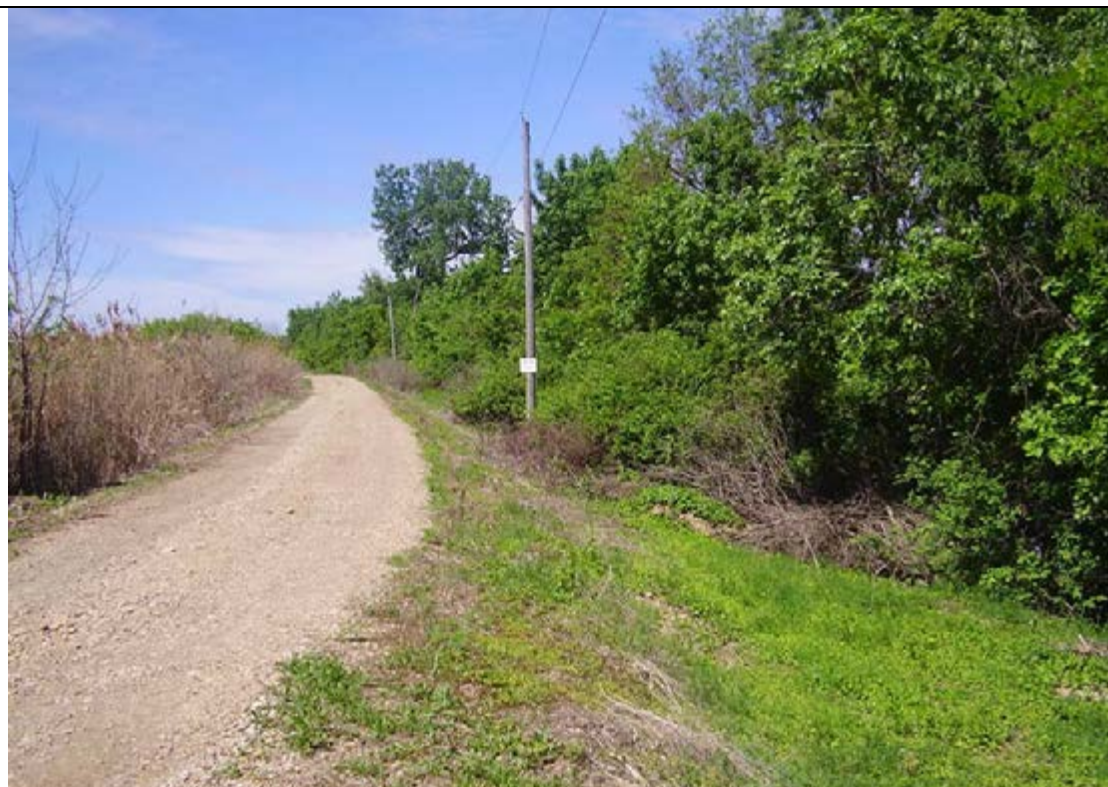
**Photo No.**  
**8**

Crest and downstream slope  
of the WAPS.

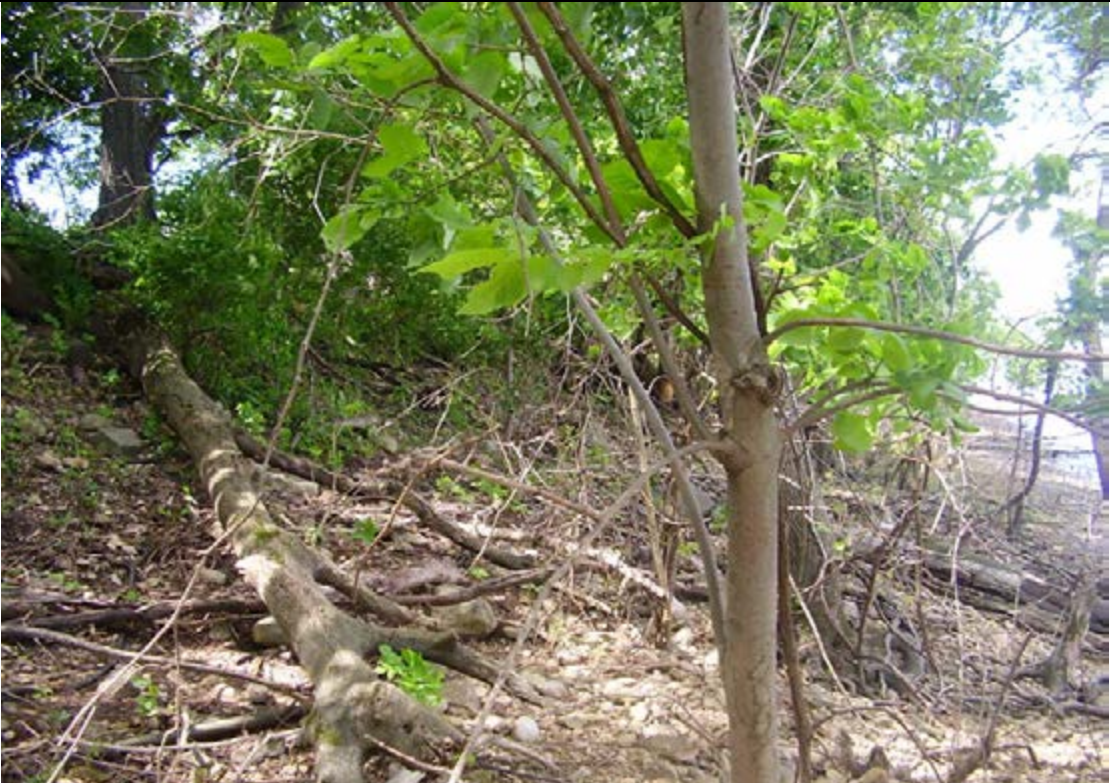
| <b>Photo No.</b><br><b>9</b> | <b>Date:</b><br>5/23/11 | | |

| <b>Description:</b><br>Downstream slope of the WAPS. | | | |

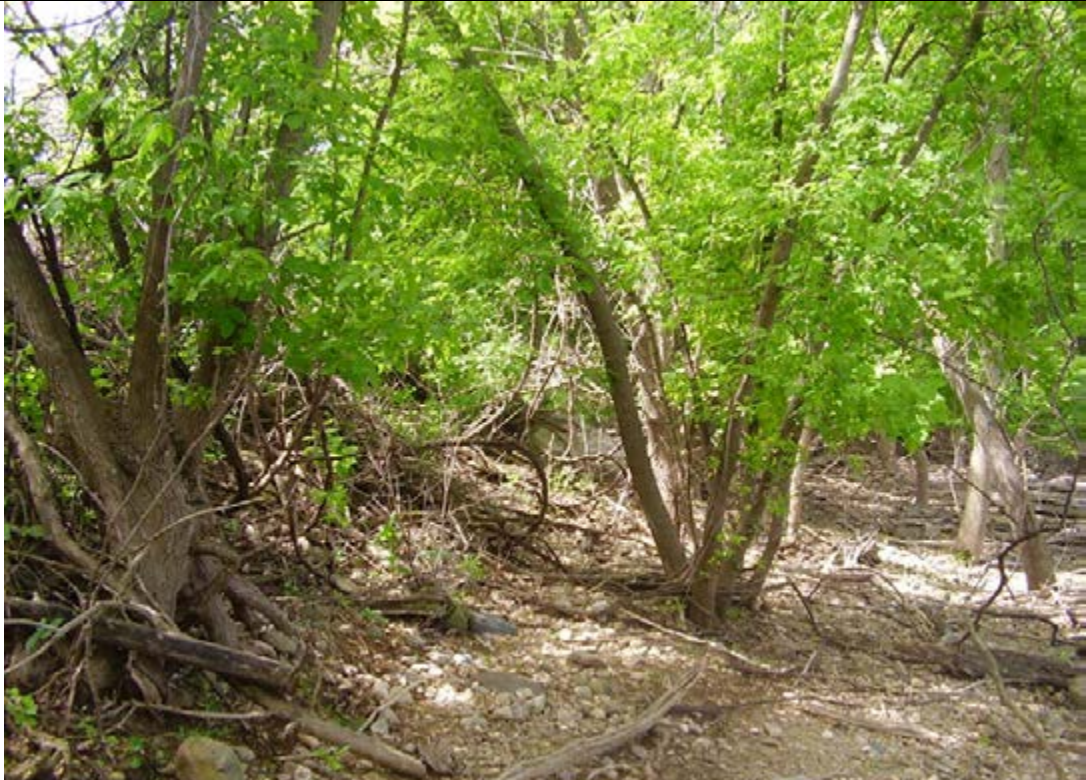
| <b>Photo No.</b><br><b>10</b> | <b>Date:</b><br>5/23/11 | |

| <b>Description:</b><br>Downstream slope of the WAPS. | | |

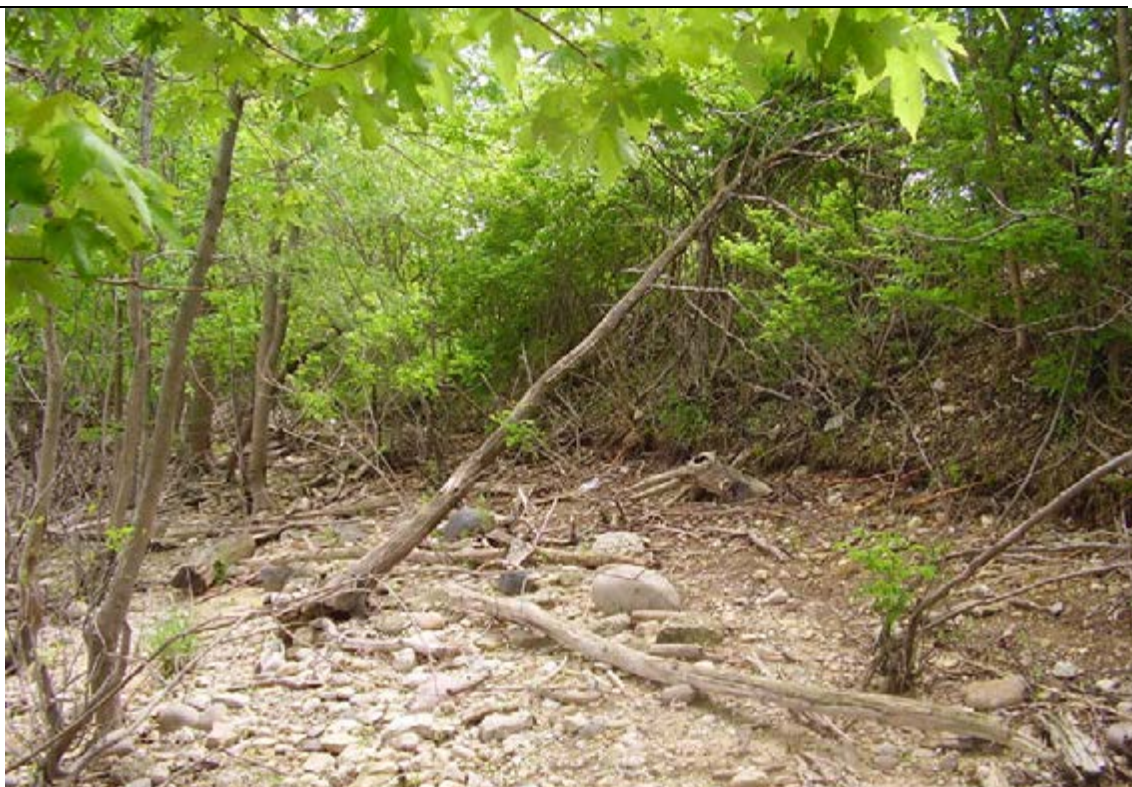
**Photo No.**  
**12**

**Description:**  
Downstream slope of the  
WAPS.

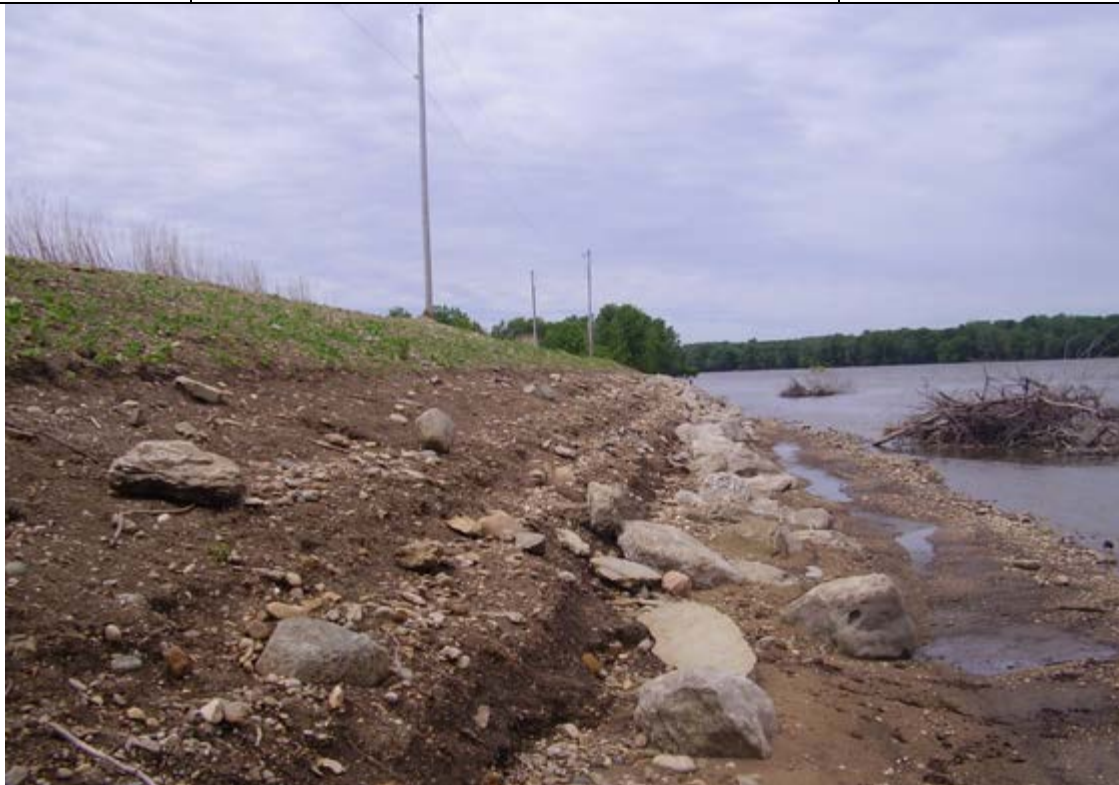
**Photo No.**  
**14**

**Description:**  
Toe access road along the  
eastern portion of the  
WAPS.

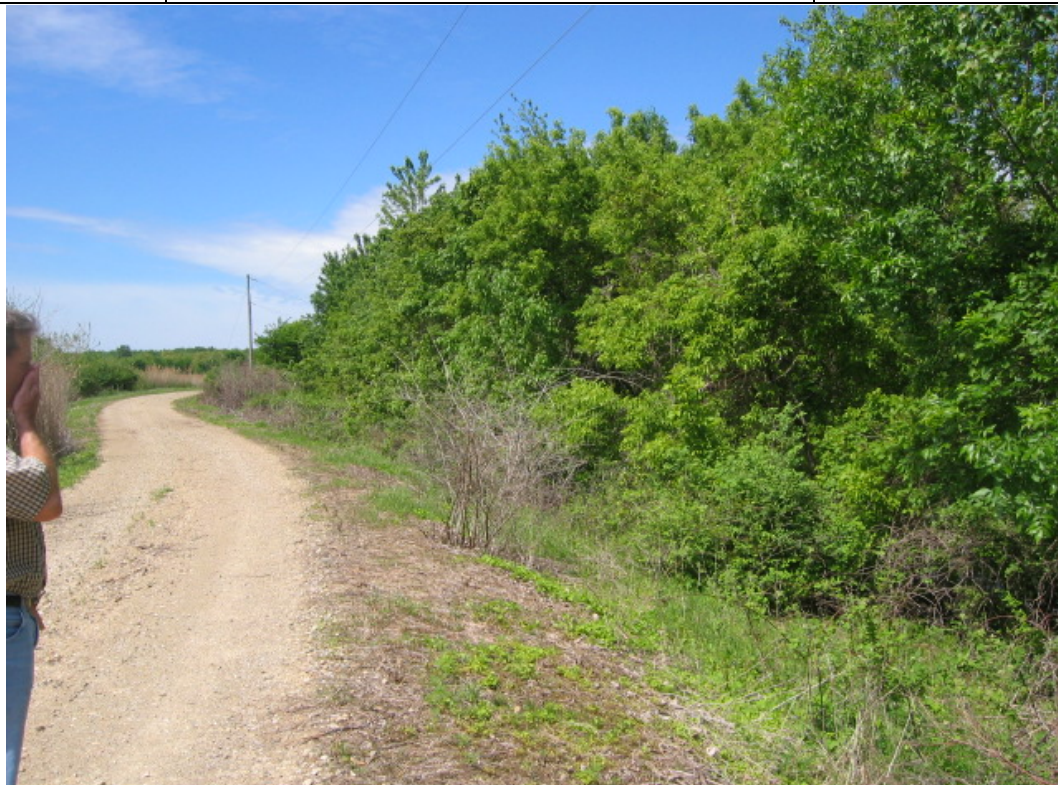
**Photo No.**  
**16**

**Description:**  
Crest of the WAPS.

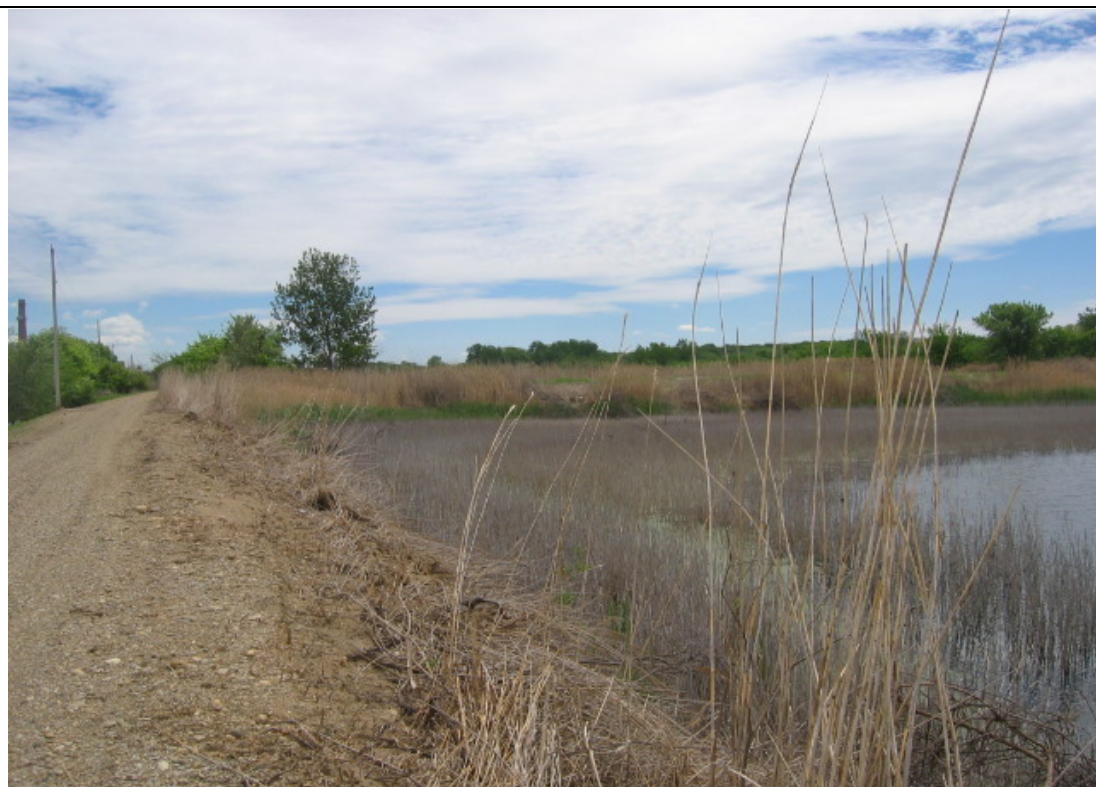
**Photo No.**  
**18**

**Description:**  
Crest and upstream slope of  
the WAPS.

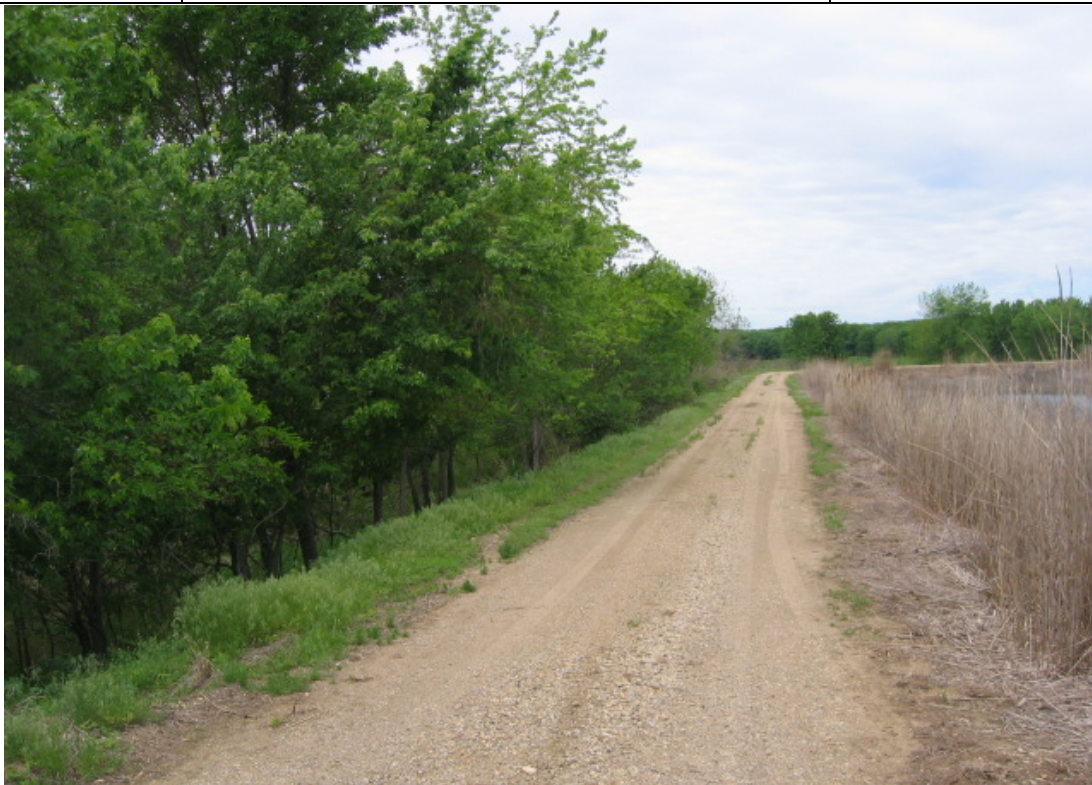
**Photo No.**  
**20**

**Description:**  
Crest and upstream slope of  
the WAPS.

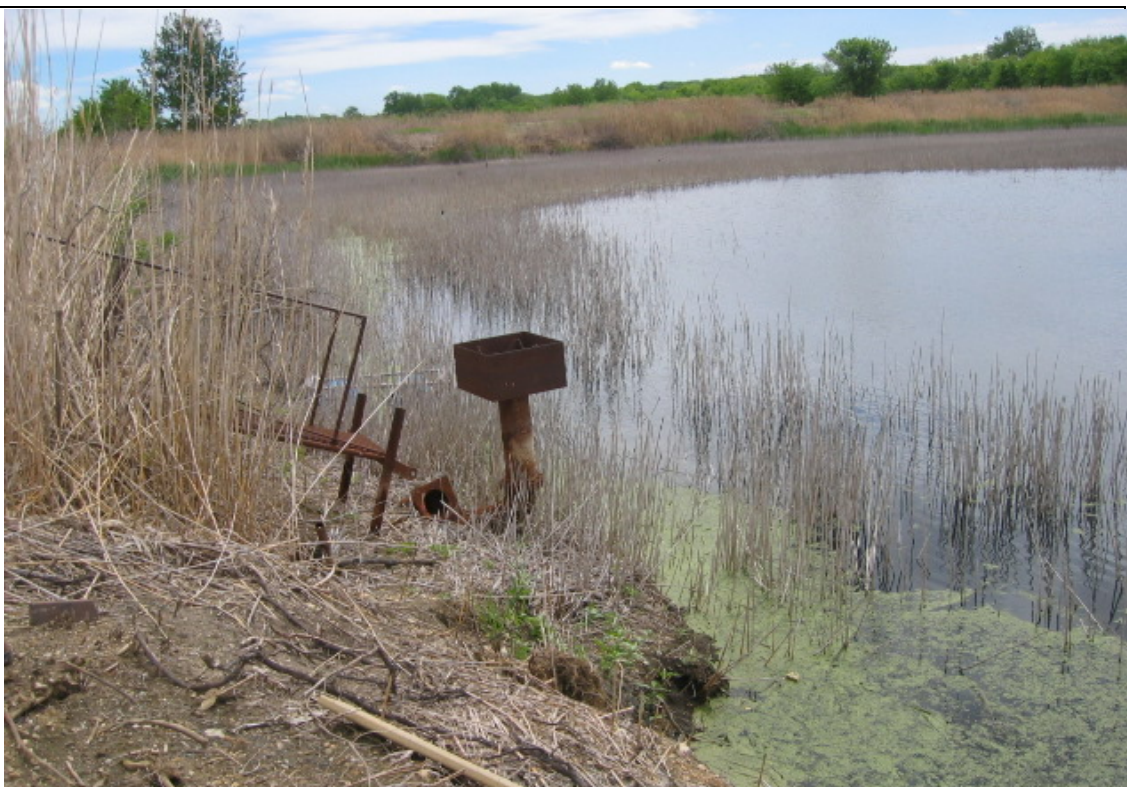
**Photo No.**  
**22**

**Description:**  
Decant structure in the  
WAPS.

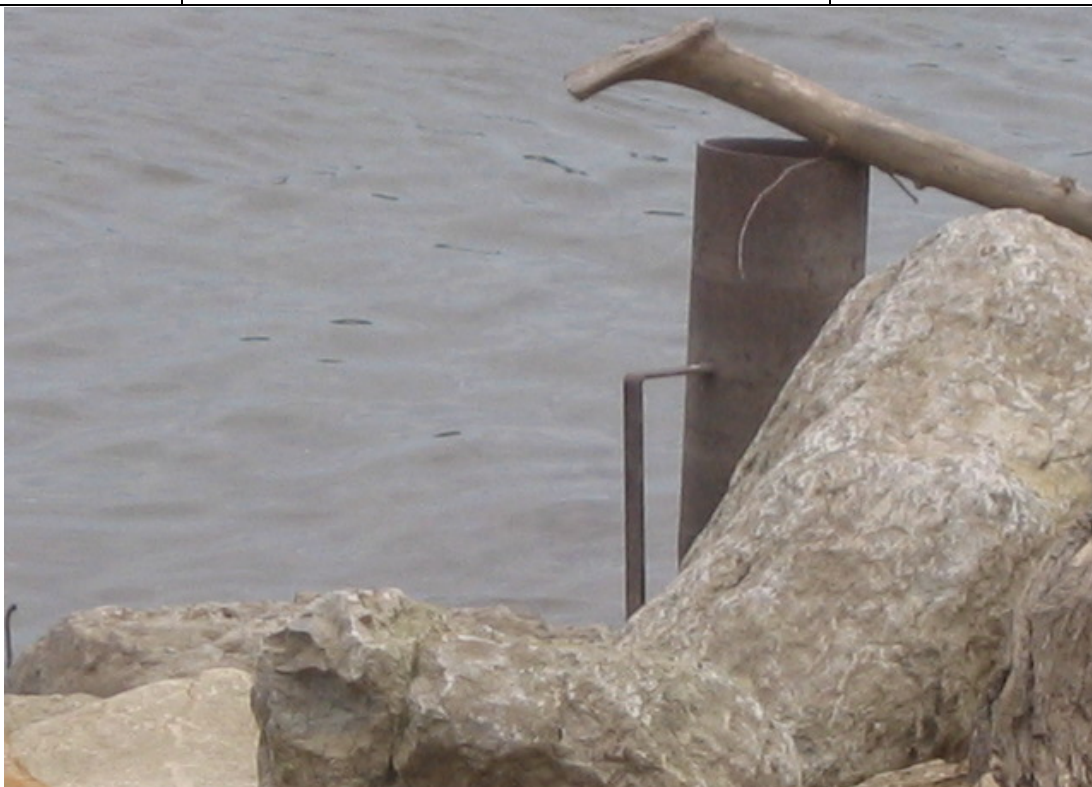
**Photo No.**  
**24**

**Description:**  
Upstream slope and ponded  
water in the WAPS.

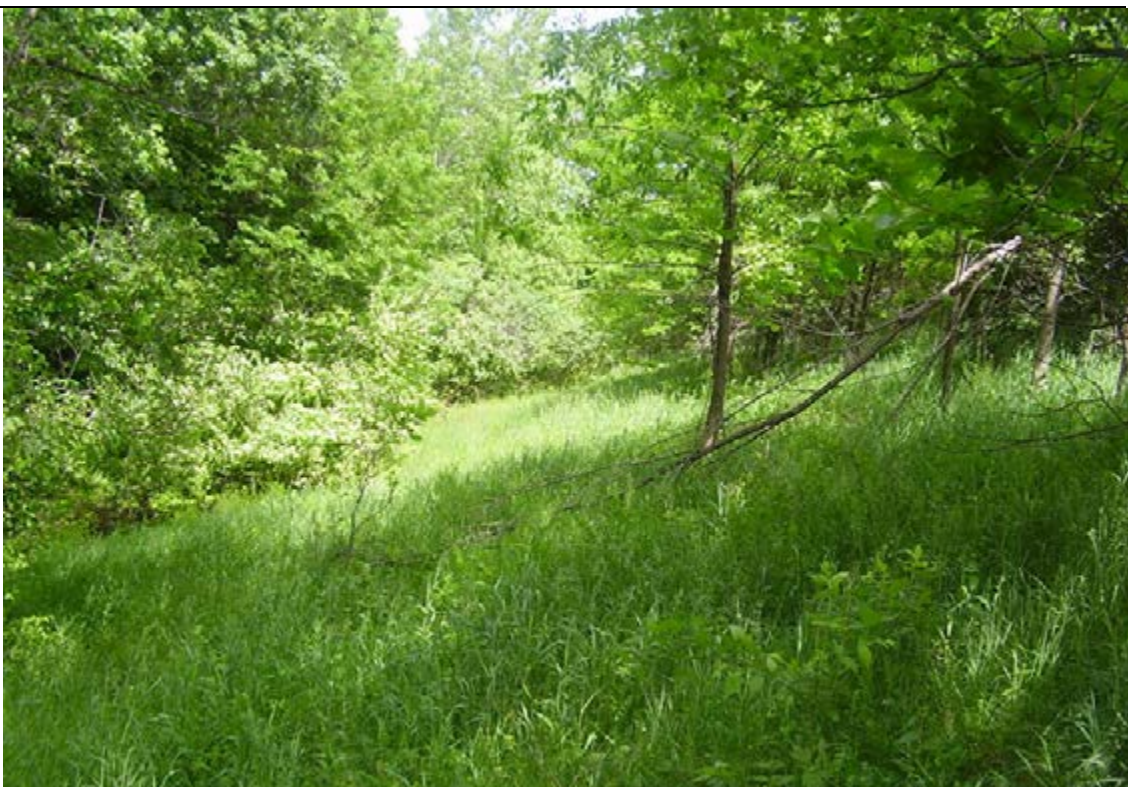
**Photo No.**  
**26**

**Description:**  
Downstream slope of the  
EAPS.

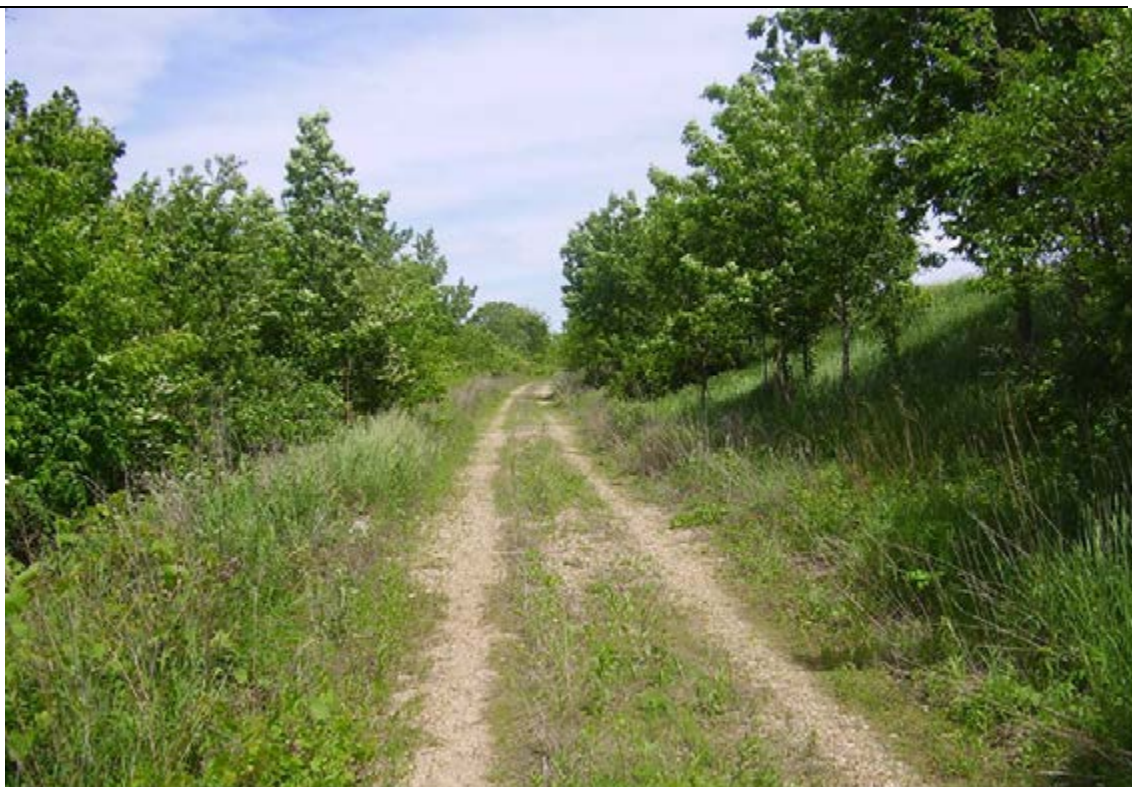
**Photo No.**  
**28**

**Description:**  
Crest of the 1978  
embankment and  
downstream slope of the  
1995 embankment along the  
EAPS.

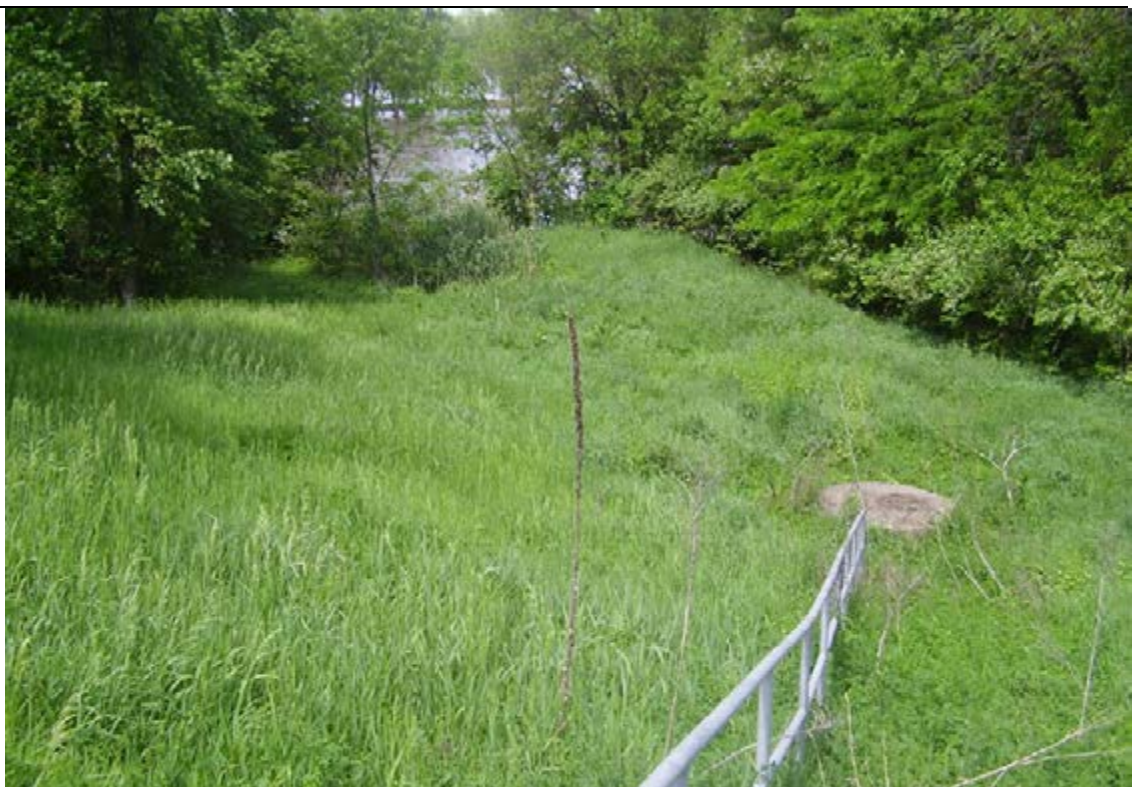
**Photo No.**  
**30**

**Description:**  
Downstream slope of Pond  
2E.

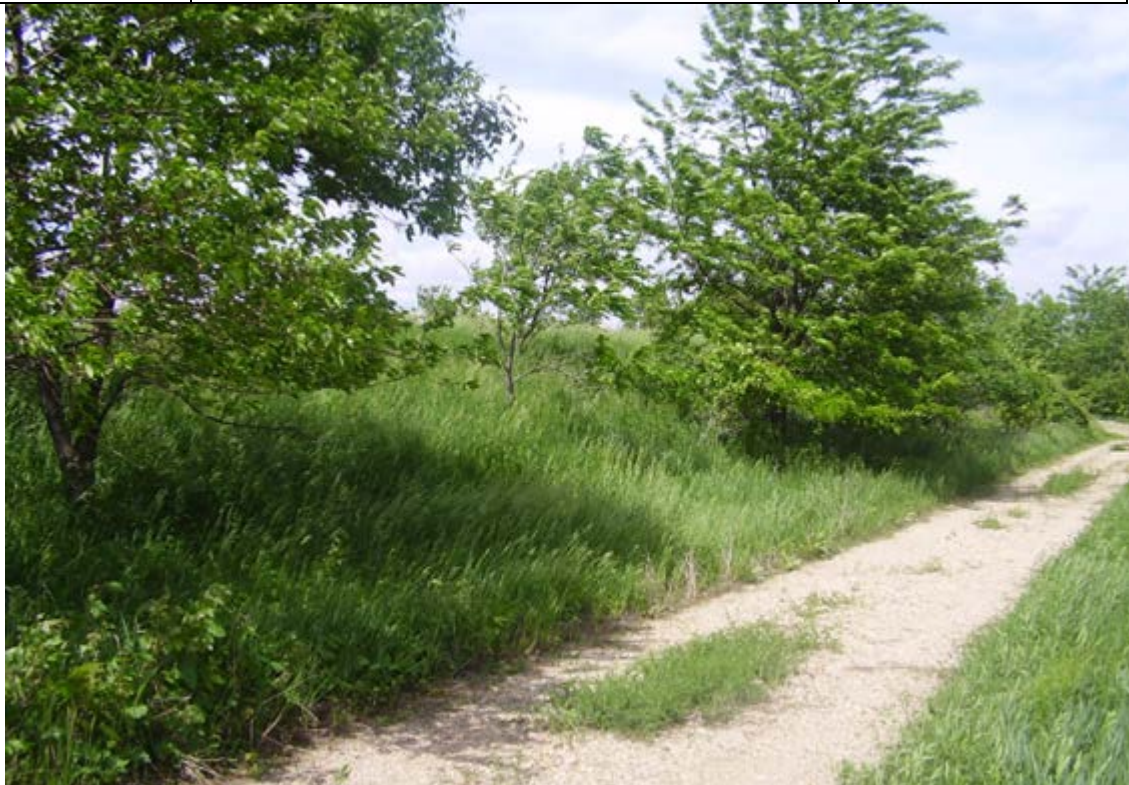
**Description:**  
Downstream slope of Pond  
2E along crest of the 1978  
embankment.

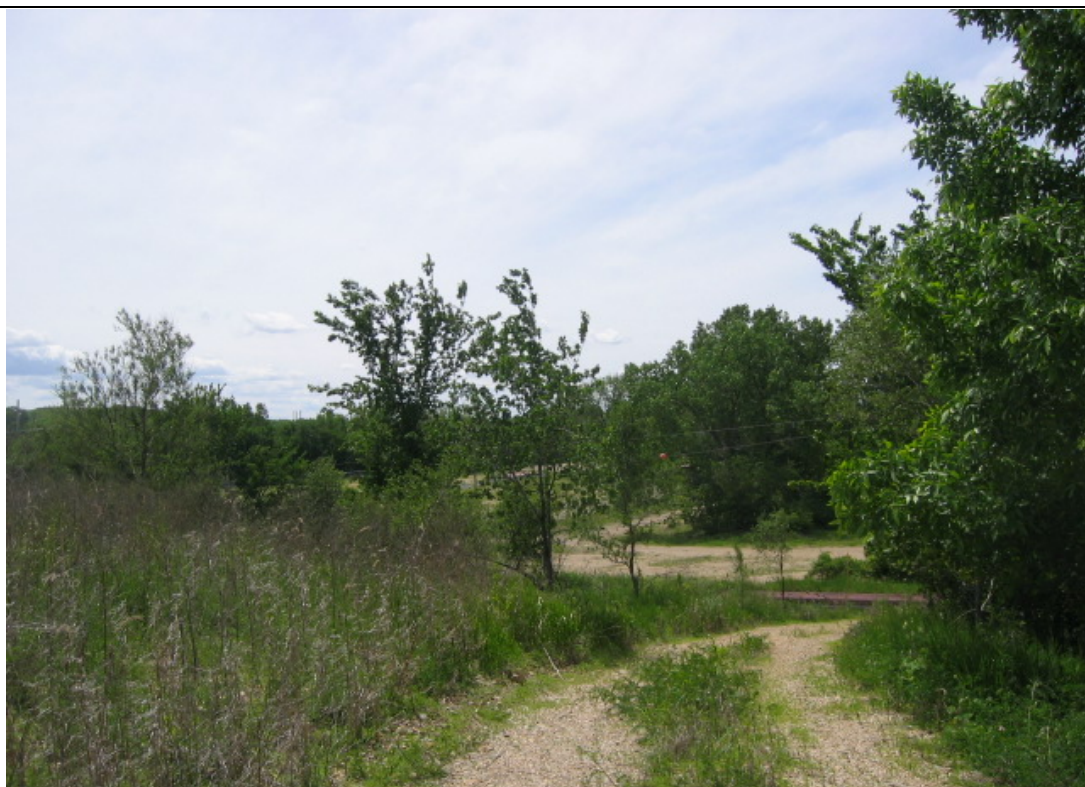
**Photo No.**  
**32**

**Description:**  
Crest of the EAPS.

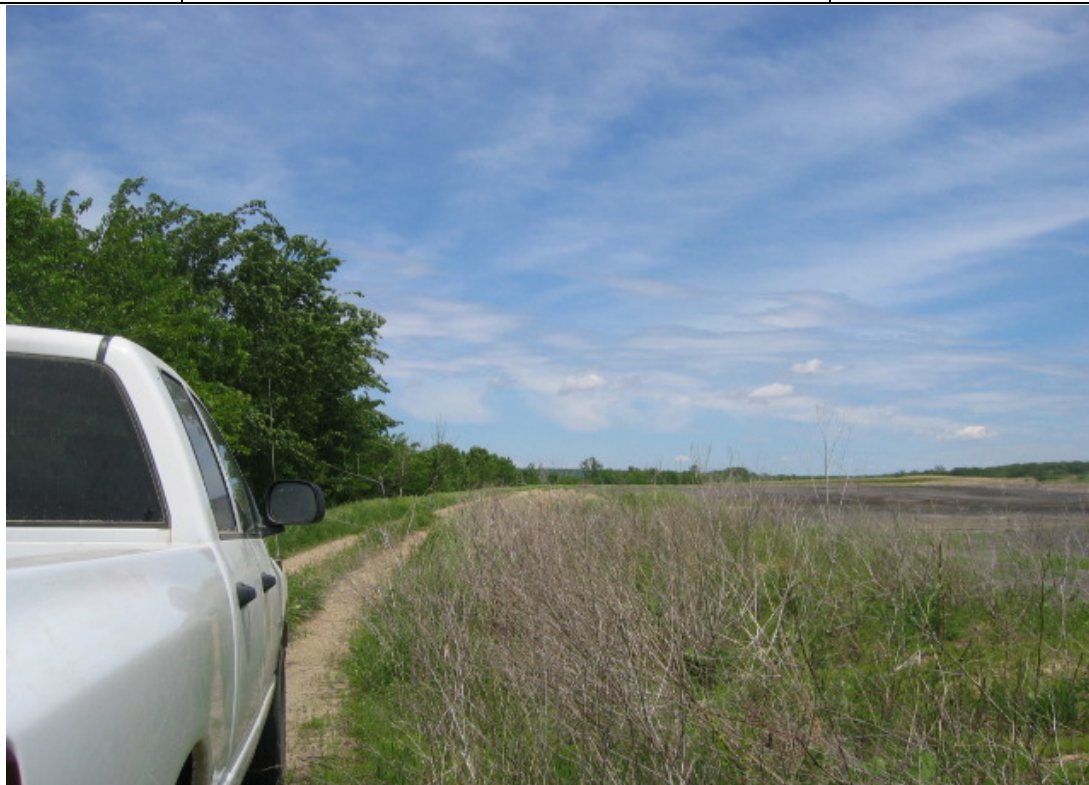
**Description:**  
Crest and upstream slope of  
the EAPS.

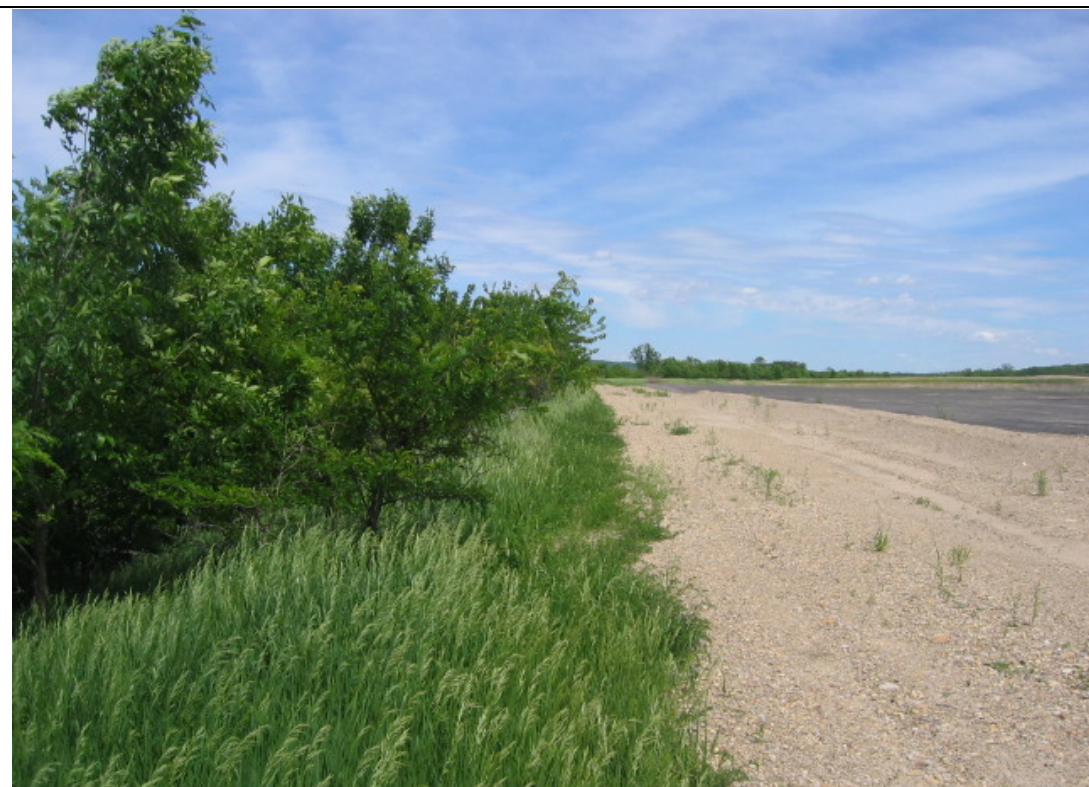
**Photo No.**  
**34**

**Description:**  
Crest and upstream slope of  
the EAPS.

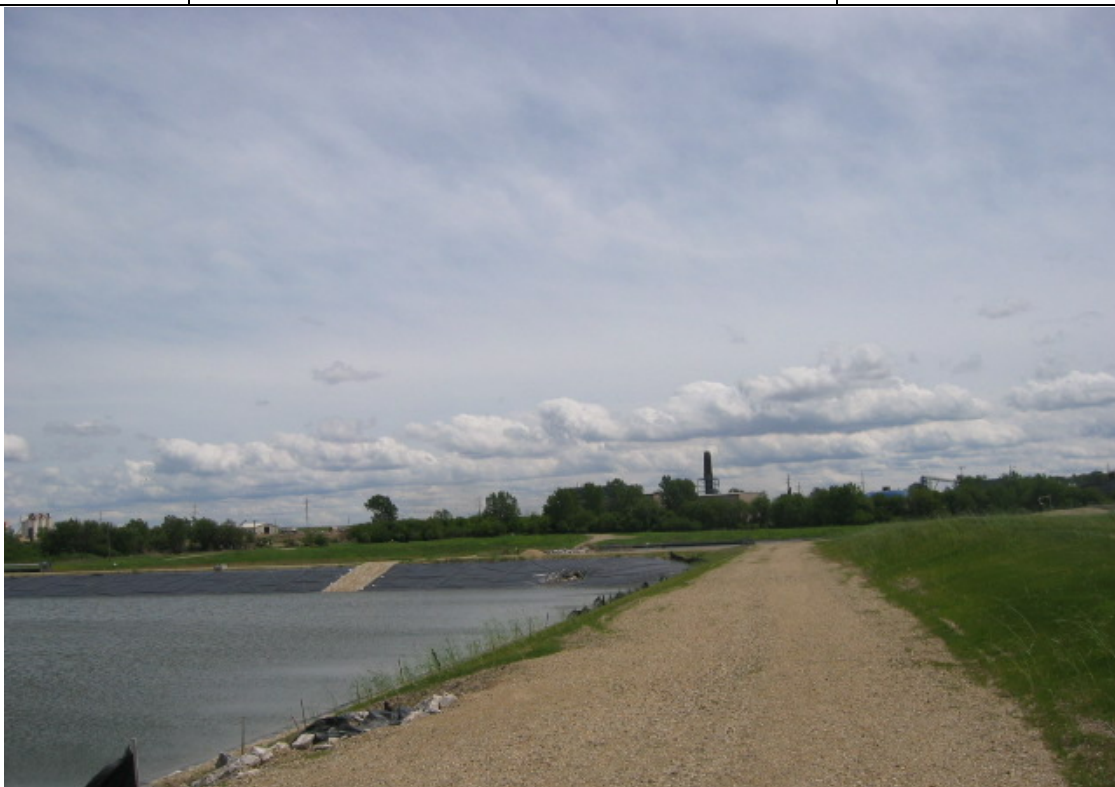
**Description:**  
Crest of embankment  
between the EAPS and Pond  
2E.

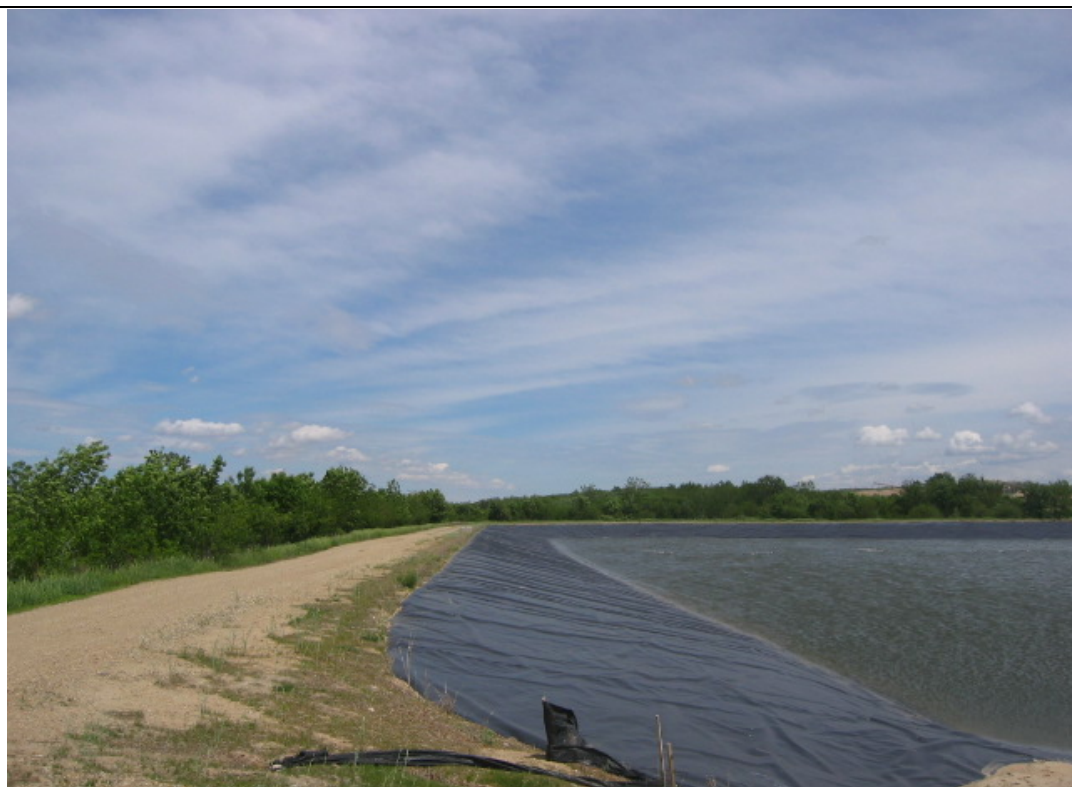
**Photo No.**  
**36**

**Description:**  
Crest and upstream slope of  
Pond 2E.

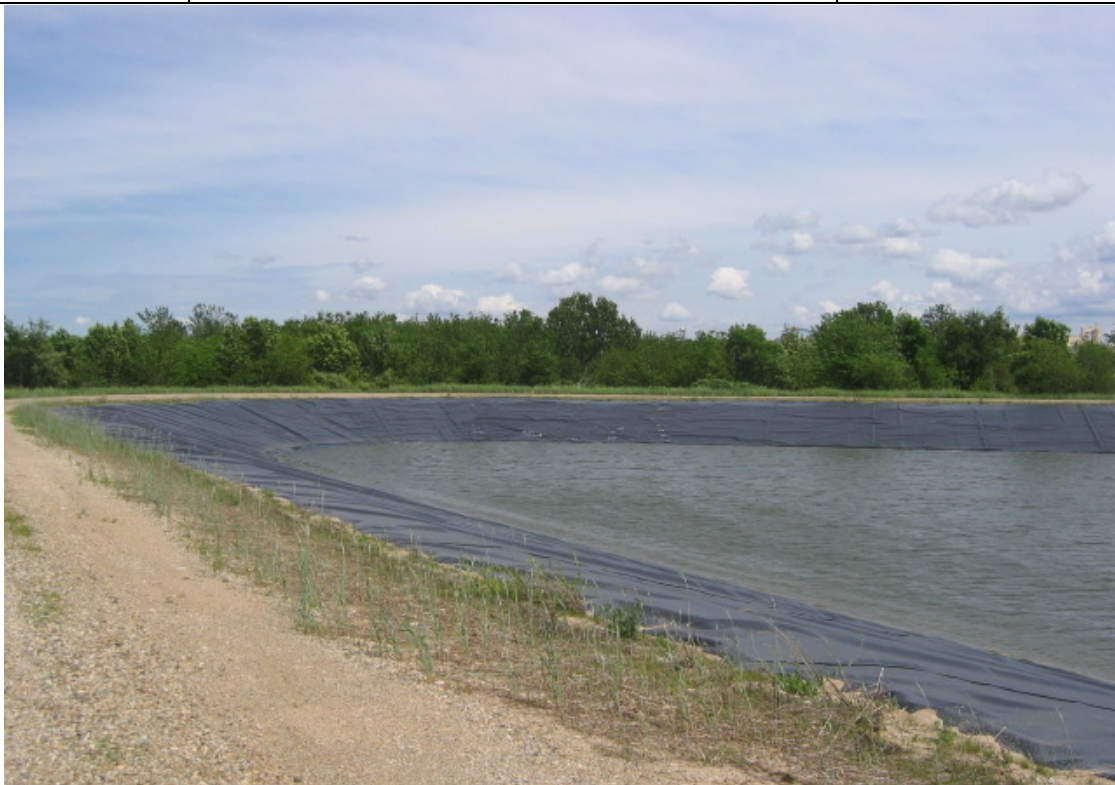
**Description:**  
Crest and upstream slope of  
Pond 2E.
