**DRAFT REPORT  
ROUND 10 DAM ASSESSMENT - MAY 23, 2011  
DYNEGY MIDWEST GENERATION, INC. – HENNEPIN POWER STATION  
ACTIVE EAST ASH POND SYSTEM, EAST ASH POND SYSTEM, WEST ASH POND  
SYSTEM  
HENNEPIN, ILLINOIS**

RE: DRAFT Assessment of Dam Safety of Coal Combustion Surface Impoundments at the  
Hennepin Power Station

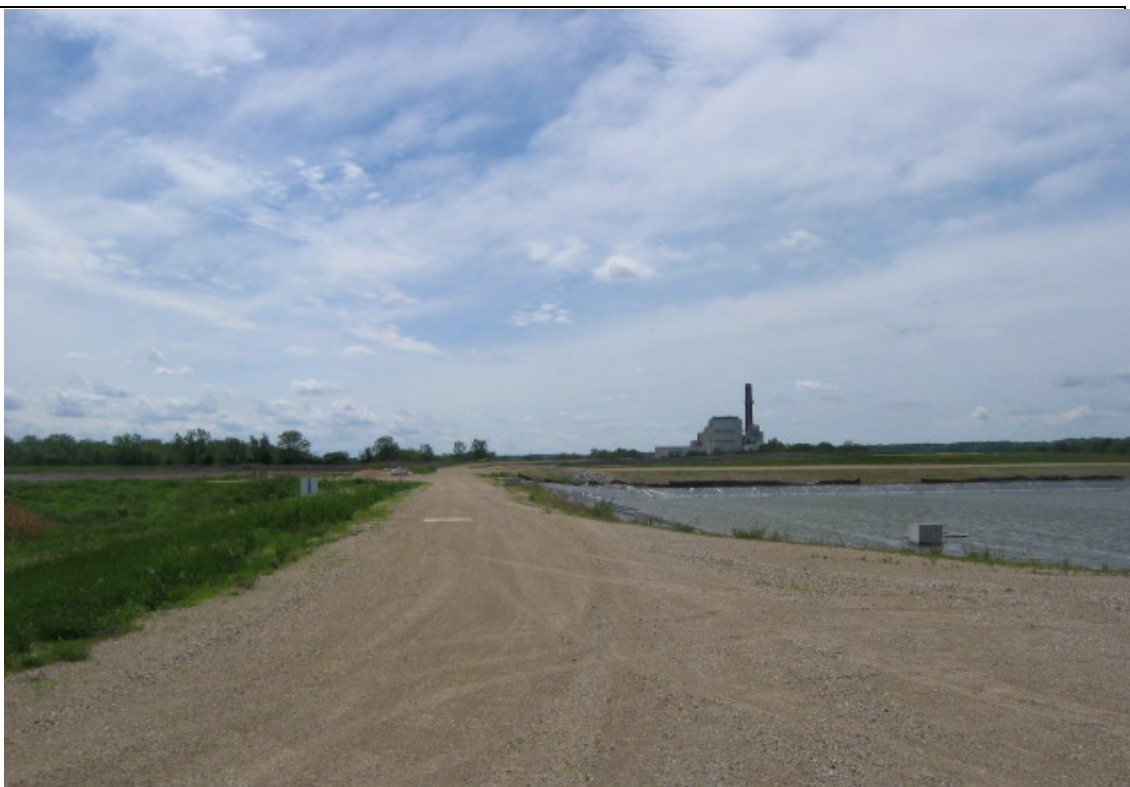
**Photo No.**  
**38**

**Description:**  
Crest of the embankment  
between Pond 2E and  
Secondary Cell.

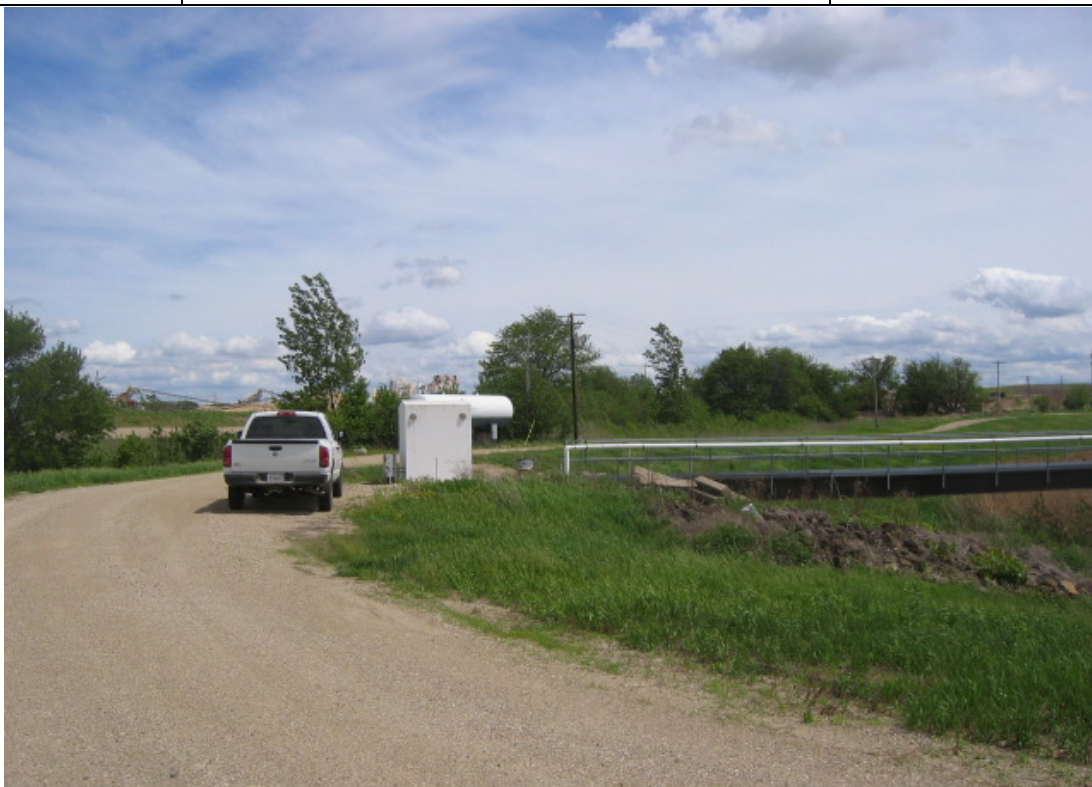
**Description:**  
Crest and upstream slope of  
the Secondary Cell.

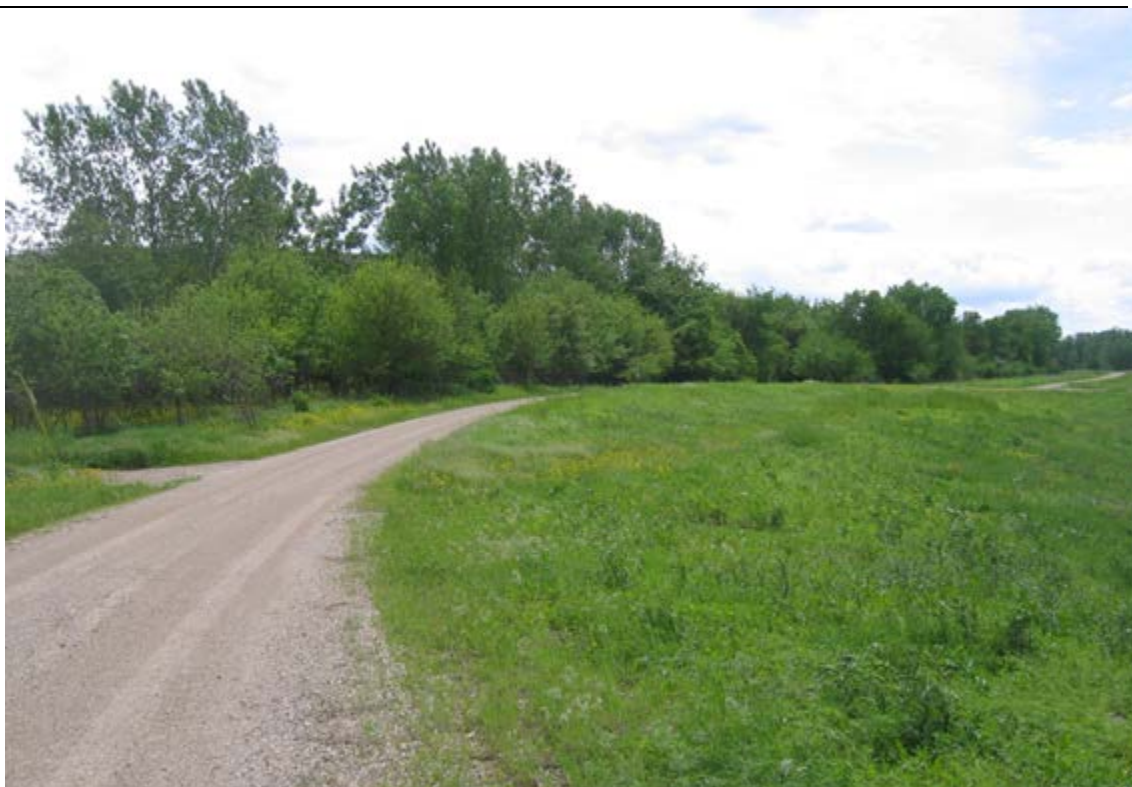
**Photo No.**  
**40**

**Description:**  
Crest and upstream slope of  
the Secondary Cell.

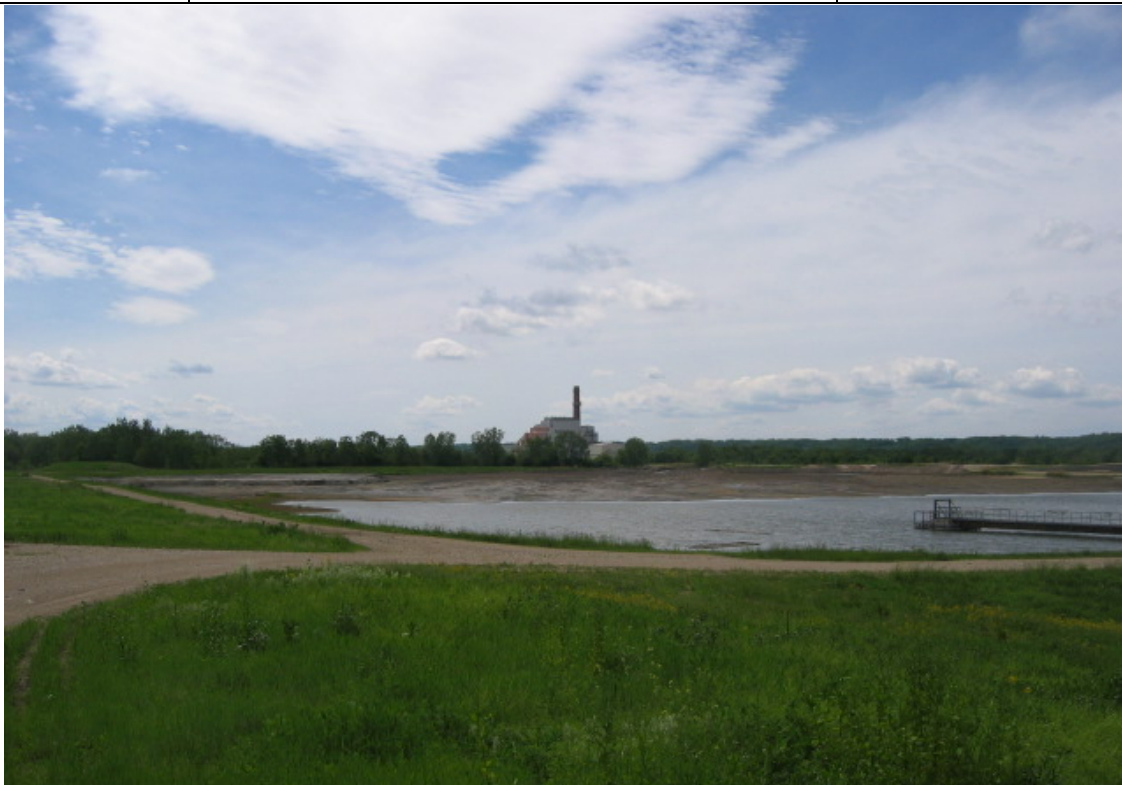
**Description:**  
Crest and upstream slope of  
the Secondary Cell.

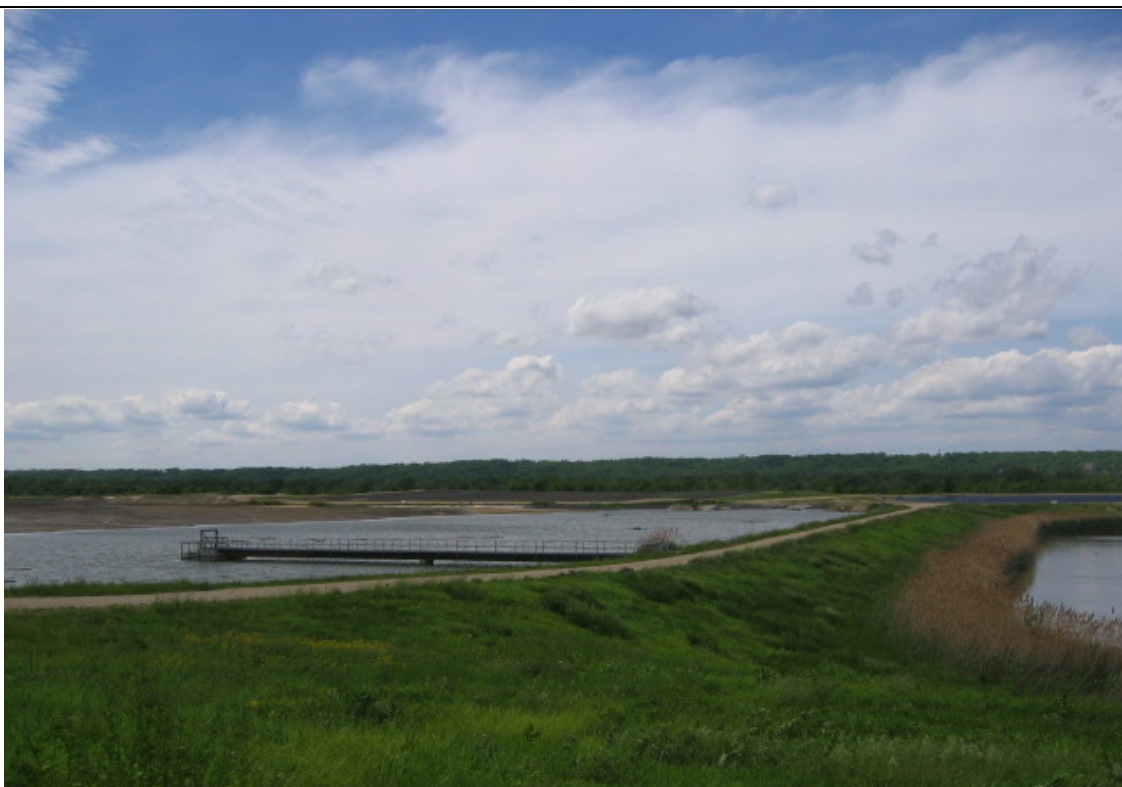
**Photo No.**  
**42**

**Description:**  
Crest and upstream slope of  
the Secondary Cell.

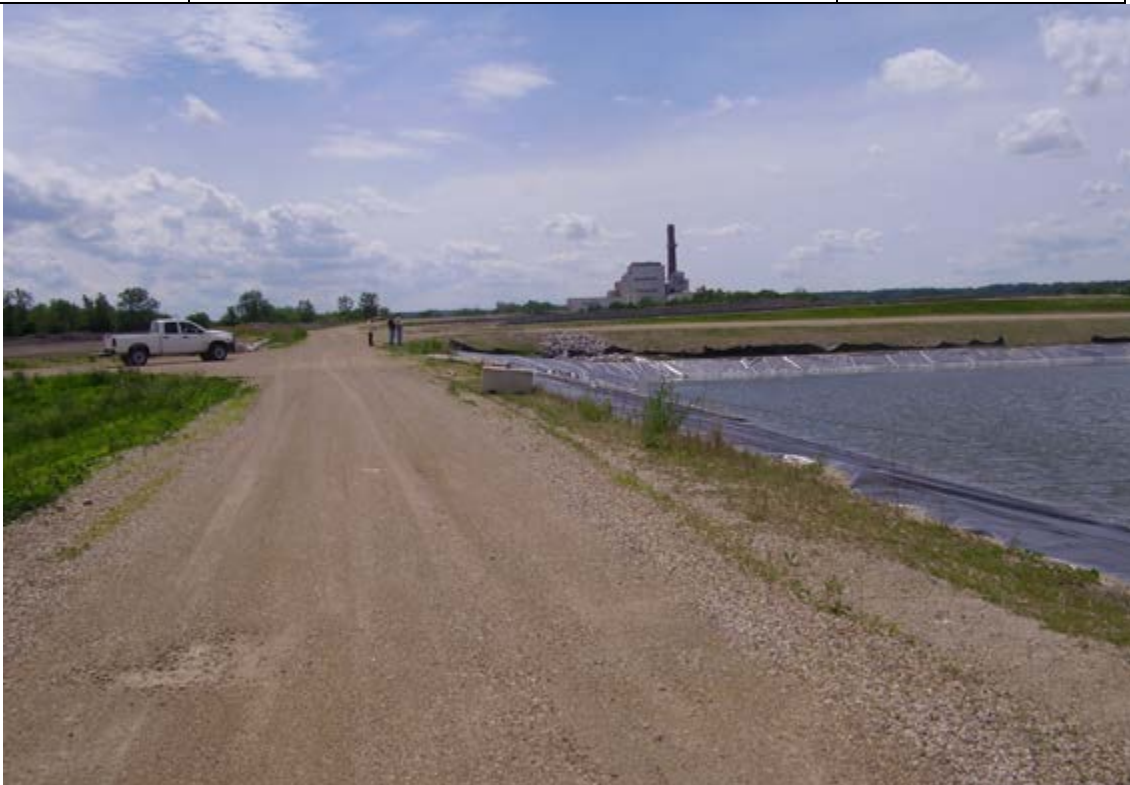
Crest of the embankment  
between Pond 2E and the  
Secondary Cell.

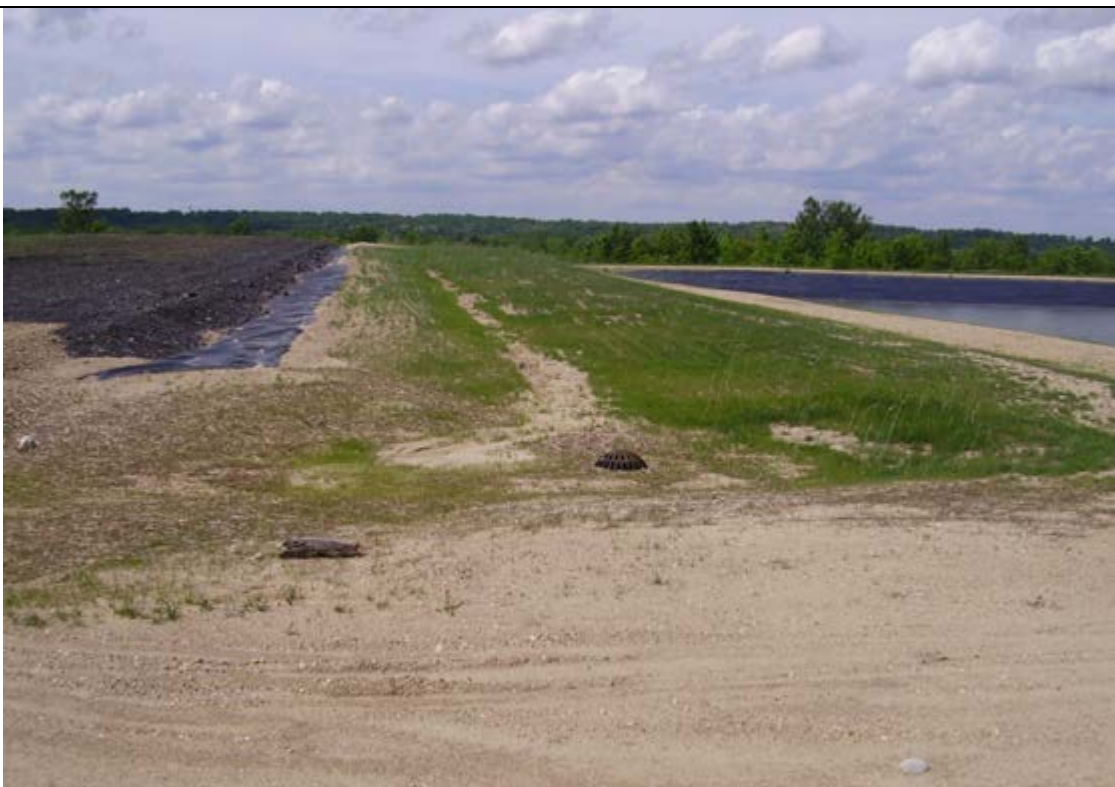
**Photo No.**  
**44**

Upstream slope of the EAPS.

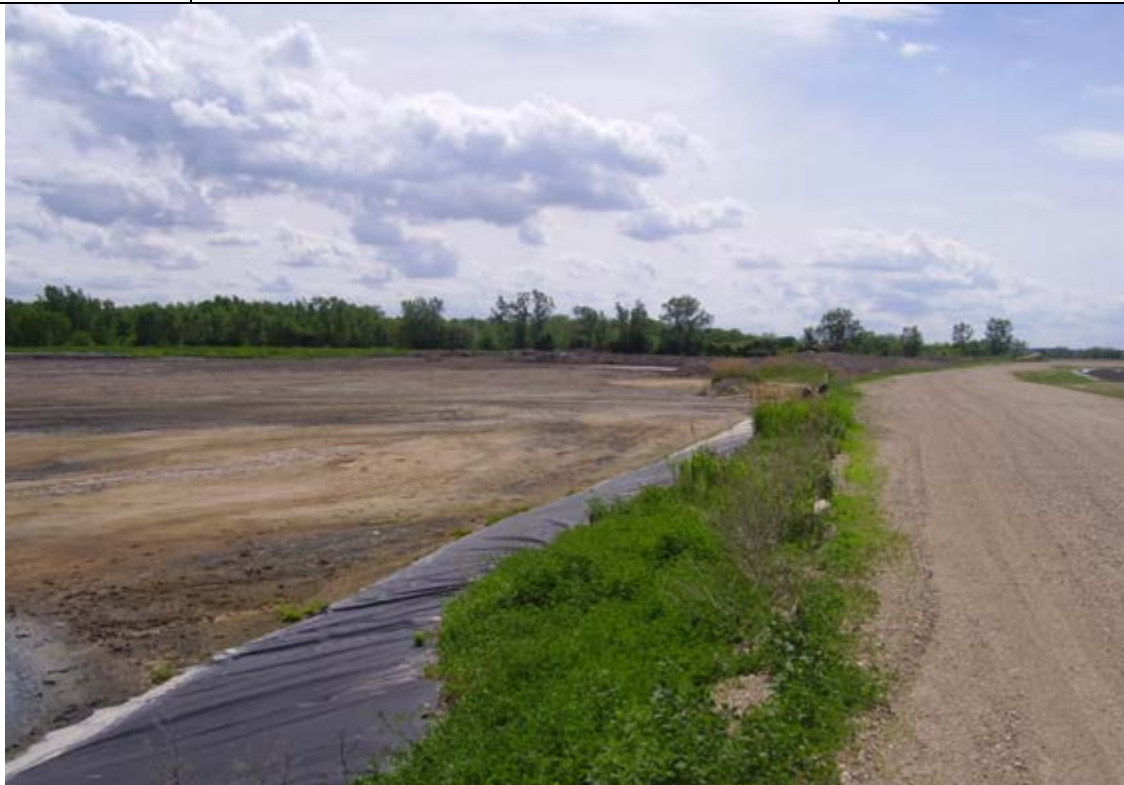
**Description:**  
Crest and upstream slope of  
the Primary Cell.

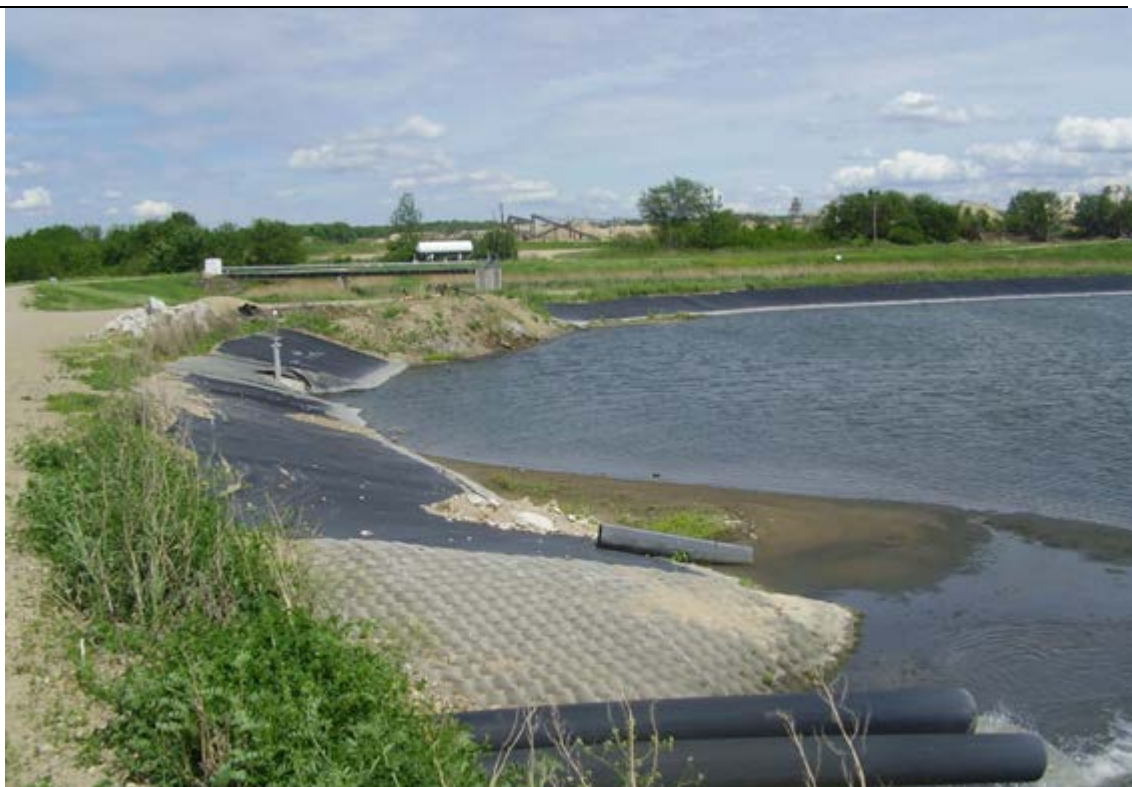
**Photo No.**  
**46**

**Description:**  
Upstream slope of the  
Primary Cell.

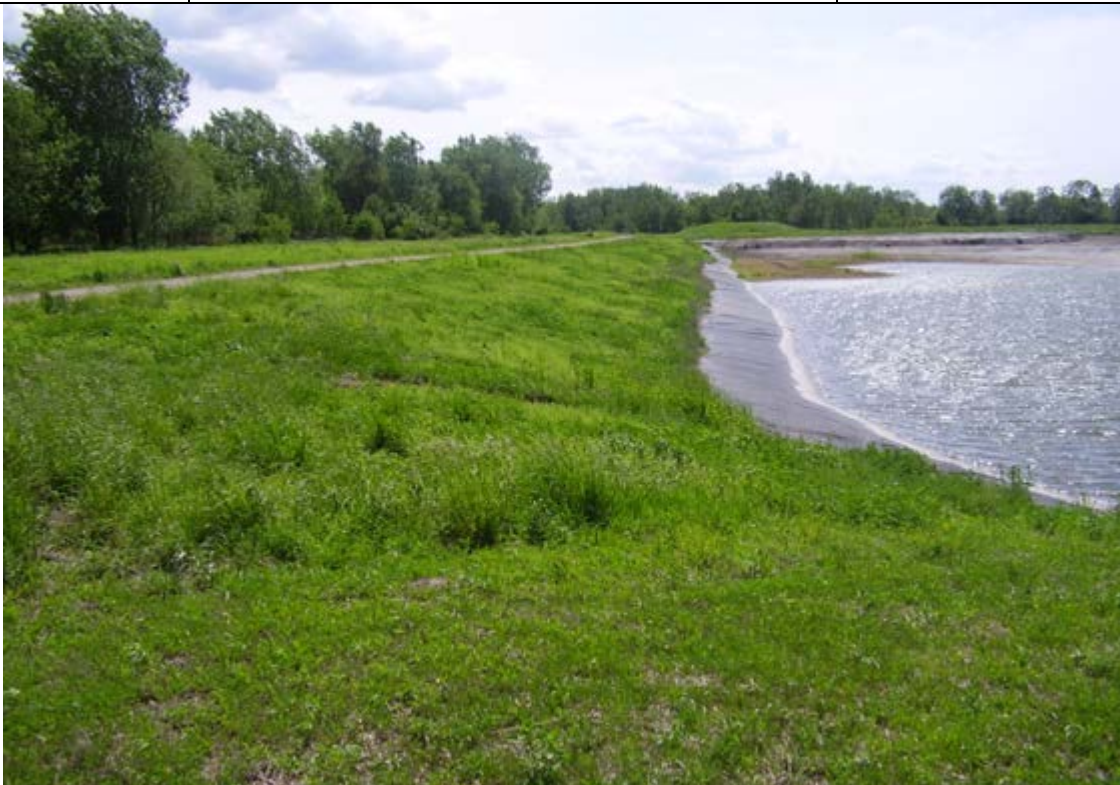
**Description:**  
Upstream slope of the  
Primary Cell.

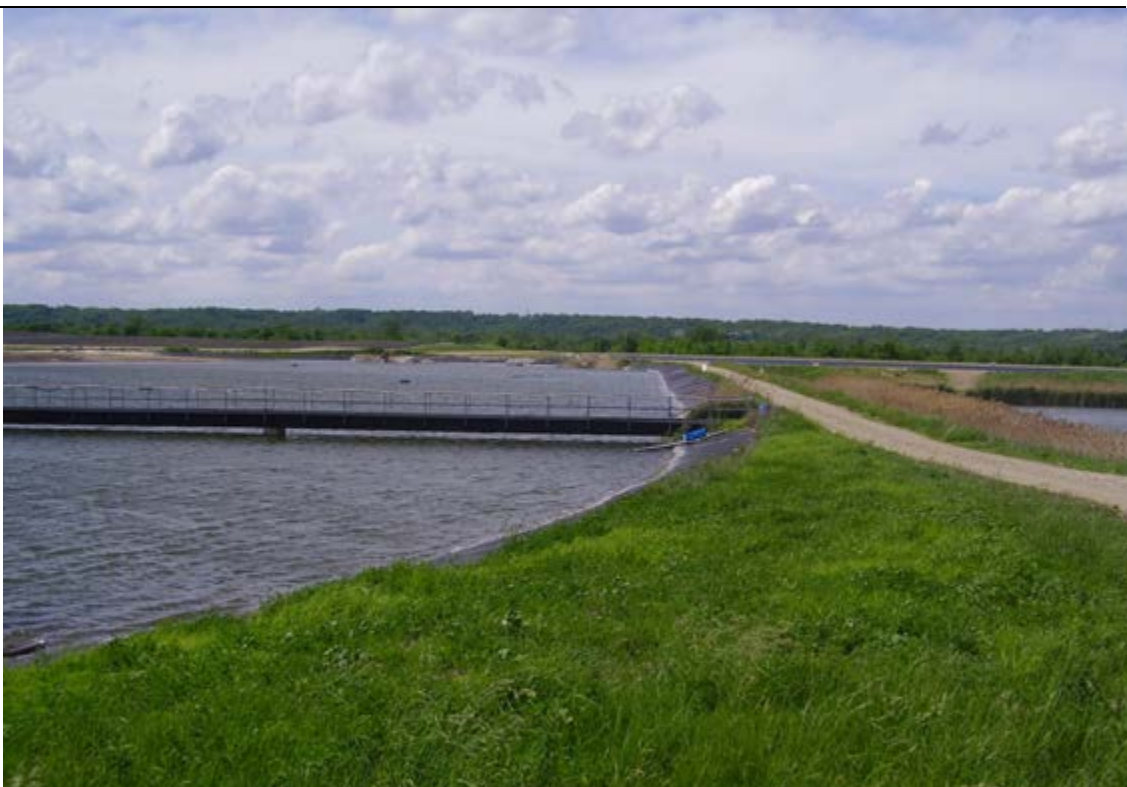
**Photo No.**  
**48**

**Description:**  
Upstream slope of the  
Primary Cell near the decant  
structure.

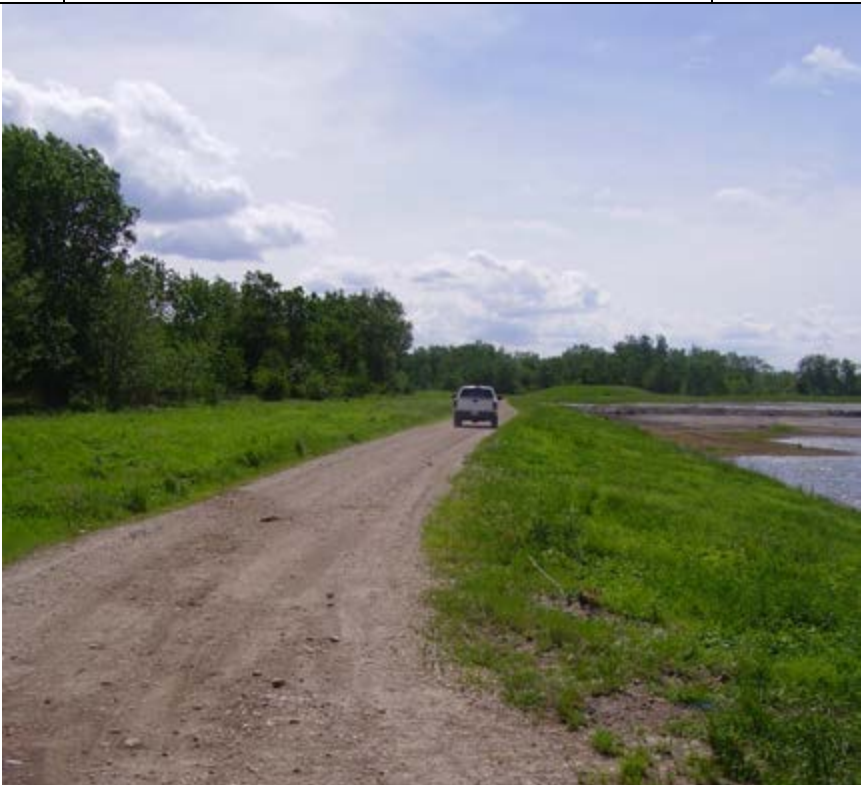
| <b>Photo No.</b><br><b>49</b> | <b>Date:</b><br>5/23/11 | | |

| <b>Description:</b><br>Crest and upstream slope of the Primary Cell. | | | |

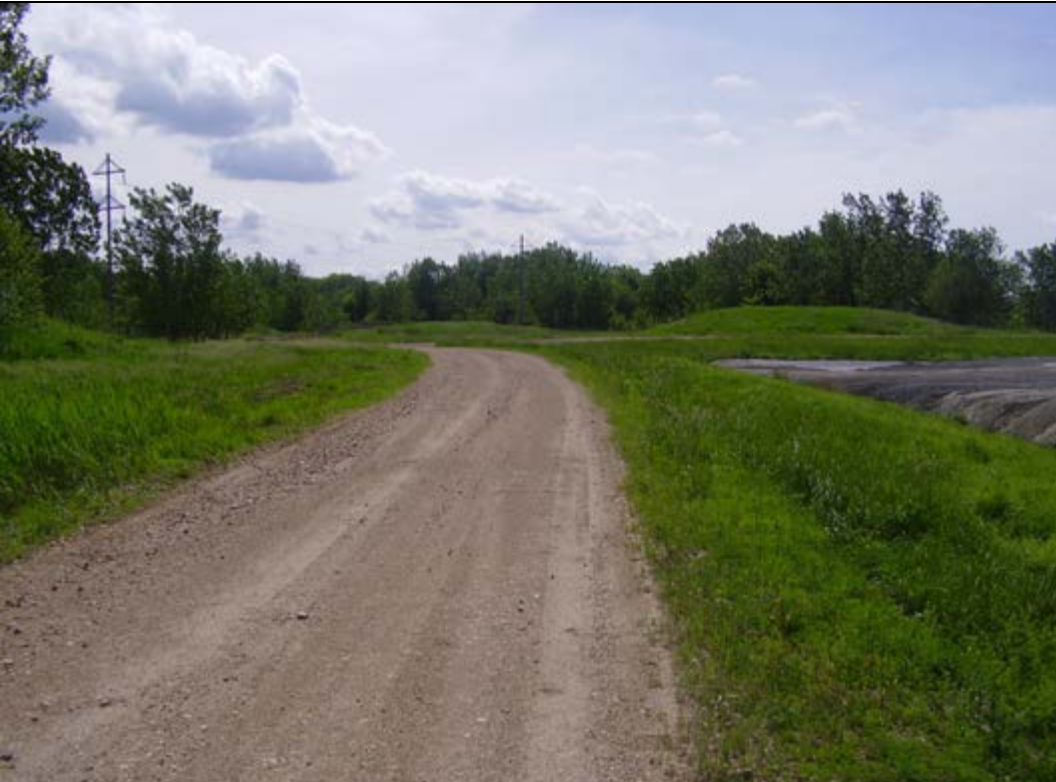
| <b>Photo No.</b><br><b>50</b> | <b>Date:</b><br>5/23/11 | |

| <b>Description:</b><br>Crest and upstream slope of the Primary Cell. | | |

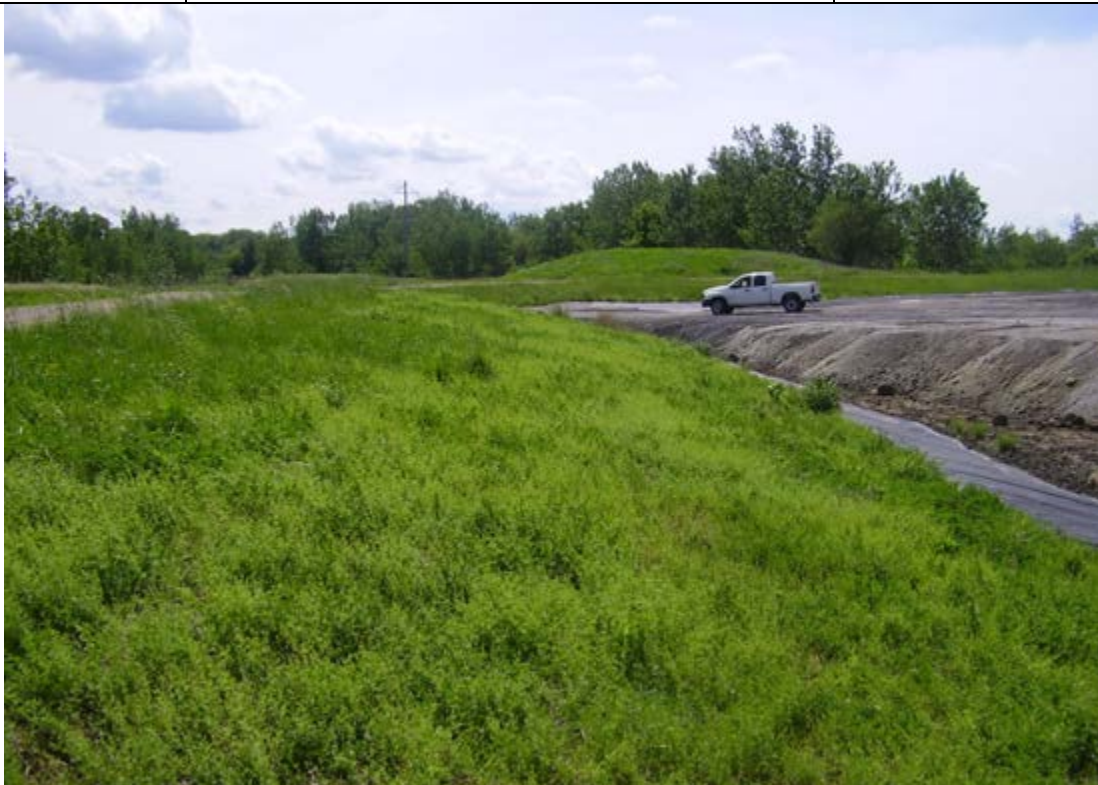
**Description:**  
Upstream slope of the  
Primary Cell.

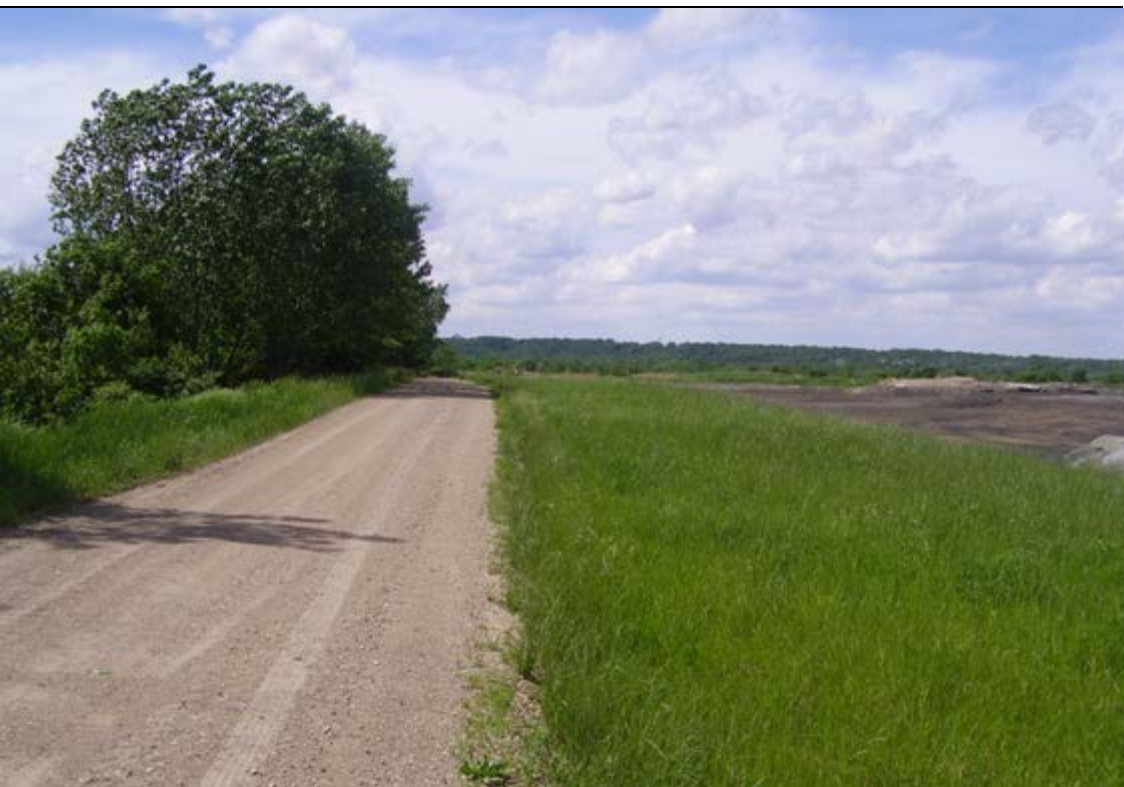
**Photo No.**  
**52**

**Description:**  
Crest and upstream slope of  
the Primary Cell.

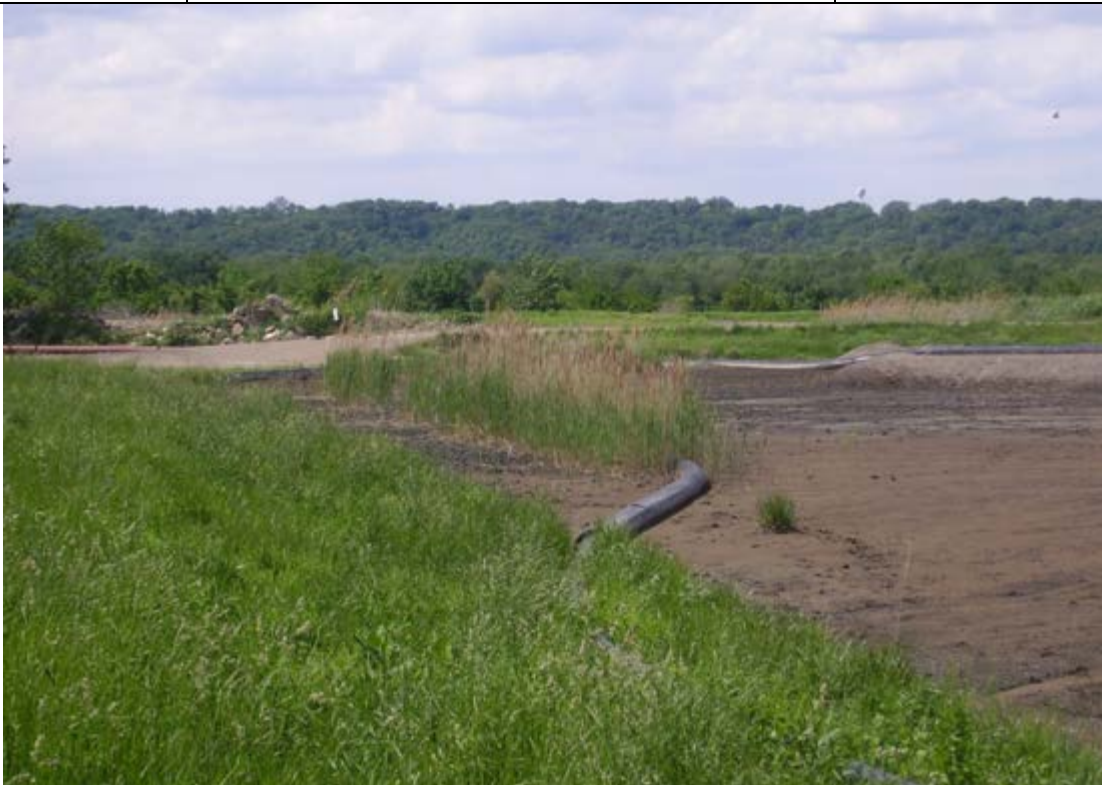
**Description:**  
Crest and upstream slope of  
the Primary Cell.

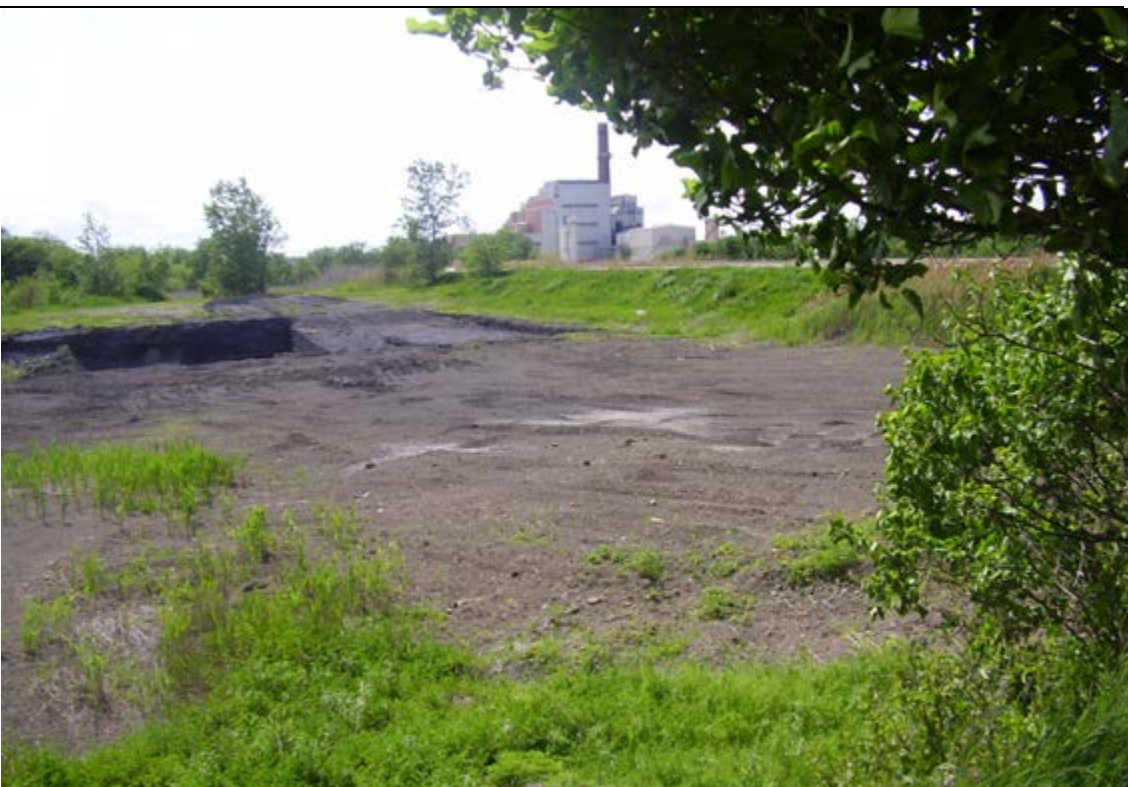
**Photo No.**  
**54**

**Description:**  
Downstream slope of the  
EAPS.

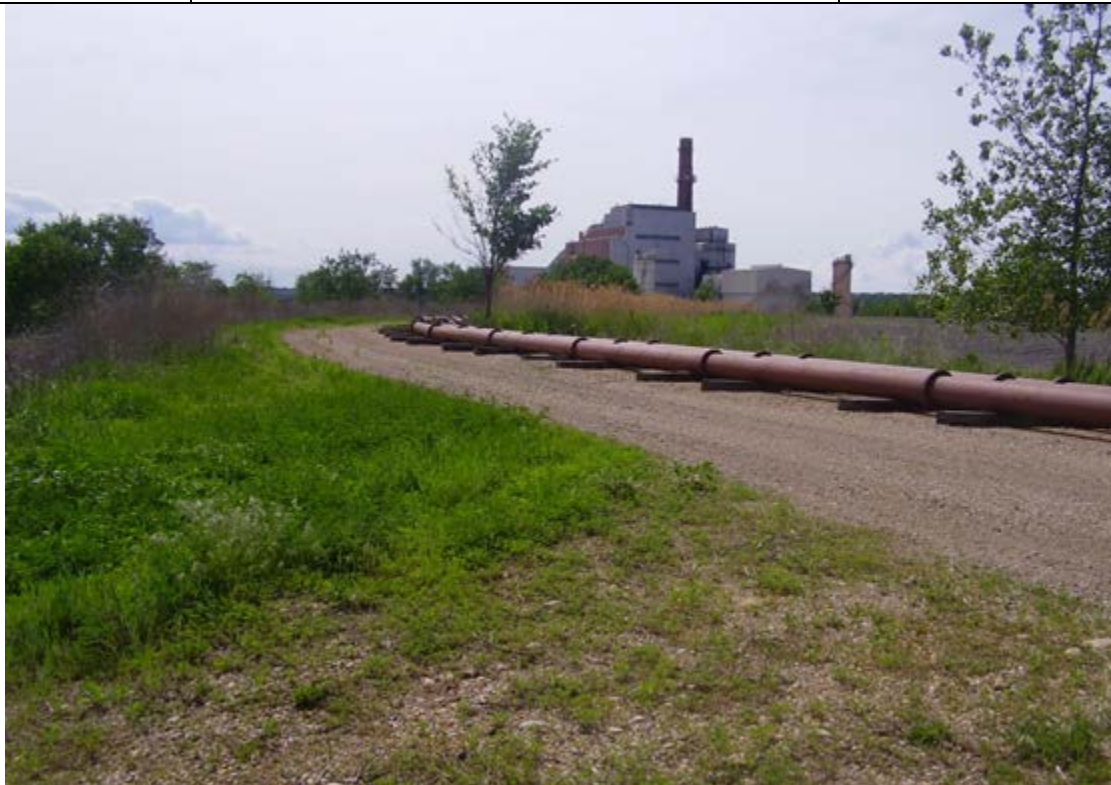
**Description:**  
Crest and downstream slope  
of the EAPS.

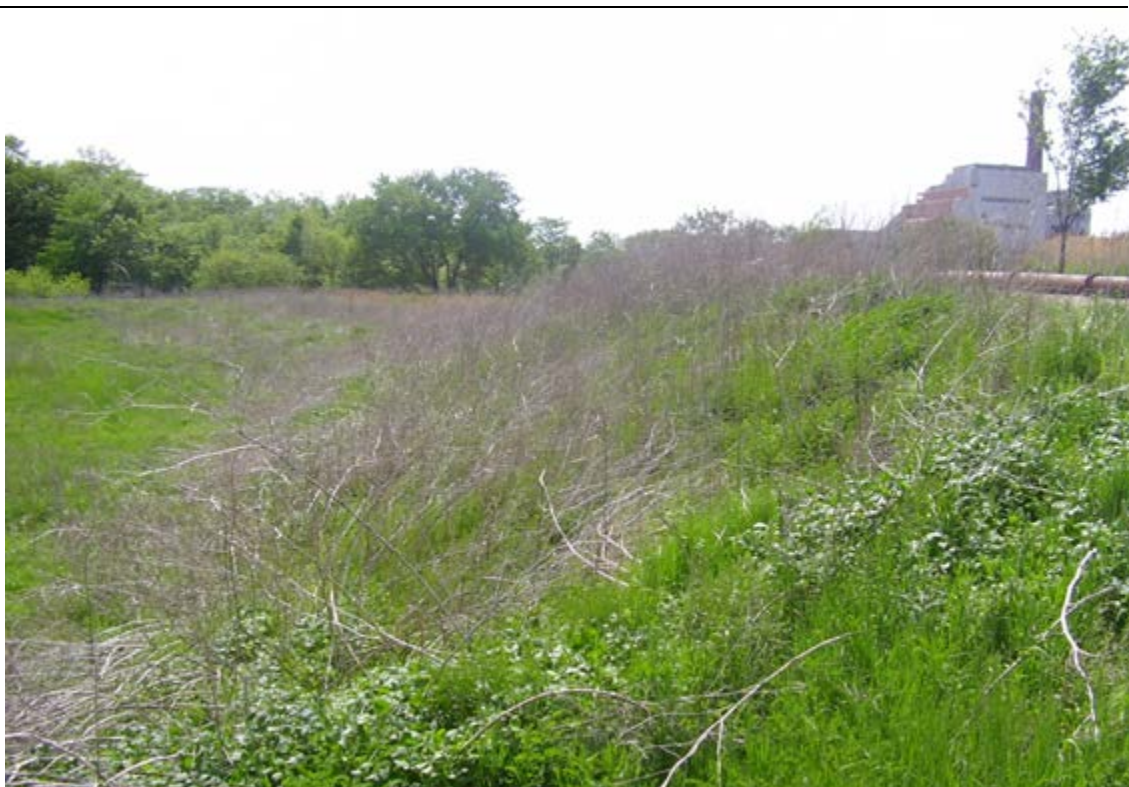
**Photo No.**  
**56**

**Description:**  
Downstream slope of the  
EAPS.

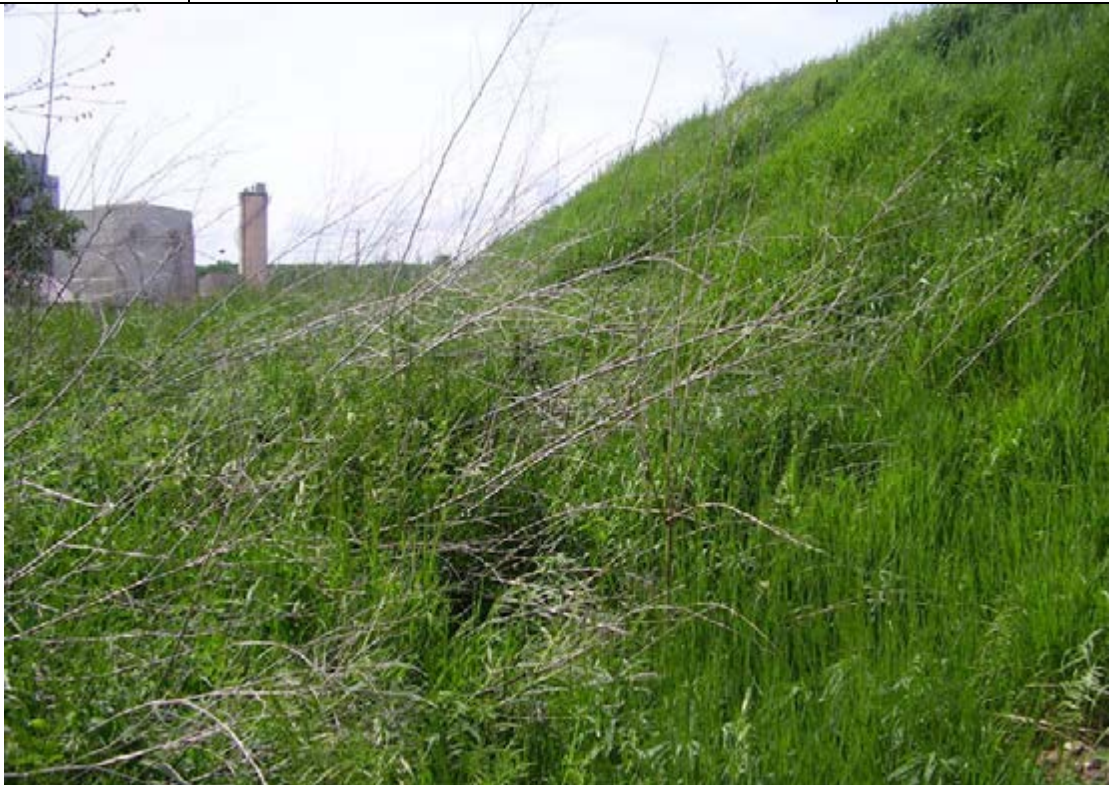
**Description:**  
Downstream slope of the  
EAPS.

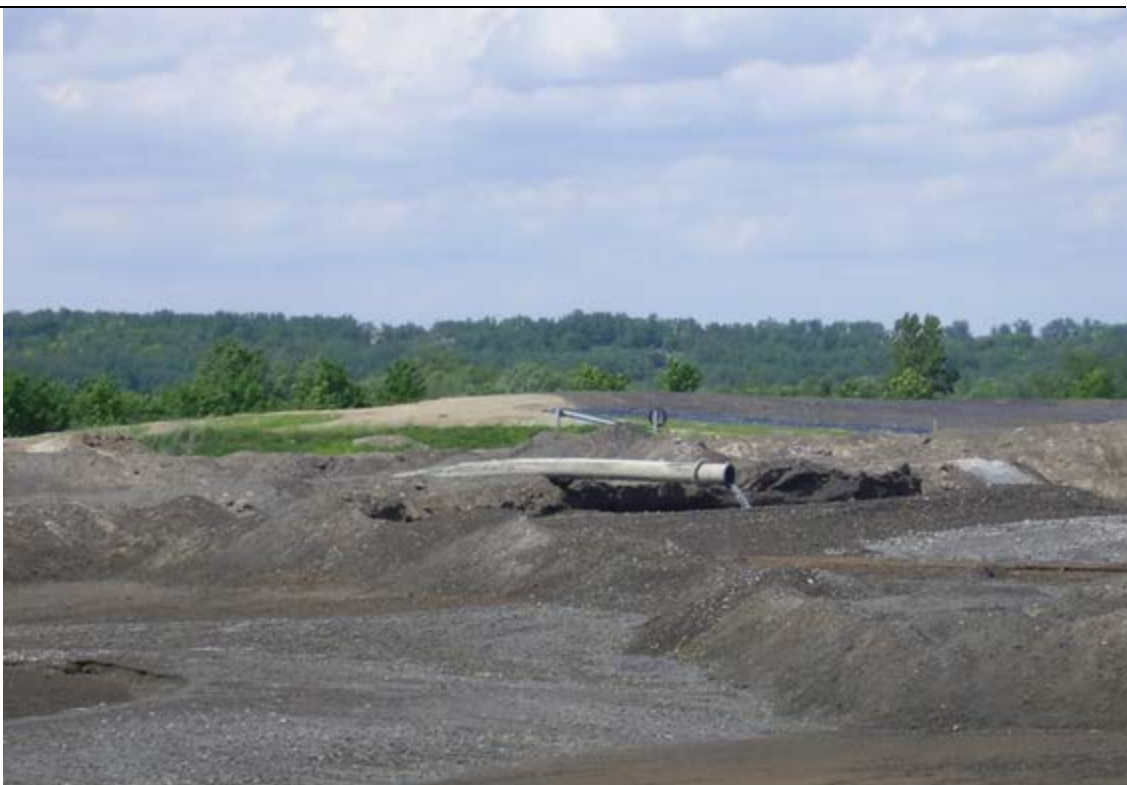
**Photo No.**  
**58**

**Description:**  
Discharge pipe into the  
northwest portion of the  
Primary Cell.

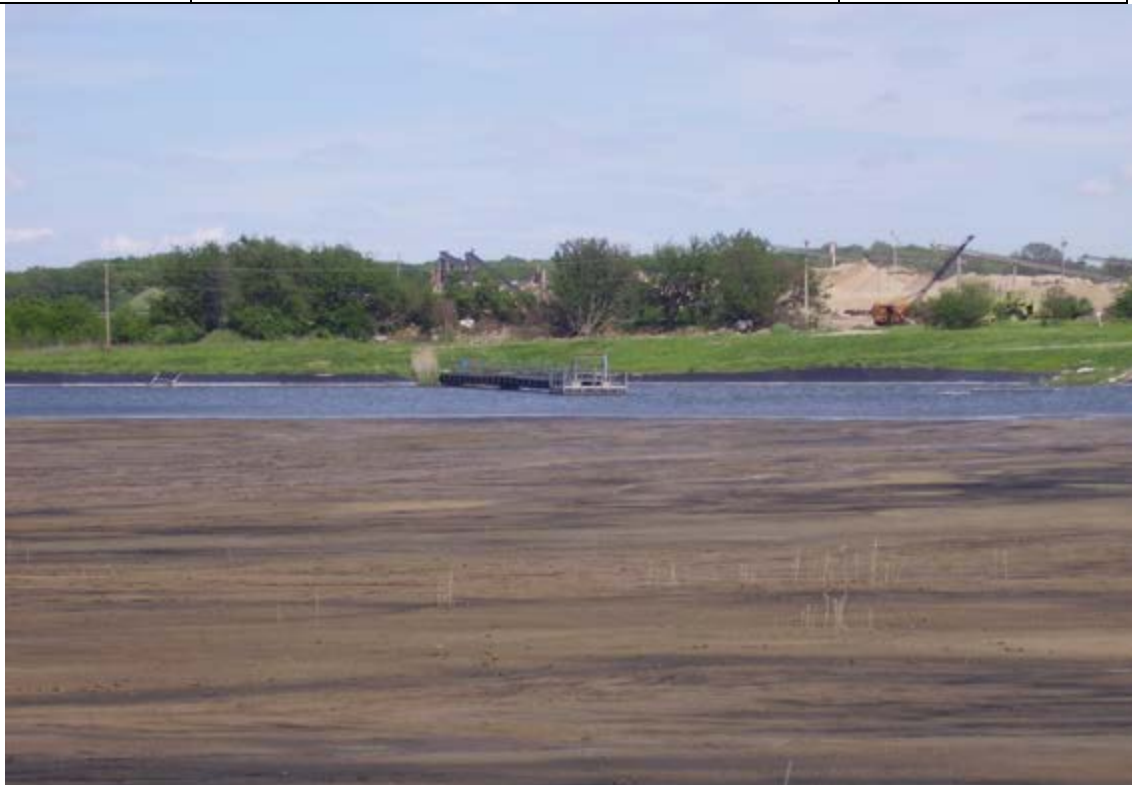
**Description:**  
Old decant structure in the  
Primary Cell.

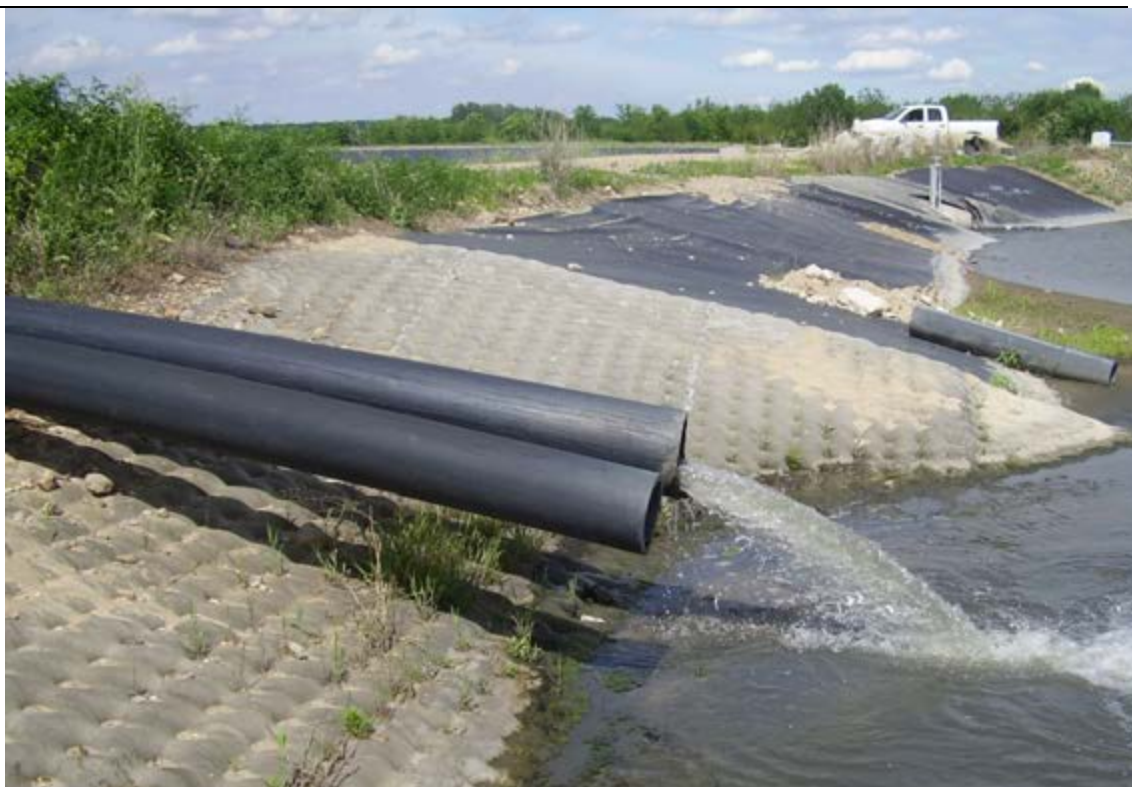
**Photo No.**  
**60**

**Description:**  
Discharge pipe into the  
Primary Cell near the  
northeast corner.

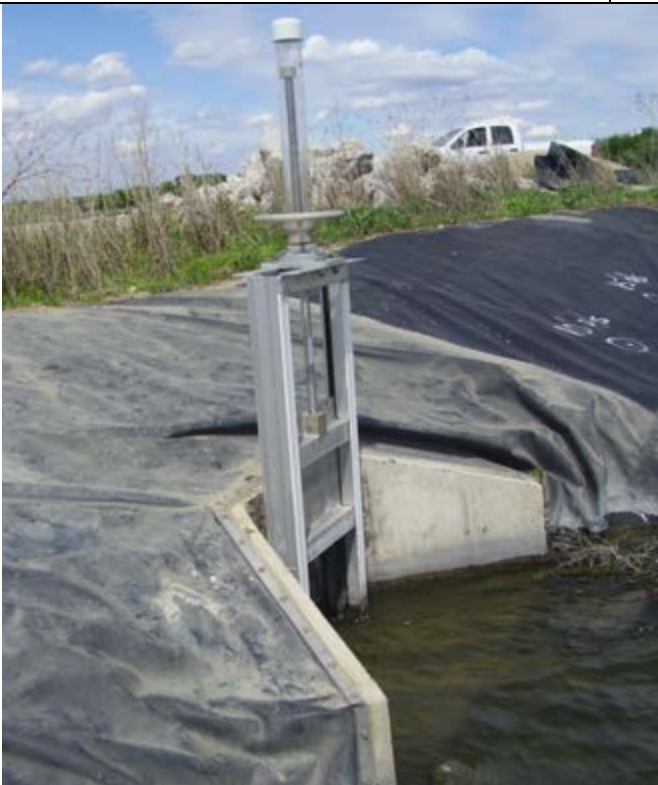
| <b>Photo No.</b><br><b>61</b> | <b>Date:</b><br>5/23/11 | | |

| <b>Description:</b><br>Decant structure in the Primary Cell. | | | |

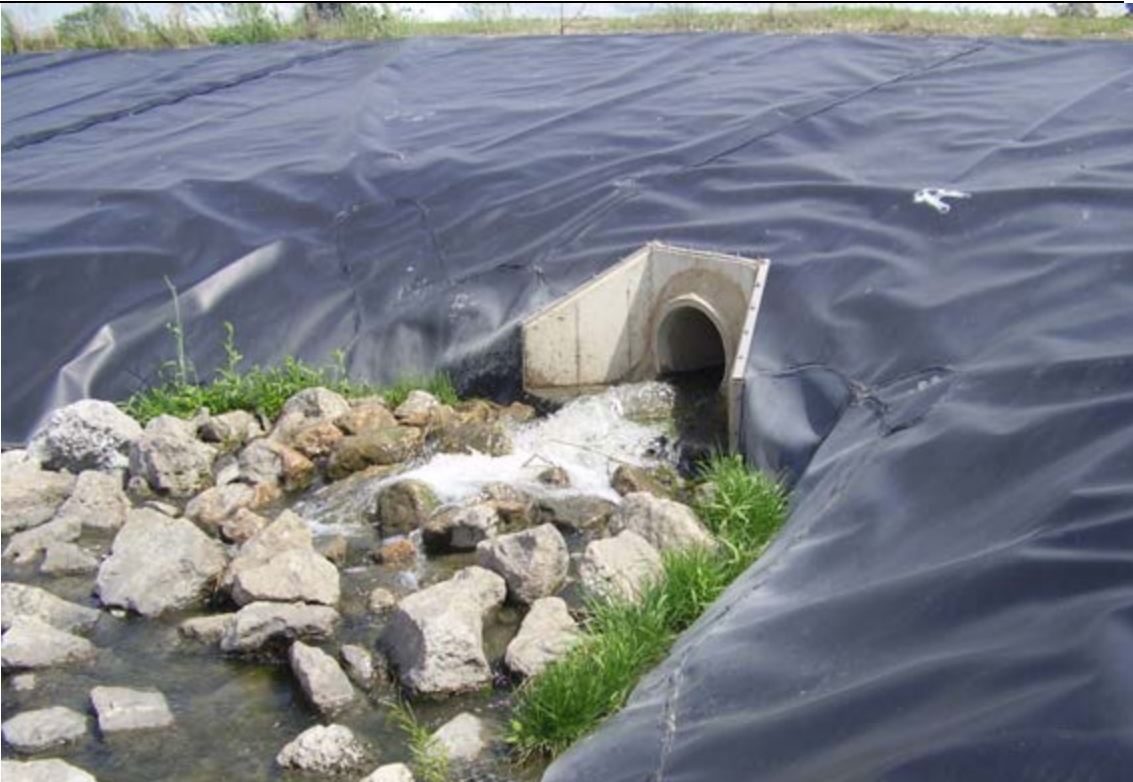
| <b>Photo No.</b><br><b>62</b> | <b>Date:</b><br>5/23/11 | |

| <b>Description:</b><br>Discharge pipe from the Primary Cell to Pond 2E. | | |

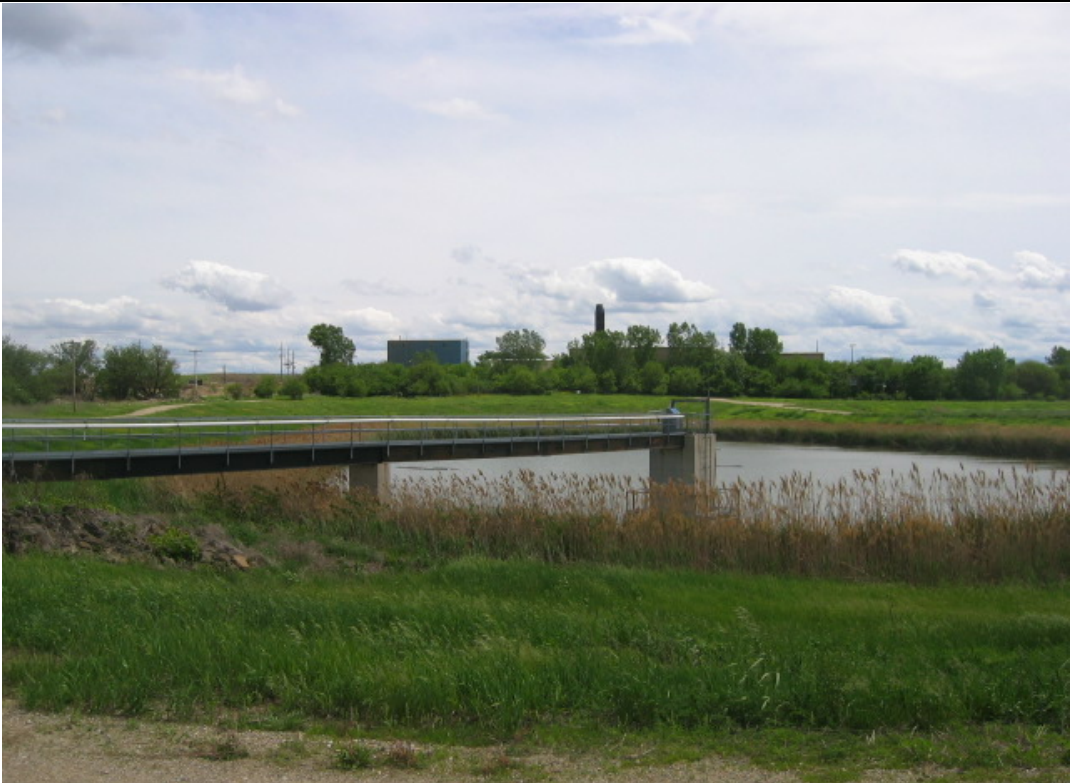
| <b>Photo No.</b><br><b>63</b> | <b>Date:</b><br>5/23/11 | | |

| <b>Description:</b><br>Decant structure in the Secondary Cell. | | | |
