**DRAFT REPORT  
ROUND 10 DAM ASSESSMENT - MAY 23, 2011  
DYNEGY MIDWEST GENERATION, INC. – HENNEPIN POWER STATION  
ACTIVE EAST ASH POND SYSTEM, EAST ASH POND SYSTEM, WEST ASH POND  
SYSTEM  
HENNEPIN, ILLINOIS**

RE: DRAFT Assessment of Dam Safety of Coal Combustion Surface Impoundments at the  
Hennepin Power Station

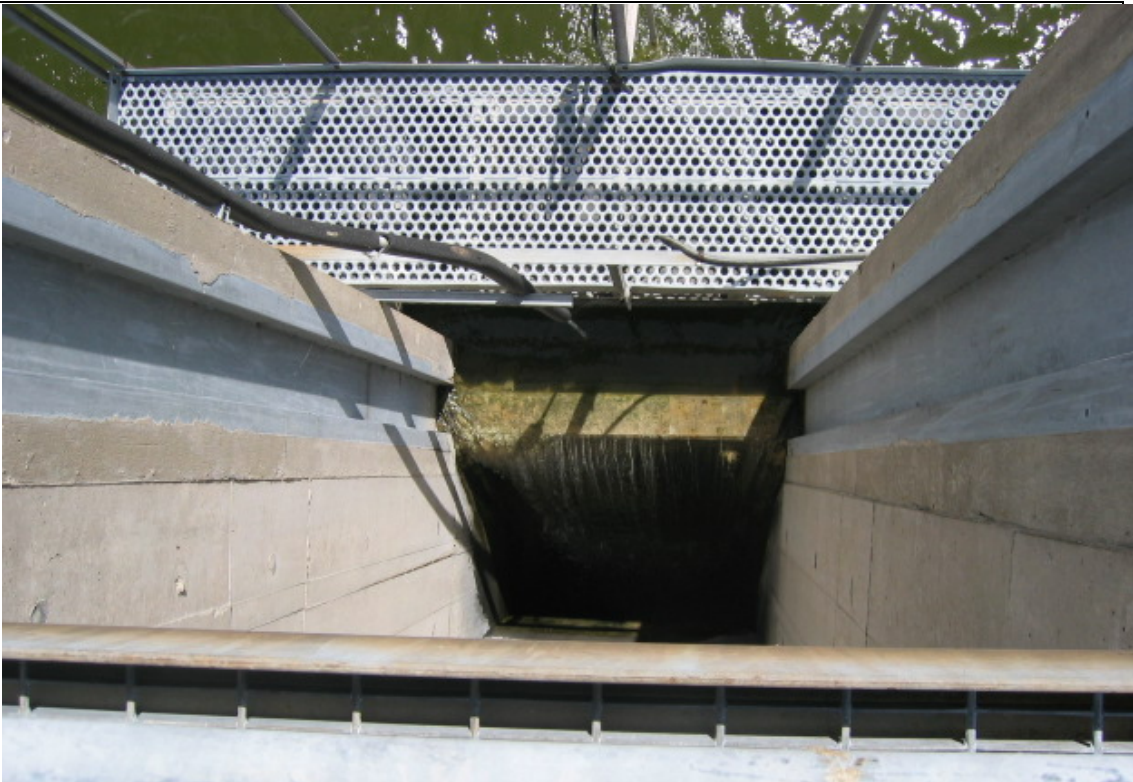
| <b>Photo No.</b><br><b>64</b> | <b>Date:</b><br>5/23/11 | |

| <b>Description:</b><br>Decant structure in the Secondary Cell. | | |

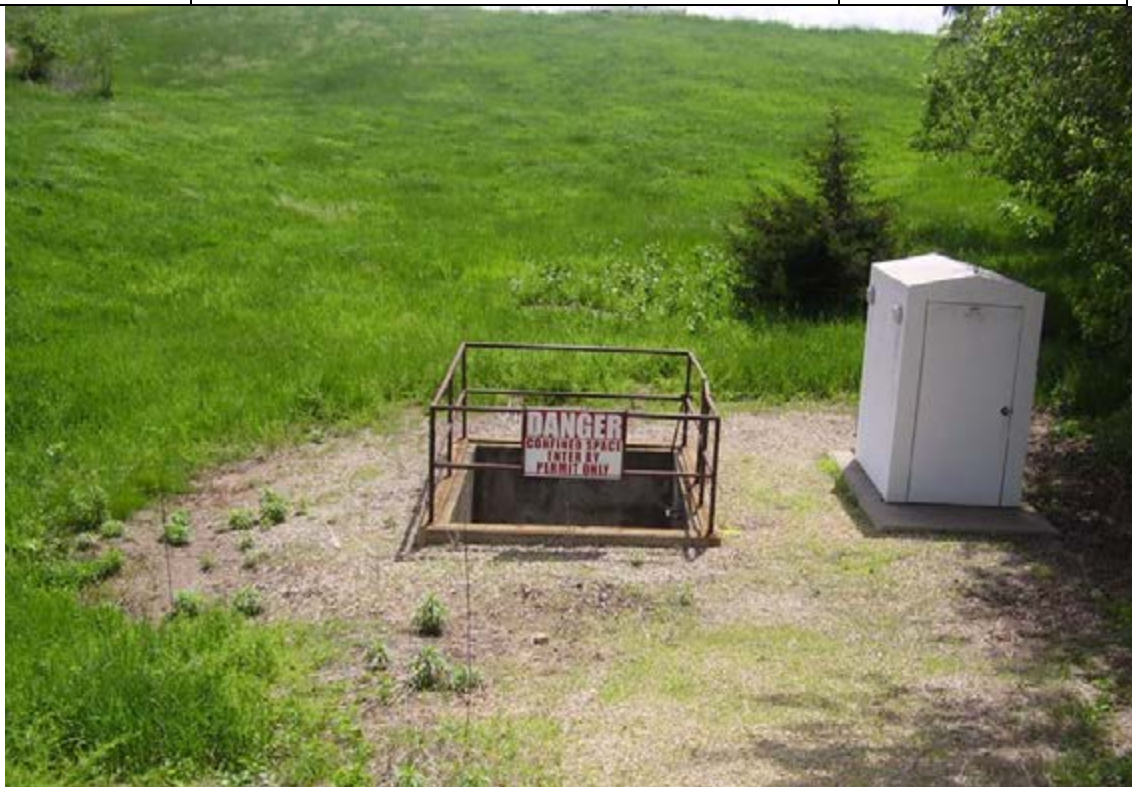
Surface features of the flume structure in the discharge line from the Secondary Cell to the Illinois River.

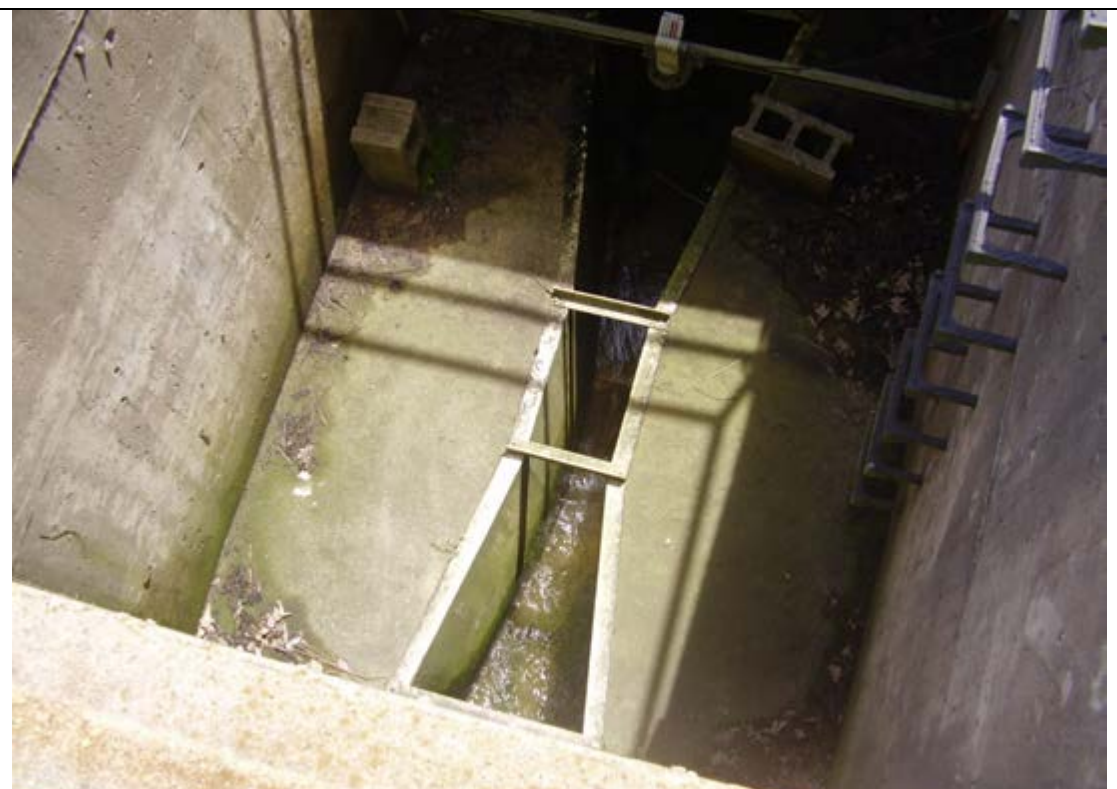
**Photo No.**  
**66**

Flume structure in the discharge line from the Secondary Cell to the Illinois River.

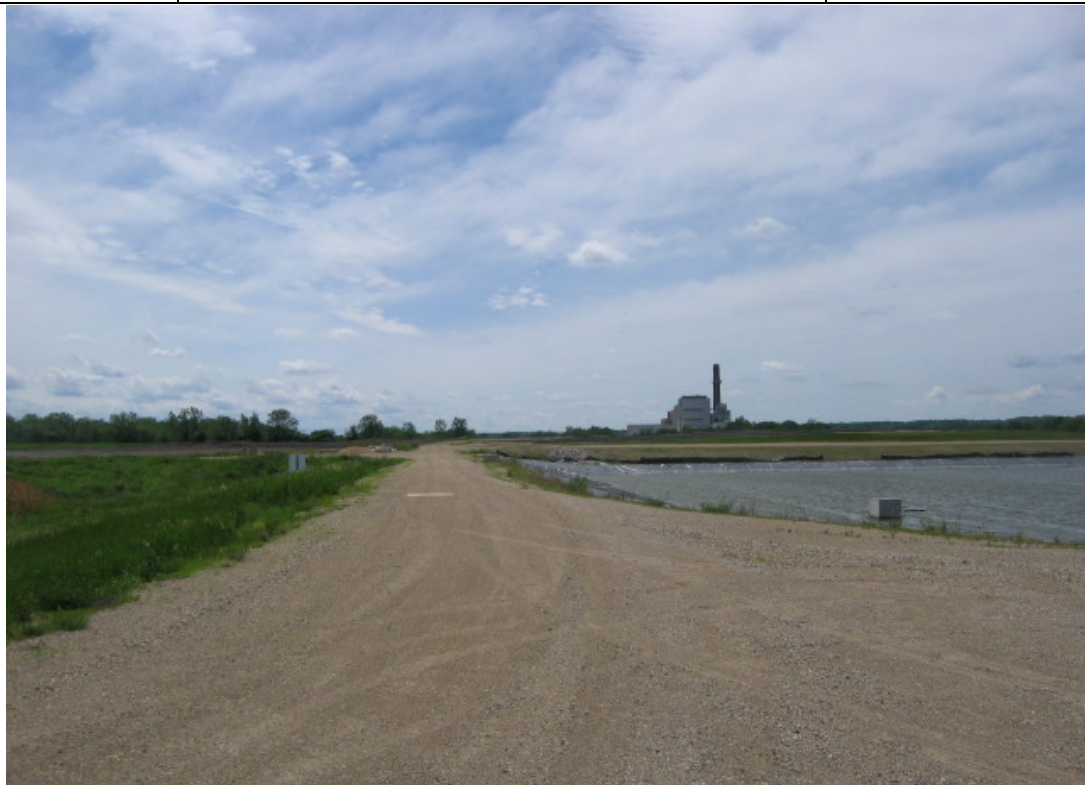
Crest of the interior  
embankment in the AEAPS  
with the Pond 2E decant  
structure shown.

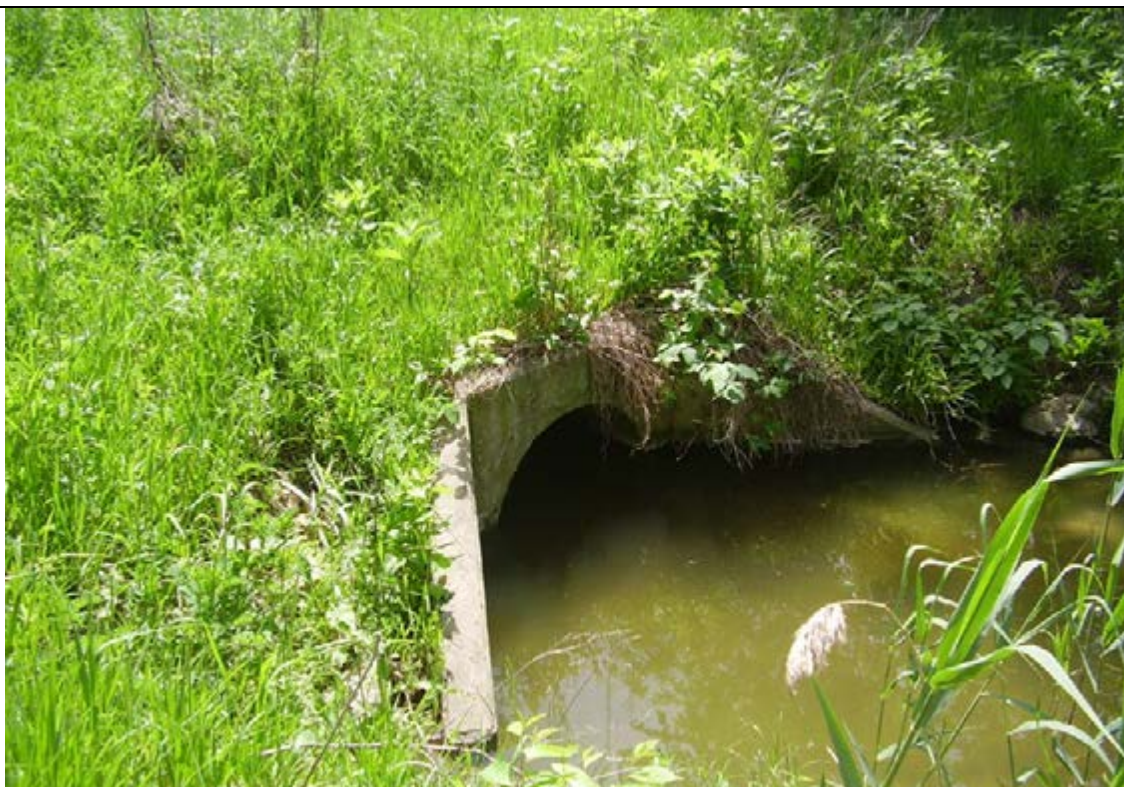
Outfall at the Illinois River.

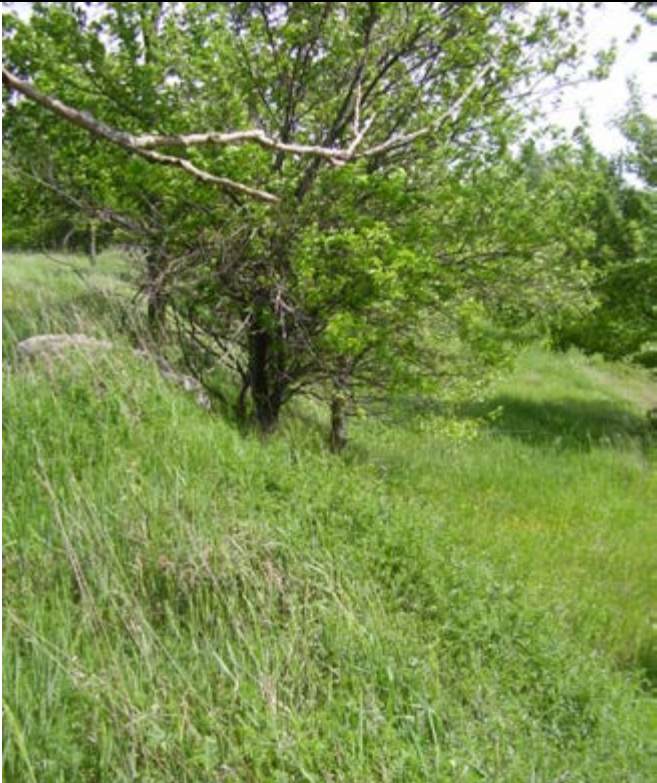
| <b>Photo No.</b><br><b>69</b> | <b>Date:</b><br>5/23/11 | | |

| <b>Description:</b><br>Downstream slope of EAPS near Pond 4. | | | |

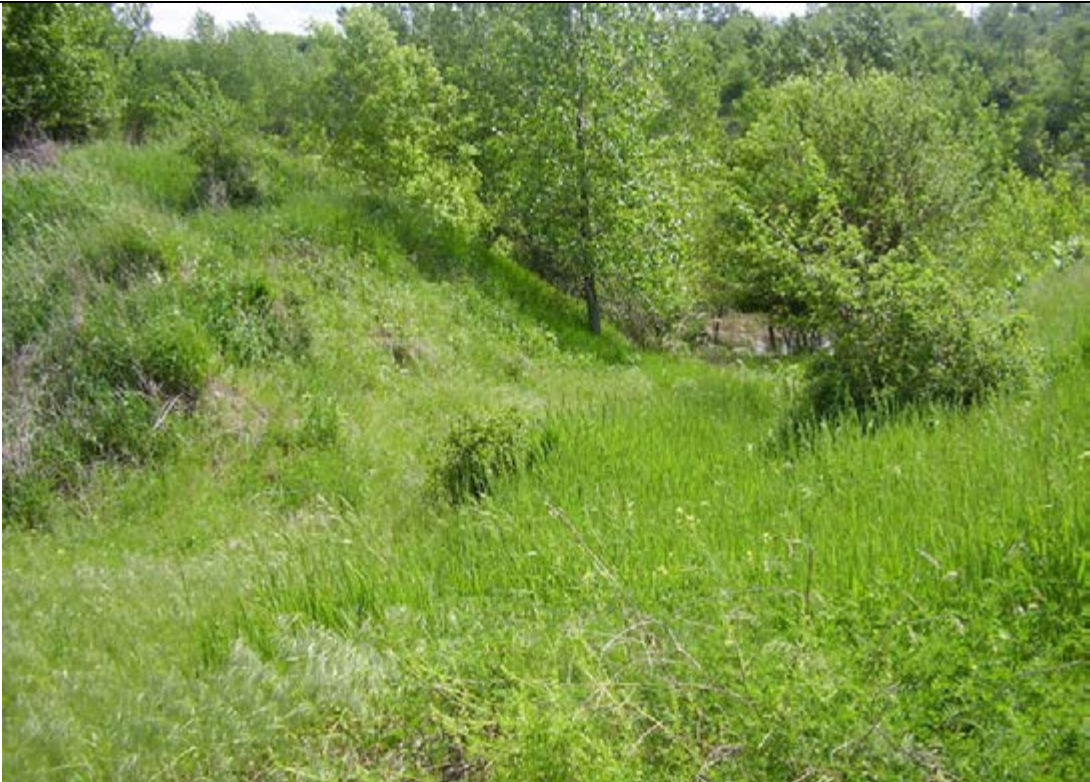
| <b>Photo No.</b><br><b>70</b> | <b>Date:</b><br>5/23/11 | |

| <b>Description:</b><br>Downstream slope of the EAPS near Pond 4. | | |

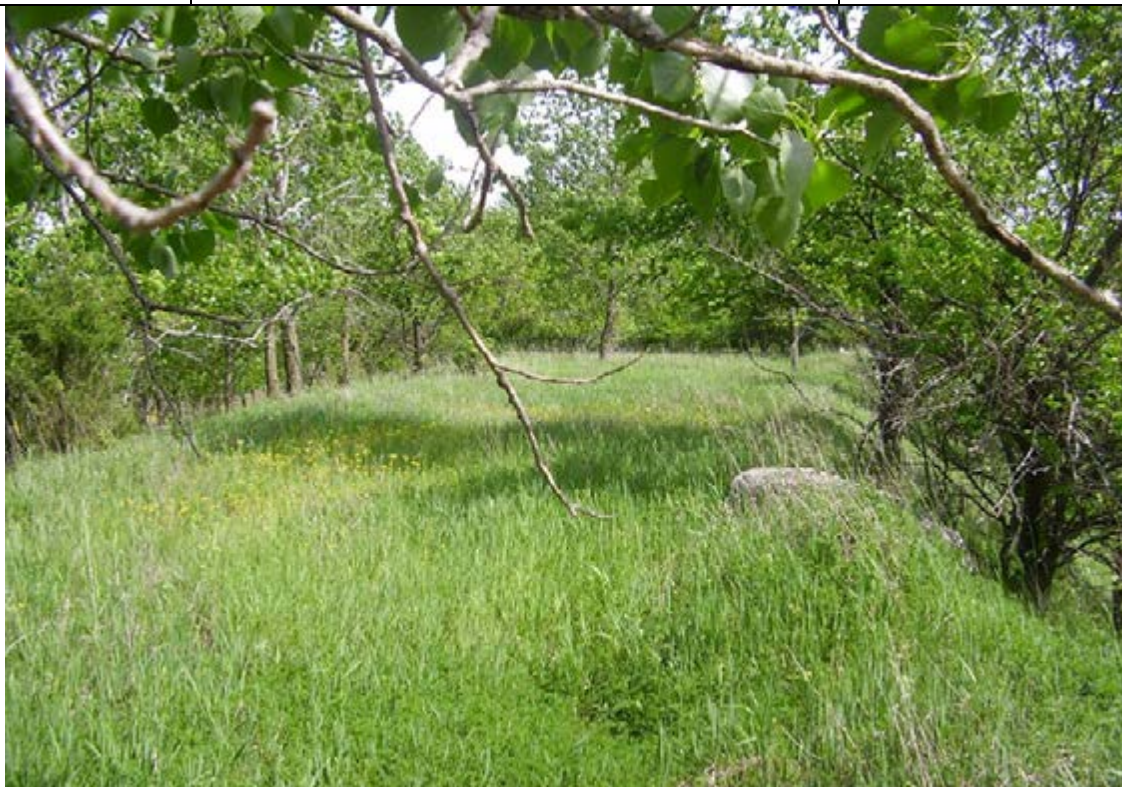
**Description:**  
Crest of the EAPS near Pond  
4.

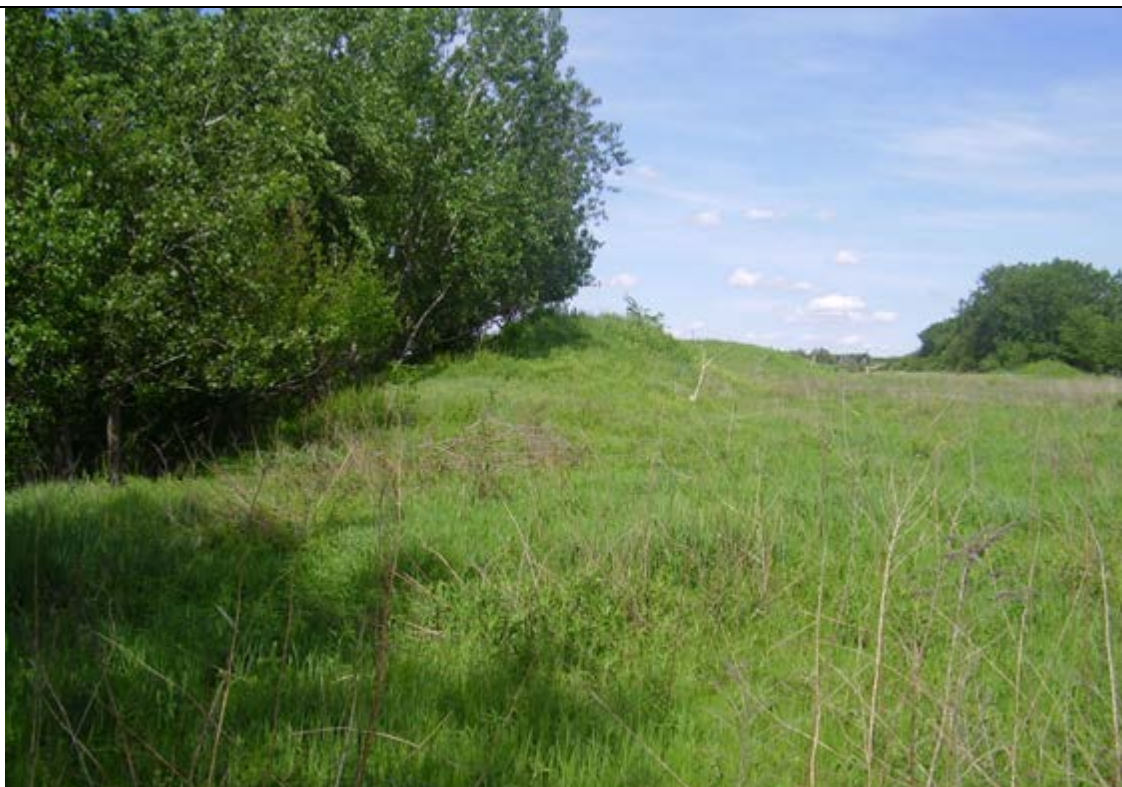
**Photo No.**  
**72**

**Description:**  
Crest of the EAPS near Pond  
4.

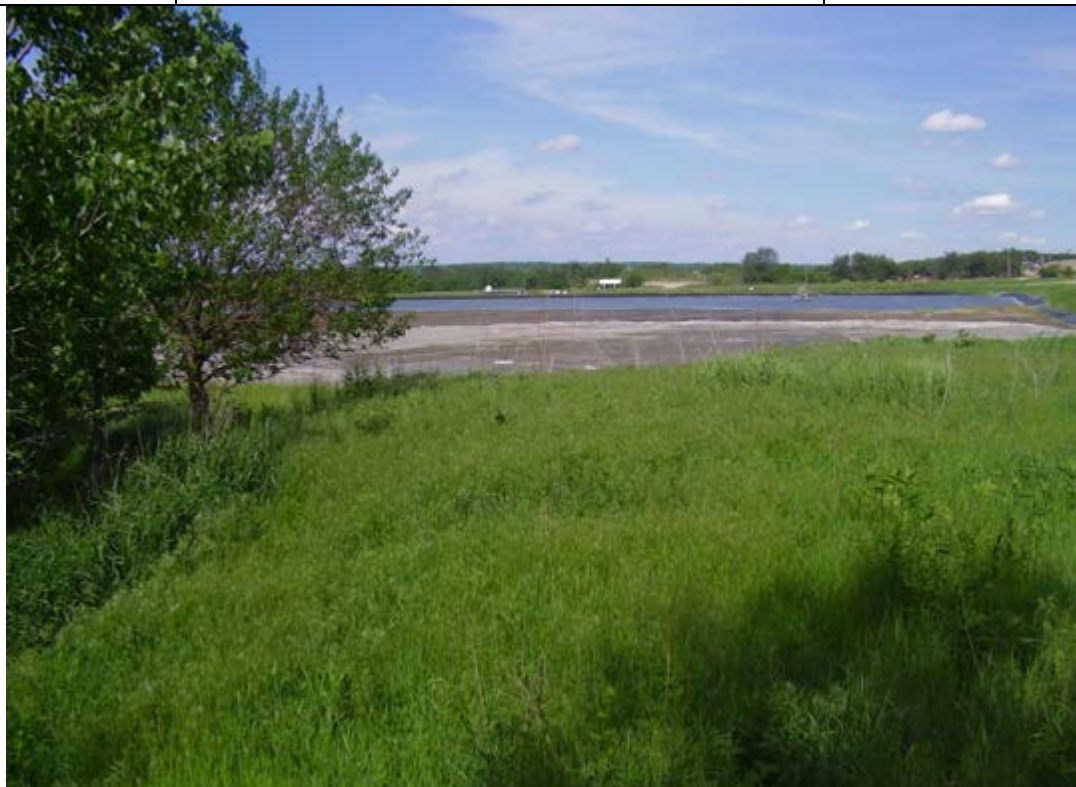
**Description:**  
Crest of the EAPS looking  
over the Primary Cell.

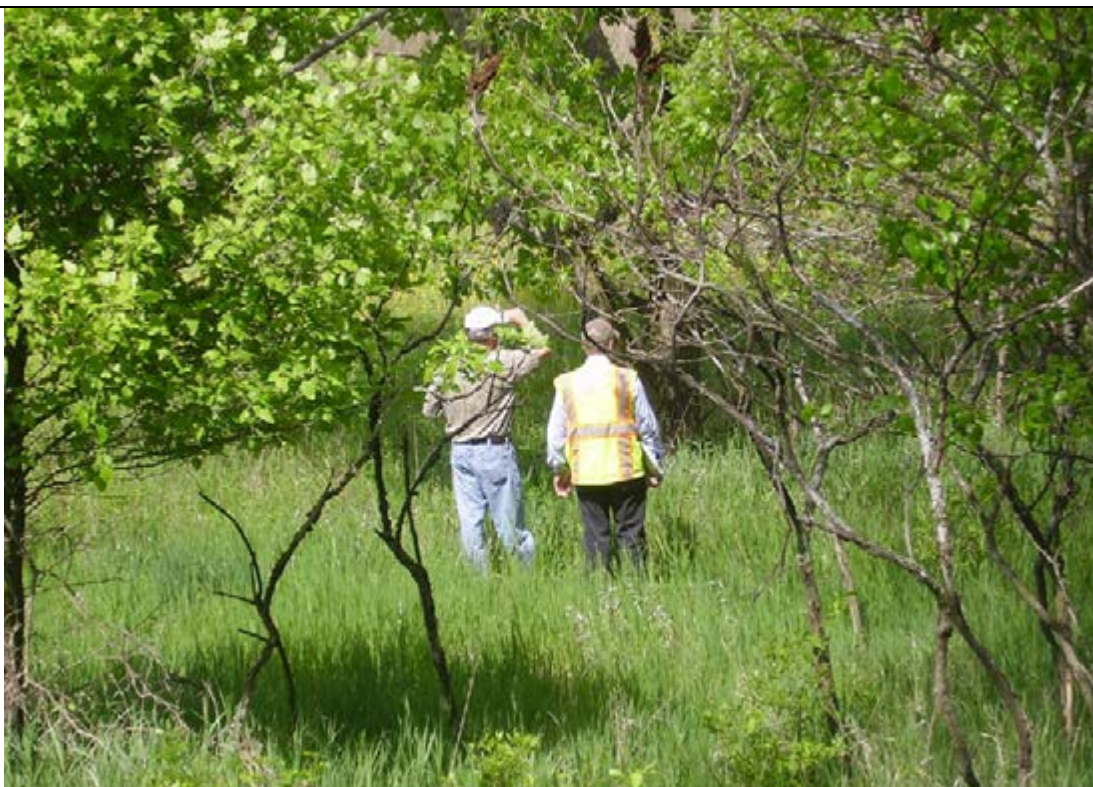
**Photo No.**  
**74**

**Description:**  
Crest of the EAPS near Pond  
4.
