Re: Responses to Recommendations in Final Coal Combustion Waste Impoundment  
Round 7 - Dam Assessment Report for Riverside Generating Station

## Riverside Generating Station Recommendations

Re: Geotechnical Report Addendum No. 2  
Revised Global Stability Analyses  
South Ash Containment Pond Embankments  
Riverside Generating Station  
Bettendorf, Iowa  
Terracon Project No. 07105081/02105081G

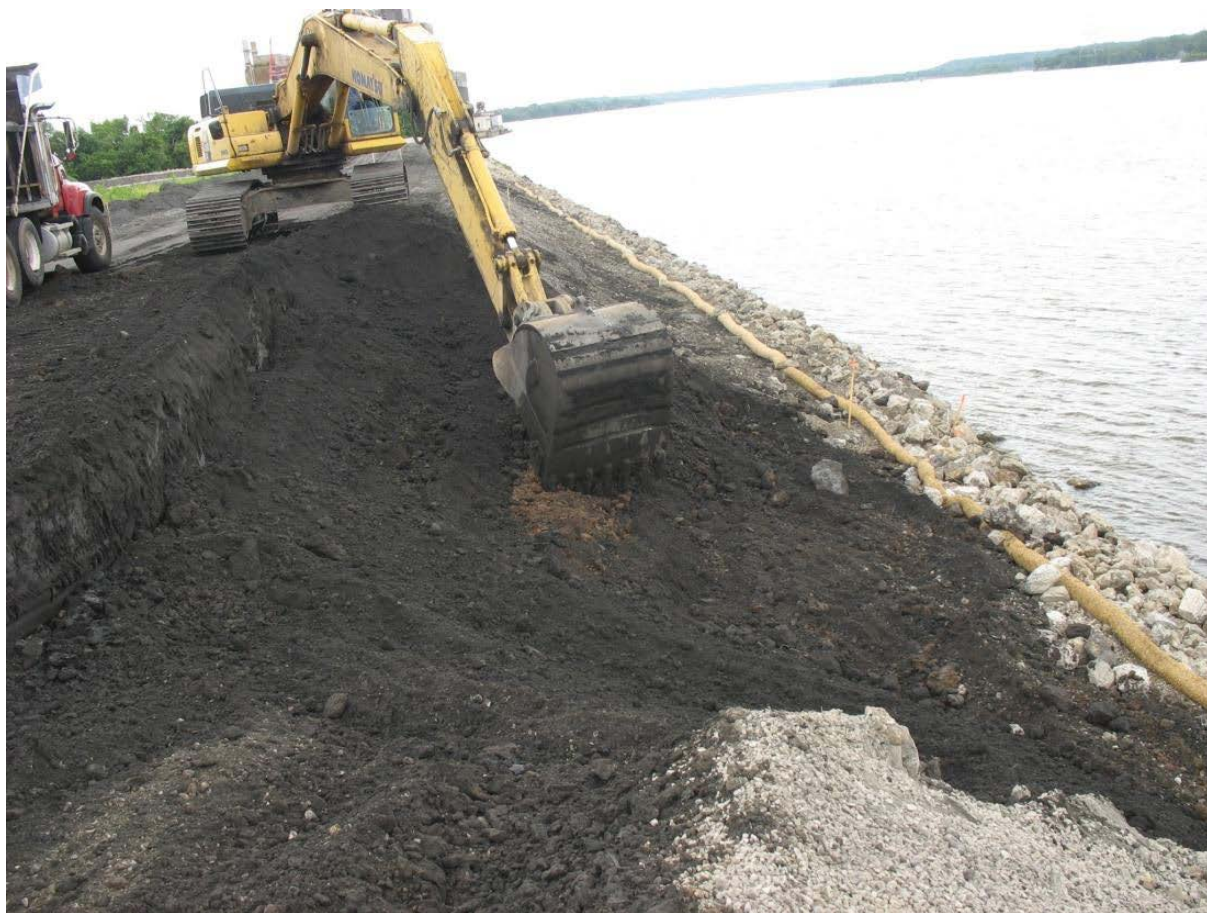
Excavating embankment at about Station 11+50

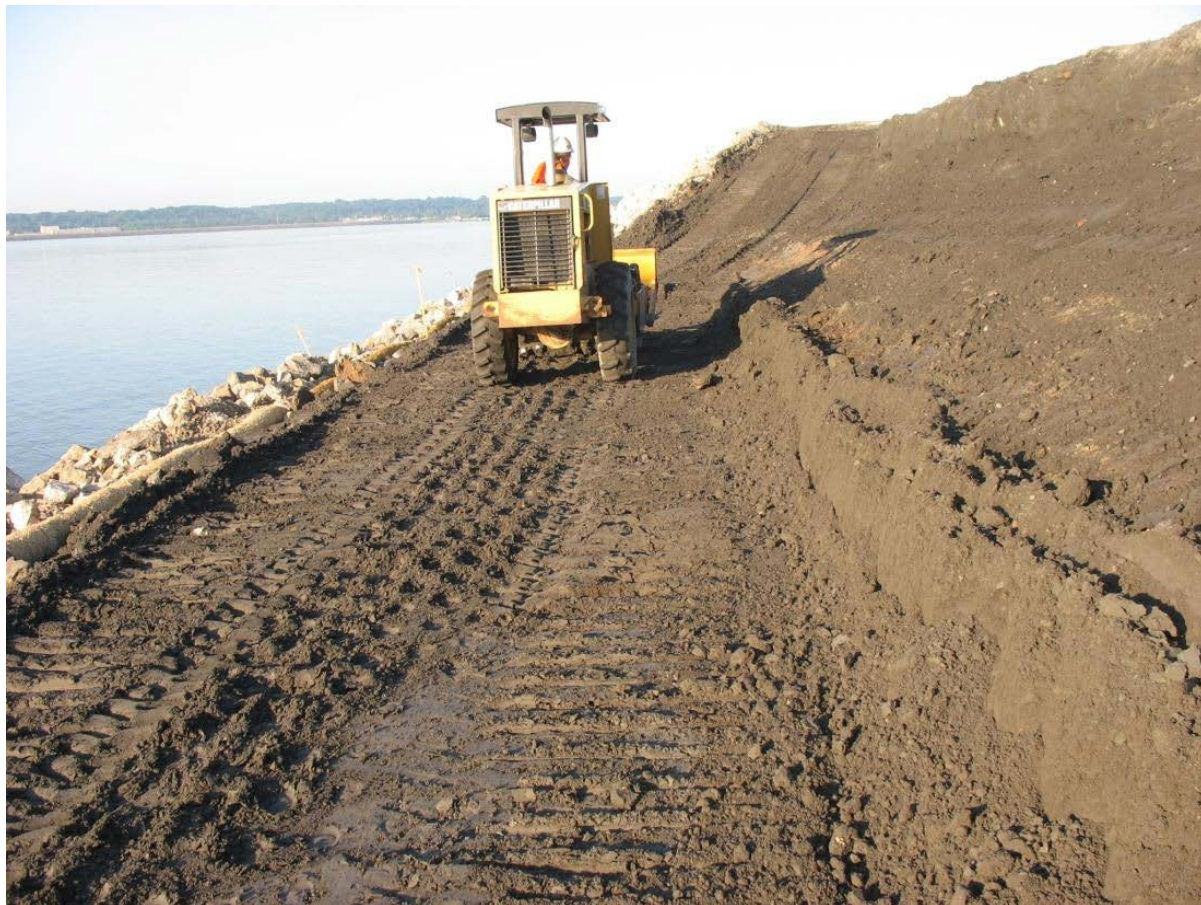
Proof rolling base of excavation at about Station 12+50

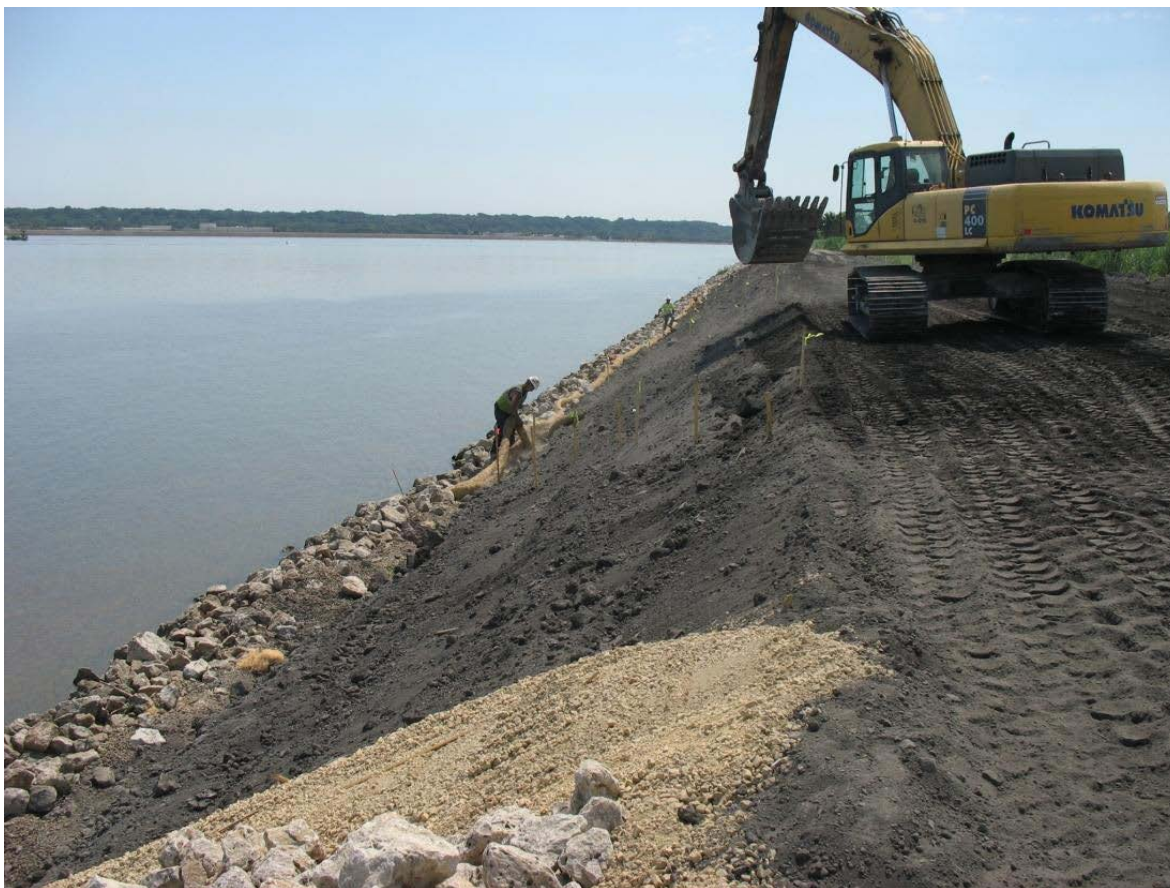
Dressing up slope before placement of bedding material

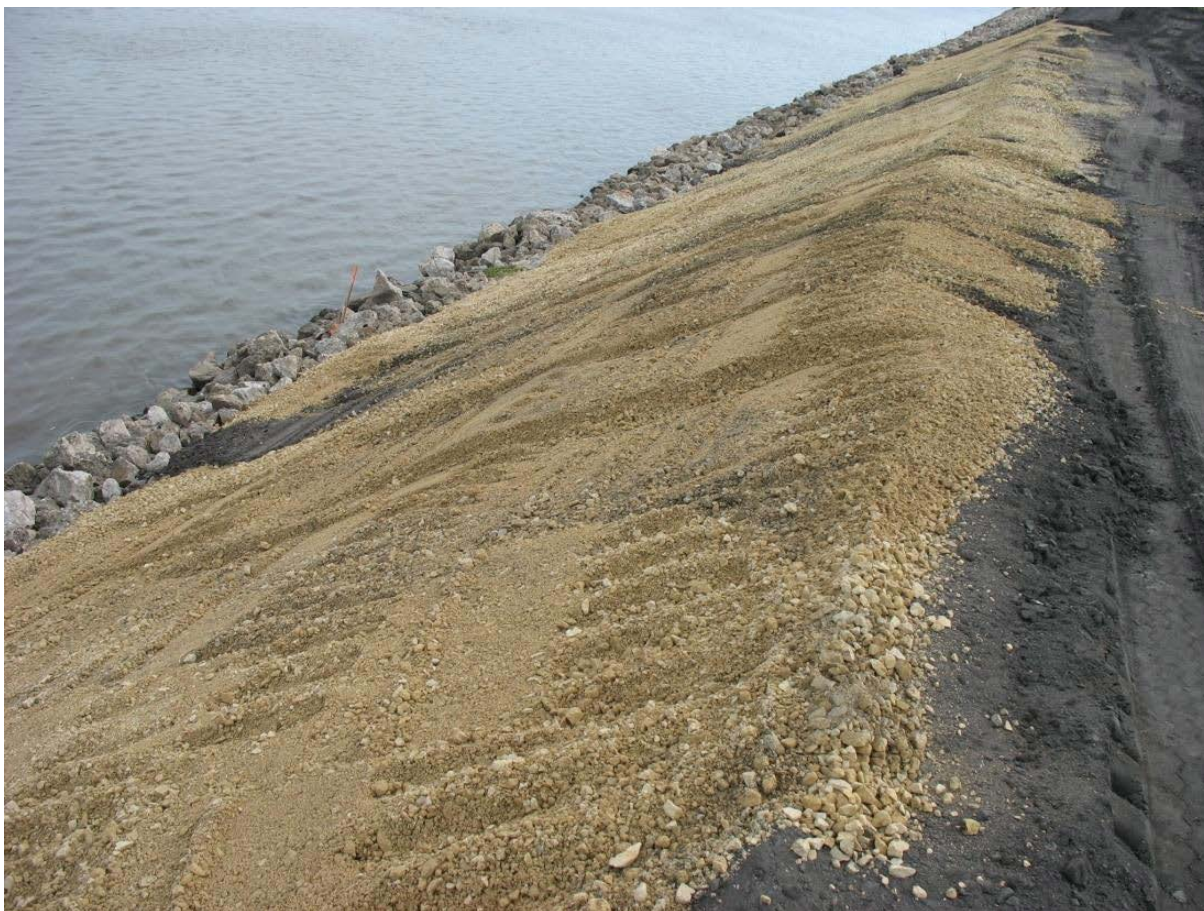
Bedding material on improved slope  
Direction Looking: South

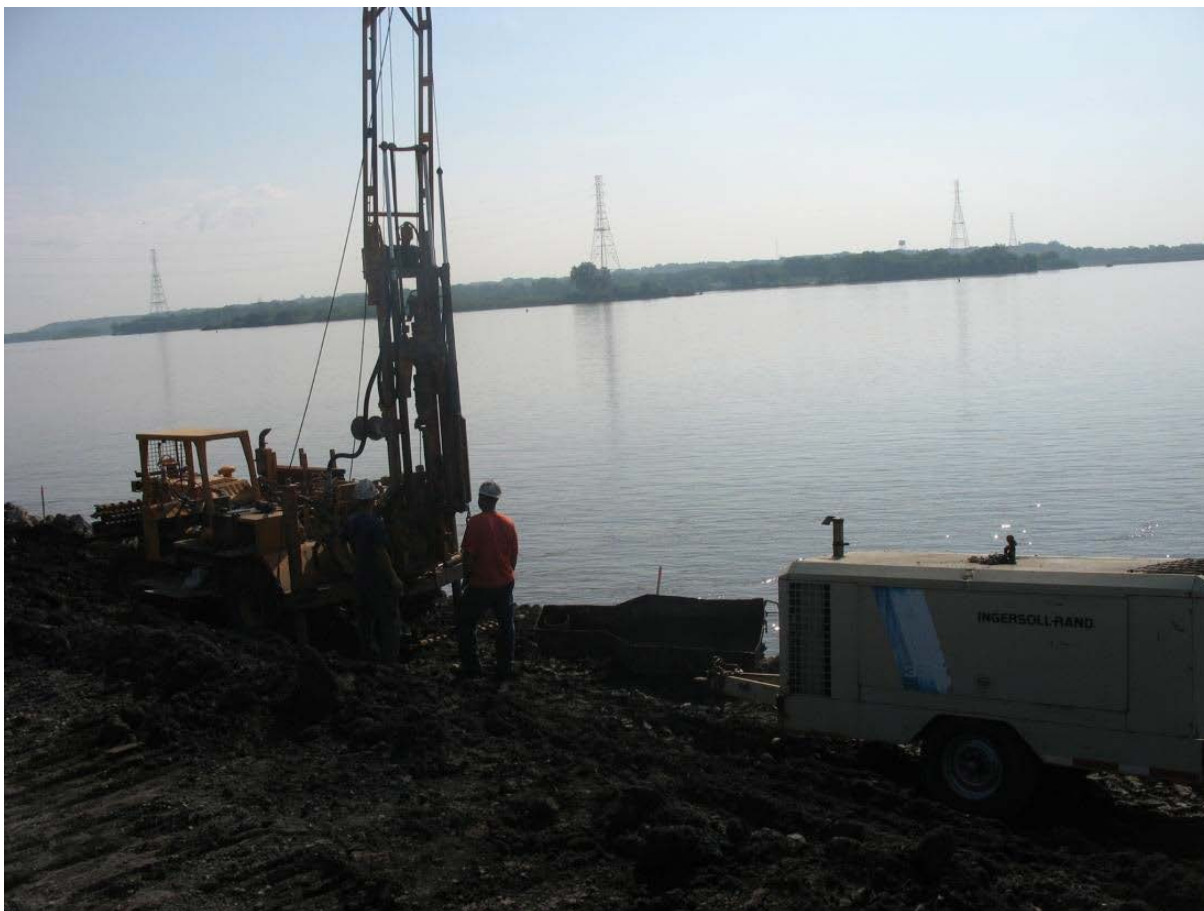
Additional borings being drilled at about Station 7+55 at toe of levee  
Direction Looking: Northeast  
Date: 07/26/2011

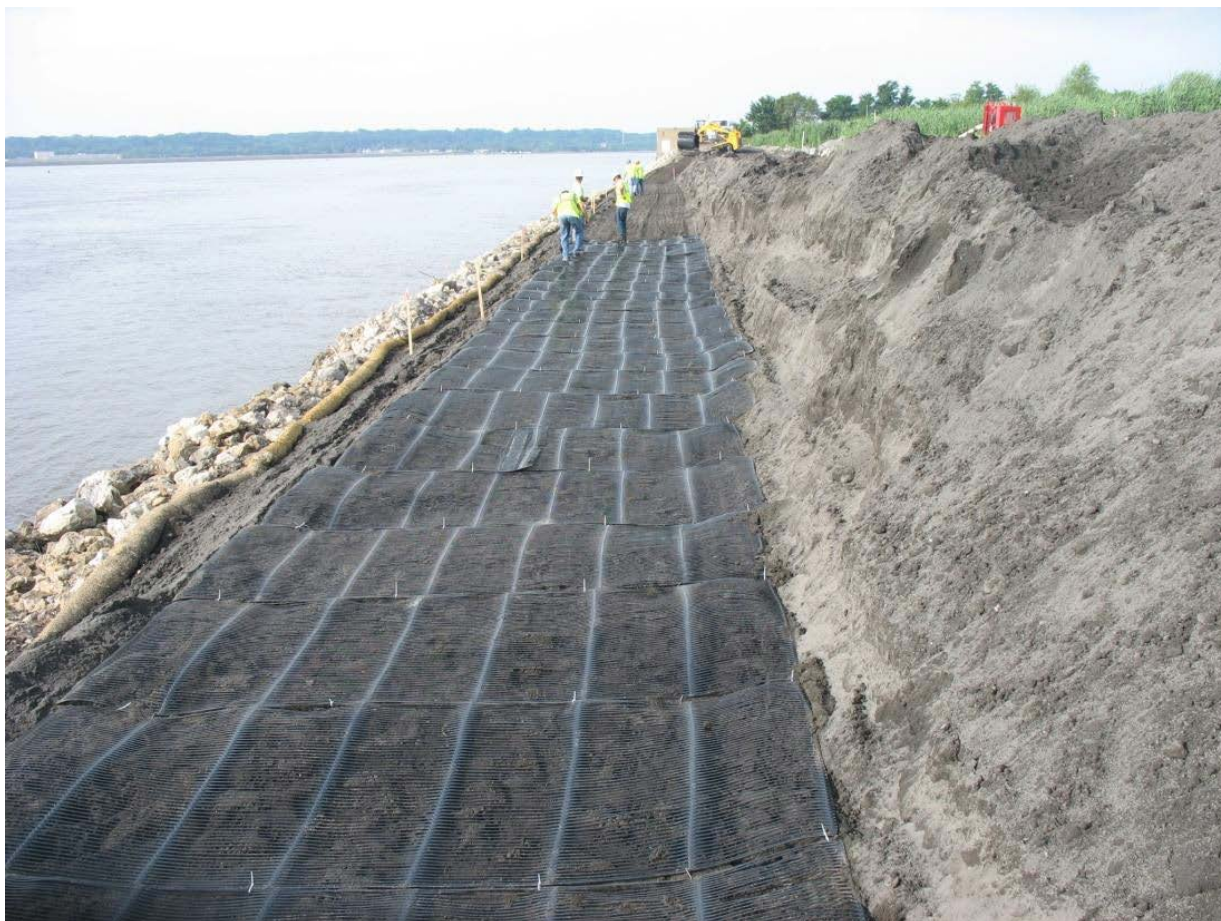
Geogrid placed at elevation 566' from about Station 6+00 to about Station 8+95  
Direction Looking: South  
Date: 07/27/2011

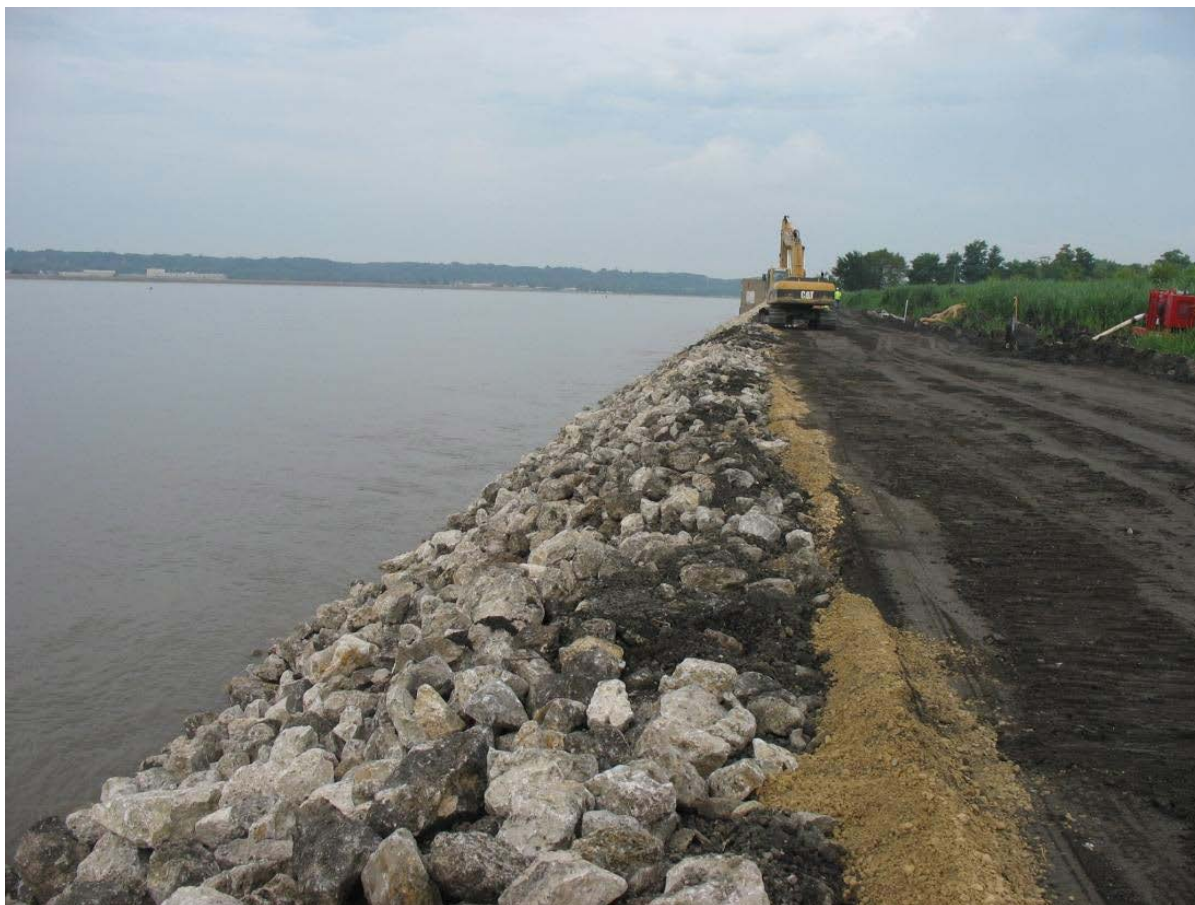
Improved slope at about Station 8+00  
Direction Looking: South

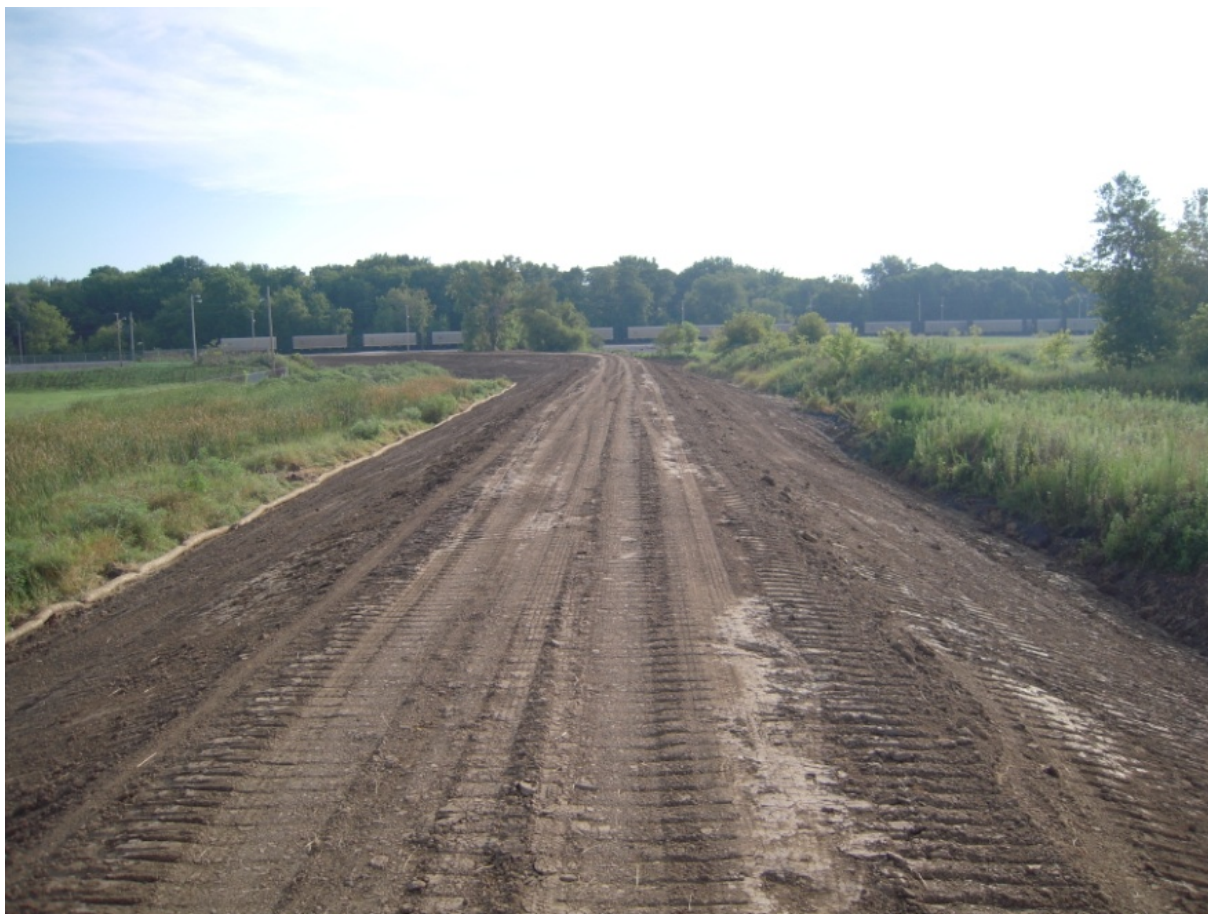
North Pond Embankment after removal of stumps and dressing up  
Direction: Looking North Date: 8/15/2011

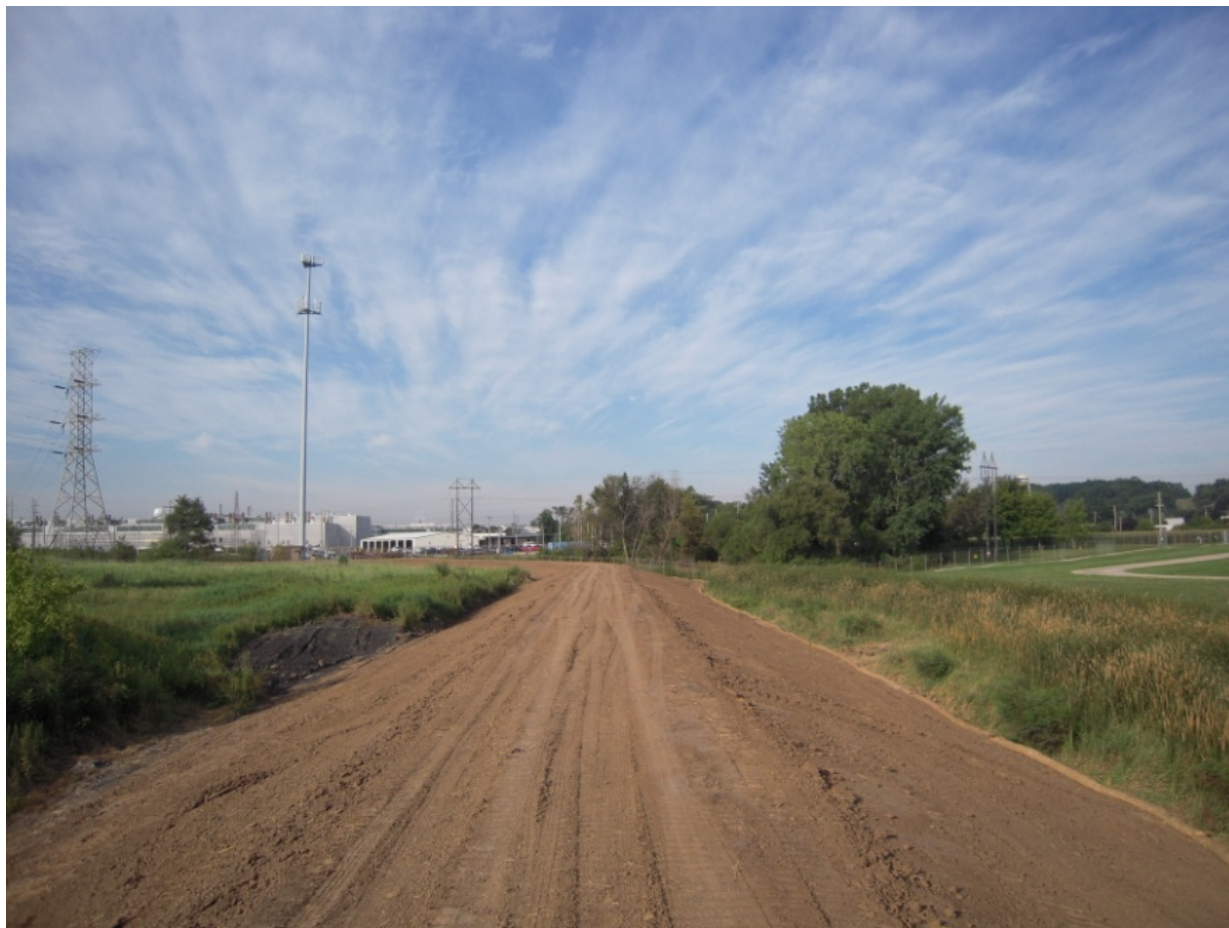
North Pond Embankment after removal of stumps and dressing up  
Direction: Looking Southeast      Date: 8/15/2011

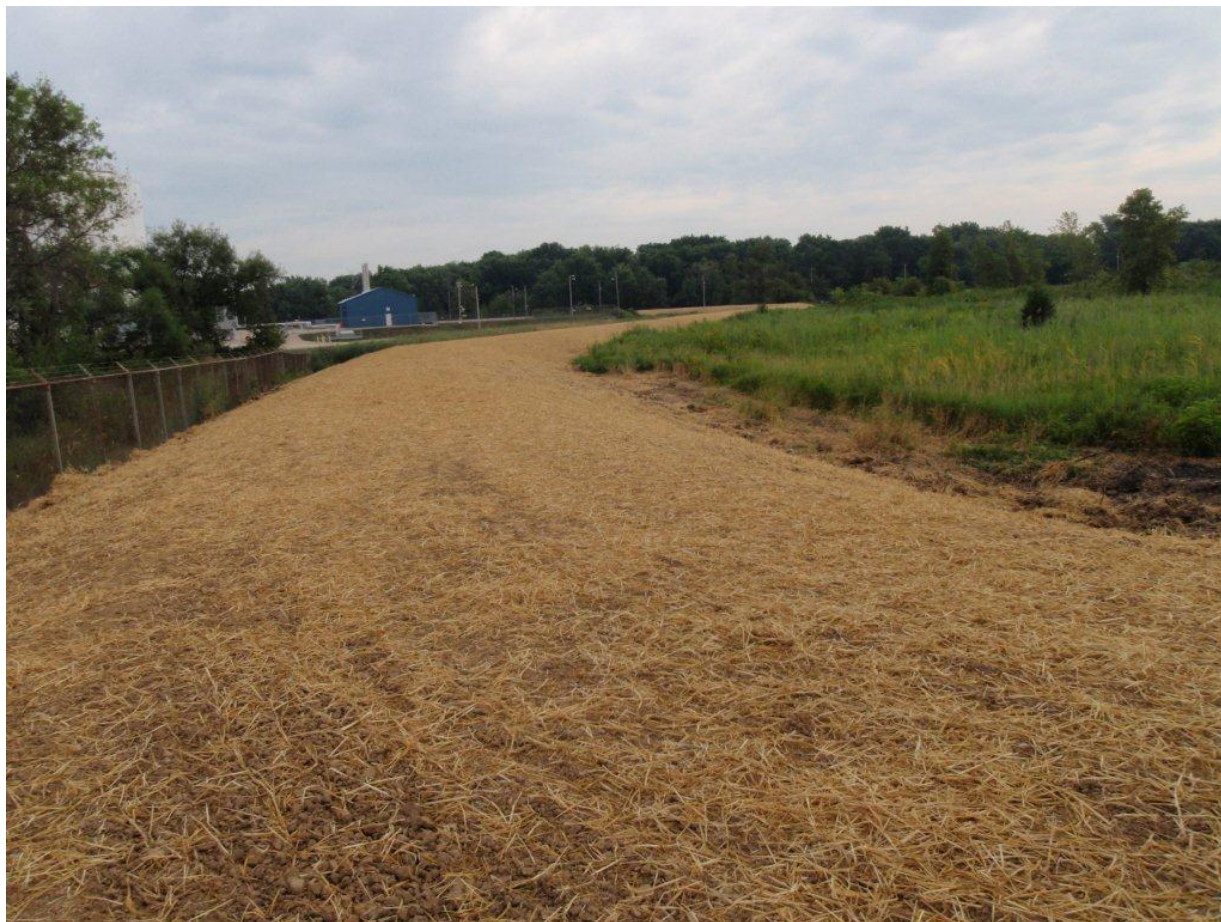
North Pond Embankment after seeding

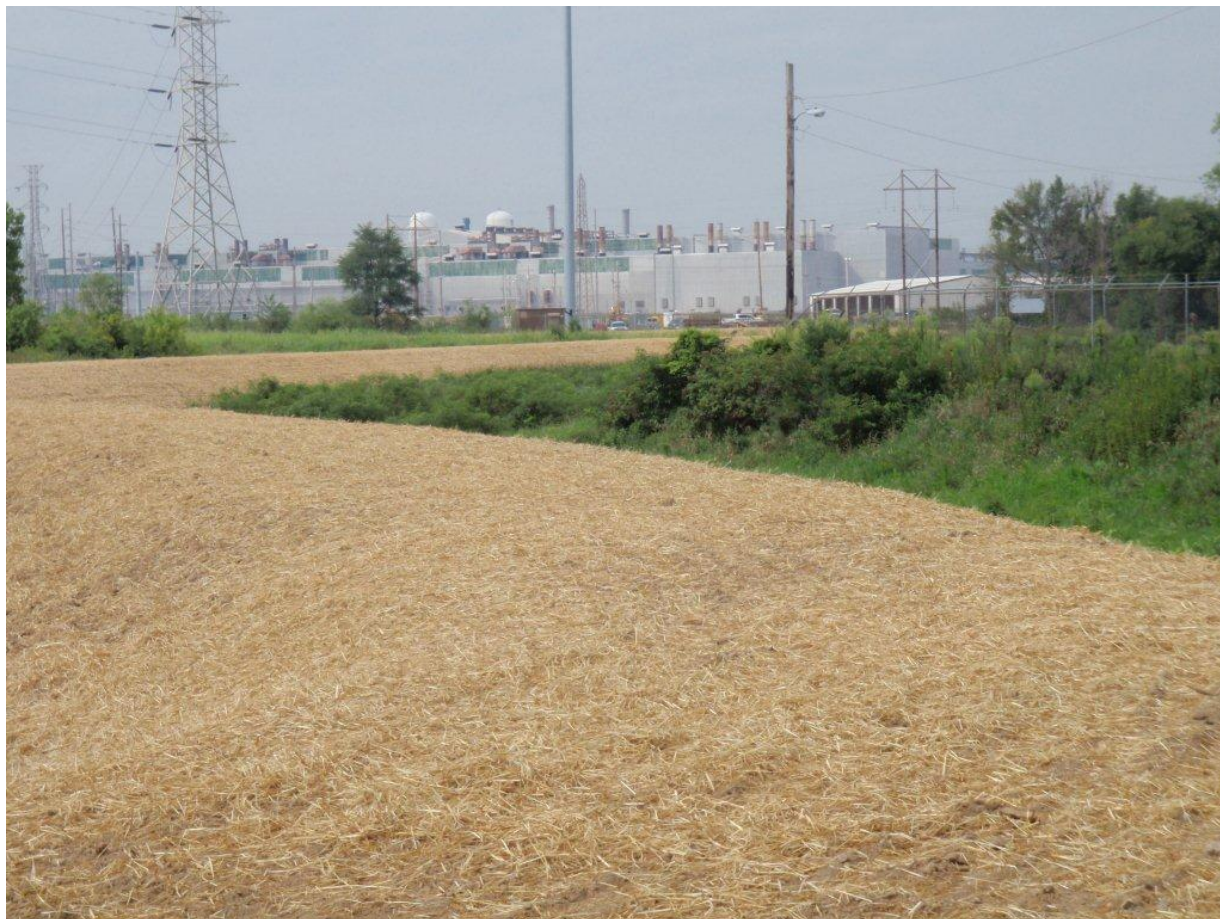
North Pond Embankment after seeding

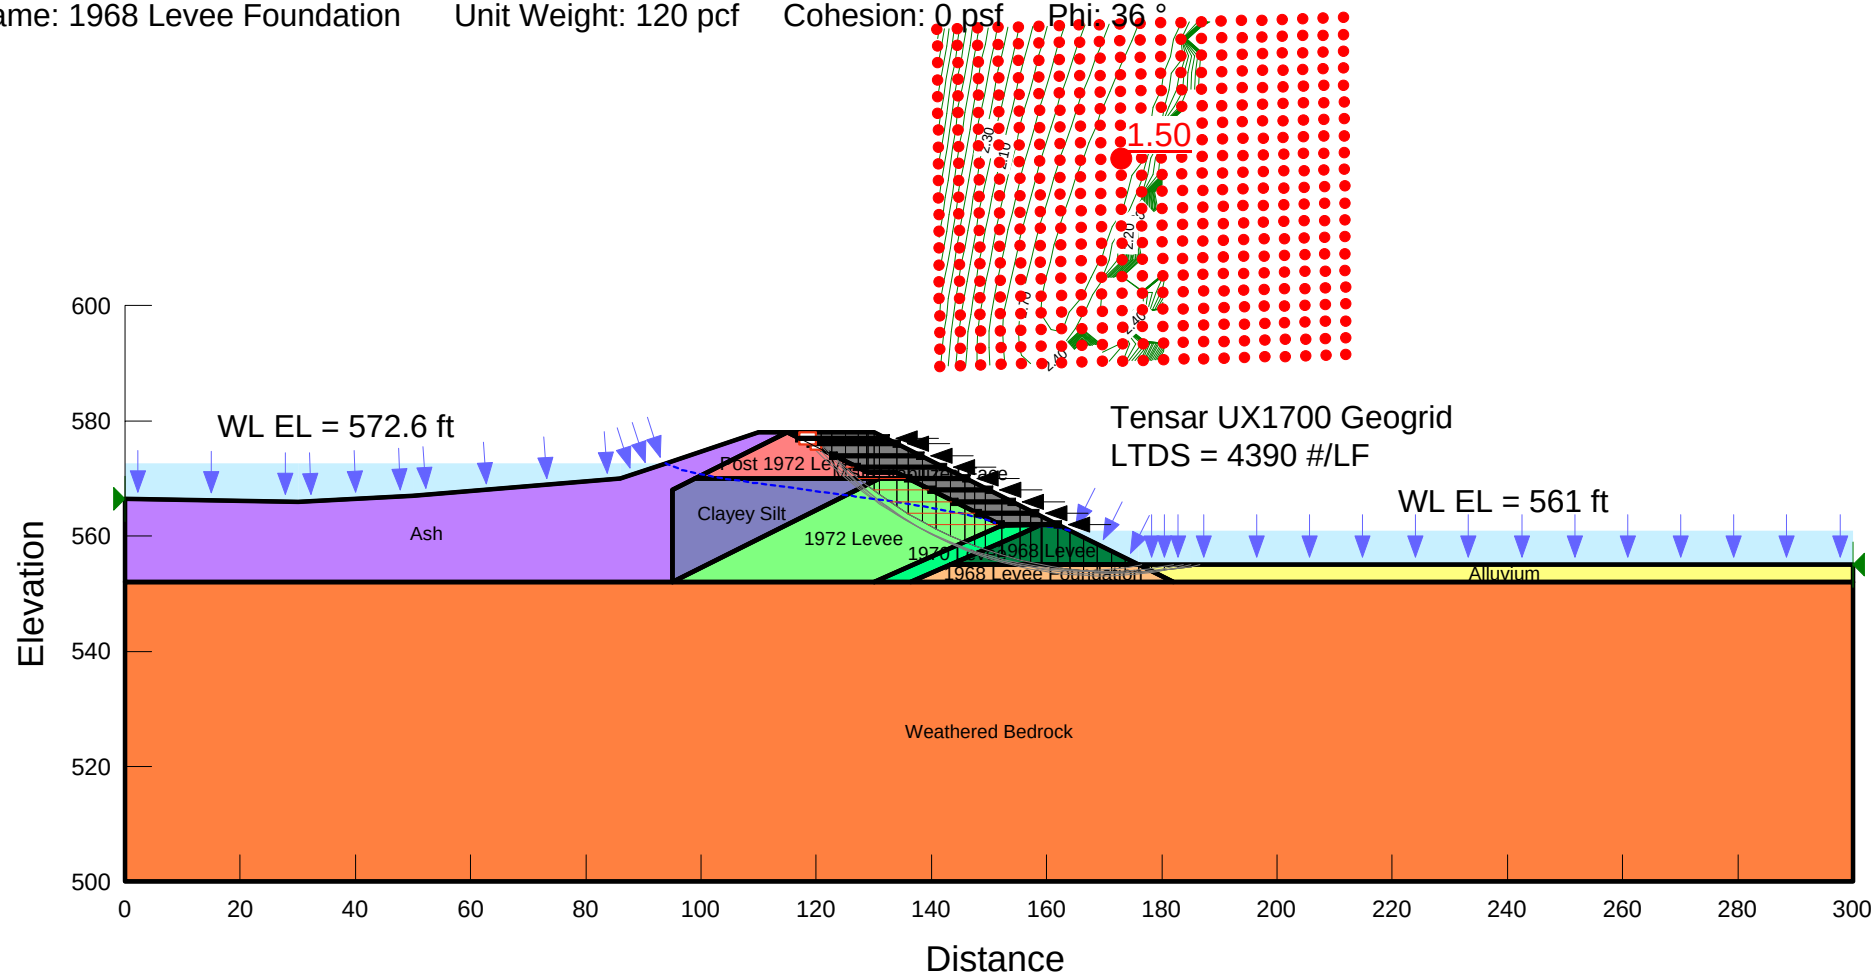
Title: 10-ft Stabilized Face - Steady State Seepage

| Section | Estimated Factor of Safety Obtained from Steady State Seepage Analysis <sup>1</sup> | |
|---|---|---|
| E | 1.5 | 1.50 |
