# **Dam Safety Assessment of CCW Impoundments**

**Plant Jack Watson**

**United States Environmental Protection Agency  
Washington, DC**

December 7, 2010

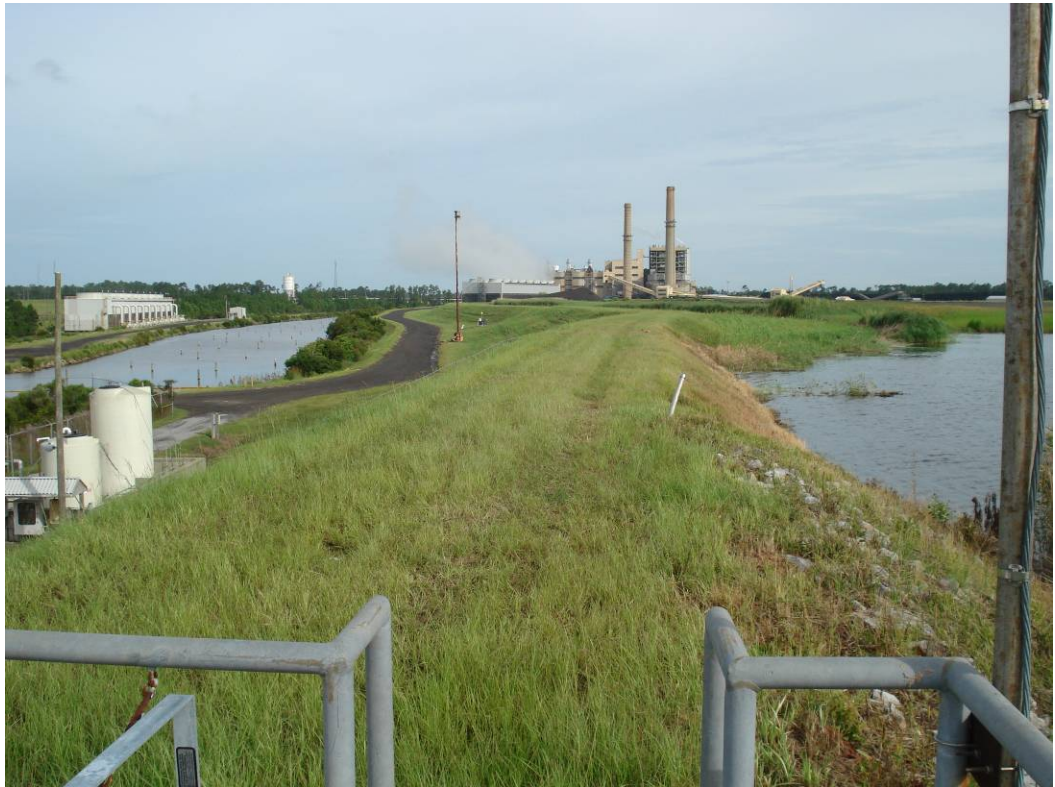
Photo Number:  
1

Overview of northwest section of embankment from outlet structure showing typical condition of crest & inboard slope.

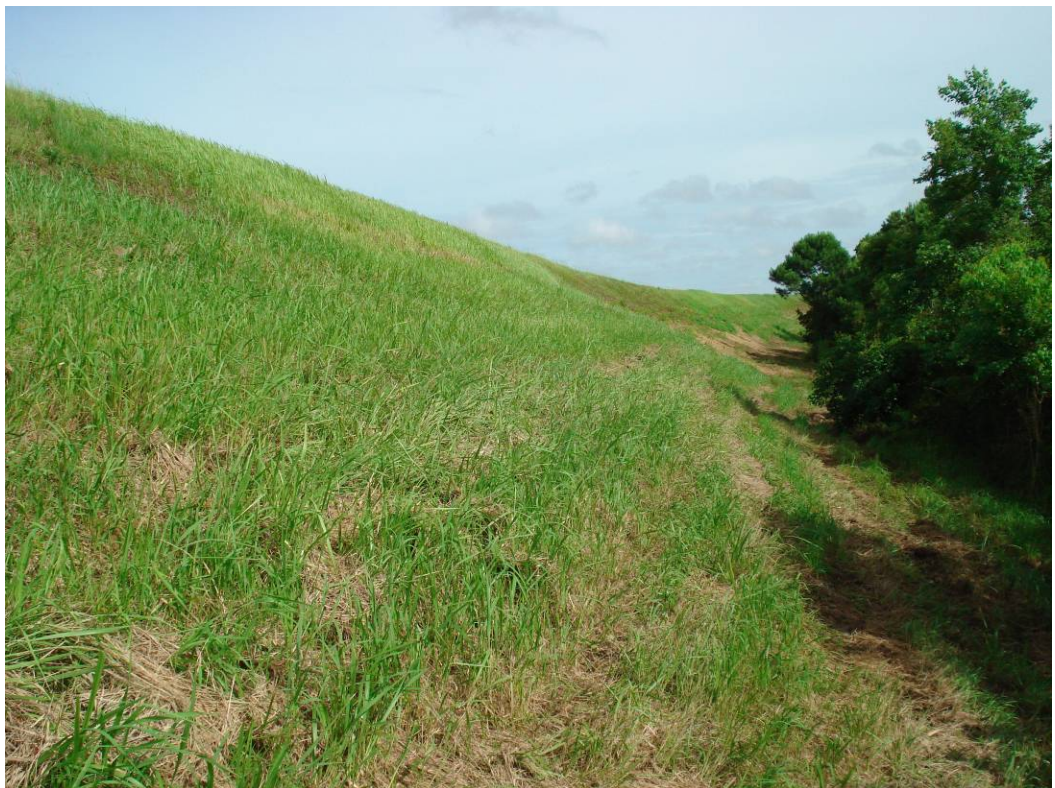
Photo Number:  
2

- Four piezometers were noted at the toe and within the outboard dike slope.
- Small trees and brush cover most of the bench's short outboard slope which meets the bayou (Appendix B – Photo 2). Intermittent forays into this area did not reveal evidence of seepage or instability.

Typical condition of outboard slope. Note vegetation on lower berm slope.

- The brush and trees growing on the outboard slope of the outboard bench should be cut and the slope surface turfed. This action will assist in detection of seepage during future inspections and high pool elevations. It is noted that Mississippi Power initiated the removal of this vegetation following receipt of the draft of this report.
