# **Dam Safety Assessment of CCW Impoundments**

## **GenOn Energy – Shawville Generating Station Shawville, Clearfield County, Pennsylvania**

**United States Environmental Protection Agency  
Washington, DC**

December 17, 2012

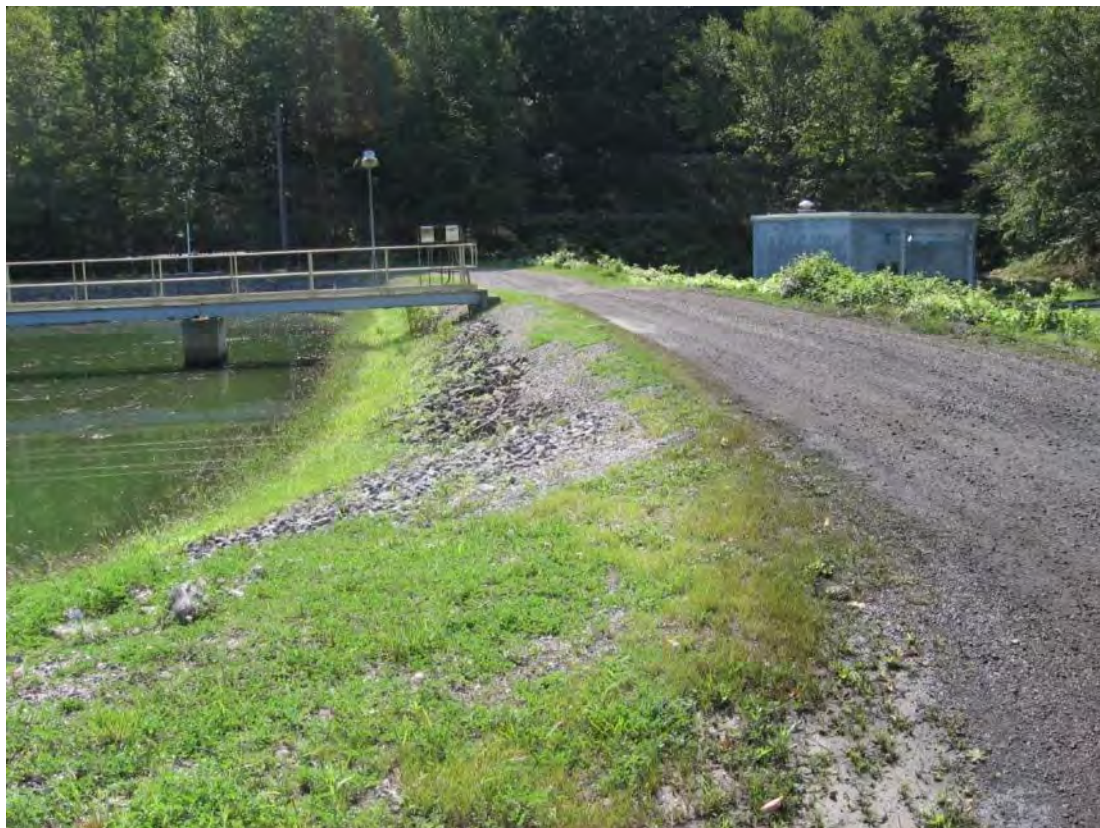
Date:  
9/6/12Photo Number:  
3Photographer:  
S. SzewczakOrientation:  
NE

Description:  
Ash Pond B;  
Inboard slope  
and crest of  
northwestern  
embankment.

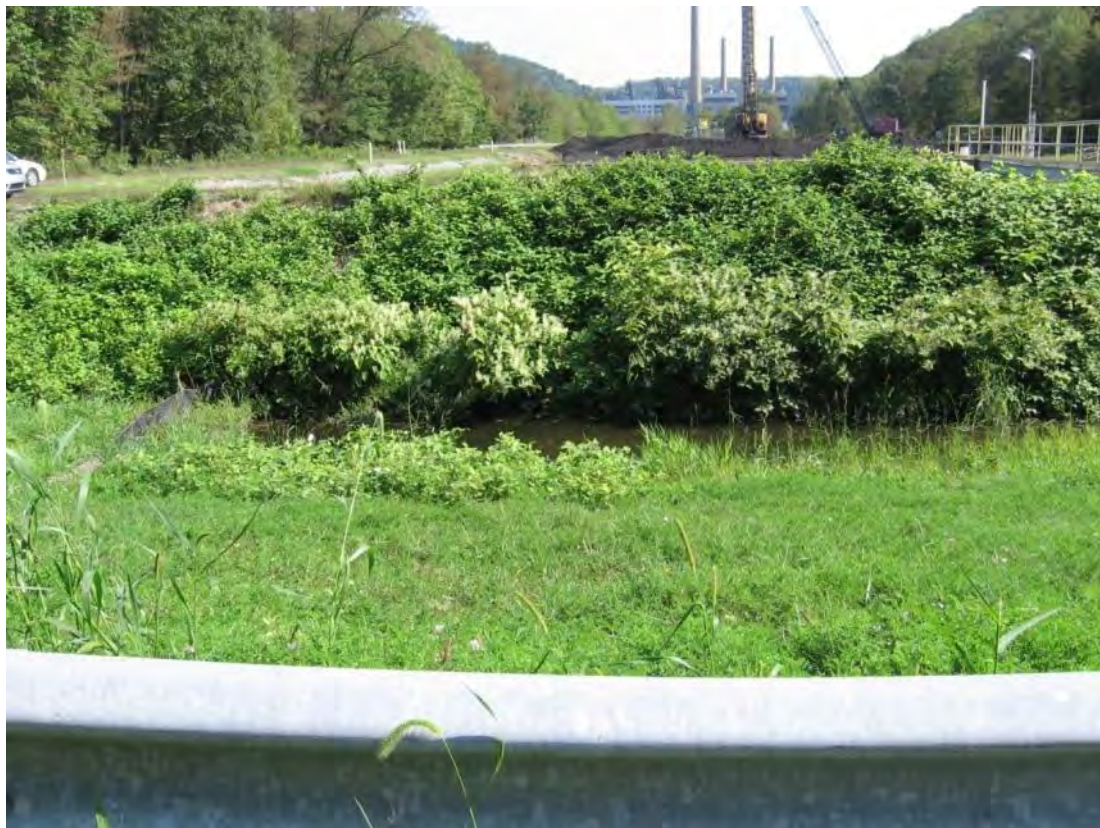
Ash Pond B;  
Outer slope of  
southwestern  
embankment.  
Water along toe  
is stormwater  
runoff from  
upstream  
diversion  
ditches. No  
evidence of  
seepage  
through the  
embankment.

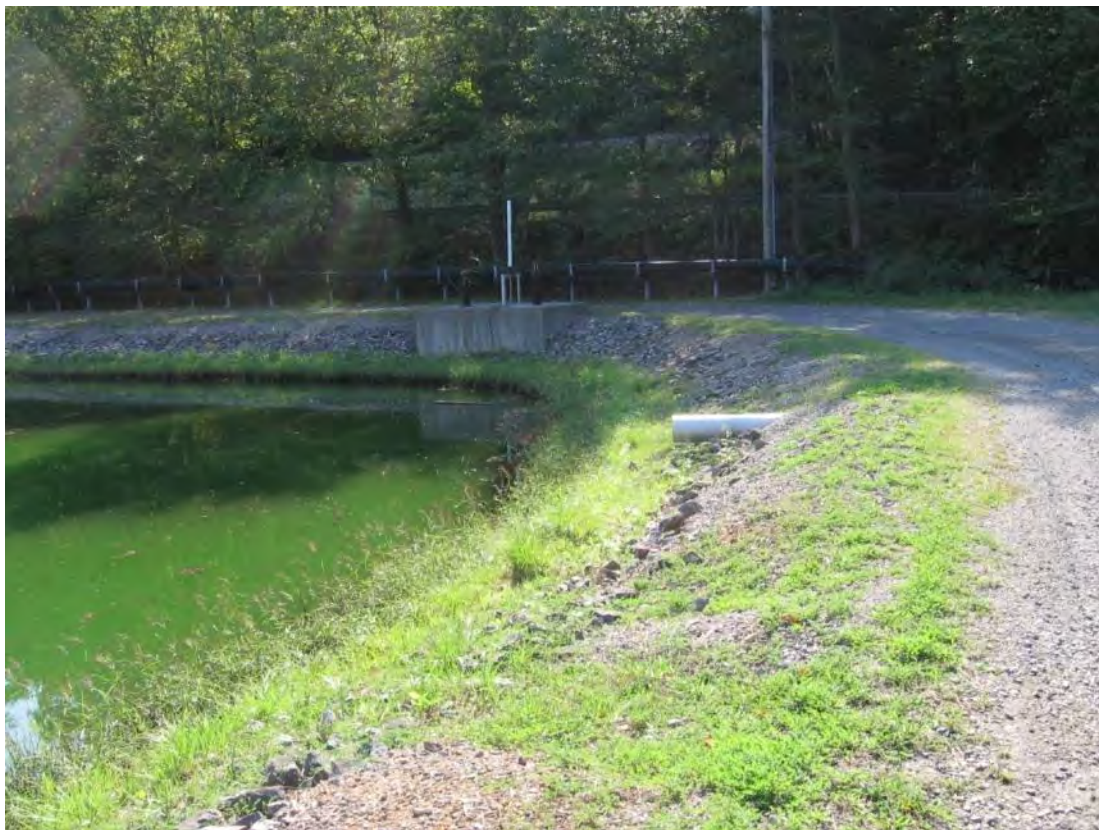
Description:  
Ash Pond B; inboard slope of southeastern embankment.

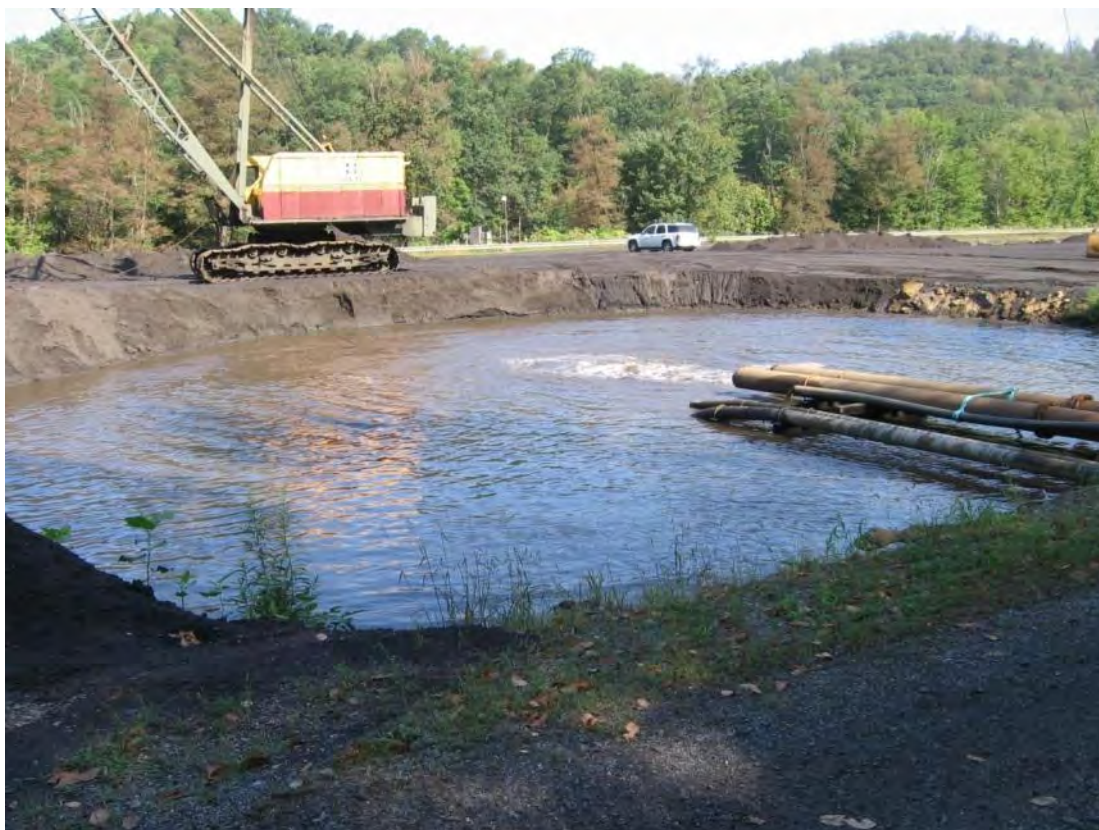
Ash Pond B;  
Constructed  
forebay and ash  
sluice piping at  
the southeast  
corner.

Forebay berm  
constructed of  
compacted ash.

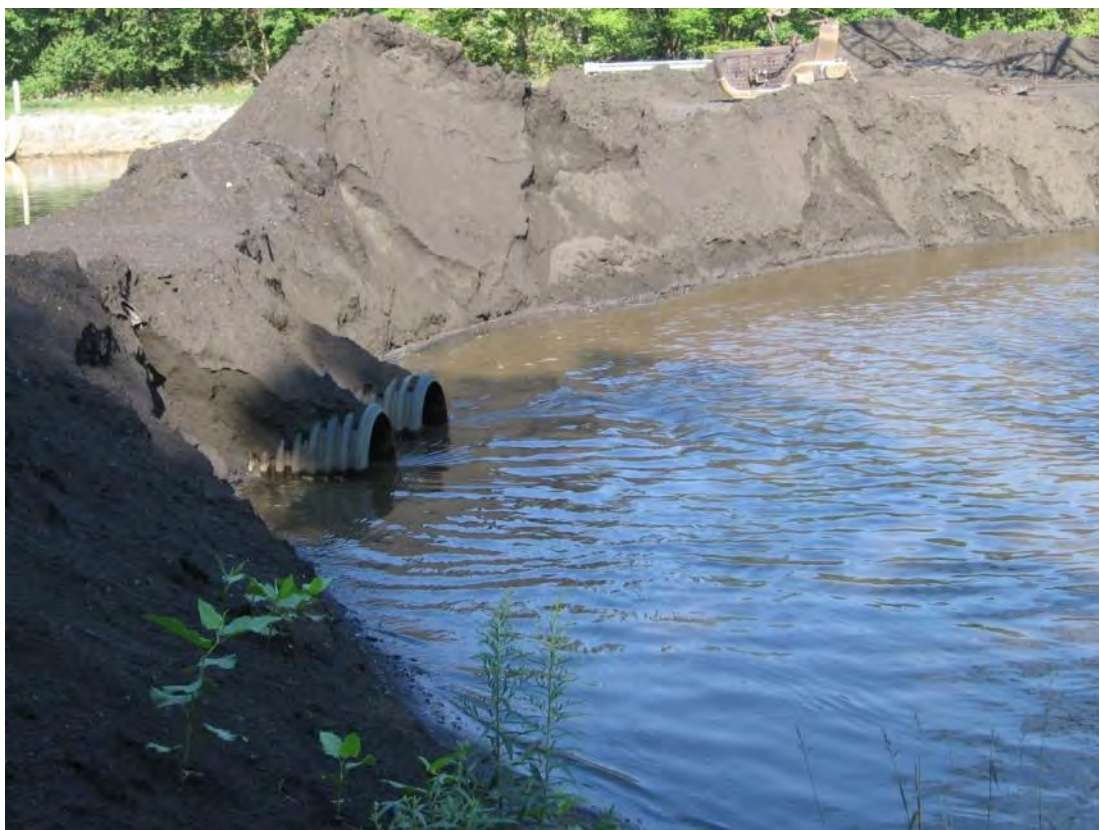
Ash Pond B; (2)  
24" HDPE pipes  
connecting the  
forebay to the  
main portion of  
Pond B through  
the compacted  
ash berm.

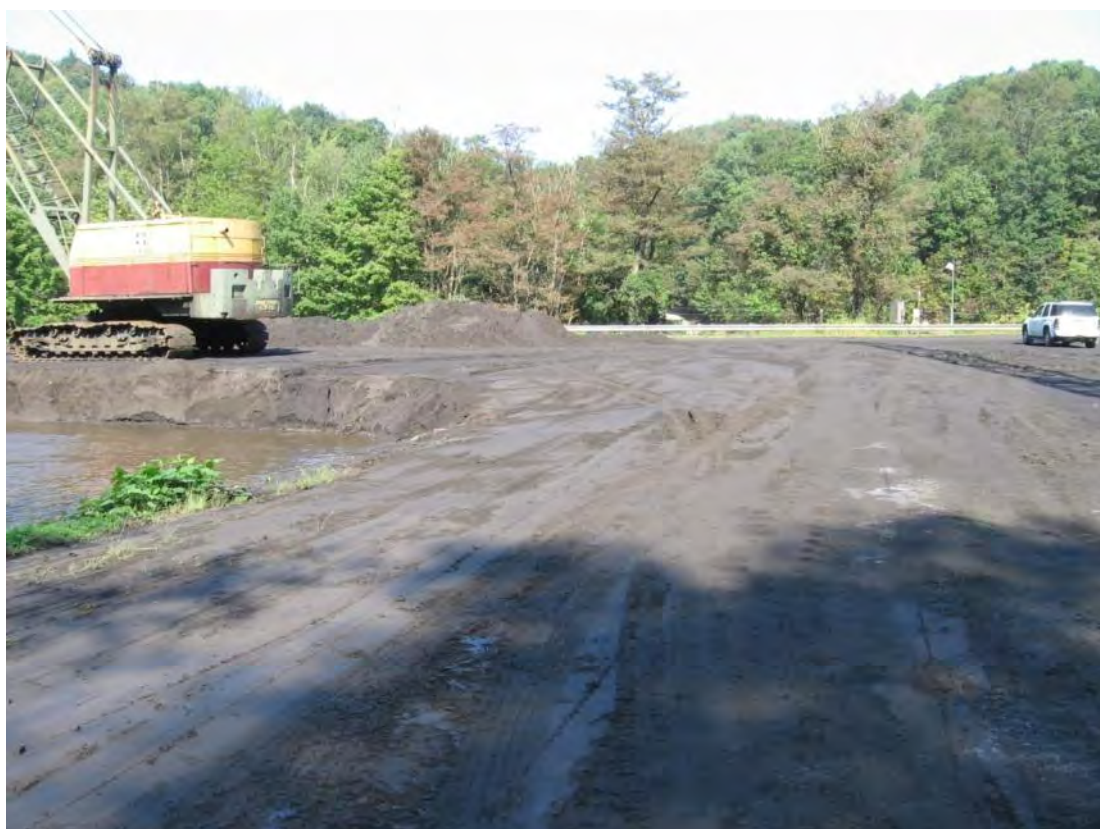
Center Dividing Embankment separating the impoundment into the two (2) cells: Ash Pond A (right) and Ash Pond B left. Berm primarily compacted earth topped with a compacted ash roadway surface.

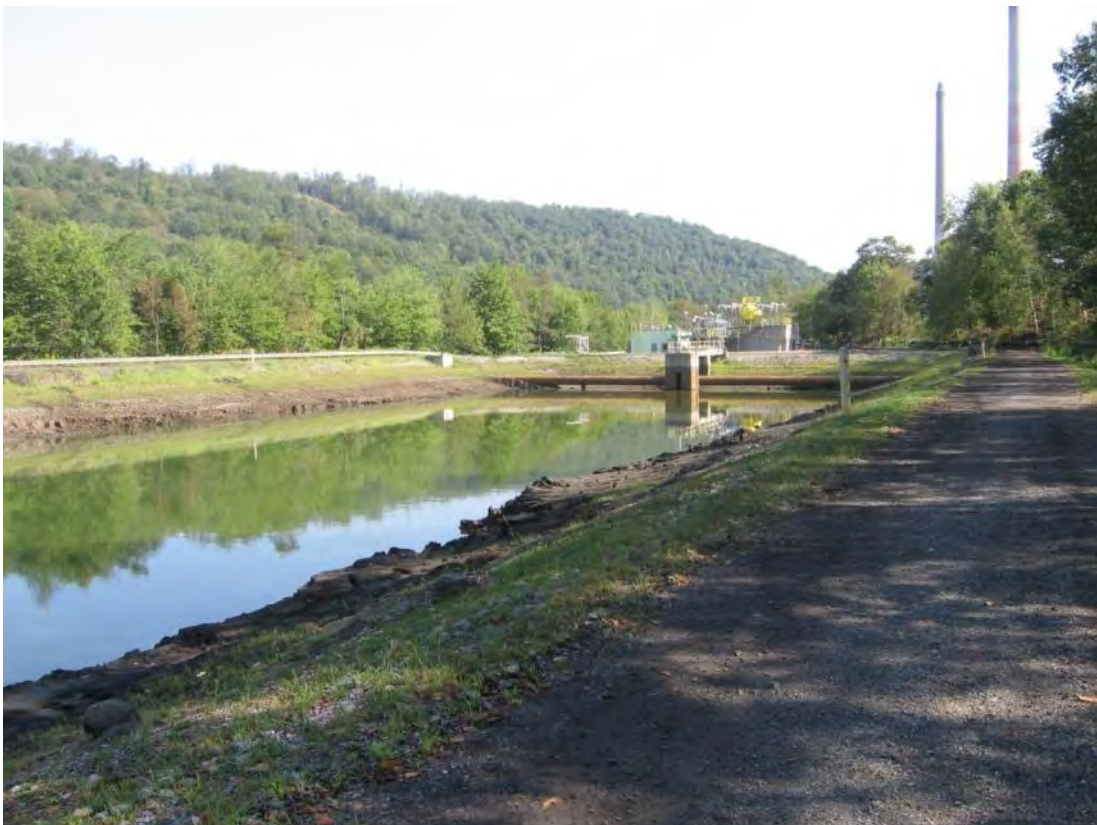
Description:  
Ash Pond A;  
Overall view  
looking towards  
the generating  
station. Note  
that water level  
has been  
lowered for  
maintenance by  
approximately 6  
feet.

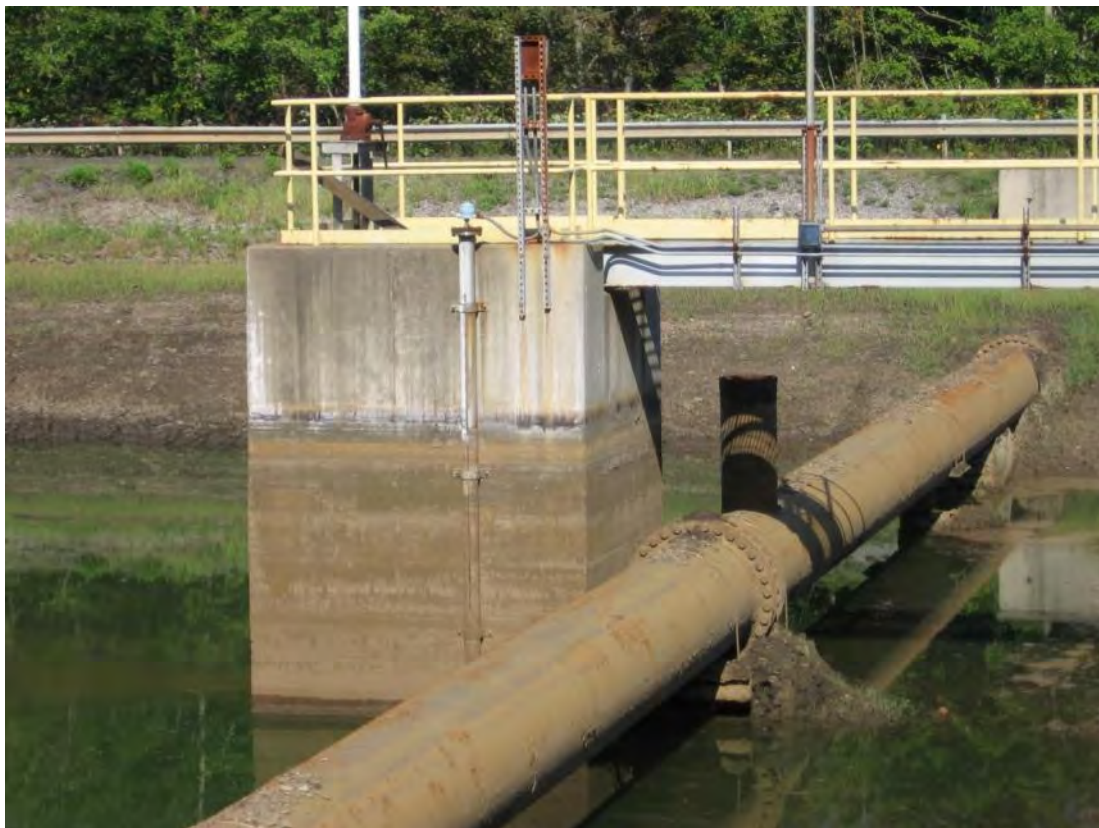
Description:  
Ash Pond A;  
close up view of  
decant  
structure.

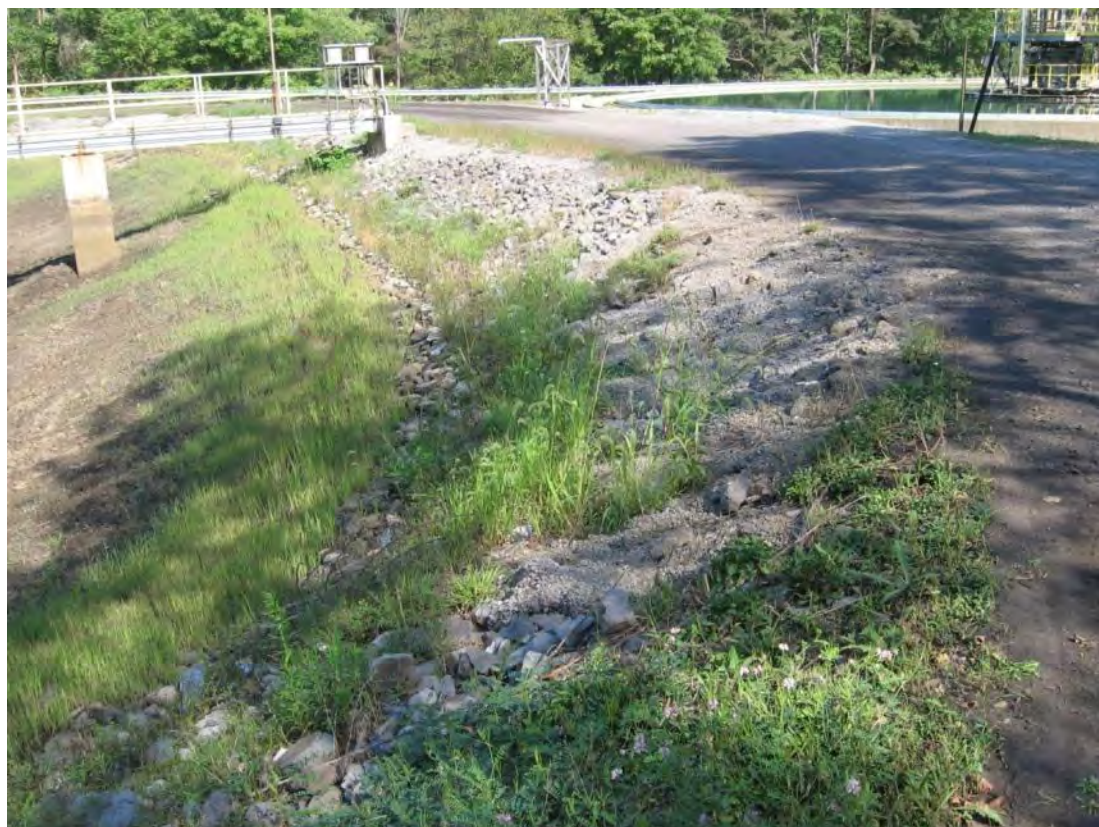
Description:  
Ash Pond A;  
inboard side  
slope of  
northeastern  
embankment.

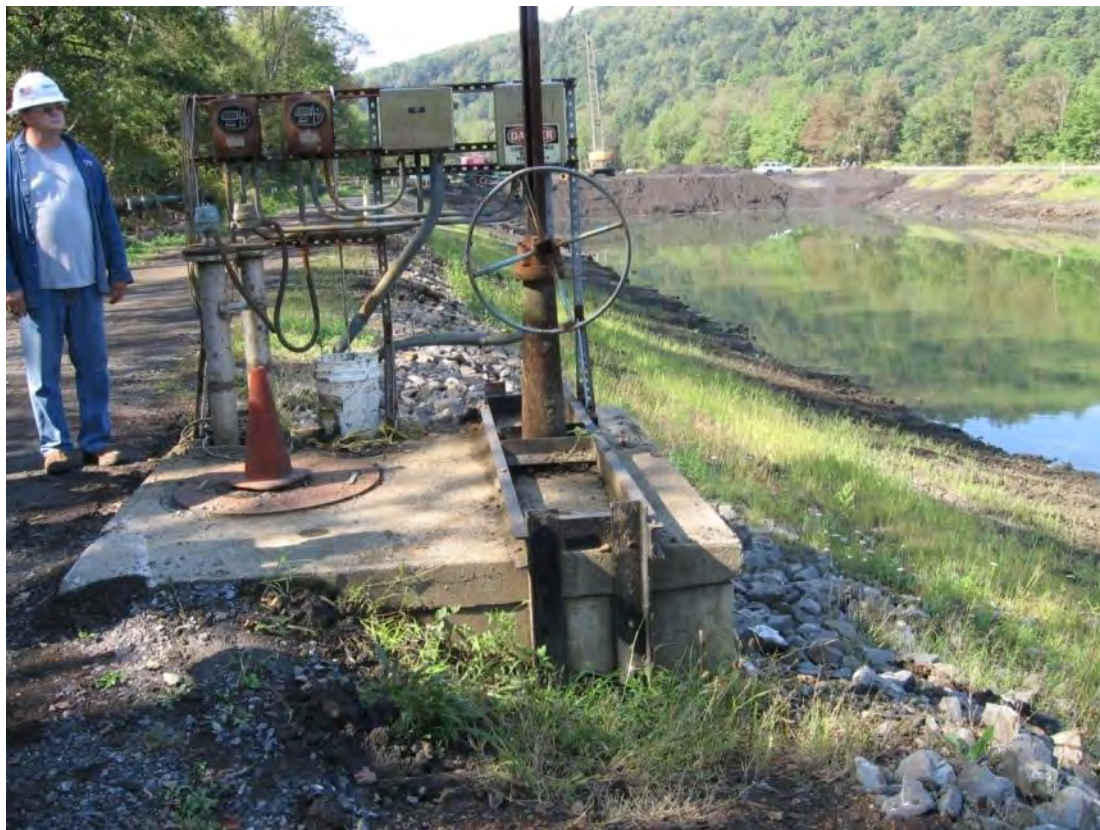
Ash Pond A; Ash Sluice Recycle Collection Structure. Receives flow from the perforated steel pipe and drains to the plant for recycling of sluiced water. Controls are for pond level control and isolation of Ash Ponds A and B.

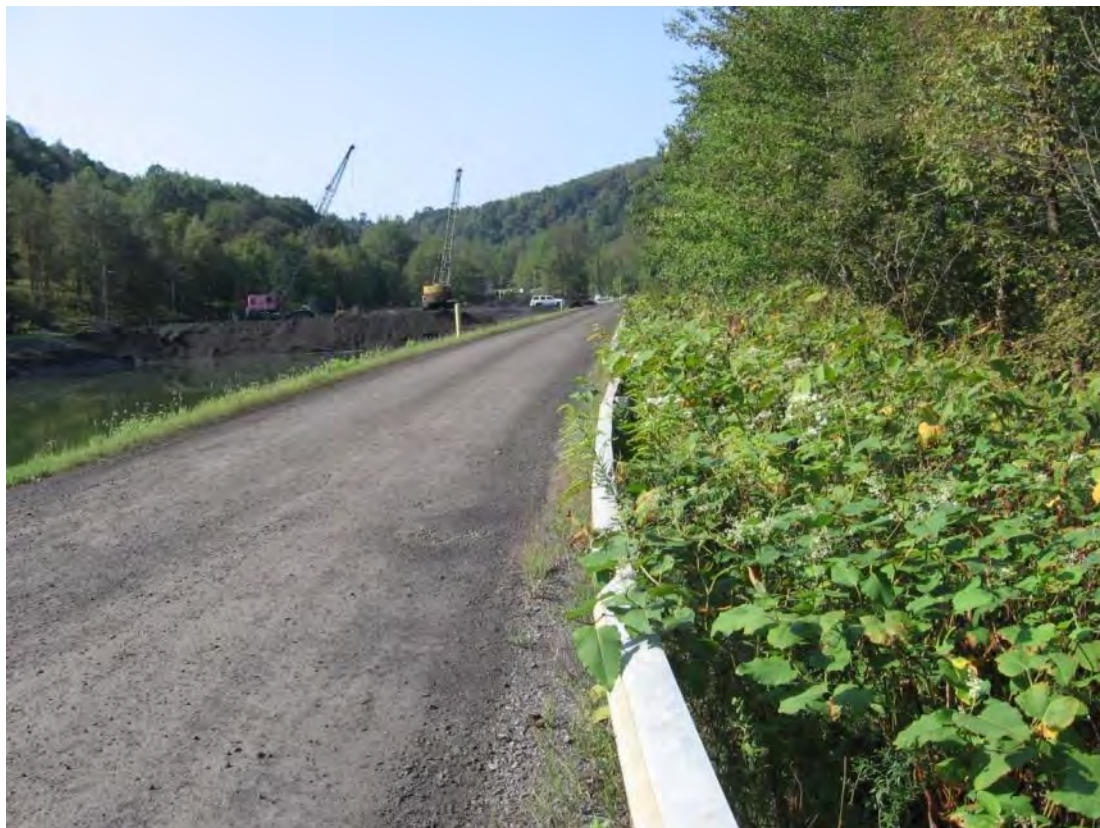
Ash Pond A; crest and outboard slope of northwestern embankment looking towards Ash Pond B. Note heavy vegetation on outboard slope.

- Evaluate the condition of the large trees along the outboard slope of the northwestern embankment, primarily those above the impoundment bottom elevation. Diseased or dead trees should be removed.

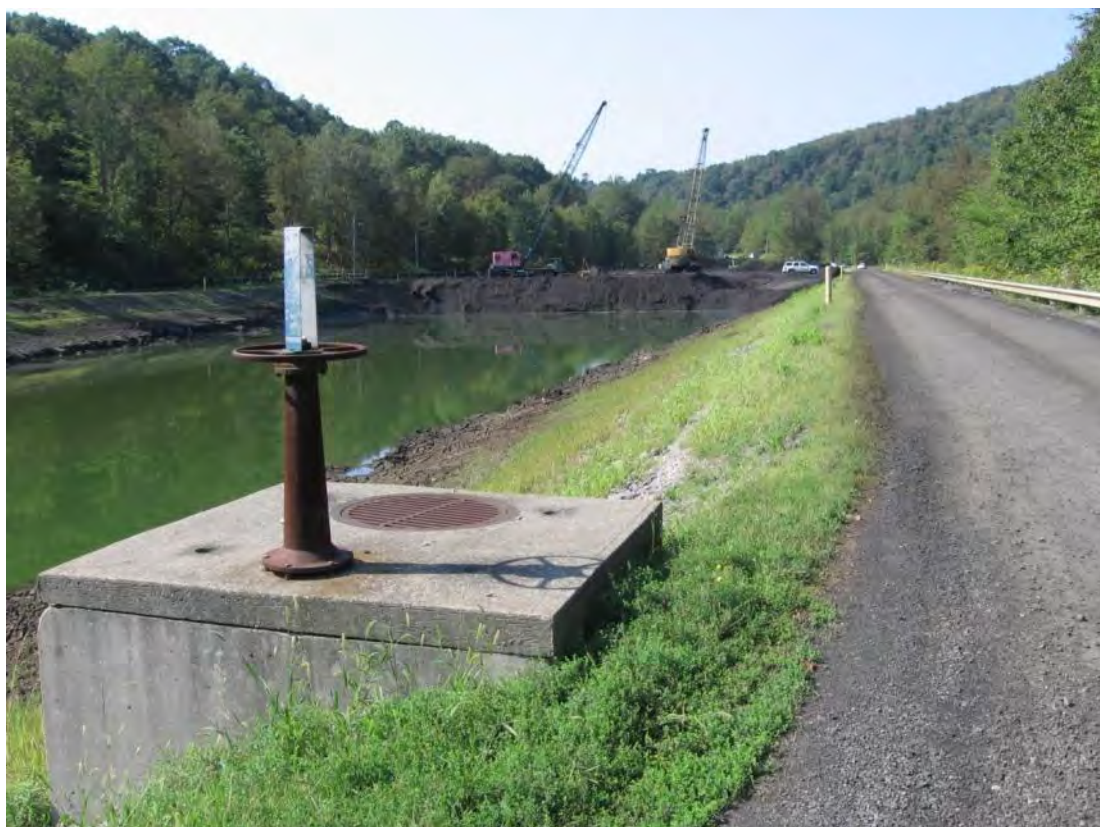
Ash Pond A; inboard side slope of northwestern embankment. Structure in foreground is Clarifier Bypass Structure (used for overflow only)
