# Coal Combustion Waste Impoundment Dam Assessment Report

*Martins Creek Steam Electric Station  
PPL Generation  
Bangor, Pennsylvania*

**Project # 0-381**  
**Assessment of Dam Safety**  
**Coal Combustion Surface Impoundments**  
**for the REAC Program**

**September 2009**

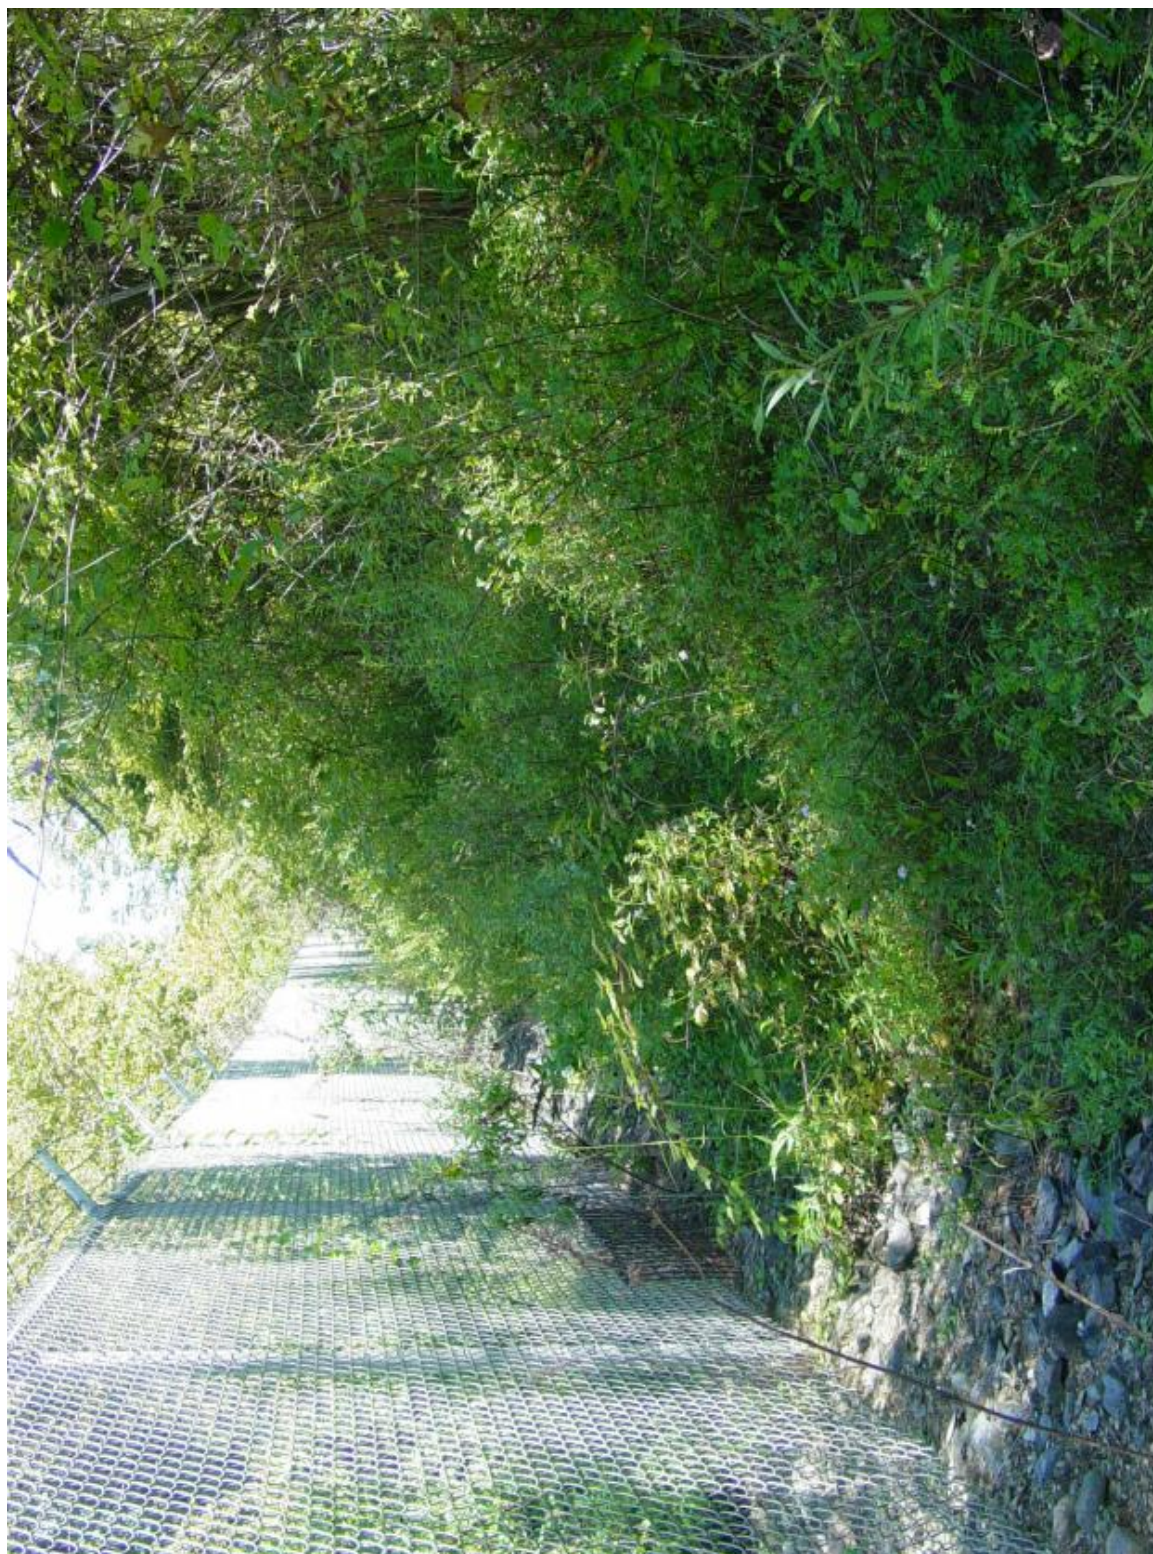
Photo BI-3: Ash Basin No. 1 Outside Slope of West Embankment at West End of Main Cross Dike End - Viewed North.

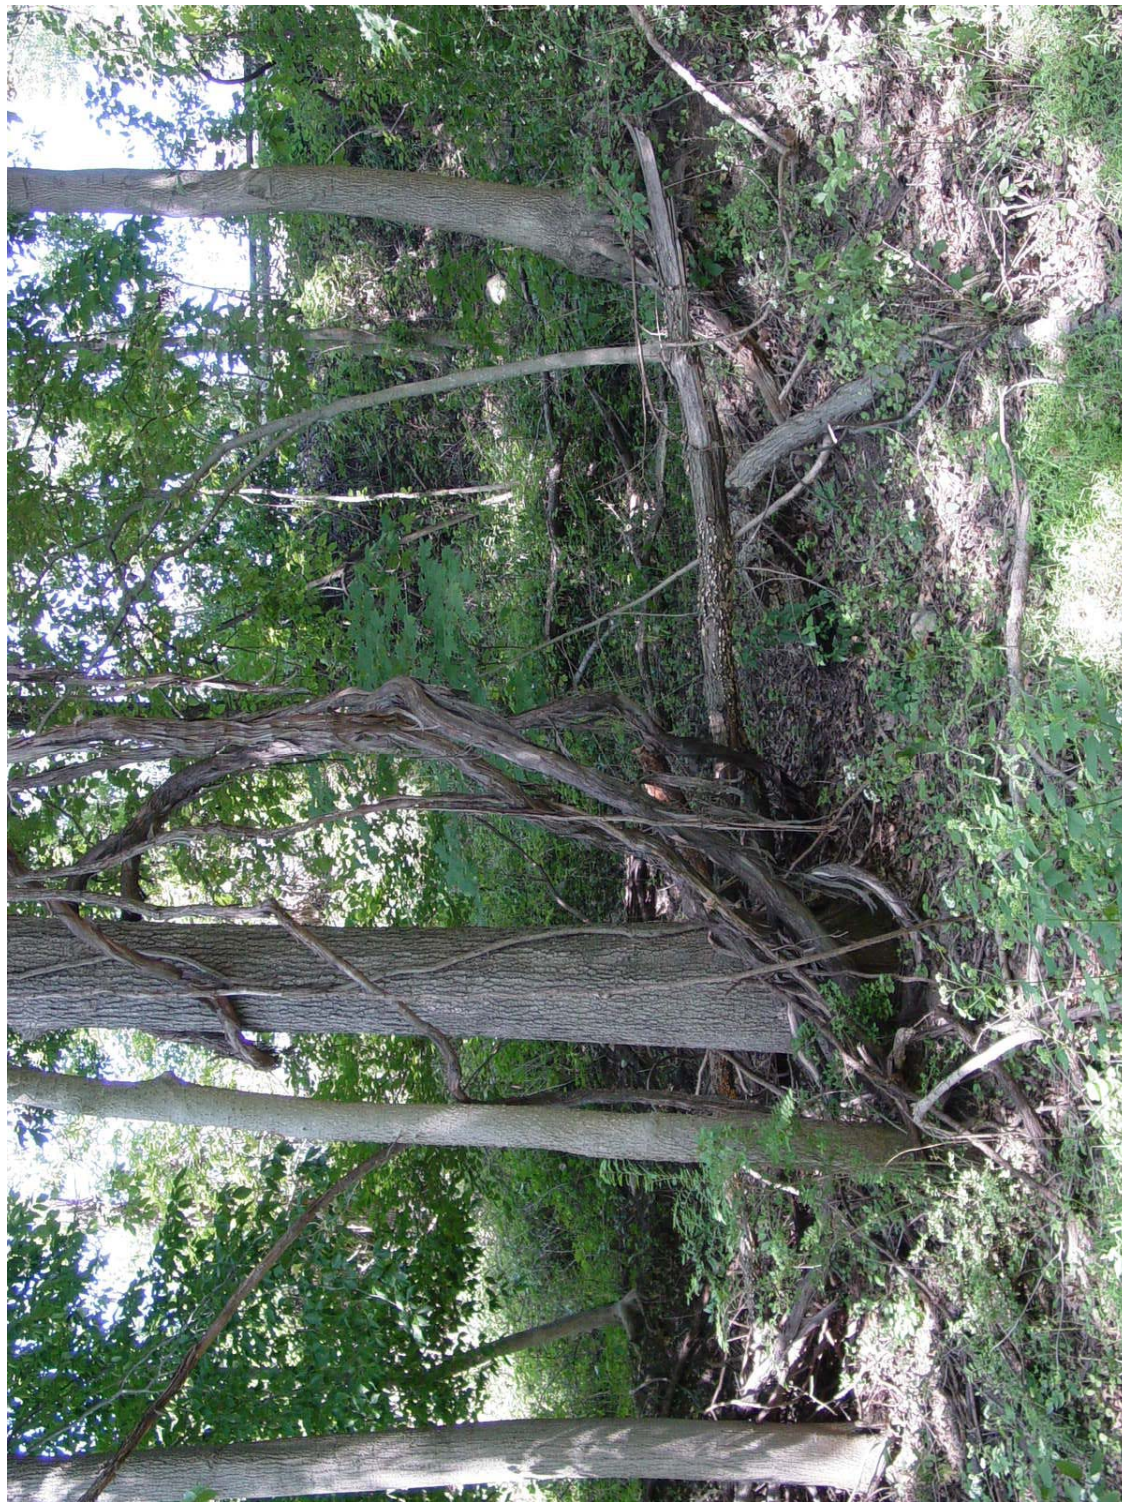
Photo BI-4: Ash Basin No. 1 Outside Toe of Embankment Below Paved Access Road outside Southeast Corner of Basin  
Near where Outlet Pipe Passes Through Embankment- Viewed West.

Ash Basin No. 1 Dam – None appear warranted at this time, other than maintaining vegetation on the crest and outside slope and visual monitoring of the shallow depression at the outside toe of the embankment at the southeast corner as recommended in Subsection 1.2.6, below.

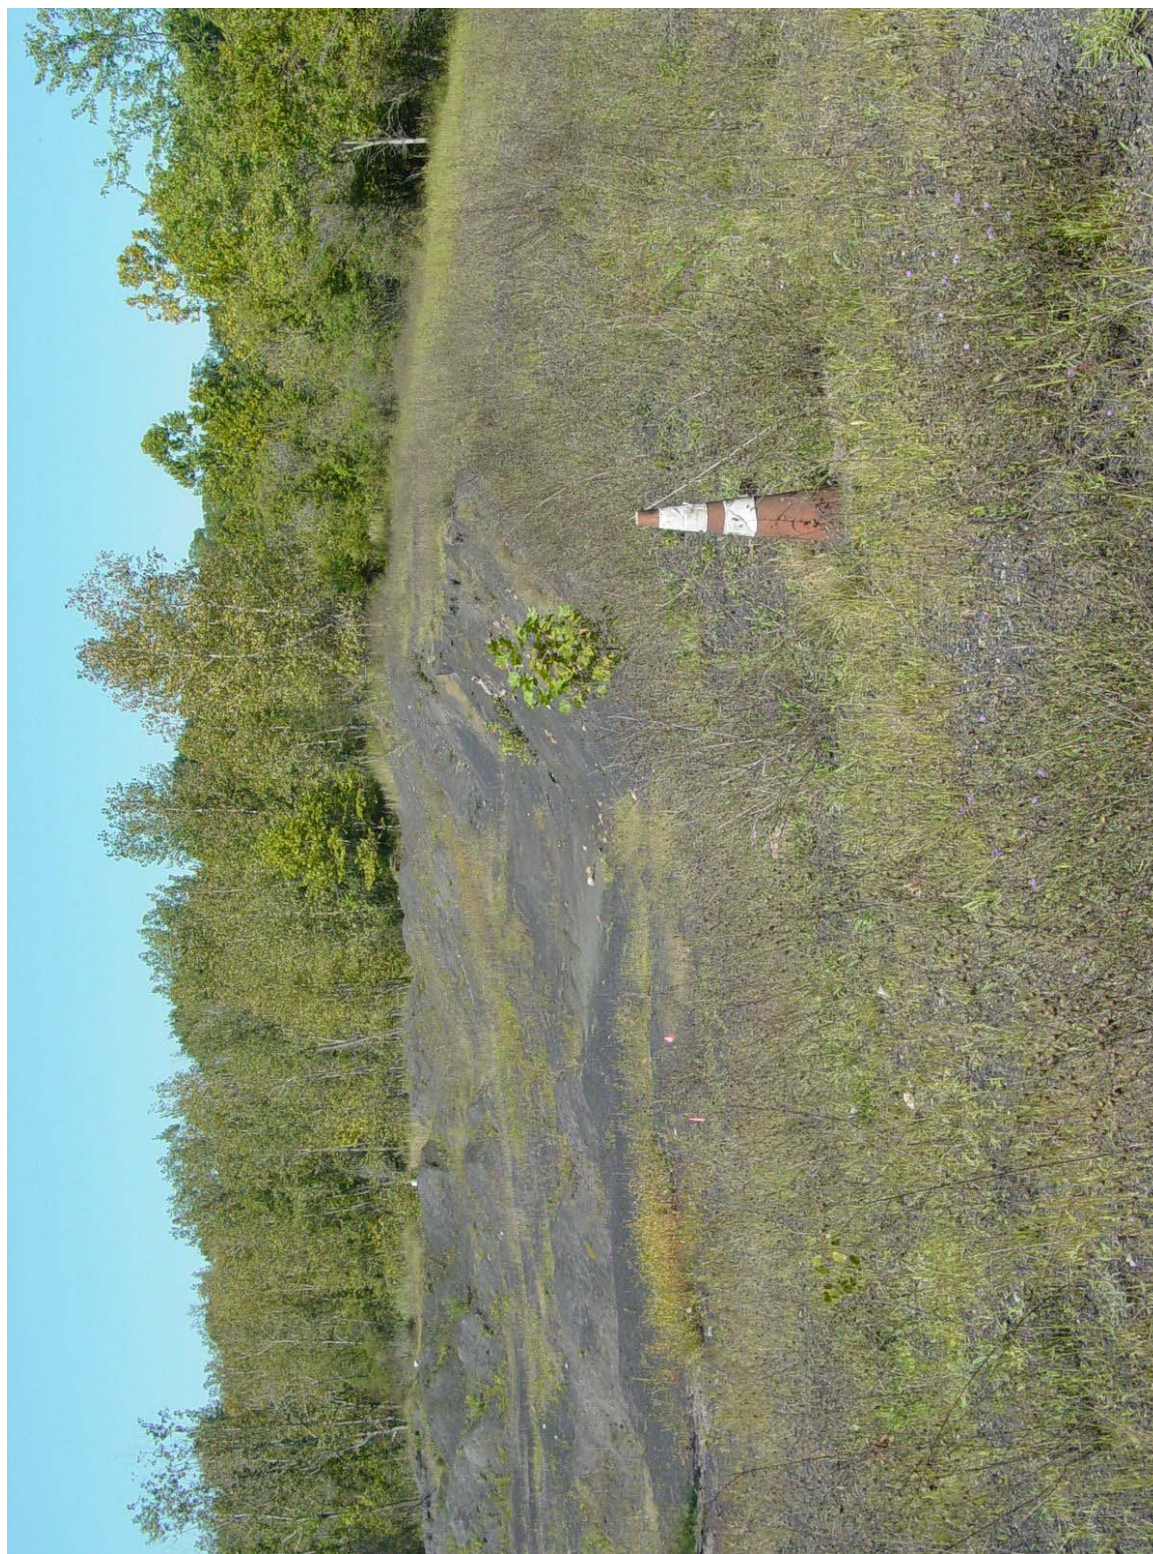
Photo BI-5: Ash Basin No. 1 North End Area where Bottom Ash Formerly was Sluiced into Basin – Viewed West.

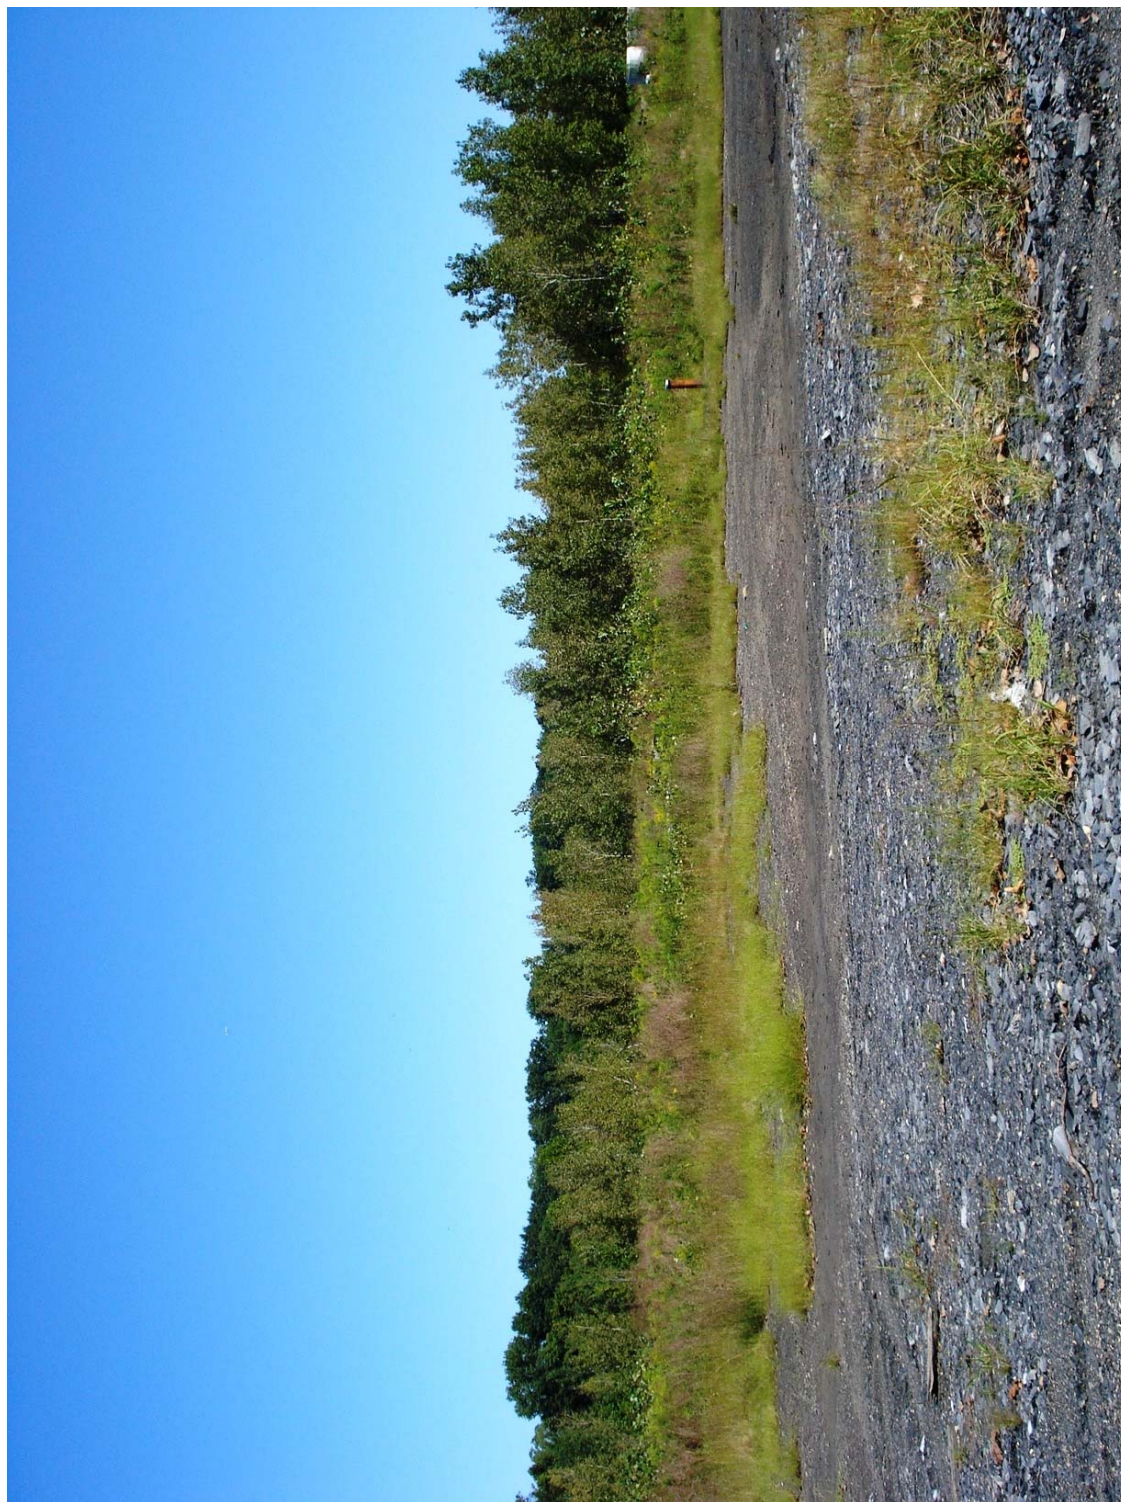
Photo B1-6: Ash Basin No. 1 Central Area North of Main Cross Dike where Dredged Material from Delaware River was Pumped into Basin during Clean-up Operations after 2005 Release from Basin No. 4- Viewed West.

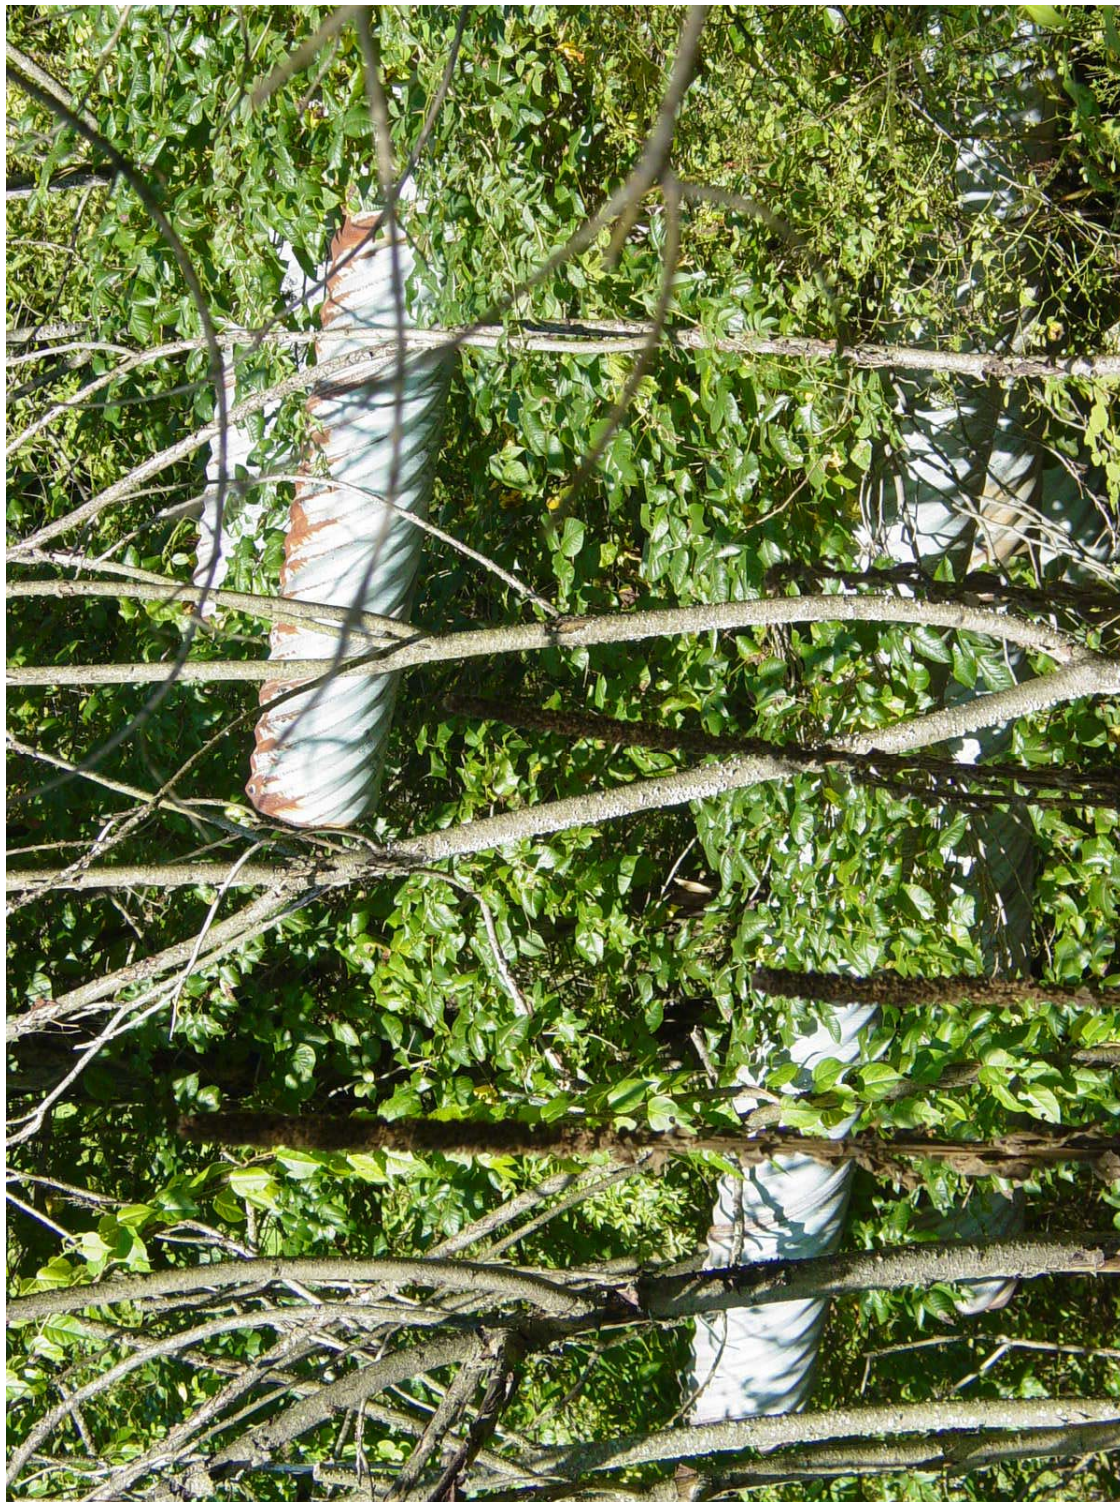
Photo B1-7: Ash Basin No. 1 View of Discharge End of 12" CMP Drains through Main Cross Dike that Divides the Higher Northern Two-Thirds of the Basin from the Lower Southern One-Third.

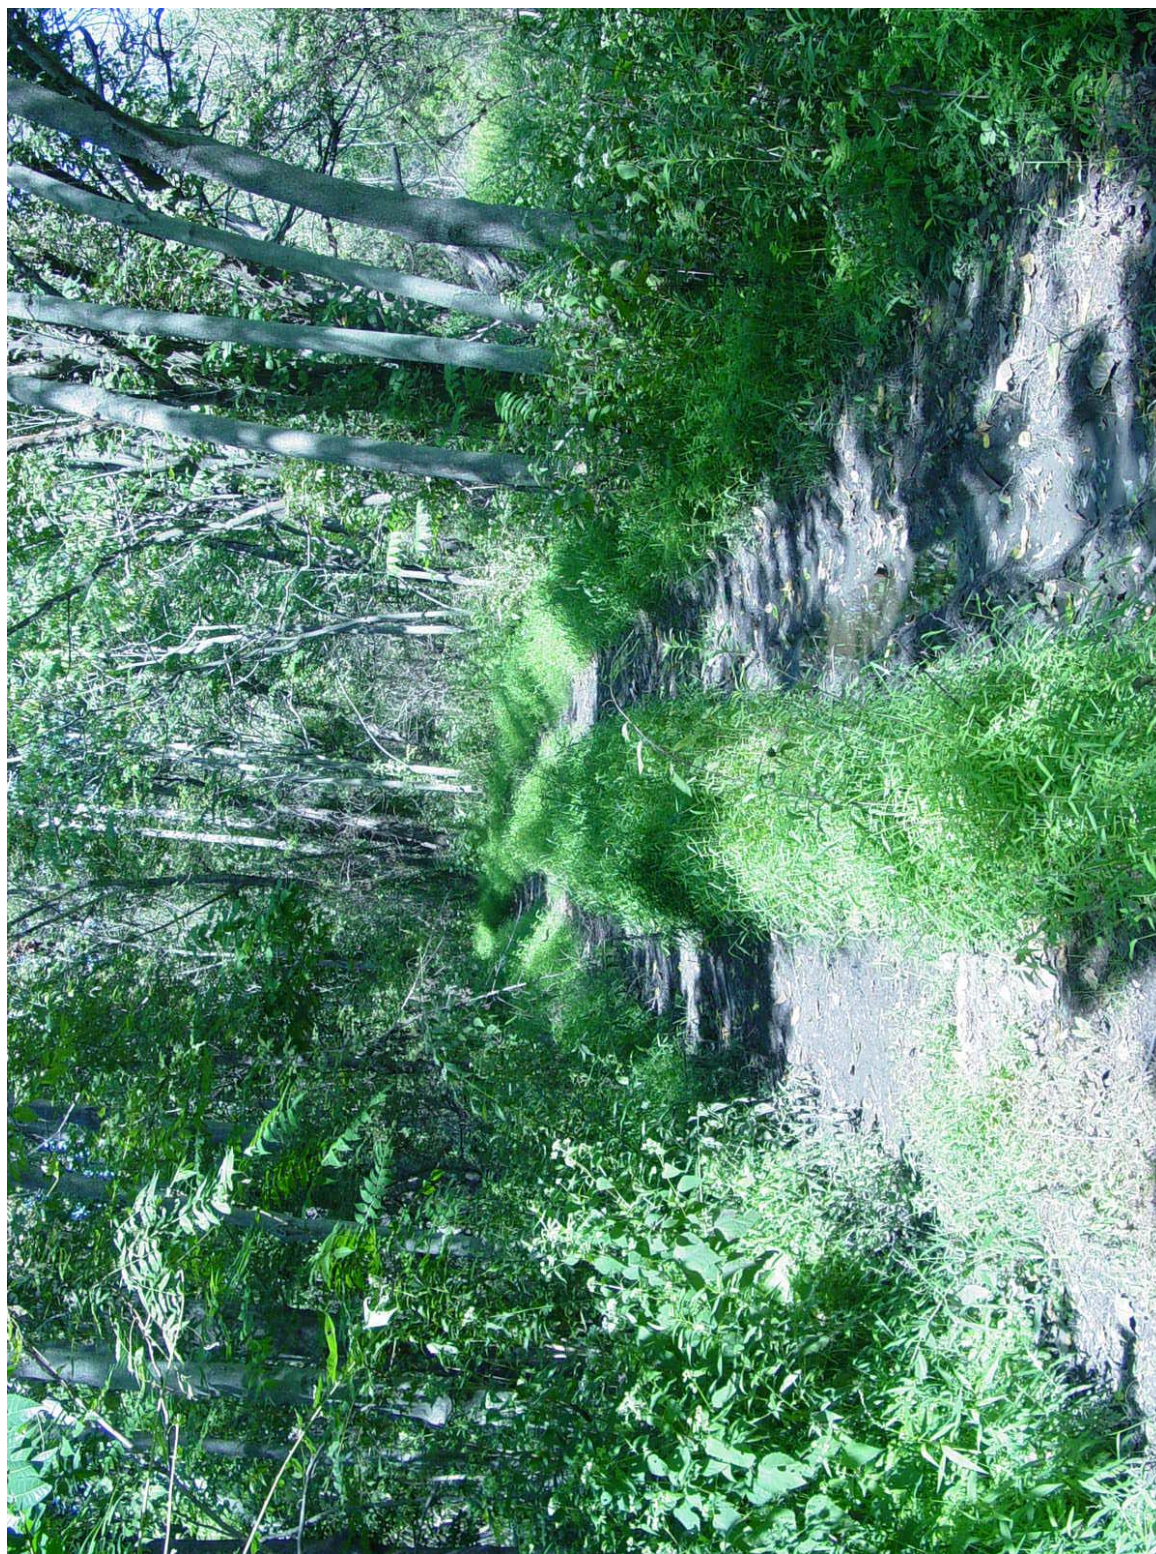
Photo B1-9: Ash Basin No. 1 Top of Small Cross Dike in Lower Southern Part of Basin - Viewed West.

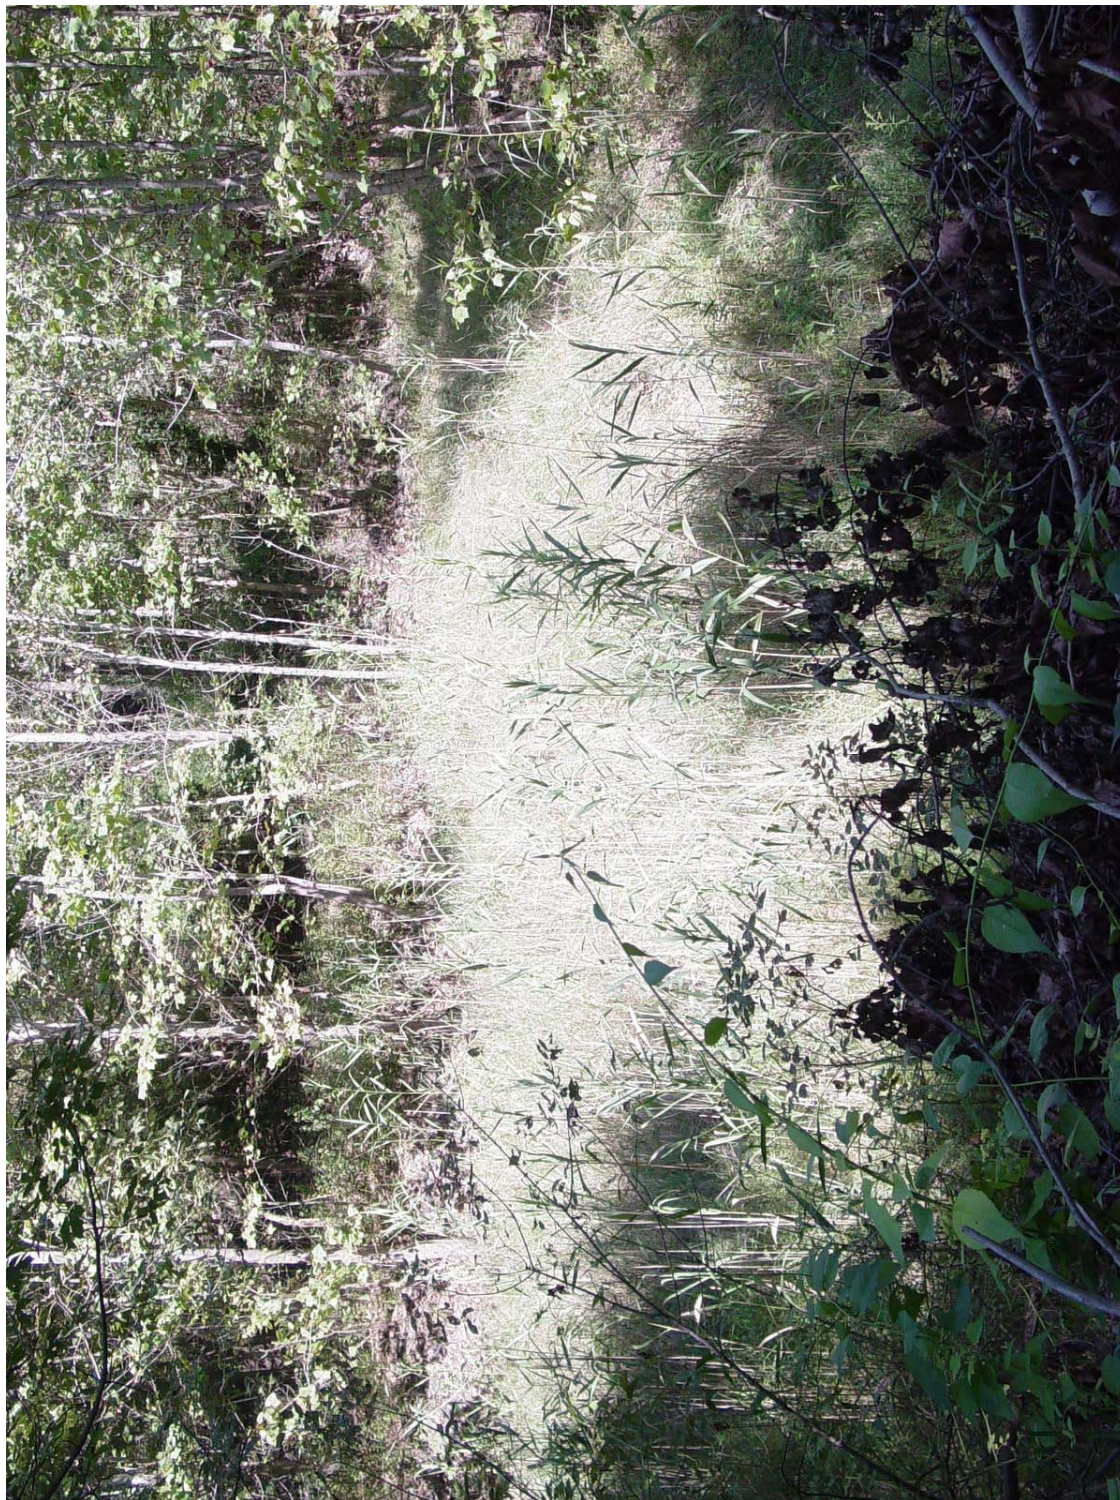
that the uppermost pipes would still allow drainage of storm water from the NEA to the SEA, if the water built up high enough against the cross dike on the west side of the NEA, where the surface of the basin fill is lower than the crests of the perimeter embankment and the cross dike. The CMPs were observed to be generally corroded with invert of the uppermost pipes completely corroded through at the inlet ends. Photo BI-8 shows the dense growth of trees and understory in the SEA just below the west part of the main cross dike. Photo BI-9 shows the top of a small cross dike (median dike) across the SEA and the typical degree of vegetation establishment in the SEA. One of the lowest areas in the SEA is relatively open and free of tree growth, but covered with tall herbaceous vegetation, (Photo BI-10).

Photo B1-10: Ash Basin No. 1 Relatively Open Low Area within Lower Southern Part of Basin Just Upstream of Drain Pipe Through Small Cross Dike- Viewed Northwest.

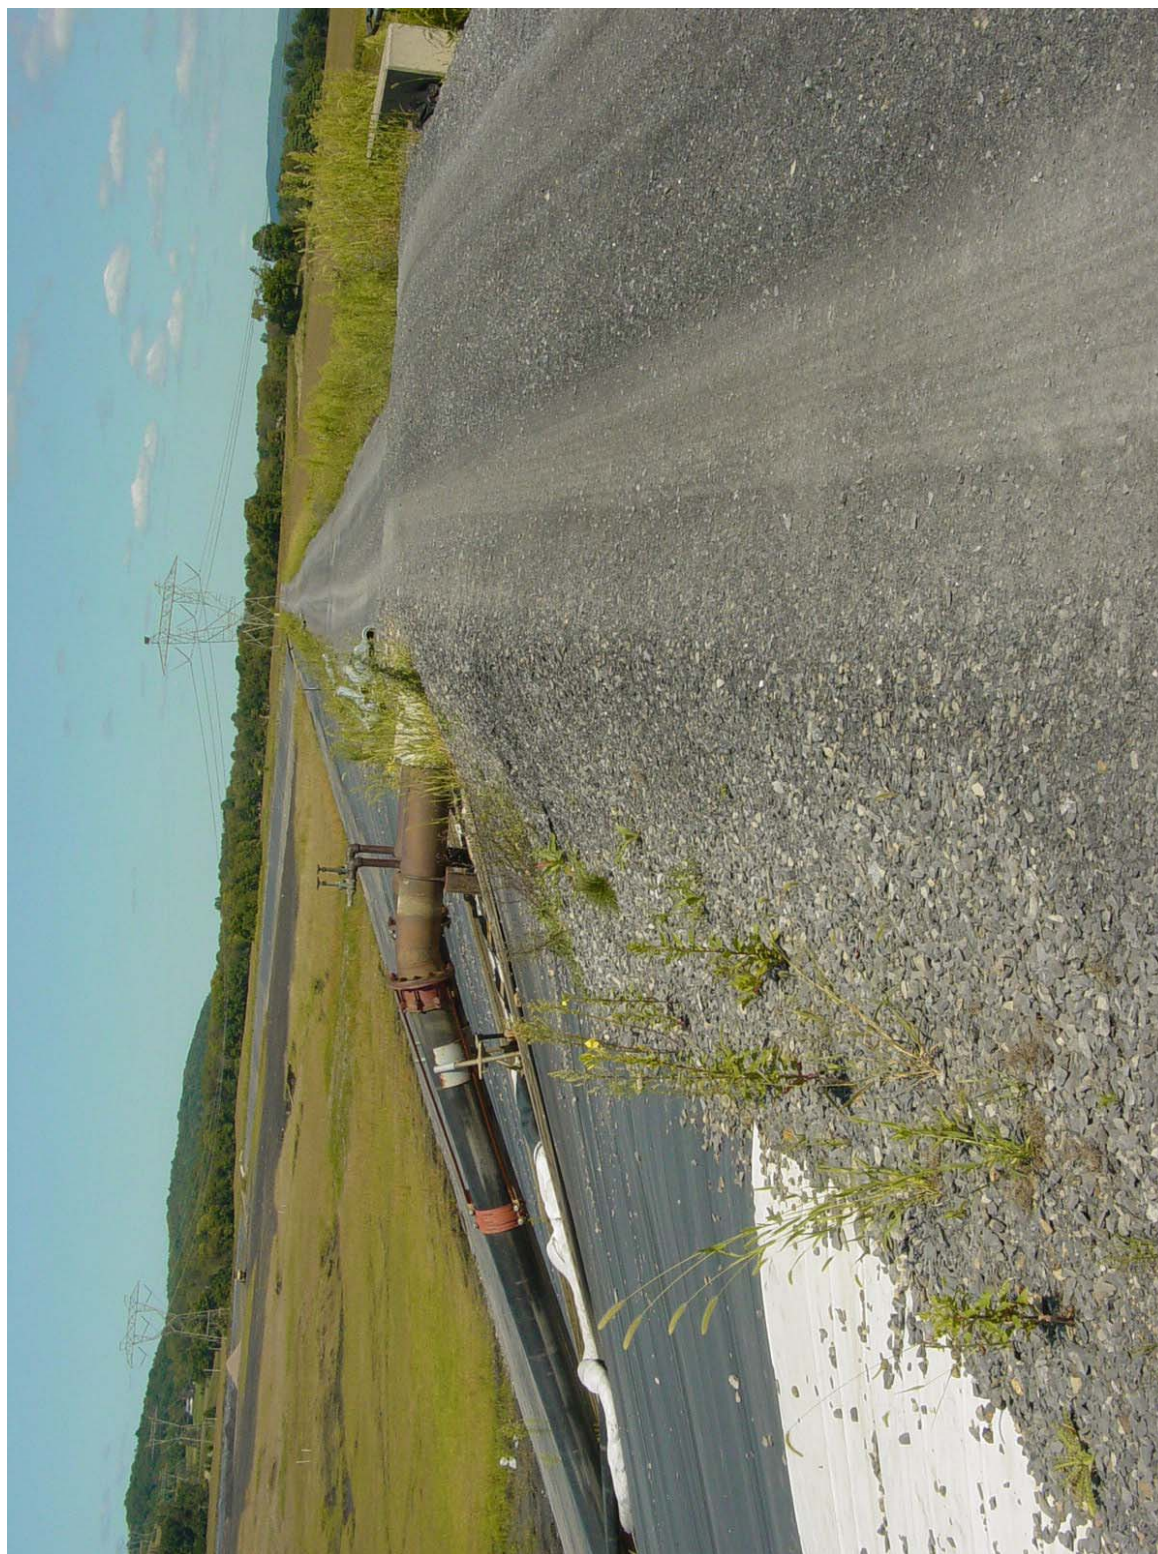
Typical views of the crest along the east embankment, north embankment, west embankment, and south embankment (partial view) are shown in Photos B4-1, B4-2, B4-3, and B4-4, respectively. Overall the gravel-surfaced crest was observed to be in good condition with some minor potholes noted on the crest of the north embankment (Photo B4-2). No major depressions, sags, or drop-outs, which might suggest excessive settlement or internal erosion, were observed in the crest. No tension cracks which might suggest soil shear failure were observed in the crest or along the edge of the crest.

Photo B4-1: Ash Basin No. 4 Crest of East Embankment - Viewed North.

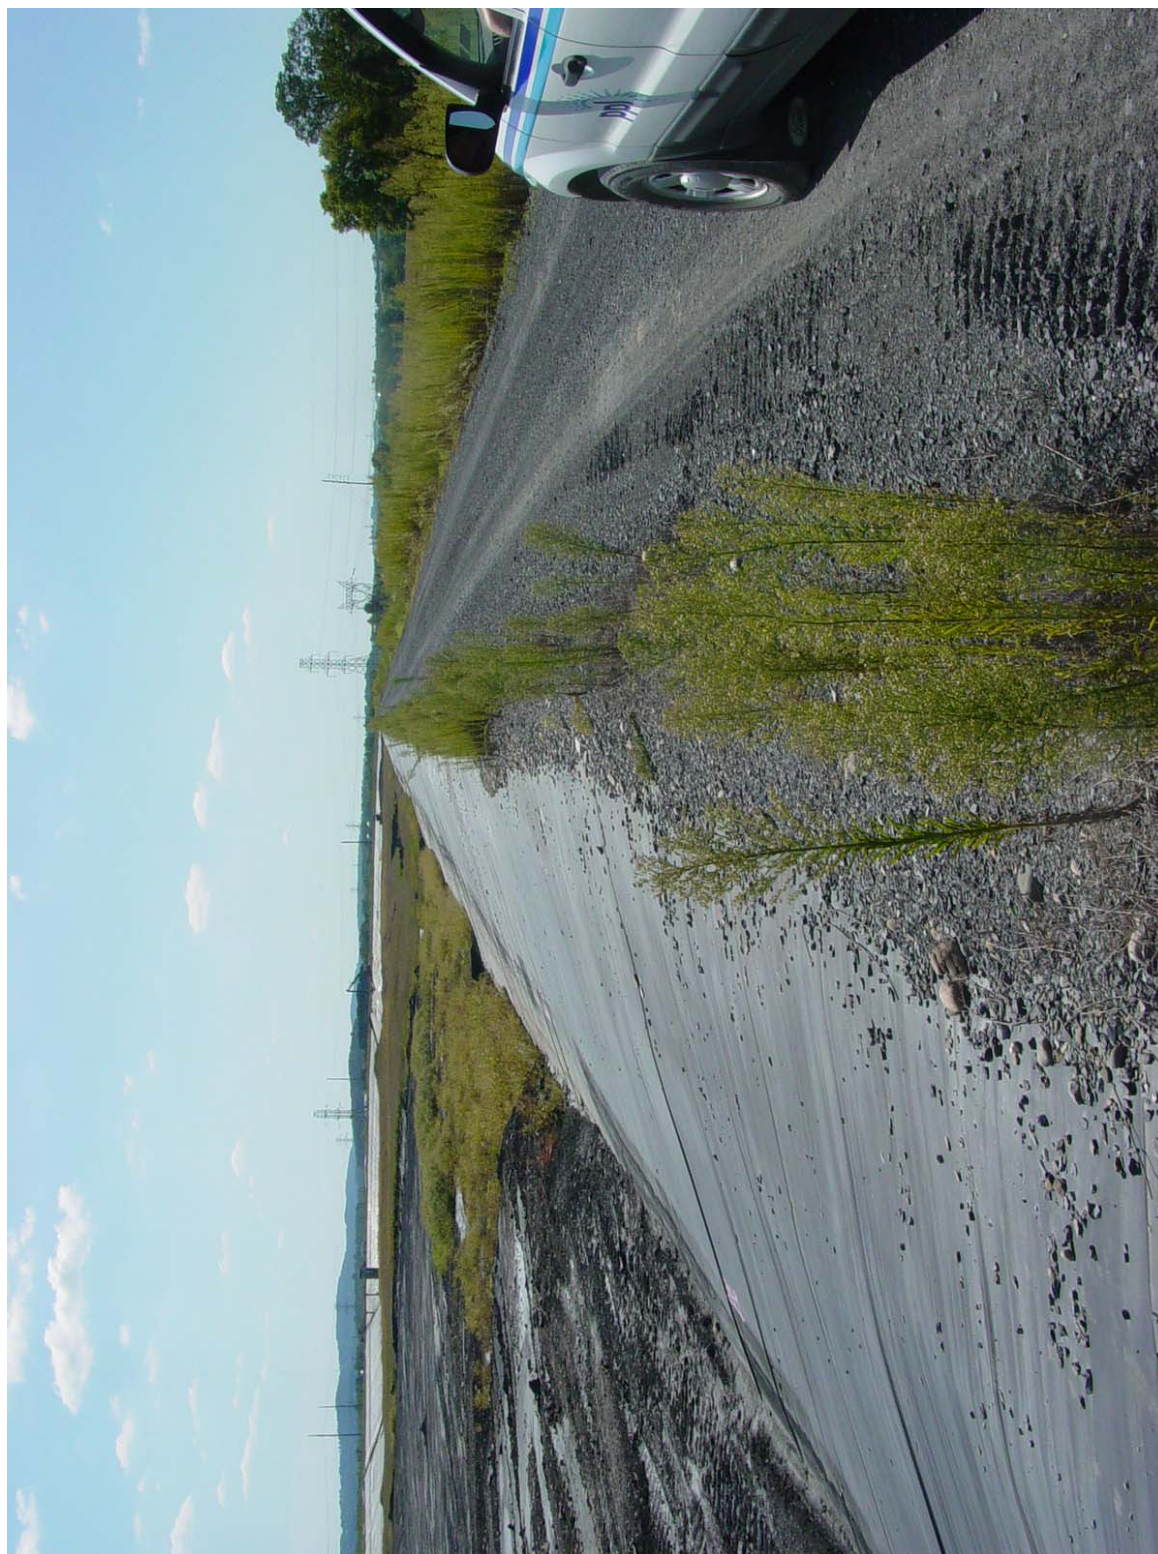
Photo B4-3: Ash Basin No. 4 Crest and Inside Slope of West Embankment – Viewed South.

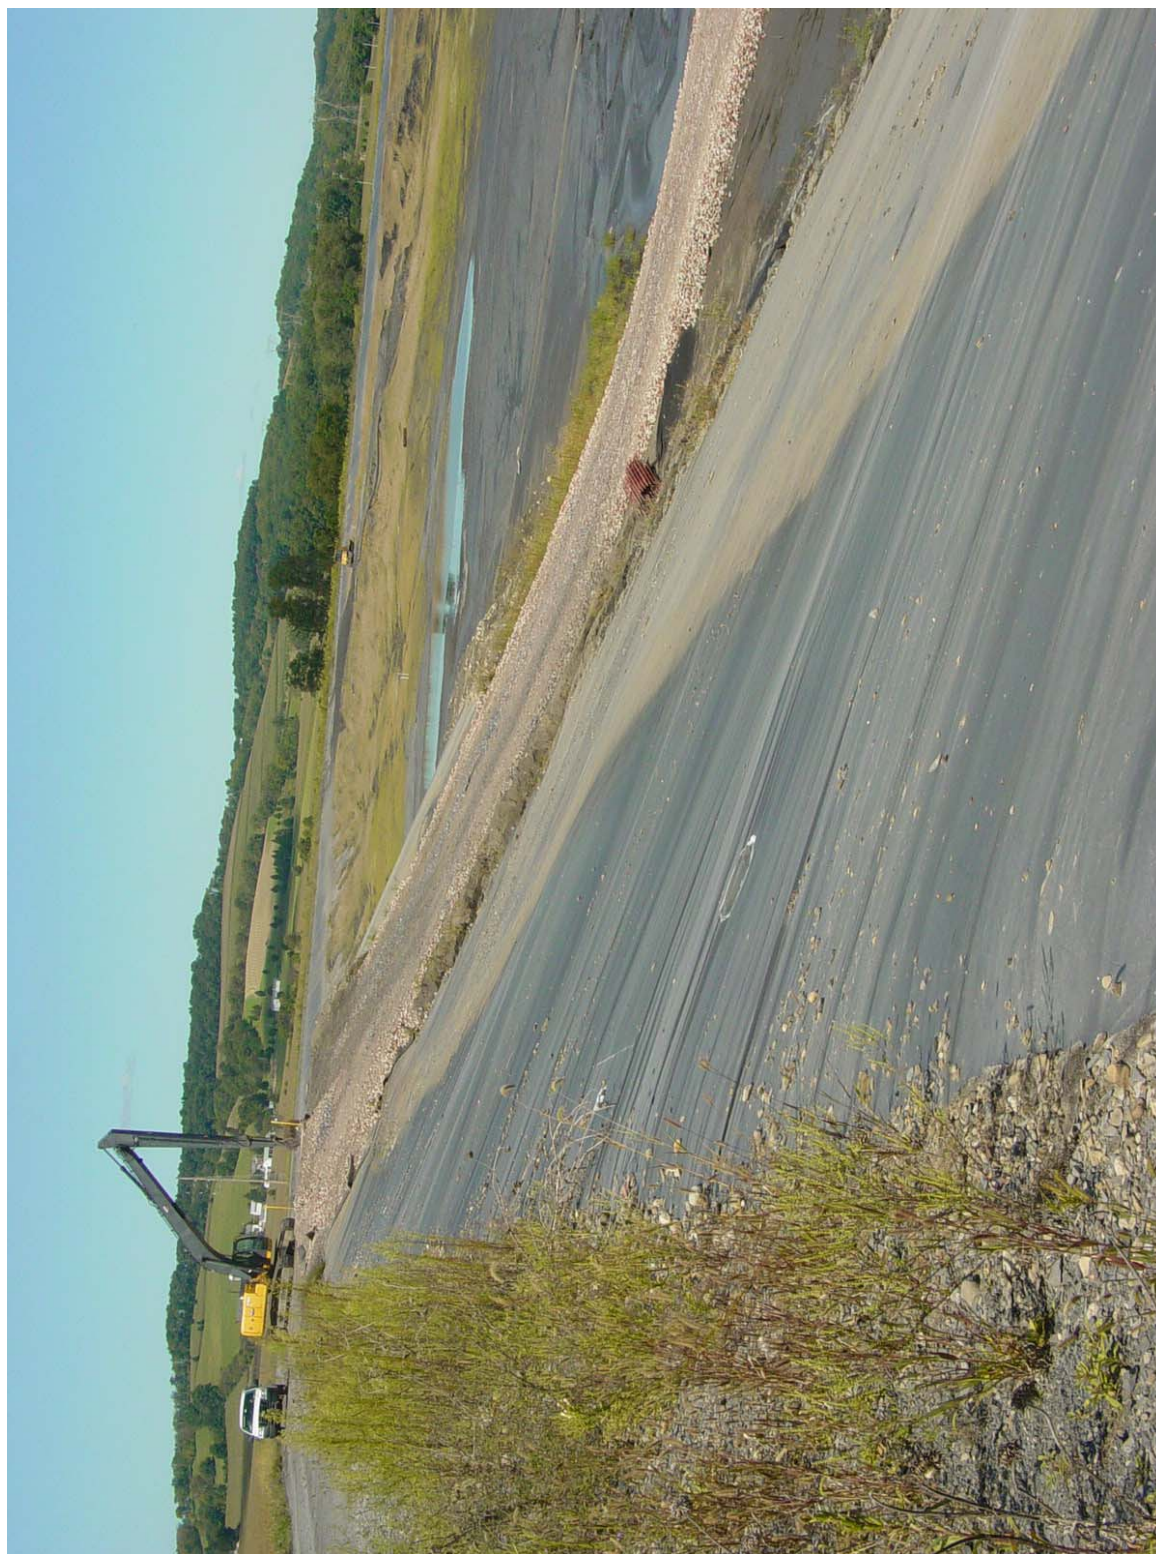
Photo B4-4: Ash Basin No. 4 Crest and Inside Slope of South Embankment – Viewed Northwest.

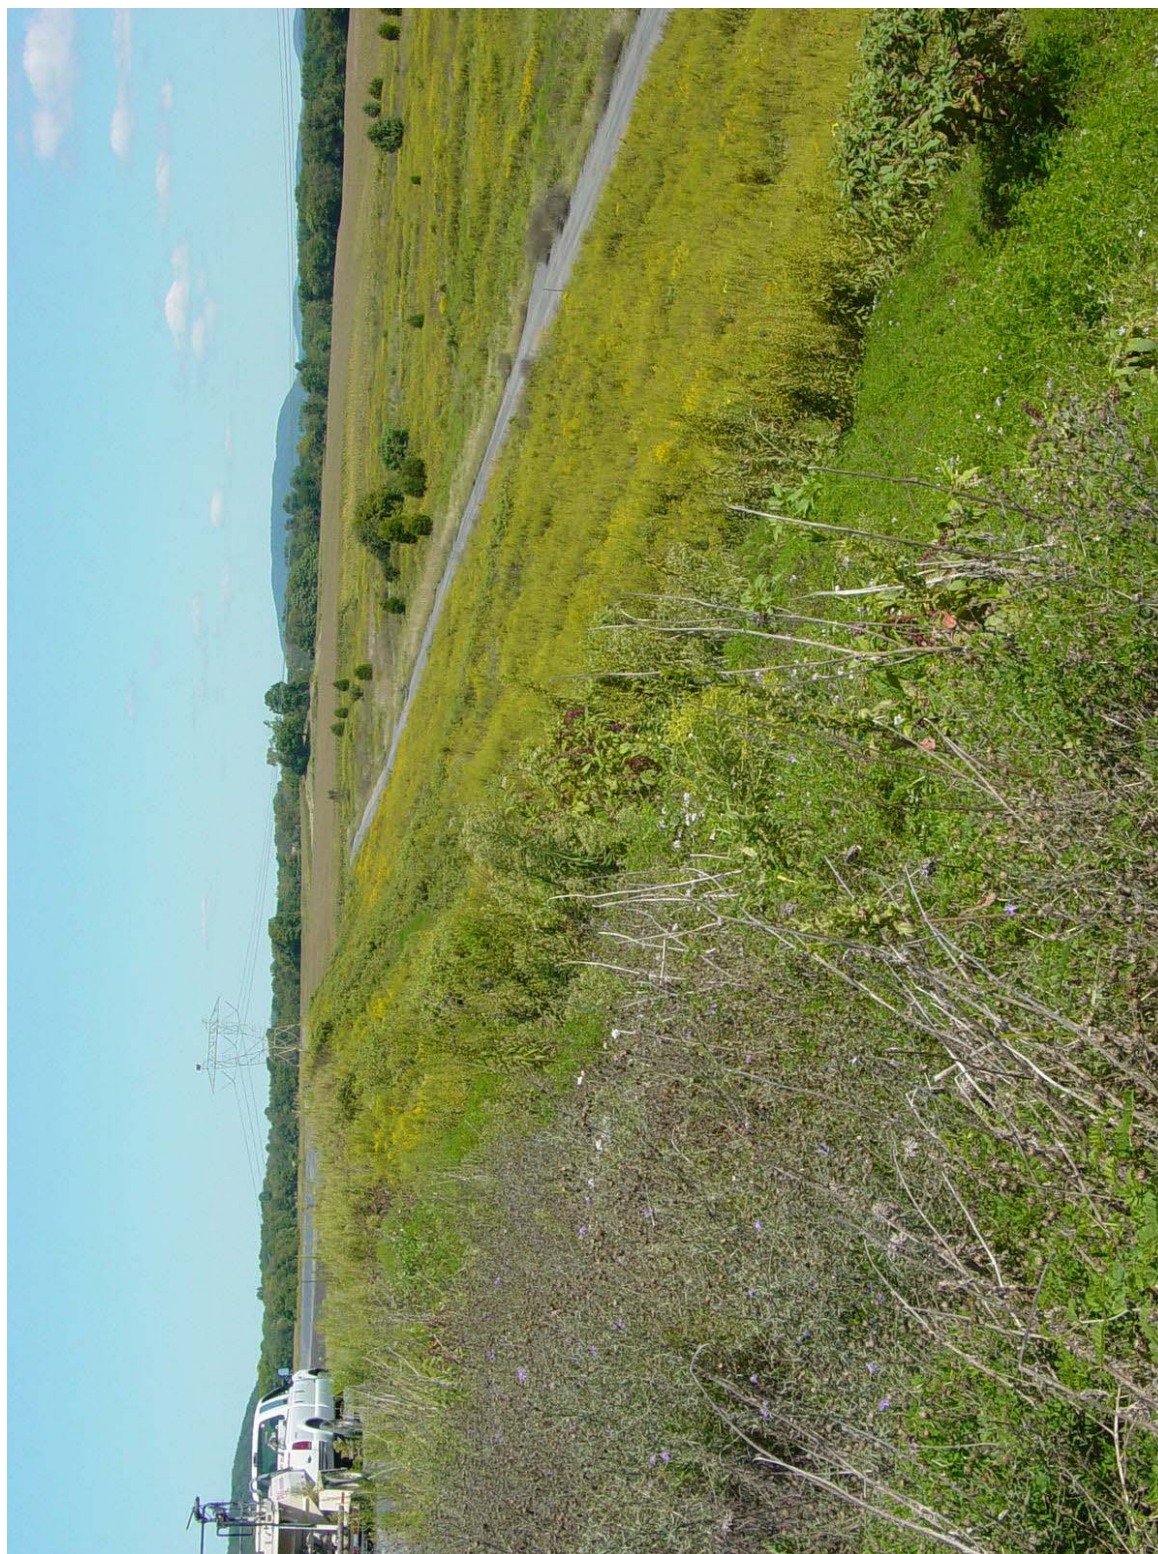
Photo B4-5: Ash Basin No. 4 Outside Slope of East Embankment – Viewed North.

Ash Basin No. 4 Dam - It is recommended that the outside slope be mowed at a frequency of 3 times per year: one time each during spring, summer, and fall. PPL's quarterly inspections and the annual inspection by the independent consultant should be coordinated with the mowing schedule. On the basis of observations made by an outside consultant in June 2009, it is recommended that a burrowing animal control program be implemented. It appears that the animals should be trapped and moved to a different location or eradicated. It is recommended that the control program be implemented within a time frame of 1 year. Filling of their burrows apparently is not effective and only encourages the animals to make new burrows. The post-closure maintenance program should also include repair of eroded areas that may develop on the outside slope or final closure cap. If the decant tower and outlet pipe are to remain open and functional after closure, it is recommended that these structures be maintained or repaired as needed, based on the results of routine inspections.

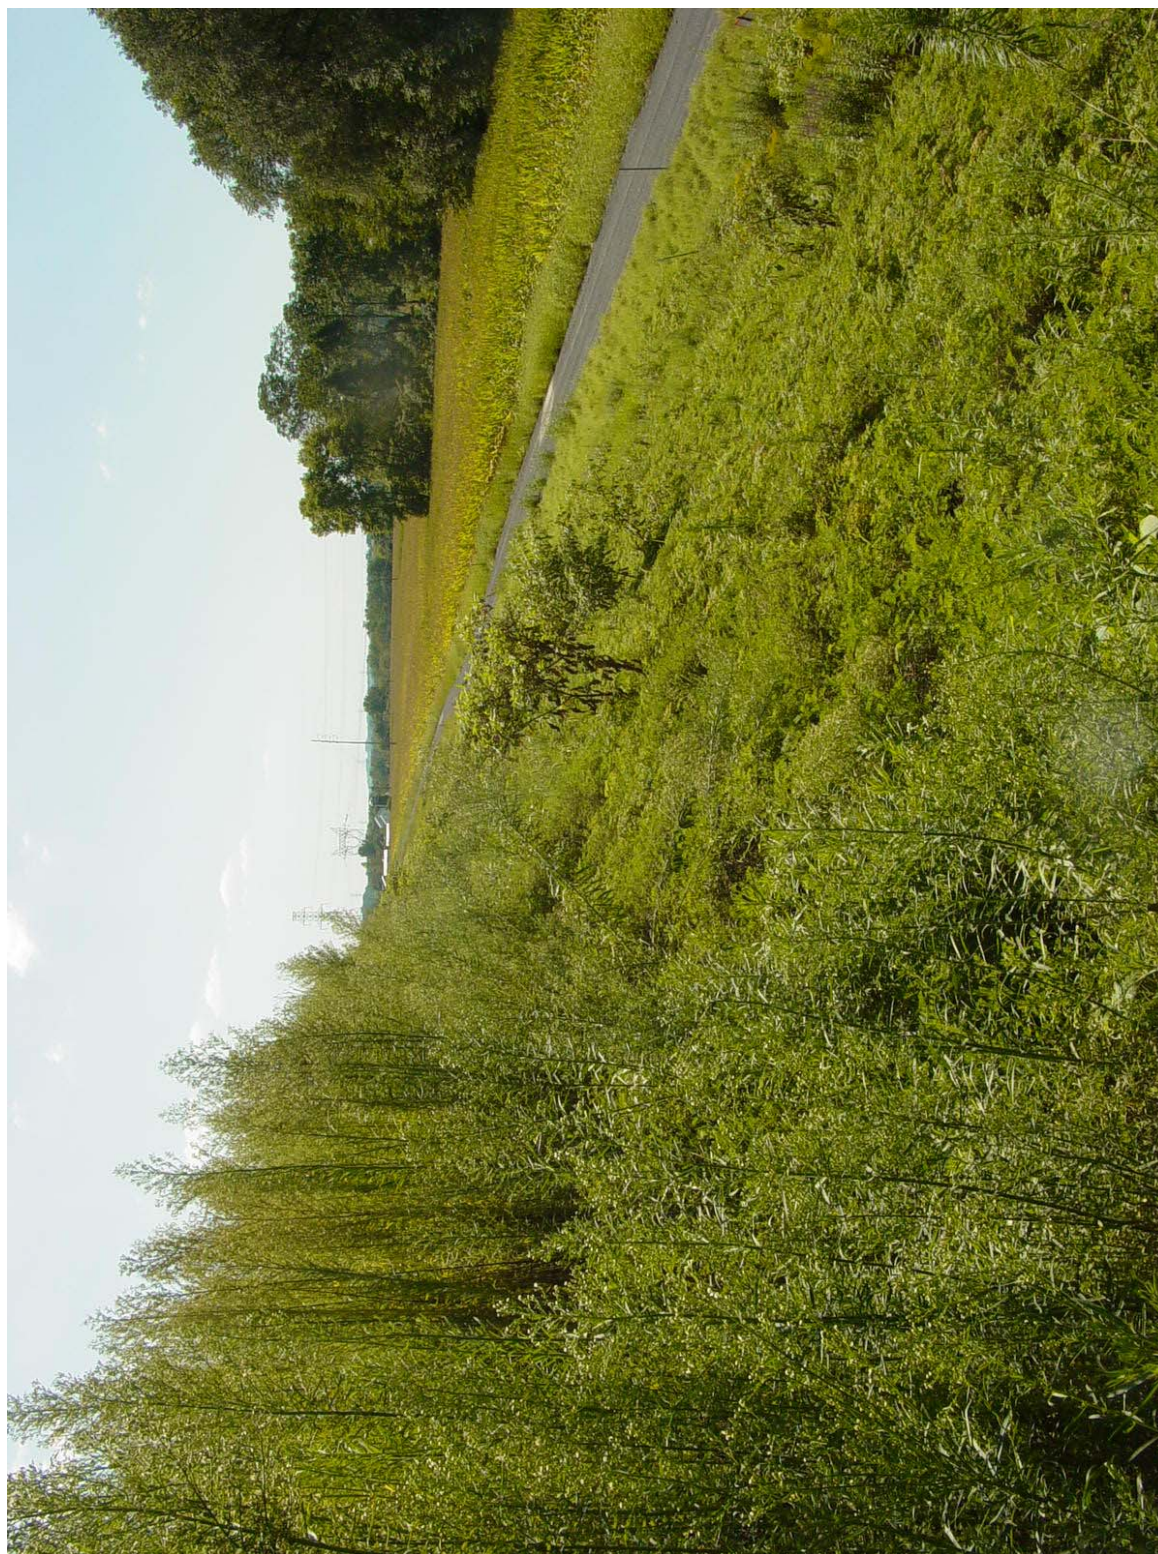
Typical views of the outside slope along the east embankment, north embankment, west embankment, and south embankment (including toe area) are shown in Photos B4-5, B4-6, B4-7, and B4-8, respectively. As shown, the slopes were observed to have a tall, thick growth of mostly herbaceous vegetation, such as *Sericea Lespedeza*, Crown Vetch (the lower-growing originally specified vegetation), and various volunteer weeds. Some briars and small bushes were also observed. The slope had not been mowed since May 2009. Mr. Steve Holler with PPL indicated the slope was normally mowed once annually. No obvious slumps, slide scarps, tension cracks, major bulges, or other signs of slope shear failure were observed, and no depressions, drop-outs, seepage, or major wet areas were observed on the slope or in the toe area, but the tall thick growth of vegetation severely hampered observations for these conditions. No animal holes were obvious either, due to the thick vegetation; however, a previous inspection performed by an outside consultant (HDR/DTA) on June 15, 2009 identified over a dozen new woodchuck burrows after PPL had completed filling 35 previously identified burrows on June 11, 2009. The HDR/DTA inspection also noted wet areas and standing water along the east and northeast (north) embankments, which they noted was likely due to limited (poor) drainage.

Photo B4-7: Ash Basin No. 4 Outside Slope of West Embankment – Viewed South.
