# Coal Combustion Waste Impoundment Dam Assessment Report

*Martins Creek Steam Electric Station  
PPL Generation  
Bangor, Pennsylvania*

**Project # 0-381**  
**Assessment of Dam Safety**  
**Coal Combustion Surface Impoundments**  
**for the REAC Program**

**September 2009**

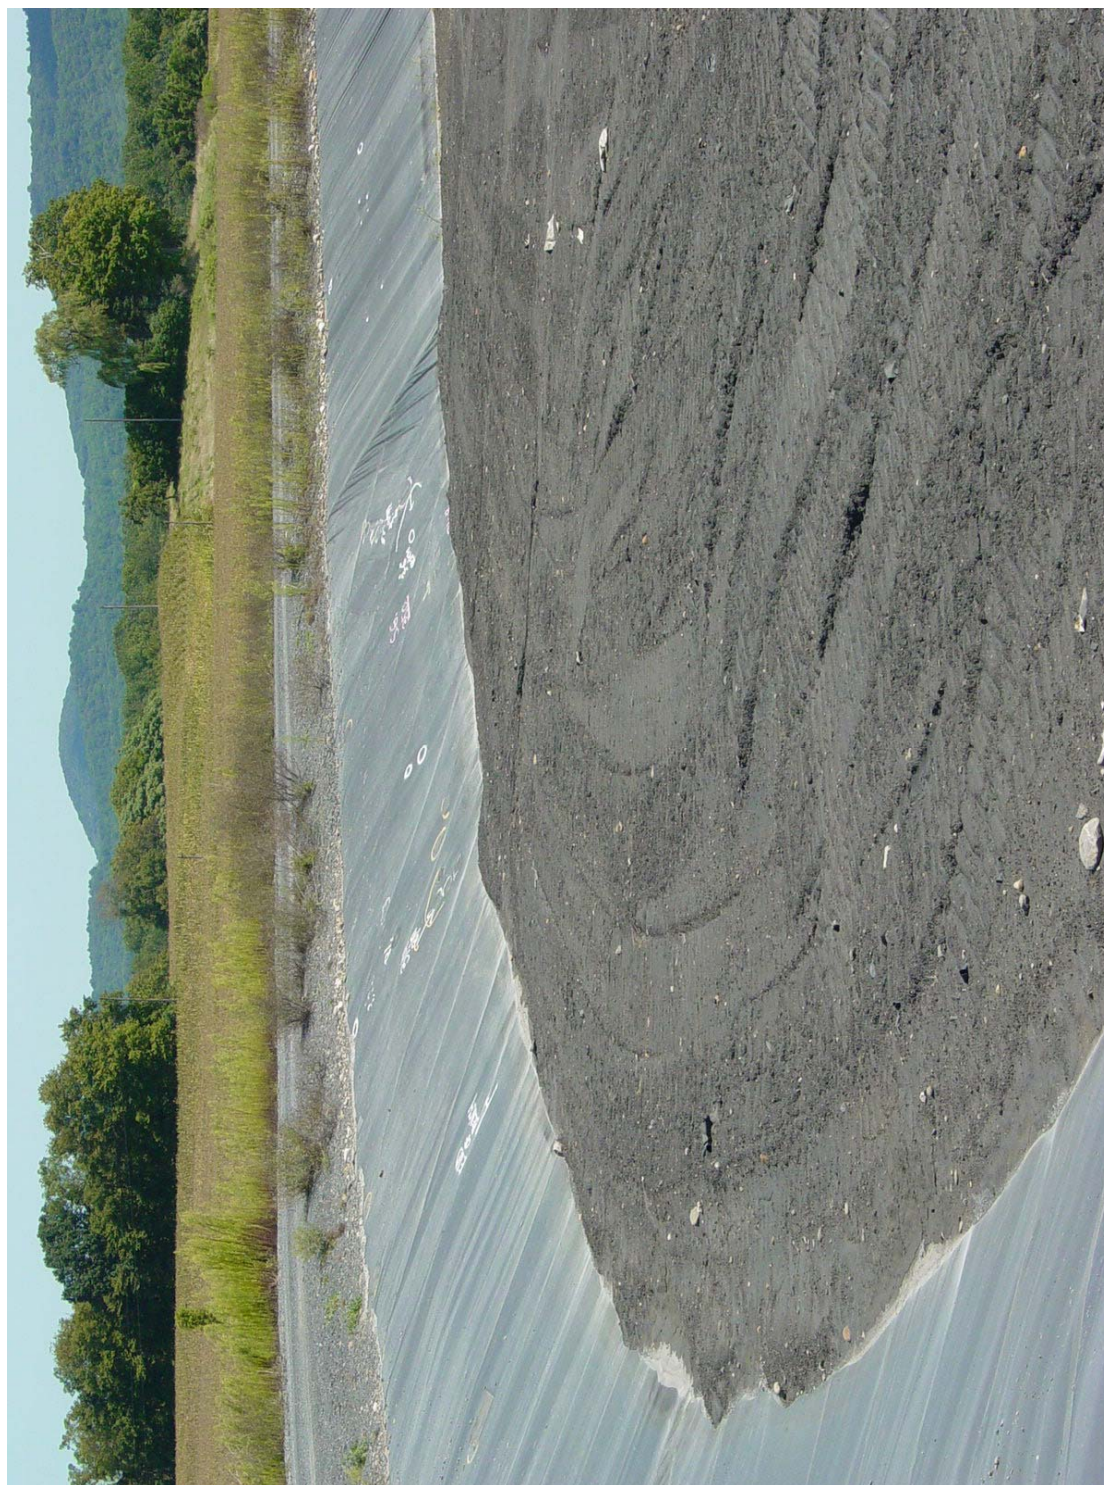
Photo B4-12: Ash Basin No. 4 Inside Slope of North Embankment at Northwest Corner – Note Highest Point of Ash in the Basin Spread in Place by Dozer in Preparation for Closure; White Marks on Liner from PPL Inspection Indicating Holes and Defects to be Patched.

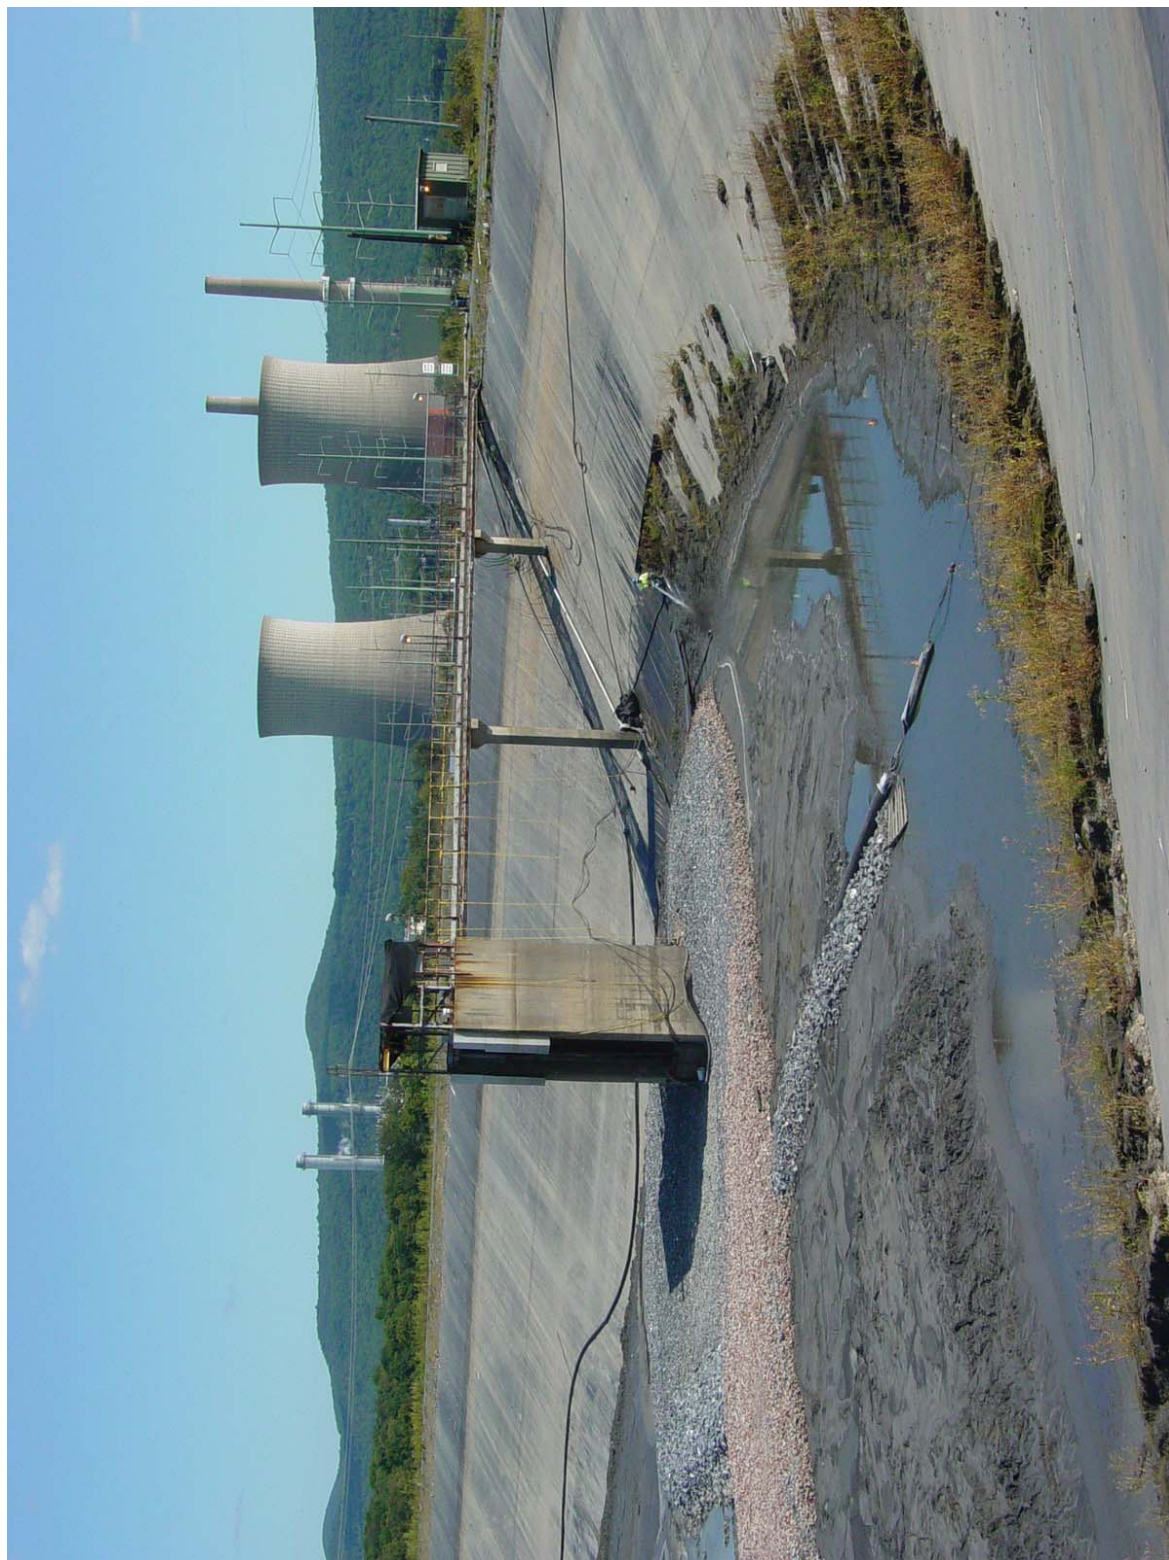
Photos B4-16 and B4-17 provide outside views of the overflow structure (decant tower) located at the southeast corner of Ash Basin No. 4. A view of the outer chamber through the top walkway grate is shown in Photo B4-18, and a partial view of the inner chamber through the top grate is shown in Photo B4-19. The structure was observed to be in overall good visual condition. As previously described, major modifications were made to the structure after the uncontrolled release in 2005 (see Subsections 2.4.2 and 3.3). The structure is no longer used for outflow through the bottom discharge pipe. It now is used basically as a sump pit from which filtered storm water is pumped to the IWTB. The crushed stone layer, which was reported by PPL to be 10 feet thick, is shown surrounding the decant tower in Photos B4-16 and B4-17. The equipment access causeway constructed of crushed brick from demolition of the smoke stacks for the former coal burning units is also shown in Photo B4-17.

Photo B4-16: Ash Basin No. 4 View of South and West Sides of Decant Tower – Viewed Northeast Note Crushed Stone Filter Around Base of Tower.

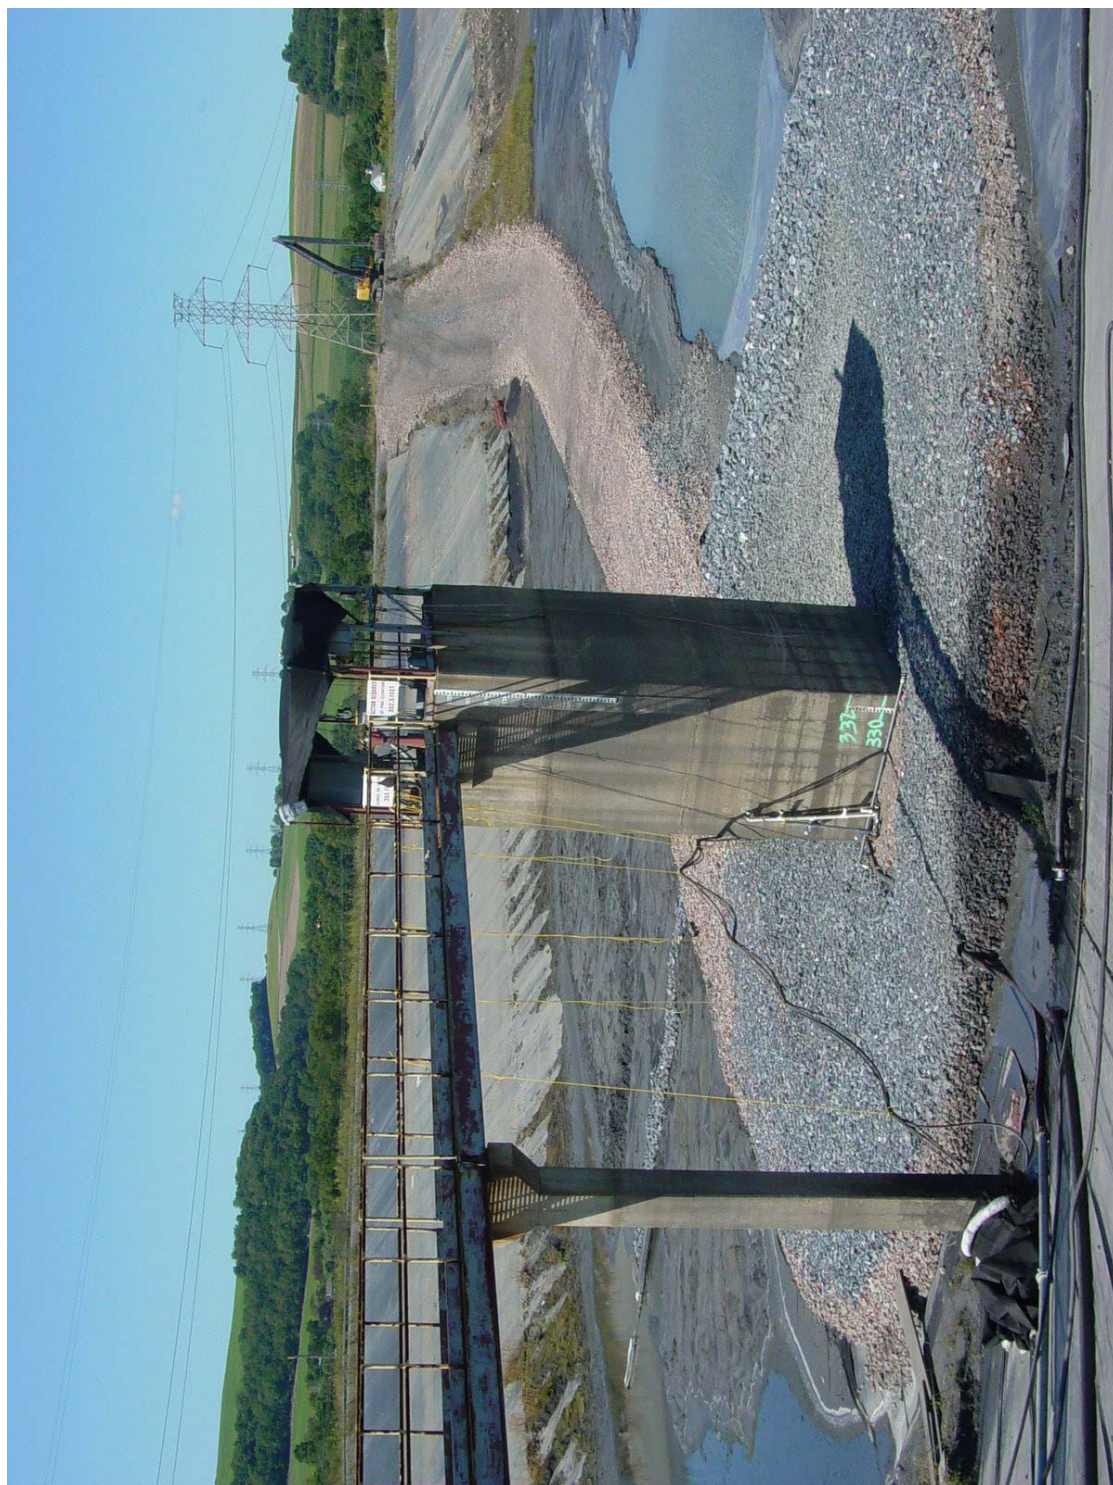
Photo B4-17: Ash Basin No. 4 View of East and North Sides of Decant Tower – Viewed Southwest Note Crushed Brick Access Causeway to Filter Around Base of Tower (Brick from Demolition of Smoke Stacks).

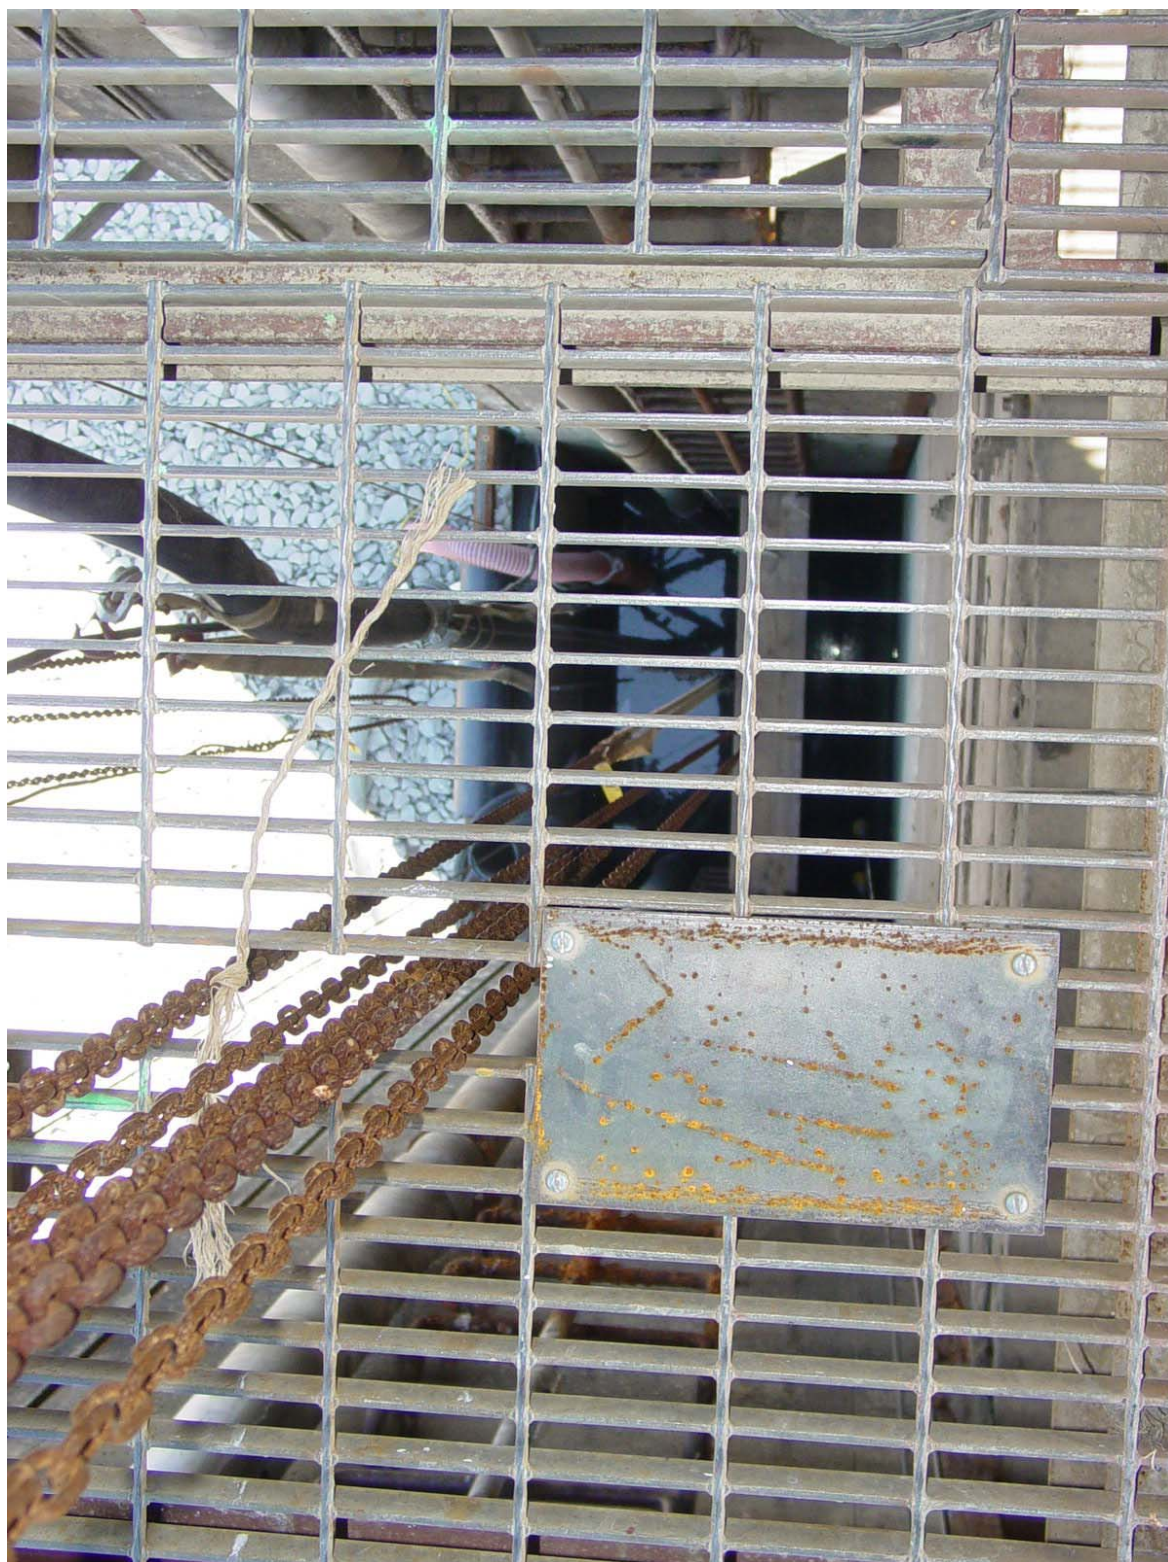
Photo B4-18: Ash Basin No. 4 View Through Top Grate into Outer Chamber of Decant Tower.

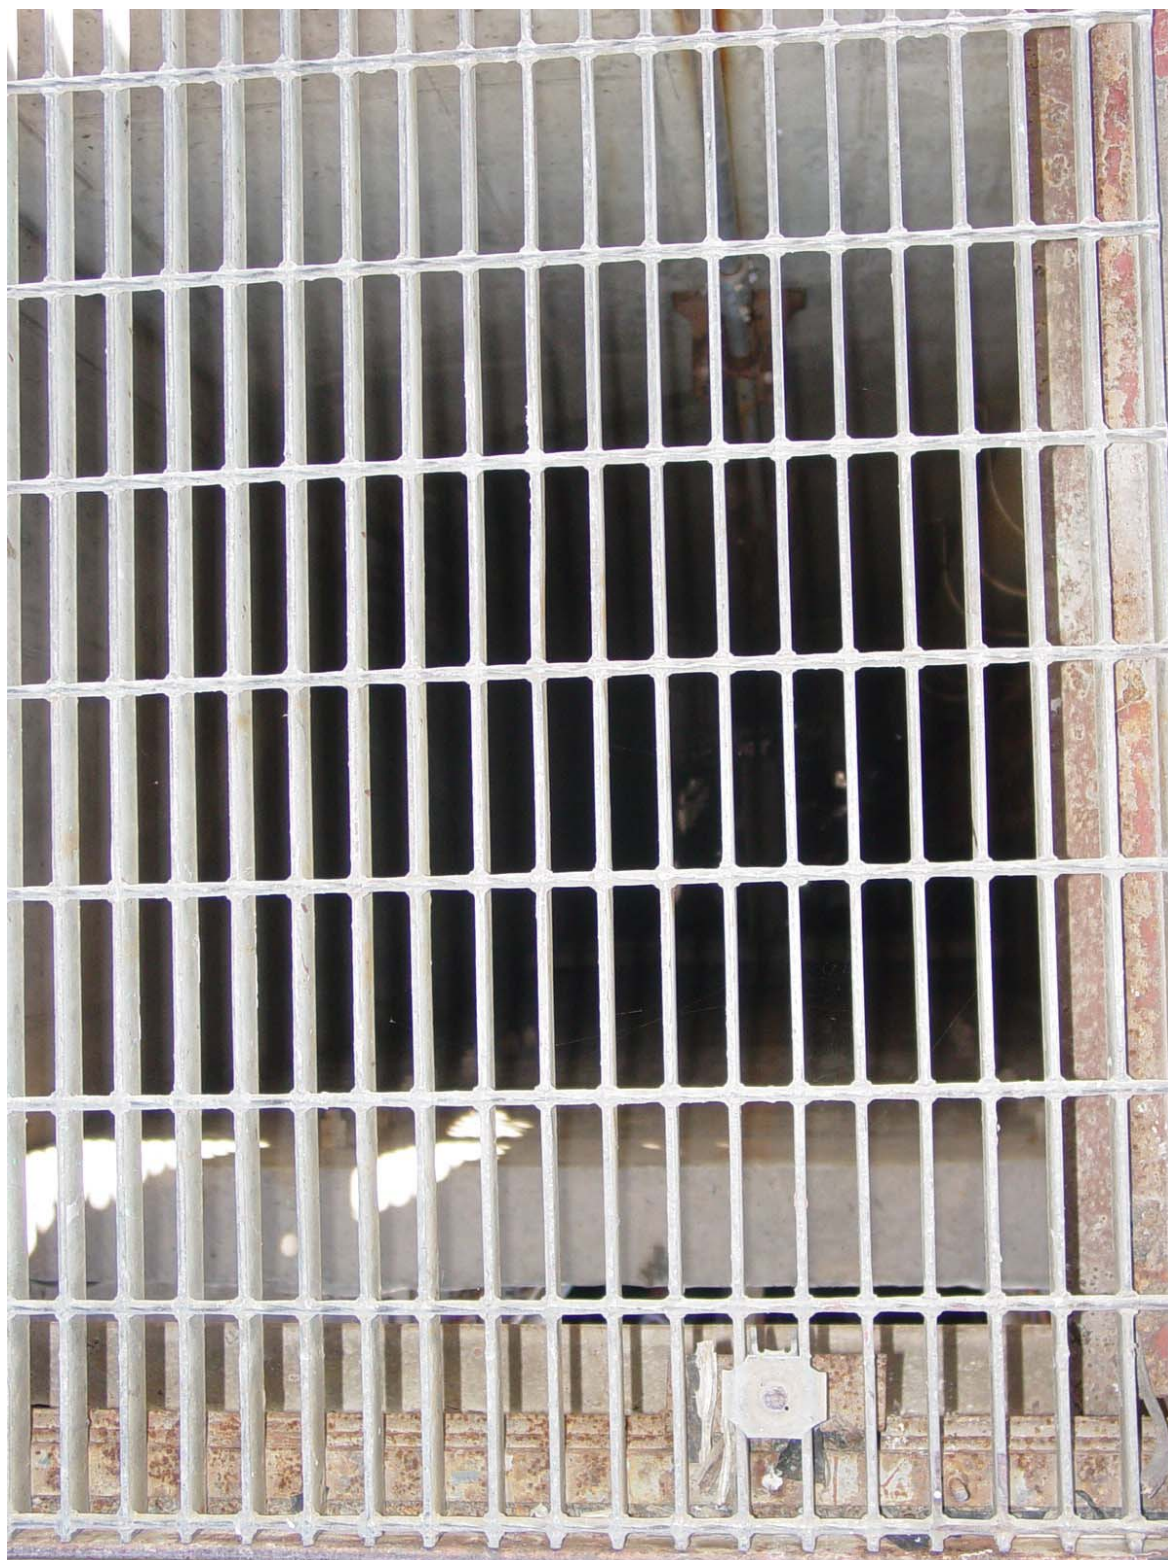
Photo B4-19: Ash Basin No. 4 View Through Top Grate into Inner Chamber of Decant Tower (Behind Concrete Stop Logs).

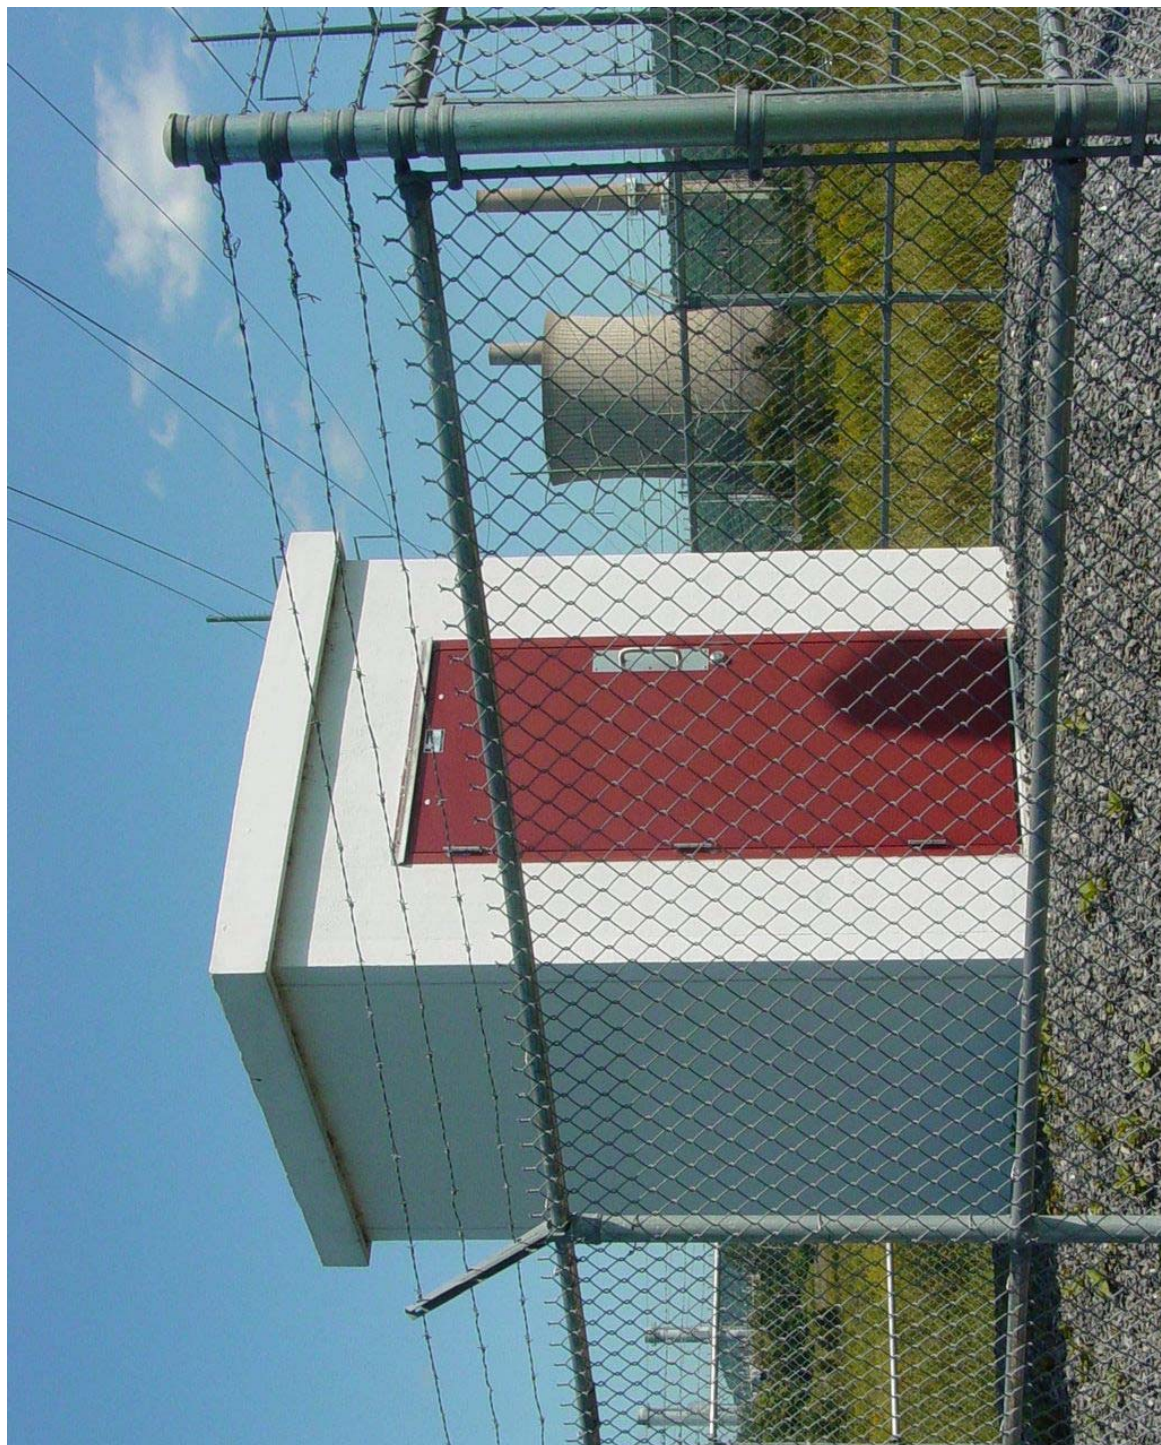
Photo B4-20: Ash Basin No. 4 View of Building Housing Operator for New Gate Valve in Underlying Concrete Vault.

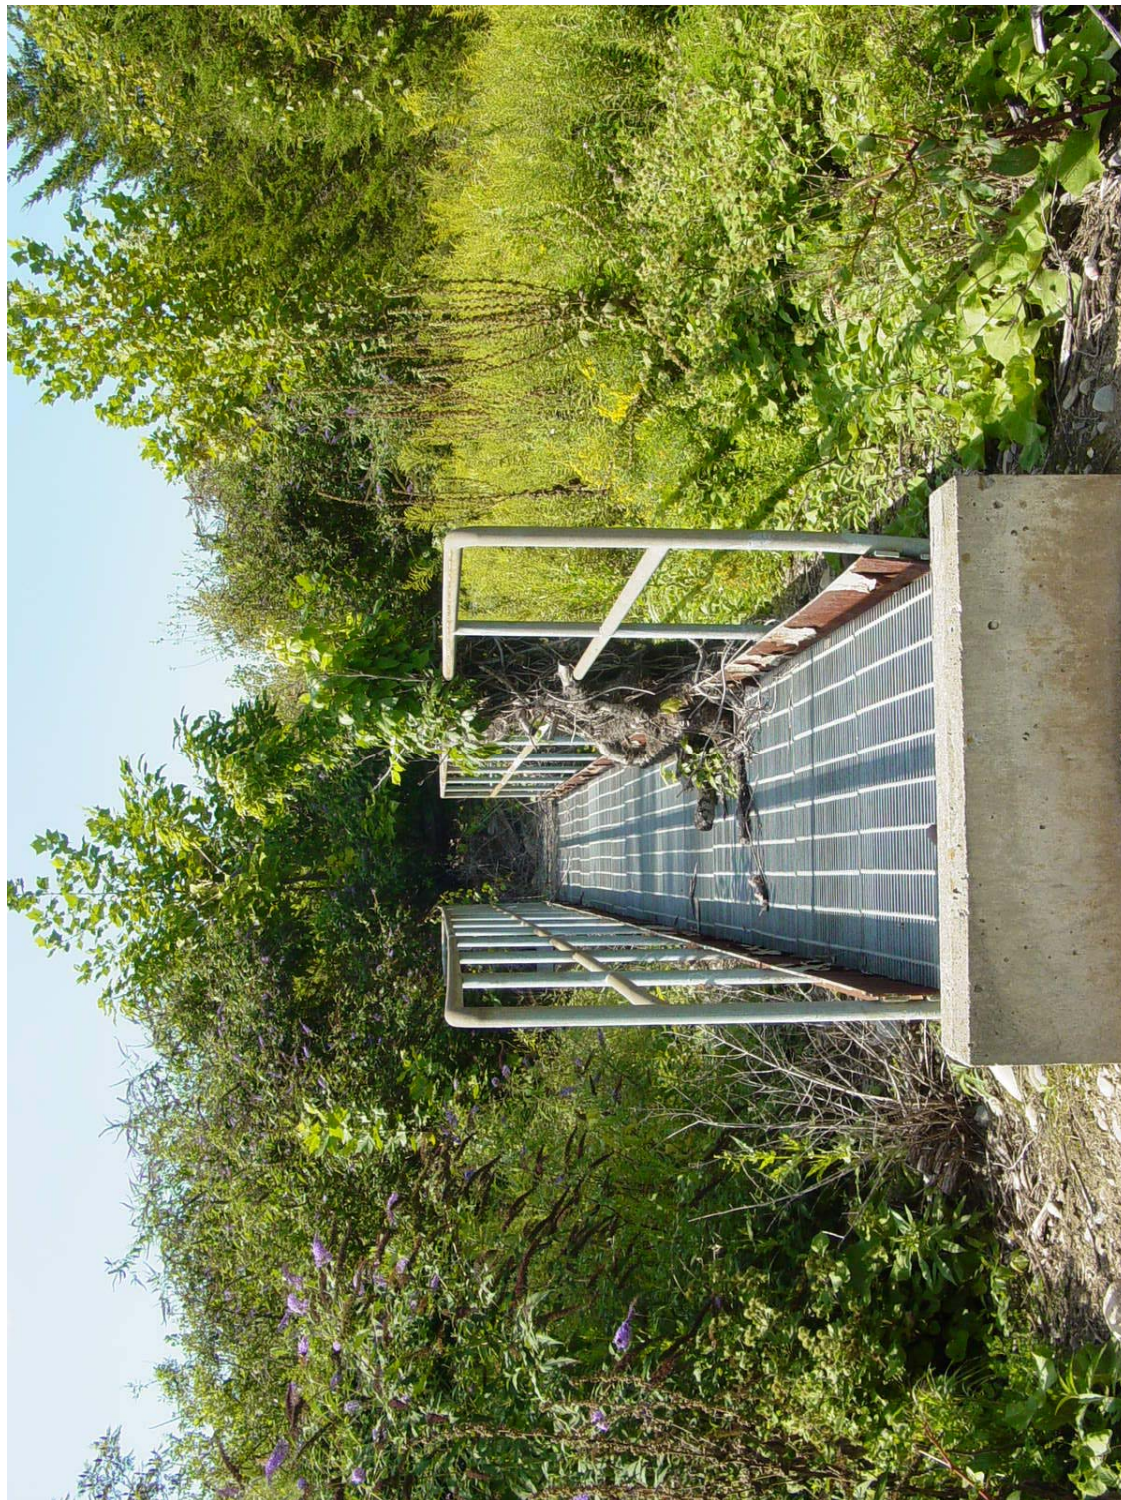
Photo B2-1: View of former Footbridge to North Decant Tower at Ash Basin No. 2 – Viewed West – Note Dense Vegetation on the Soil Cover over the Closed Basin.

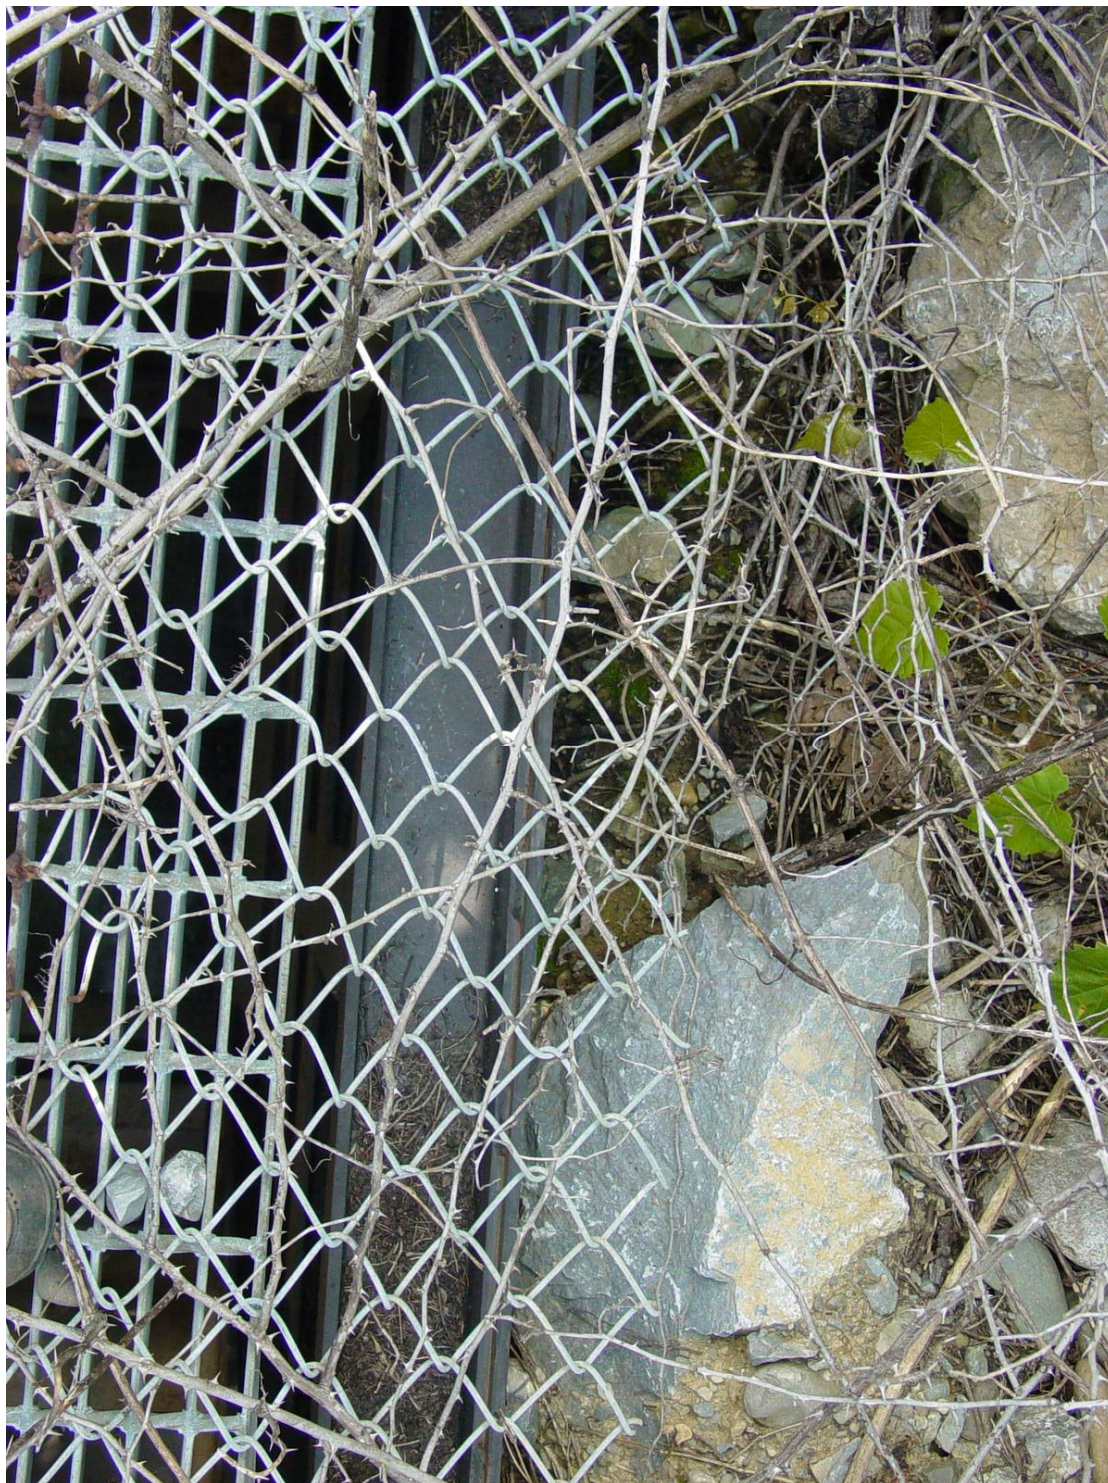
Photo B2-2: View of Top of Reinforced Steel Plate Bulkhead that Seals off the Wood Stop Log Side of the North Decant Tower at Ash Basin No. 2 – This and Two other Drainage Towers at the Closed Basin No. 2 are used for Drainage from the IWTB to the

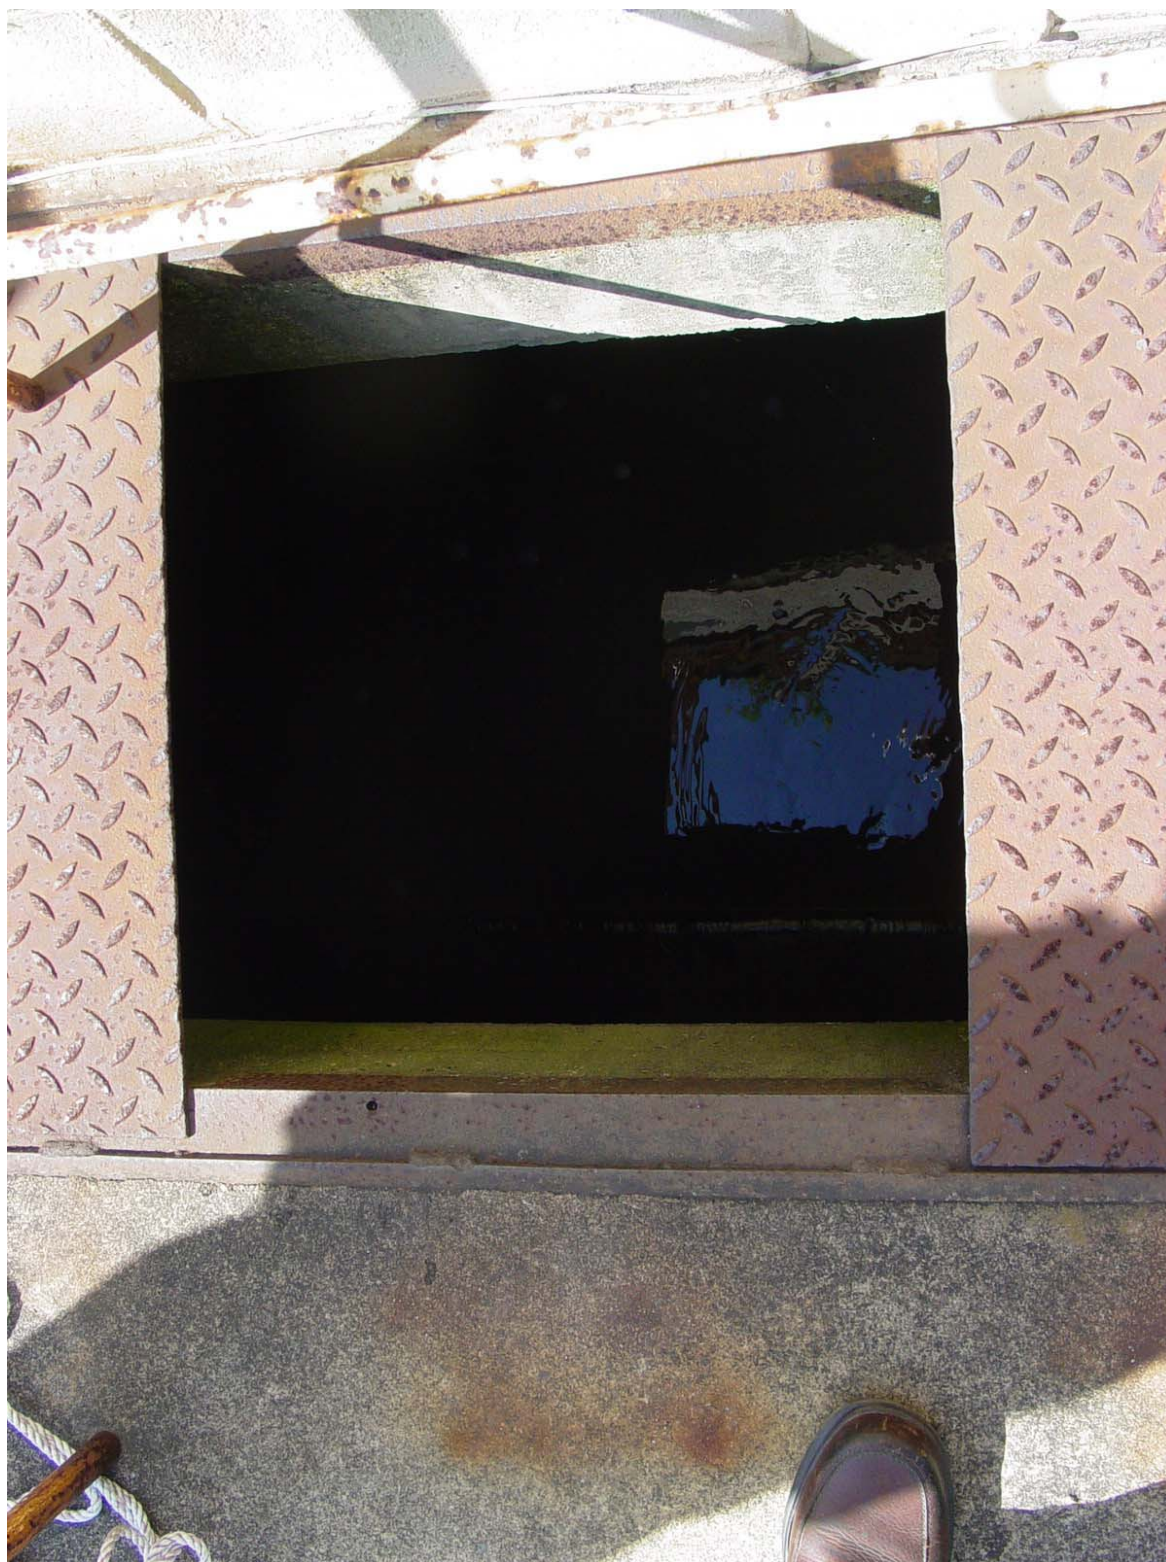
Photo B2-4: View Inside Combining Structure Basin at location of Weir

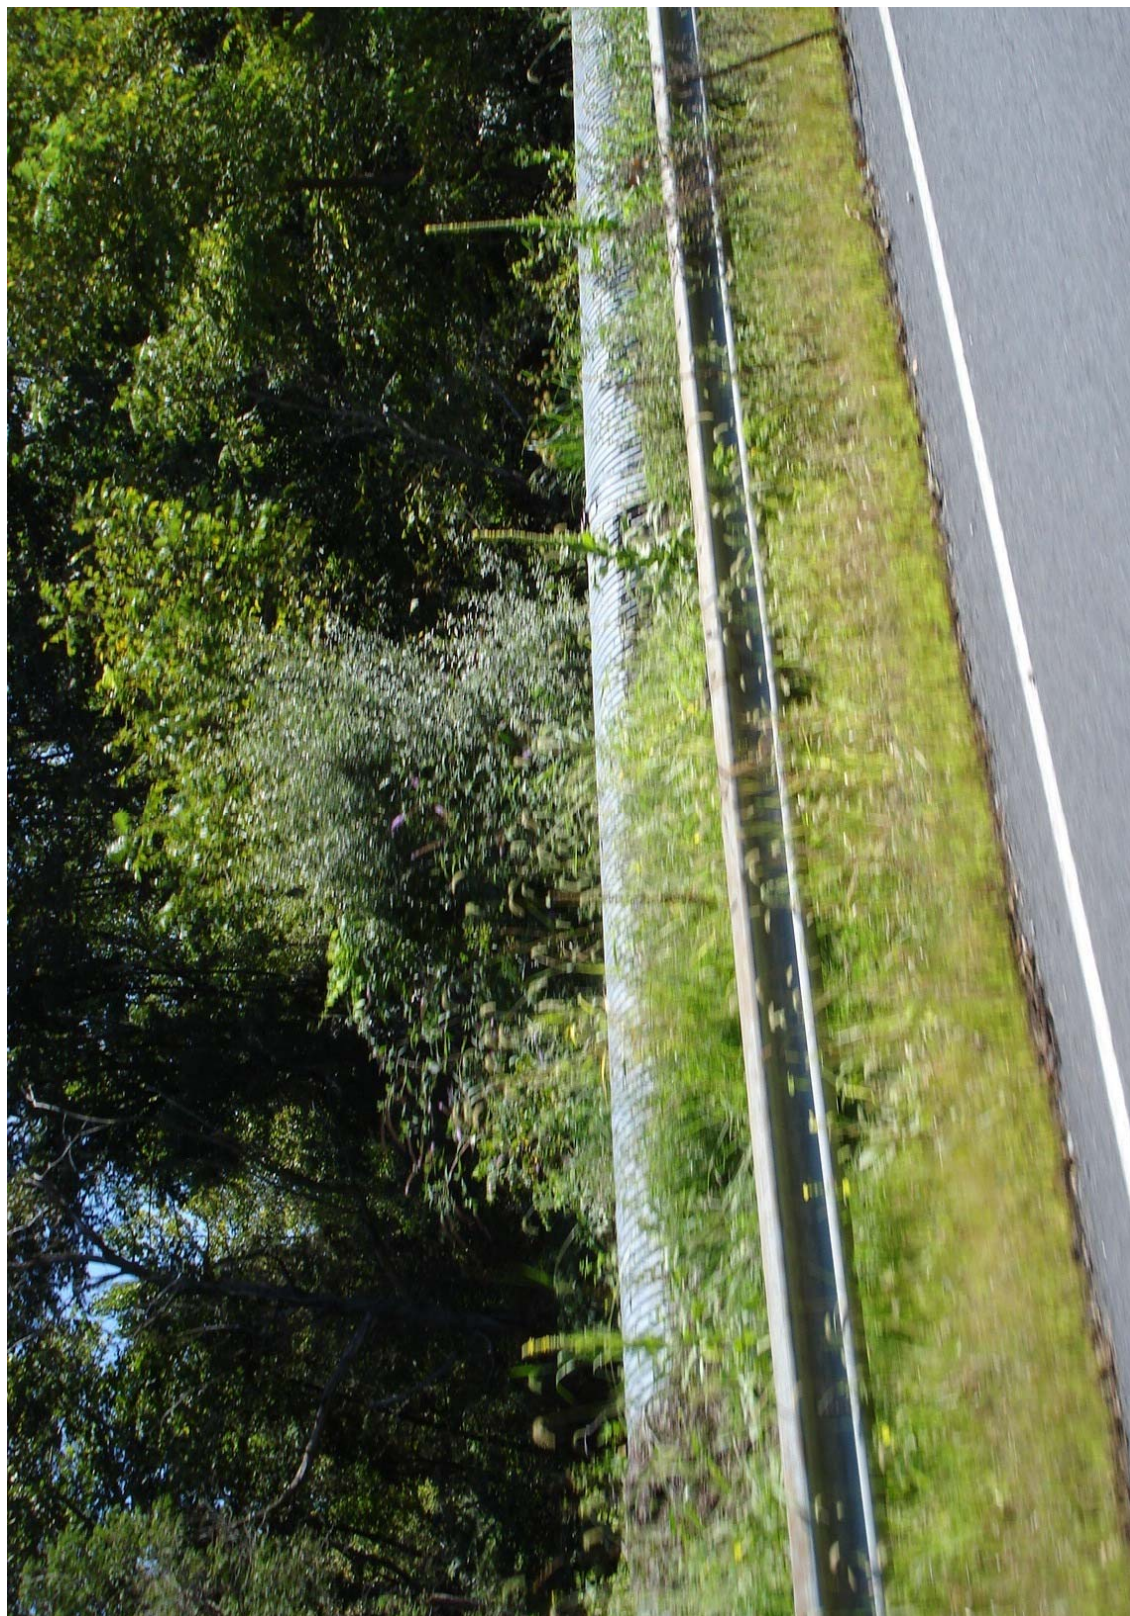
Photo B2-5: View of Above Ground 42" CMP Discharge Line from Combining Structure to Outfall Near the Delaware River.

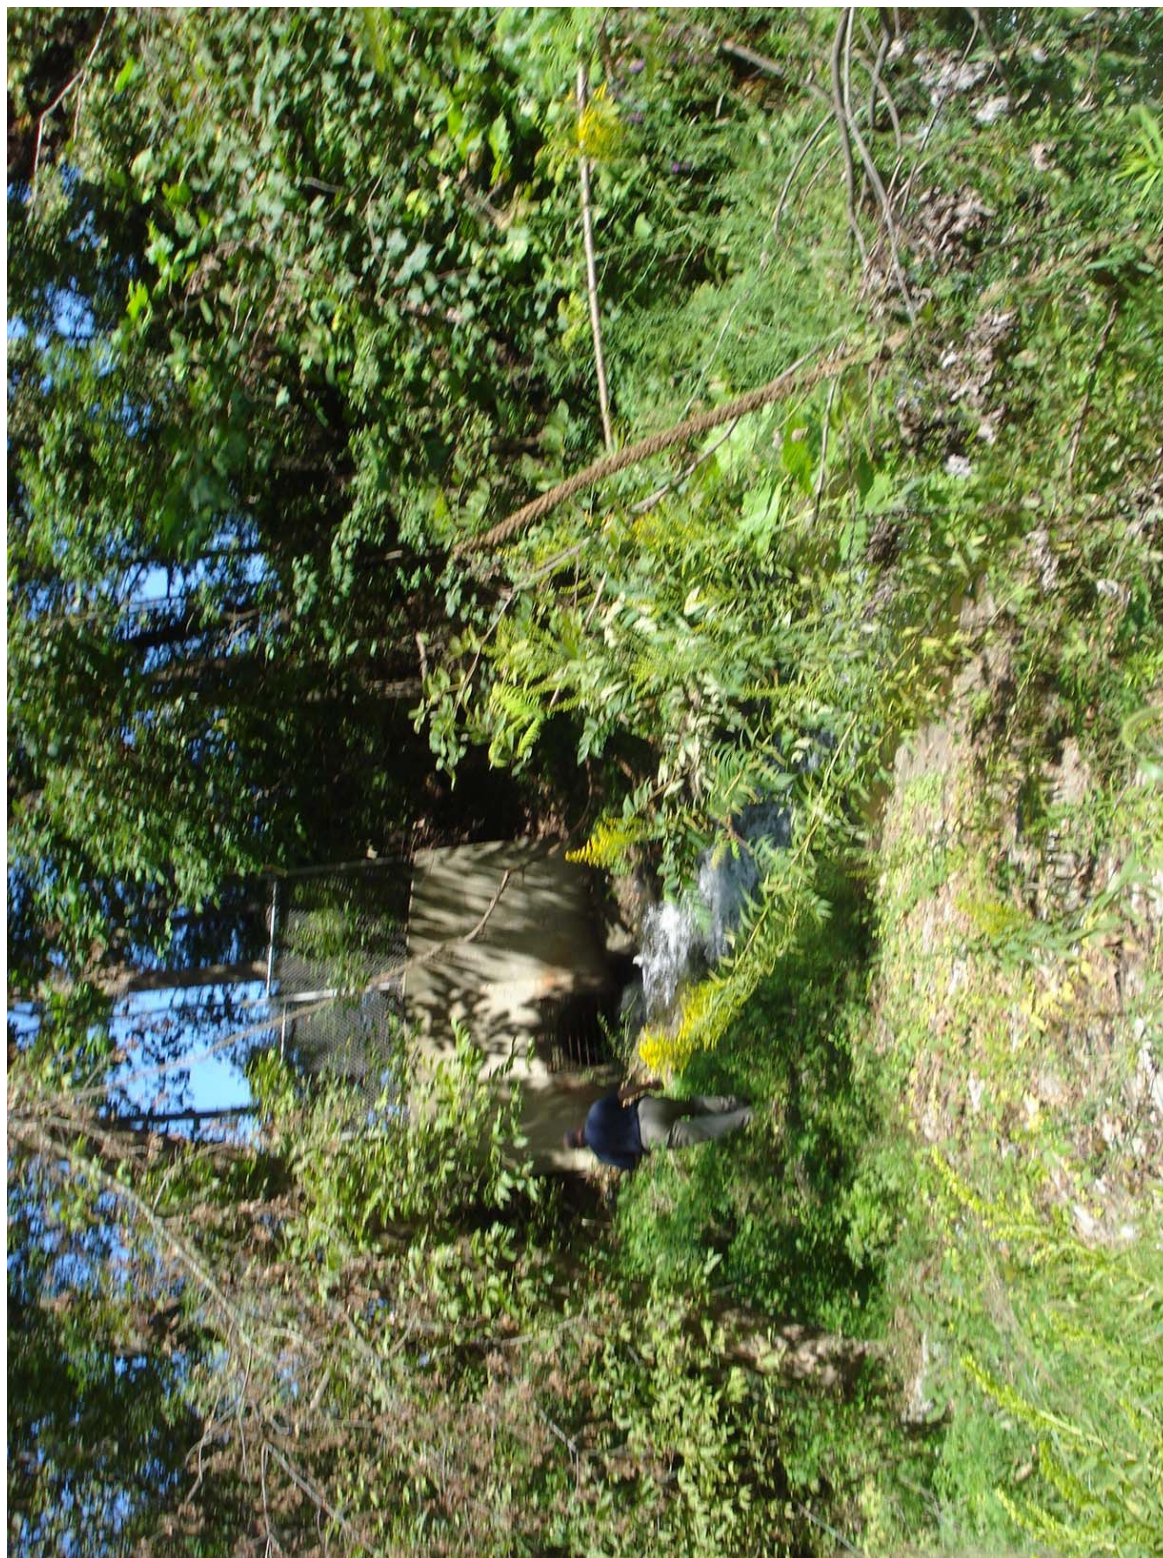
the basin and into a 42-inch diameter CMP that leads to the outfall point near the river. As previously mentioned, discharge from Ash Basin No. 4 is no longer combined with the IWTB discharge at this structure; it is now pumped into the IWTB. Farther down-gradient the 42-inch diameter discharge line is above ground, as shown in Photo B2-5. At the outfall, where the water is discharged into the grouted riprap channel, the end of the discharge line is protected with a reinforced concrete end wall, as shown in Photo B2-6. A bar screen over the outfall port through the end wall was observed to be rusty but sound.

Photo B2-6: View of Outfall of 42" CMP Discharge Line into Grouded Riorap Channel to the Delaware River.

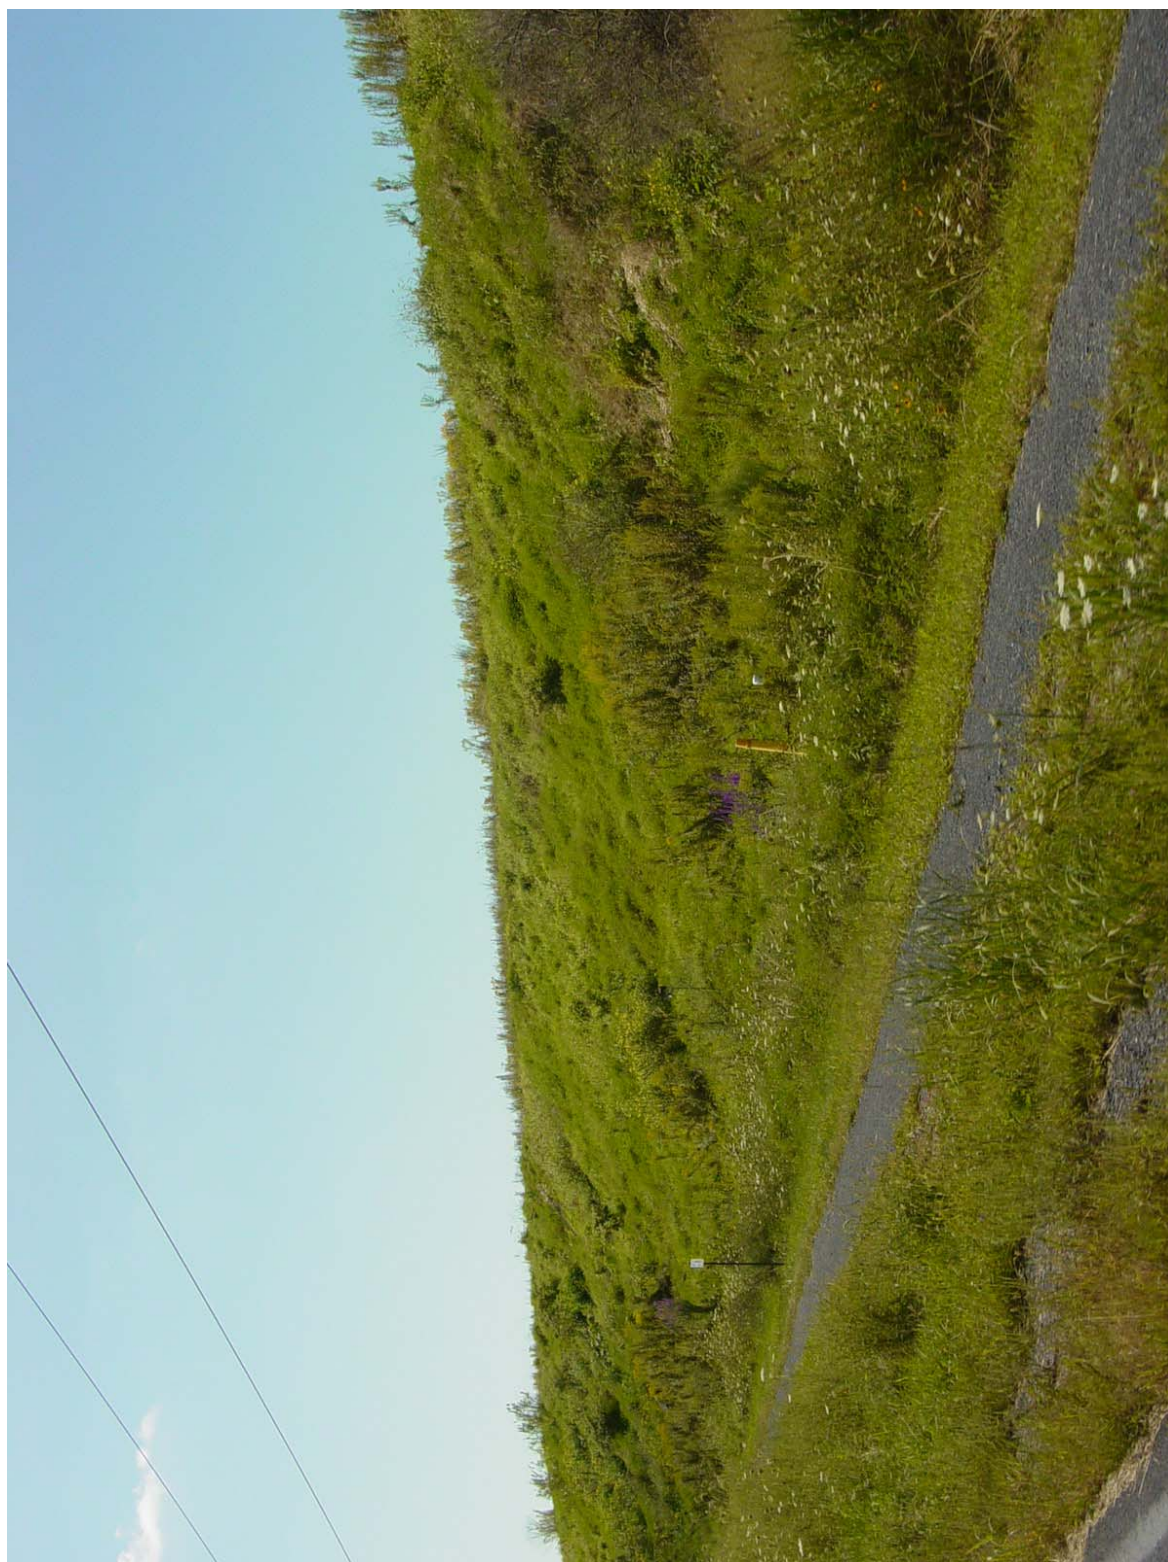
Partial views of the outside slopes of the west embankment and east embankment of the closed Ash Basin No. 3 are shown in Photos B3-1 and B3-2, respectively. As shown, the slopes have a thick cover of herbaceous vegetation; the west slope also has tall bushes.

Photo B3-2: Ash Basin No. 3 View of Outside Slope of East Embankment of the Closed Basin- Viewed Southwest.
