## RED BANNER ALERT

# SHW Serious Incident (SI) – Preliminary Notice

| <b>Incident Short Description</b> | Traffic Controller reversed into culvert and rolled onto side. |

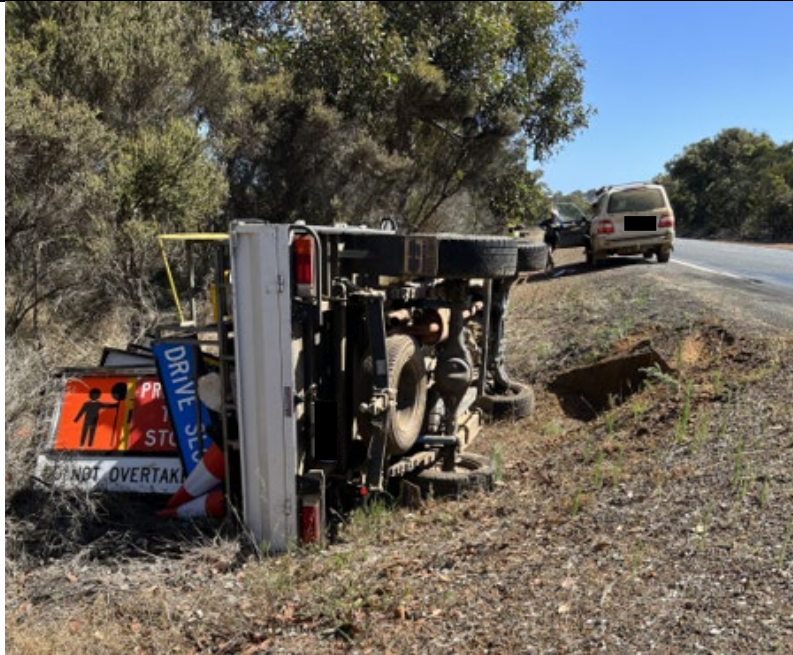
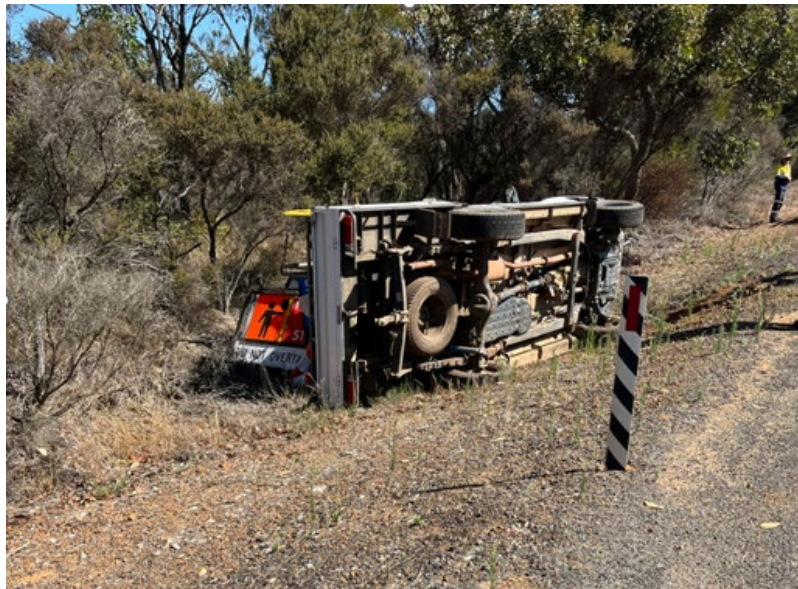
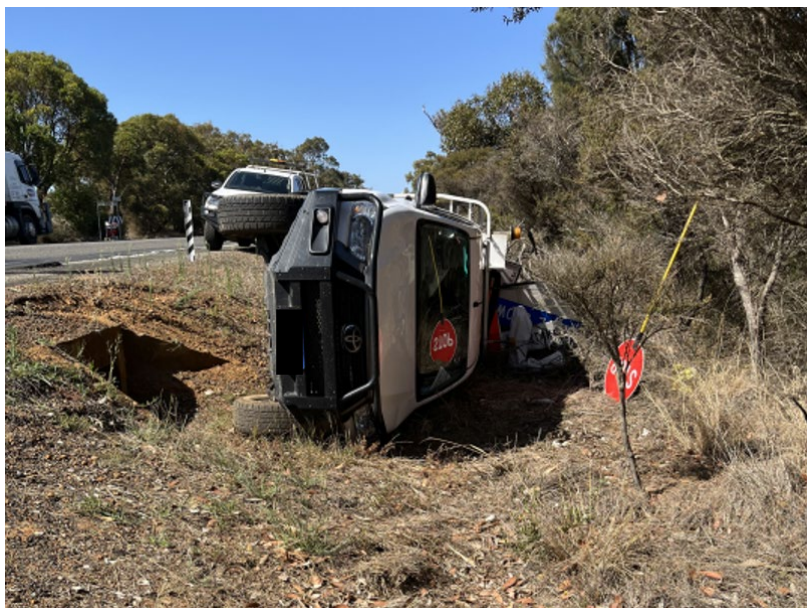
The driver reversed the LV back along the shoulder not realising they had just passed a culvert post, and there was a culvert head wall behind the vehicle. When reversing, the right (driver side) wheel has remained at road level while the left (passenger side) rear wheel has tracked into the void of the culvert wall.

The vehicle was travelling slowly and stopped once the left rear wheel entered the void. Due to the difference in height right to left, the vehicle has become unstable/unbalanced and rolled, coming to rest on the left-hand side. The driver and passenger held the door pillar handles as the vehicle tipped. The driver and passenger exited the vehicle through the driver's window. Neither driver nor passenger sustained an obvious injury.

***Vehicle position after the incident.***
