## SHW Serious Incident (SI) – Preliminary Notice

| <b>Incident Short Description</b> | Concrete boom pump tipped due to ground collapse |

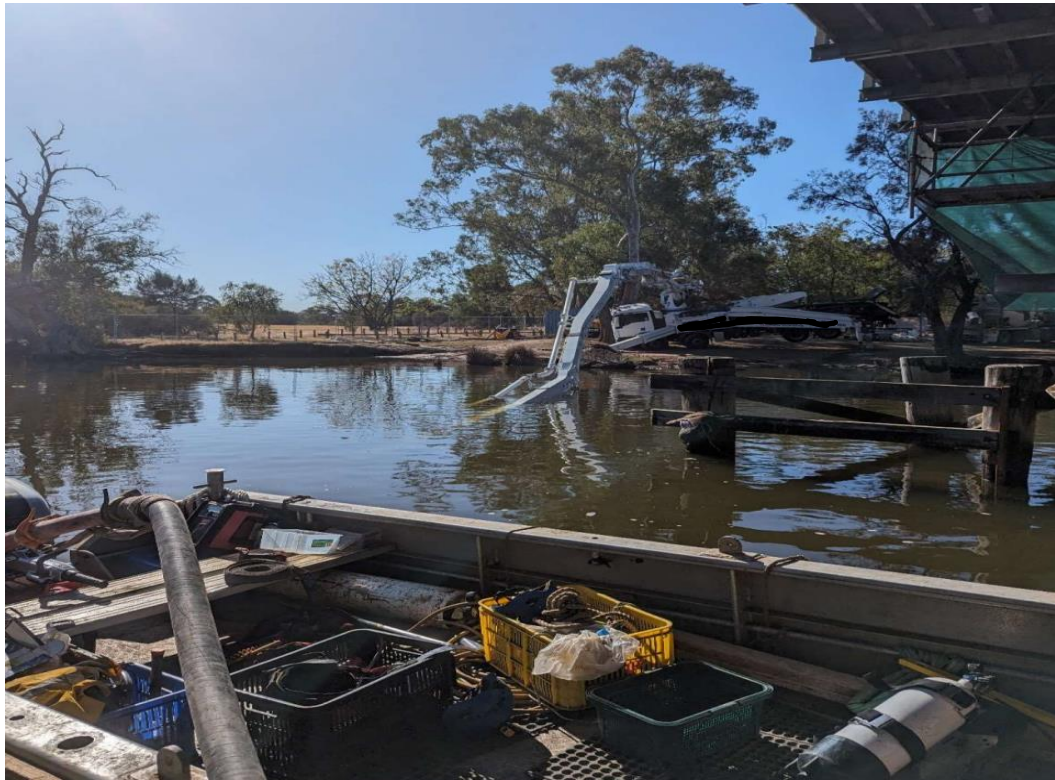
Before the line could be taken out of the form to be kinked, the ground under the left outrigger of the pump truck has collapsed and the outrigger has sunk into a hole, tilting the truck.

The boom was fully outreached over the river when the truck tilted, and the boom entered the river. The reducer at the end of the boom dropped approximately 2-3m onto the barge positioned beside the float brick platform.

*View from float brick platform of tipped truck and boom submerged in water.*

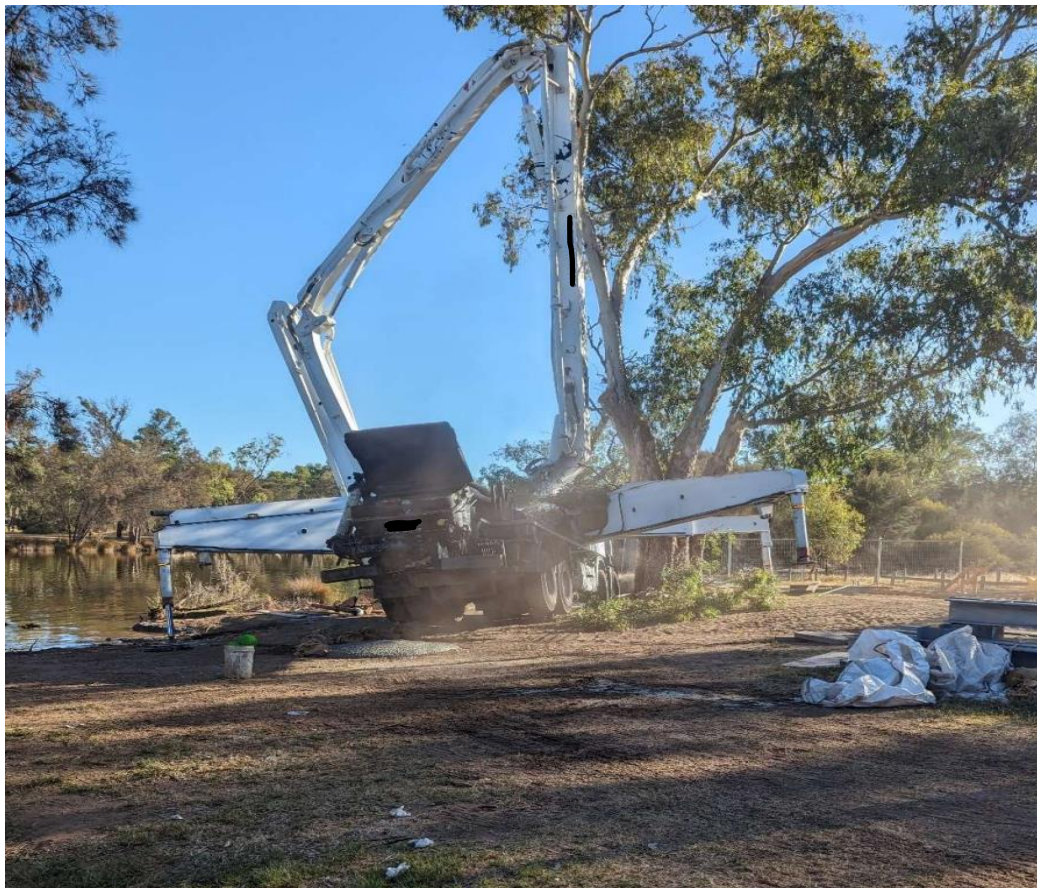
*Image of rear of pump truck lifted, showing the right rear outrigger in the air.*
