# SHW Serious Incident (SI) – Final Notice

| <b>Incident Short Description</b> | Leaf spring dislodges from trailer and injures Member of Public. |

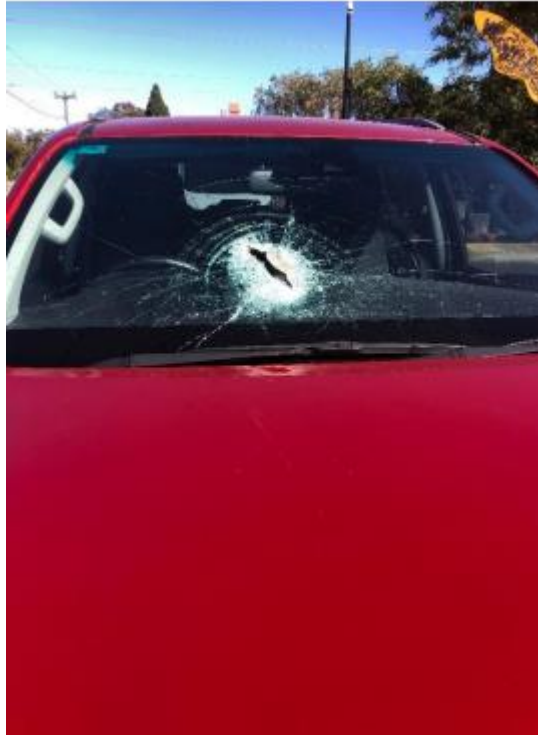
At approximately 8:00am, on the second trip on their journey back to the compound, they were travelling on a highway with two Members of Public (MoP) in an LV ute followed behind the road train. Suddenly, a leaf spring approximately 60cm in length has dislodged from the underside of the rear trailer, striking the windscreen of the LV.

Although both MoP's instinctively moved their bodies and heads to the side, the leaf spring and smashed through the windscreen and struck the passengers head, resulting in a laceration.

*Damage to the MoP windscreen and entry point of the leaf spring.*

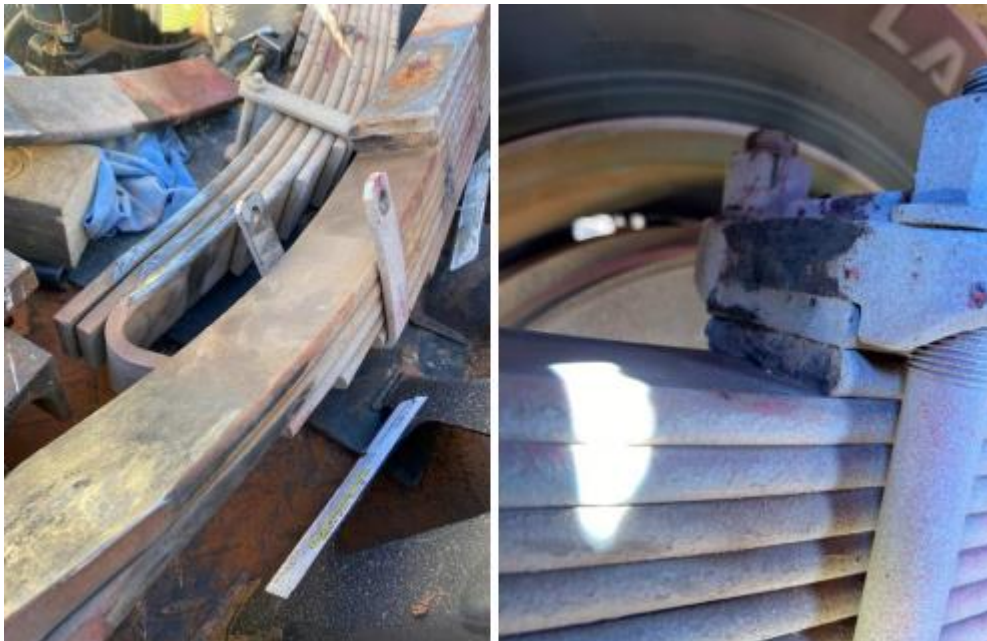
*Leaf spring pack with two missing leaf springs and restraint bolt.*

- The road train driver was not aware that a leaf spring had previously fallen from the same truck.
- Restraint bolt was missing from the leaf spring pack upon inspection post event, which allowed the second leaf spring to become loose and dislodge from its position.
- Poor conditions on highway access from the pit to various site locations.
- The risk register failed to identify hazards related to road conditions and maintenance of access roads into pits.

- All truck trailers to be inspected prior to commencement of gravel haulage to ensure no further leaf springs are found to be damaged.
- Pit haul roads to be inspected regularly and grading implemented where required to improve surface for travel.
- Include leaf spring checks as part of daily pre-starts.
- Review risk register to include risks and controls associated with road conditions.
