**mainroads**  
WESTERN AUSTRALIA

# SHW Serious Incident (SI) – Final Notice

| <b>Incident Short Description</b> | Excavator operator struck an unidentified overhead powerline |

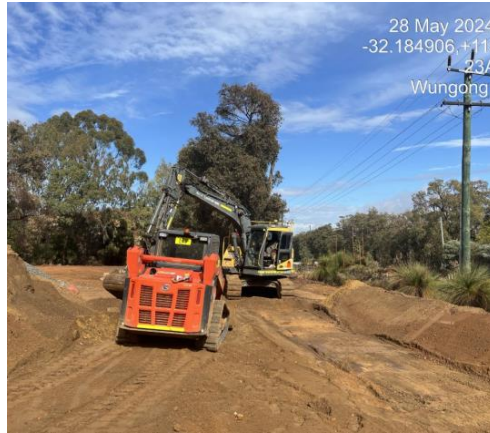
**Incident site****Contributing Factors**

At approximately 11:15am, whilst an excavator operator was moving soil, the boom of the excavator operated by a subcontractor operator has struck an unidentified overhead powerline at the construction site.

The site manager contacted the local power utility company to report the incident, and they dispatched experienced personnel to inspect the affected line. It was then confirmed the powerline was low voltage, and the powerline had not been identified in the Before You Dig (BYDA) plans.

- The powerline was not accurately identified in the BYDA plans provided for site. This incomplete mapping data led to a complete lack of awareness of the powerline's presence.
- The excavator operator was new to the site, and there was inadequate supervision provided to ensure they were aware of the site-specific hazards.
- The overhead powerline was not adequately marked, identified with visible signage, or had physical barriers, which contributed to it blending in with the surroundings.

- Collaborate closely with utility companies to ensure BYDA plans are accurate and up to date prior to commencement of works.
- Conduct comprehensive and thorough site surveys to identify all utilities, ensuring they are all identified and highly visible.
- Ensure new site personnel, especially those operating heavy machinery, receive adequate supervision and orientation. This includes ensuring they are aware of all site specific hazards.
