# SHW Serious Incident (SI) – Final Notice

| <b>Date of Incident:</b> | 13 November 2023 | <b>Time of Incident:</b> | 11:30 |

| <b>Incident Short Description:</b> | MOP collided with Main Roads Employee after veering into oncoming lane |

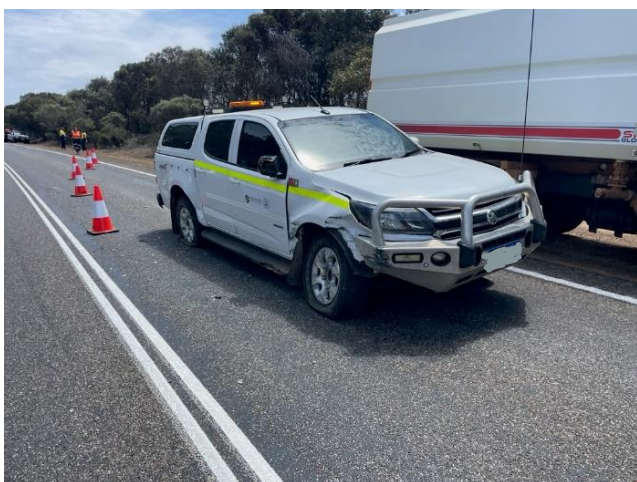
The light vehicle sustained unrepairable damaged to the driver's side front panels and tyres.

**Position of Main Roads' vehicle after incident**

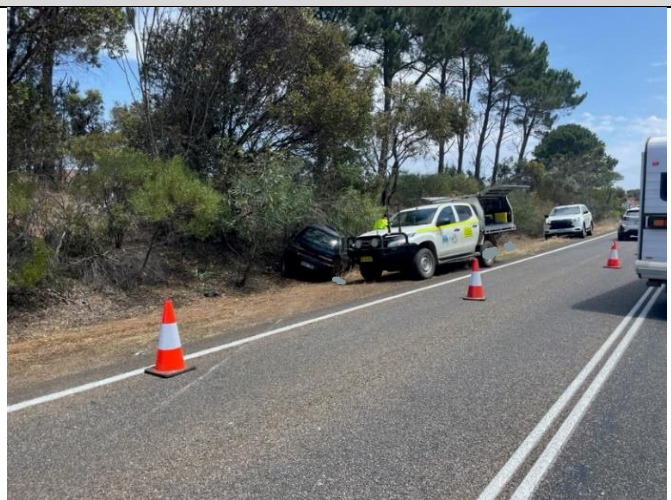
IP and MOP were transported to the hospital. The MOP had experienced a medical episode whilst driving, which resulted in the incident occurring.

**Position of MOP's vehicle after incident**
