# SHW Serious Incident (SI) – Final Notice

| <b>Incident Short Description</b> | A Worker (Injured Person) fell from a standing position on the axle of the low loader to the ground |

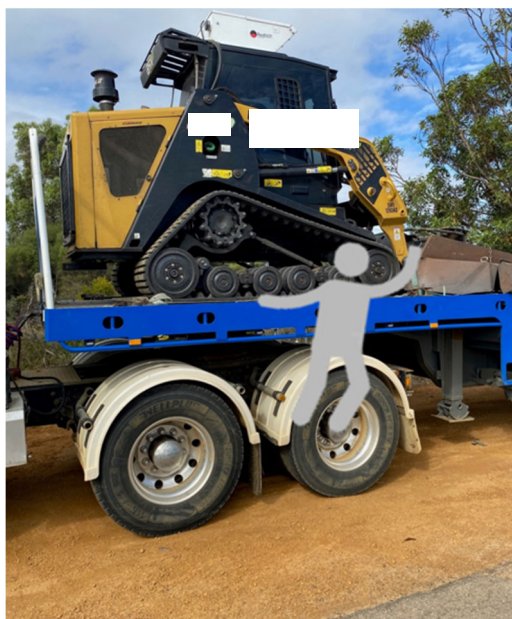
On 15 March 2024 at approximately 13:40pm, a worker (Injured Person (IP) reversed a material handler (skid steer with slasher attachment) onto a low loader. The IP was attaching tie down straps and had placed their foot on top of the axle of the low loader and was trying to attach a tie down hook to the bucket arm. The IP's foot slipped on the axle end, and they fell approximately 300-400mm to the shoulder of the road, directly onto their hip.

*Slasher in position for strapping (note location of foot and hand positions)*

- Contractor management process not fully applied to subcontractor prior to the works commencing.
- The axle end used as a step to work at height was not a safety step.

- Document and establish a loading and unloading checklist for the completion of these works that incorporates the findings and required controls from this event investigation.
