## RED BANNER ALERT

## SHW Serious Incident (SI) – Preliminary Notice

| <b>Incident Short Description</b> | MoP has failed to stop at a Vehicle Control Point, collided with a Fire Services vehicle and then impacted a Traffic Controller. |

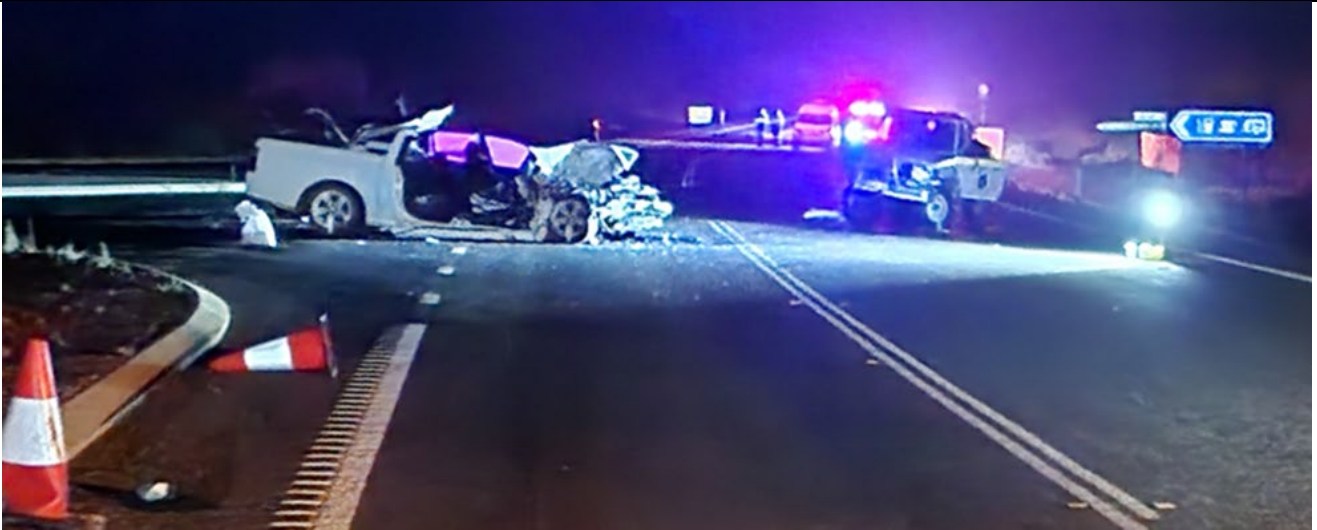
At approximately 19:55 a Member of Public (MoP) travelling westbound from the fire incident side of the VCP has driven through the road closure point without stopping. The MoP collided with a Fire Services Fast Attack Vehicle, and then struck a contractor Traffic Controller (TC).

The Traffic Control vehicle was parked on the left side of the road heading east (north side of the road) on the shadow side of the closure signs, with flashing lights on; it was dark after sunset when the collision occurred. The road section east of the VCP is straight on an improved section of road with good sight distance.

*Vehicle positions after the incident. The VCP was relocated west of the intersection post-incident.*

The Fire Services crews on scene immediately called 000, requested assistance, and provided first aid where possible. Police and Fire & Rescue attended the scene and extracted the MoP driver from their vehicle. Injured persons were conveyed to the Albany Hospital, and the MoP driver transferred to Perth with head injuries. The VCP point was relocated west of the intersection.
