# SHW Serious Incident (SI) – Preliminary Notice

| <b>Incident Short Description:</b> | Fire Ignited from Grinding Activities |

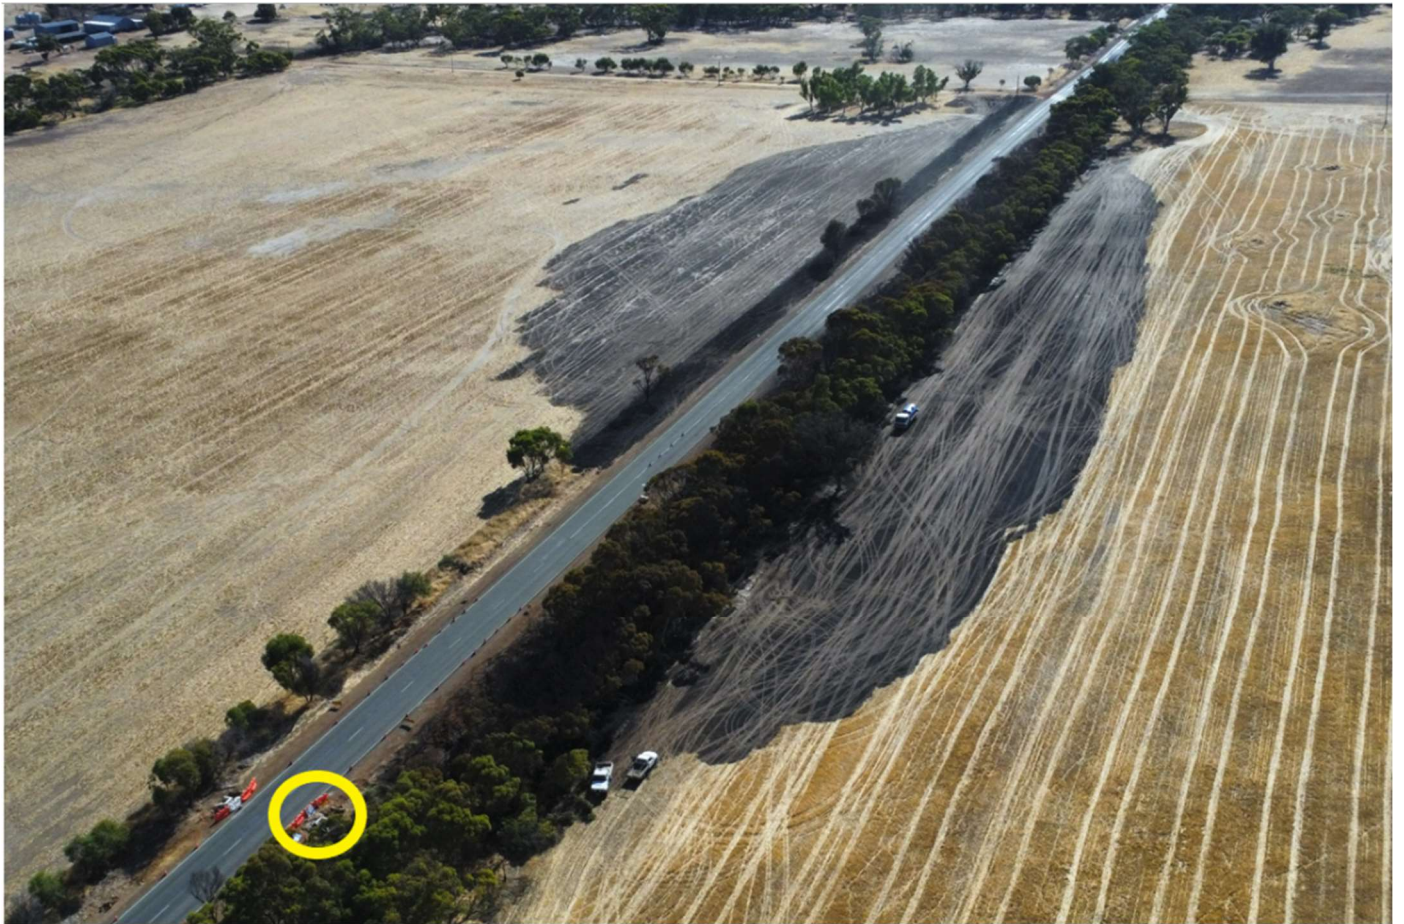
| <p>A Worker was tasked with removing formwork from a box culvert end treatment. While undertaking the task the worker attempted to remove a nut from a bar which was retaining a formwork shutter, however due to a burr on the end of the bar the nut could not come free. The worker retrieved a grinder to remove approx. 10mm of the burred end of the bar.</p> <p>Once the end of the bar was removed, the Worker picked up the offcut and as it was hot, released the offcut which unintentionally landed in dry grass/leaf material near the work area. The offcut then ignited a fire.</p> <p>The Worker attempted to control the fire with fire extinguishers and when this was unsuccessful, emergency services (local rural fire services) were contacted, and they mobilised to site to control the fire. In addition to the emergency services arriving onsite, a contingent of nearby farmers also assisted in the control of the fire.</p> <p>During the event, a Traffic Control vehicle was parked across the roadway (with the amber beacons and hazard lights activated) to prevent uncontrolled Member of Public entry to the emergency location. As the fire grew, smoke engulfed the vehicle which obstructed vision for oncoming traffic. A member of public who was coming to assist in extinguishing the fire, struck the TC vehicle at low speed. No TC personnel were in the vehicle at the time of crash. The member of public sustained no injuries.</p> <p>There was also damage sustained to personal property (a passing grain truck, boundary fence, vehicle).</p> <p>Following the incident, one of the traffic controllers reported an injury and was taken to the Wagin hospital. The TC sustained a burn to the right side of their face. The injury required an application of burn cream and dressing. Another TC was treated for suspected smoke inhalation.</p> |

***Fire damage area (looking East)***  
***Note: the yellow circle shows where the fire started.***

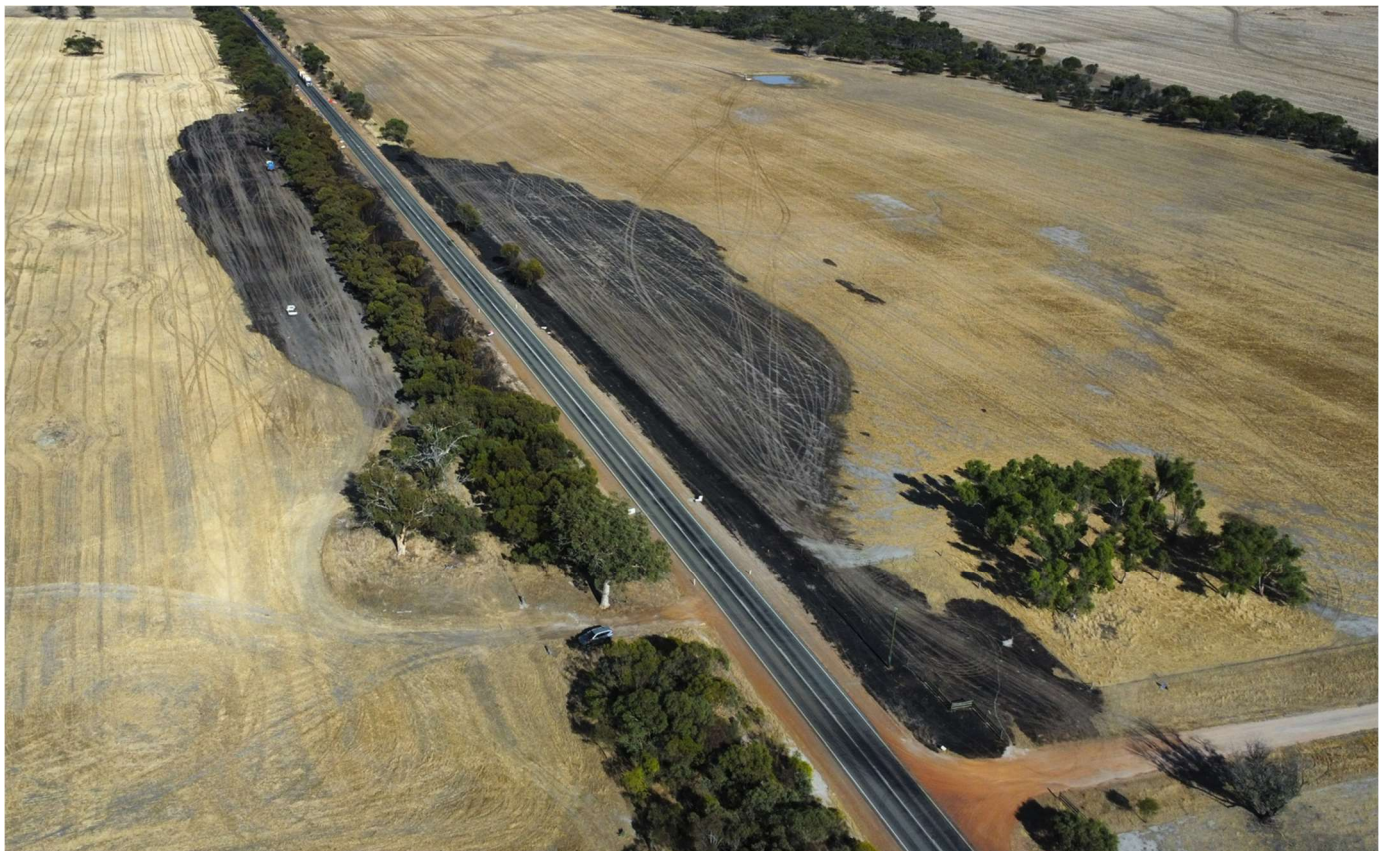
***Fire damaged area (looking West)***
