# Serious Incident – Final Notice

**CRITICAL RISK: Mobile Plant**

| <b>Incident Short Description</b> | Loader rolled over whilst undertaking operations in the materials pit. |

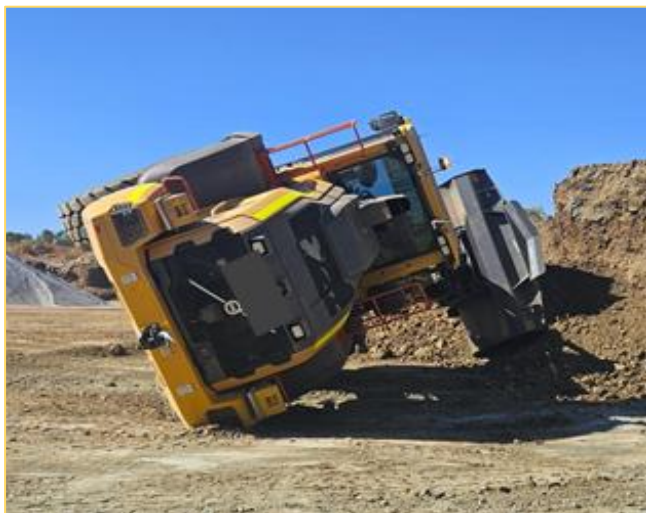
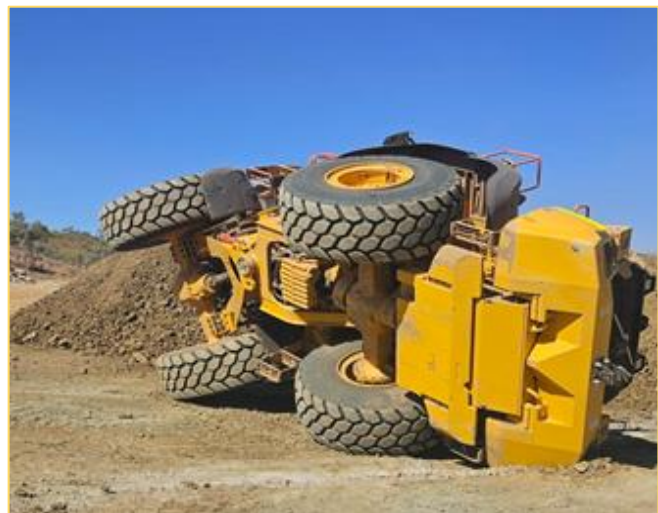
At approximately 9:40 am, a loader operator was working within the materials pit and had filled the loader bucket with material. While reversing away from the gravel stockpile, a large rock fell from the bucket and came to rest on the ground behind the machine.

The operator then proceeded to stockpile the material. During this activity, the loader travelled over the rock that had fallen from the bucket. As a result, the loader became unstable, tilted, and slowly rolled onto its right-hand side while the bucket remained fully loaded. The operator was able to safely exit the loader and did not sustain any injuries because of the incident.

- The loader was operating on uneven ground which likely contributed to instability by increasing lateral and vertical movement of the machine.
- Tyres were suspected to be overinflated, contributing to machine instability.
- Material within the bucket was unevenly distributed, resulting in a lateral shift of the centre of gravity and contributing to the rollover event.
- The loader bucket was positioned at a high elevation during travel, significantly reducing the machine's centre of gravity and stability.
- The loader operator held a VOC to operate a Volvo Wheel Loader and not the higher capacity machine he was actually operating.

- Load operator to undertake a post incident Verification of Competency (VOC).
- Pit Operations SWMS to be reviewed to verify hazards such as uneven ground, and any other hazards such as rocks in the work area.
- Plant Risk Assessments and plant daily pre-starts to be reviewed and spot checks on operators to be conducted to verify hazard awareness and knowledge on how to mitigate risks.
- Site communications (UHF radios and mobile coverage) to be reviewed to ensure sufficient communication coverage throughout the site is achieved.
