# SHW Serious Incident (SI) – Final Notice

| <b>Incident Short Description</b> | Traffic Controller on foot within 1.2m in a 60km speed zone |

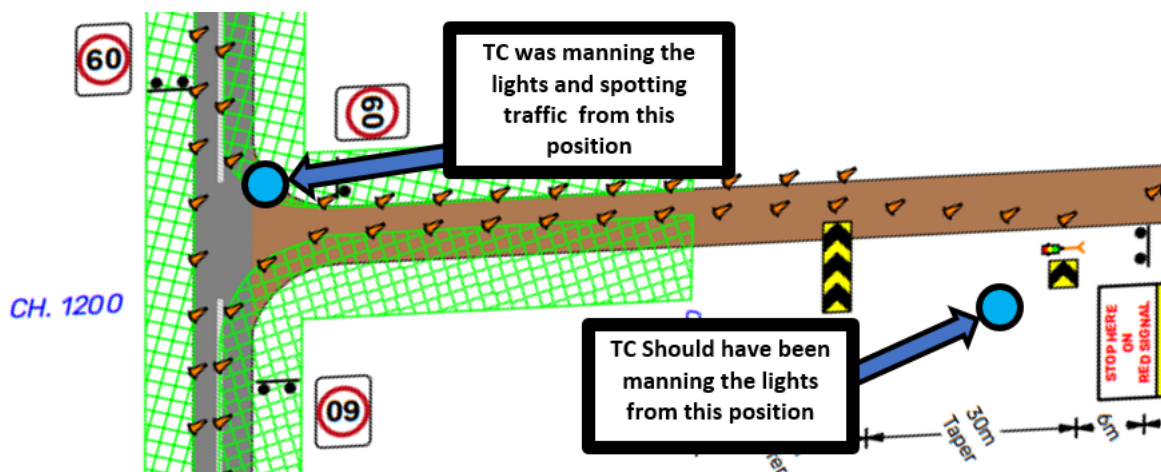
At approximately 12:08pm a Main Roads representative entered the work area to conduct a traffic audit, and has observed a TC standing within 1.2m of a live lane under a 60km/h speed reduction. The Main Roads representative addressed the behaviour observed with the TC and the incident was reported shortly after to the principal contractor's HSEQ Advisor.

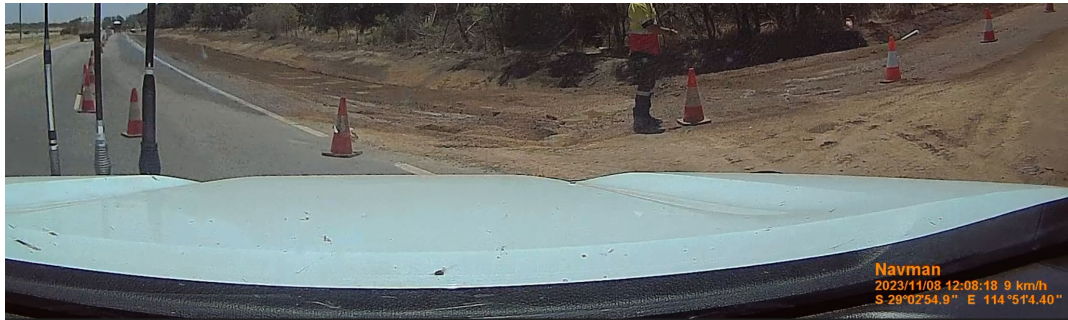
***Traffic Controller standing on delineation line***

- Review and amend TMP to develop and include TGS's for speed reductions to 40km/hr.
- Safety leadership interactions and site inspection KPI's to be met by the Principal Contractor to ensure all Critical Risks inclusive of Traffic Management and Mobile Plant is being controlled.
- Review and amend SWMS to ensure adequate controls are in place for Traffic Management and Mobile Plant risks and hazards.
