# SHW Serious Incident (SI) – Final Notice

| <b>Incident Short Description</b> | Plate compactor fell whilst being lifted and contacted the dogman's safety helmet |

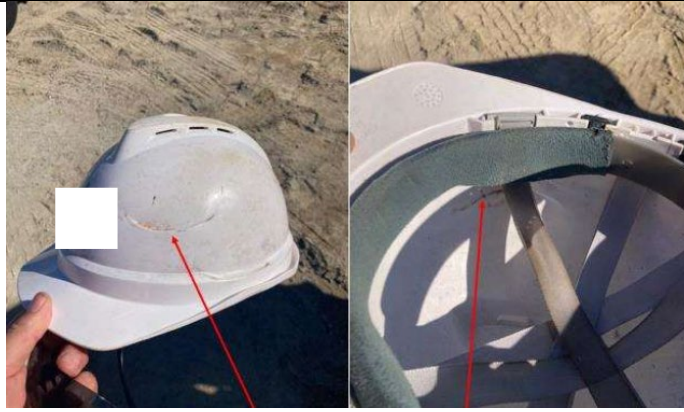
***The safety helmet was split from the contact of the handle of the plate compactor and the inside of the helmet has contacted the left-hand front of the dogman's scalp.***

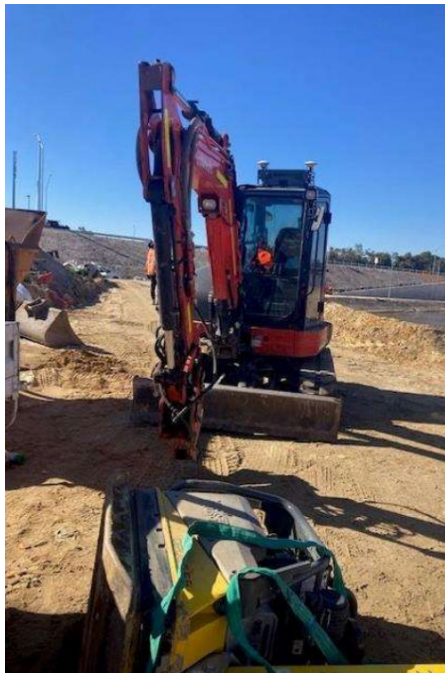
***5 tonne Kubota excavator and the plate compactor.***

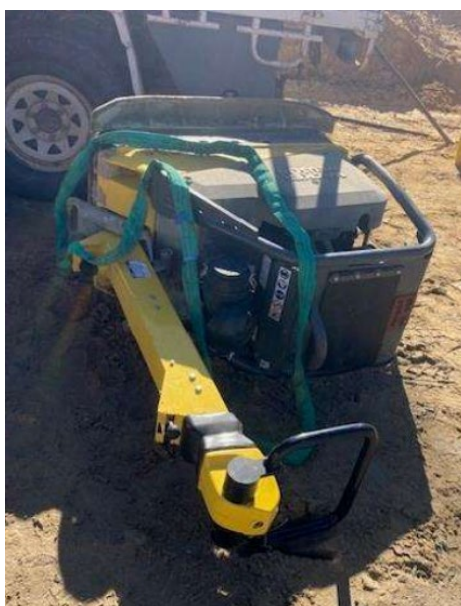
***The handle of the plate compactor has contacted the left-hand side of the dogman's safety helmet.***
