mainroads  
WESTERN AUSTRALIA

# SHW Serious Incident (SI) – Final Notice

| <b>Incident Short Description:</b> | Worker observed sitting on front step of Stabilizer when travelling |

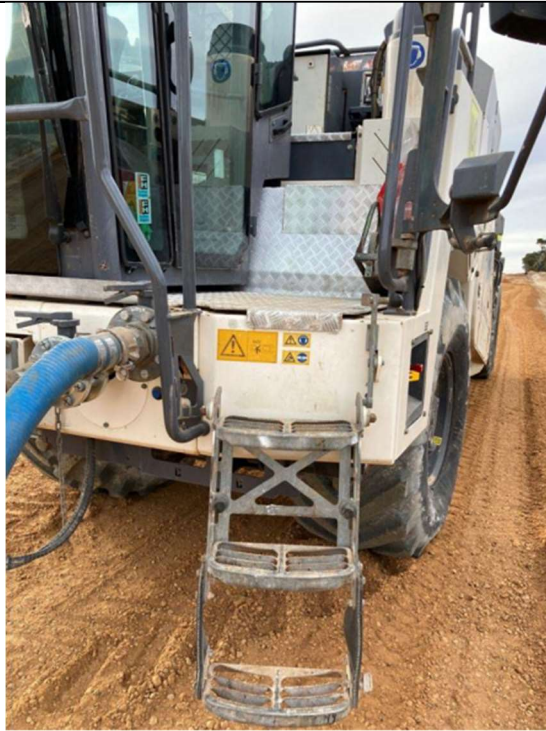
At approximately 14:00hrs on the 8th of March 2022 a stabiliser crew member conducting moisture control was observed sitting on the top of the front steps of a stabiliser machine while it was travelling to a new location. A call was immediately placed to the principal contractors Senior Supervisor who attended site and stopped the works.

A passenger seat with seat belt was provided in the stabilizer cab for a passenger but was not used. A vehicle was also available for transporting workers within the site, this was not within the area of the works at the time the stabilizer commenced travelling. All warning decals on the stabiliser were in good condition, including warnings for not accessing / riding on the plant when moving at the location the worker was sitting.

***Location of worker sitting. Warning decals clearly visible***

- Review of relevant Sub-Contractors SWMS and risk assessment
- Additional Leading Hand to be included to provide support and help to the project team
- Review and update project CRAW, Site induction and Safety Management Plan

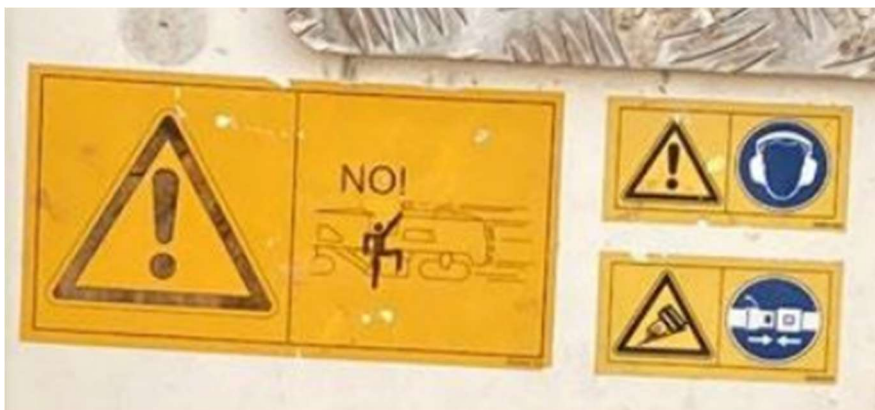
***Warning decals***

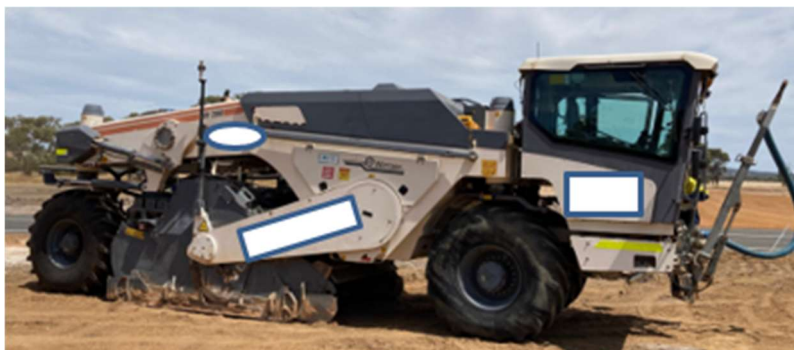
***Stabilizer***
